EVALUATION OF THE EFFECT OF BOTTOM BAR SPLICE LOCATION ON PERFORMANCE OF BEAMS IN REINFORCED CONCRETE PERIMETER FRAMES

A Dissertation Presented

DOCTOR OF PHILOSOPHY

Civil and Environmental Engineering

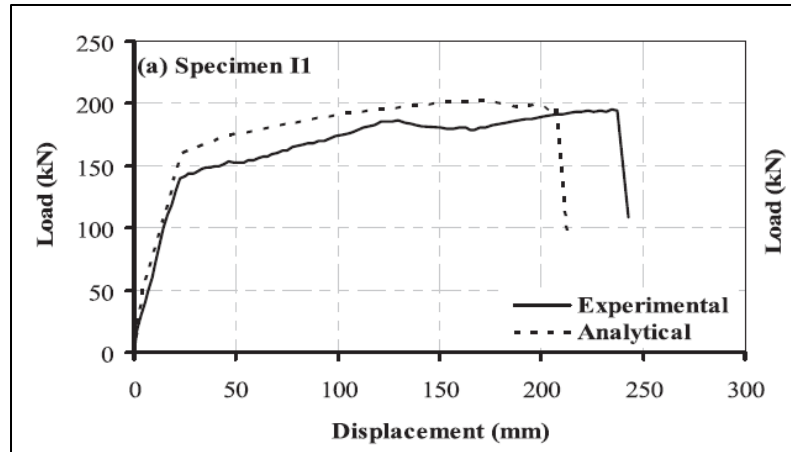
Figure 2.7: Analytical and experimental load displacement results (Qian and Li 2012a)

The laboratory results showed that the failure mechanism was controlled by the formation of a plastic hinge in the left beam near the column face. Also, increment of the longitudinal and transverse reinforcement ratios of the non-seismic detailing increased the load-carrying capacity and the displacement response of reinforced concrete frames in resisting progressive collapse caused by the loss of an exterior column. Finally, the finite element simulations compared well with the load-displacement response measured in the laboratory as shown in Figure 2.7.

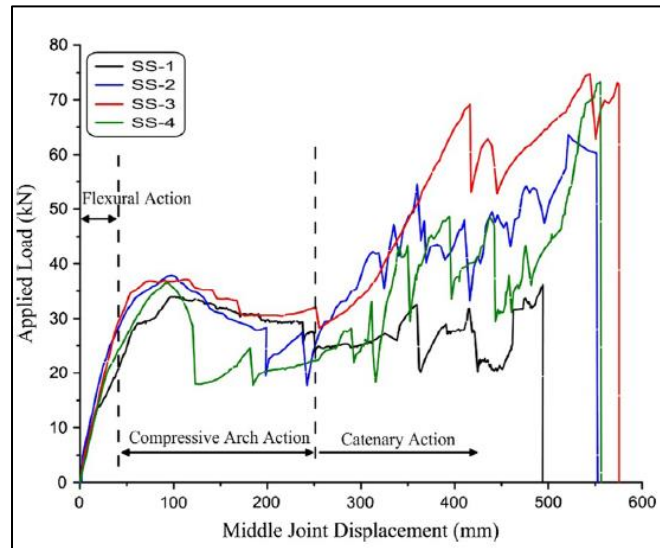
Figure 2.12: Three stages described by Alogla Weekes and Augustus-Nelson (2016)

arch action began when cracks developed at the beam-column joint interfaces. Finally, once the cracks were developed throughout the beam length and passed completely through the beam section, the behavior was dominated by catenary action. Figure 2.12 shows load-deflection curves where the three behavior stages are marked. The load-carrying capacity of specimens containing the new reinforcing scheme proposed by the investigators was 5 to 12% larger in the compressive arch action stage and 52 to 109% larger during catenary action compared with the specimen with a standard reinforcing pattern.

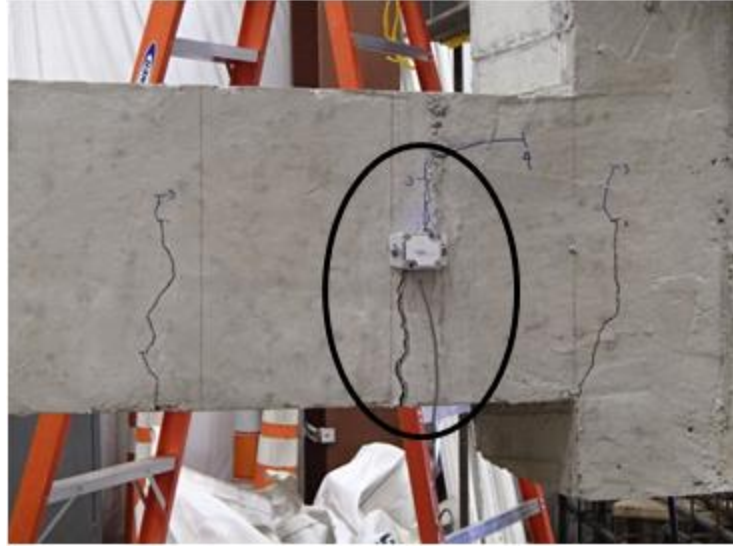
Figure 5.2: Critical flexural crack near the center column (Specimen 1)

The test was conducted by applying a vertical force on the center column using force control. At 32 kip of applied force and a 1.4 in. vertical displacement of the center column (vertical displacements were measured after the specimen was in position so they do not include the estimated vertical deflection that occurred after the specimen placement), flexural cracks developed at the top of the beams near the exterior columns, and at the bottom of the beams near the center column. The maximum width of these newly formed cracks was 0.008 in. One of the existing dead load cracks near the center column on the south beam widened to 0.060 in., as shown in Figure 5.2. Figure 5.3 illustrates the crack pattern that the specimen exhibited at this force level.

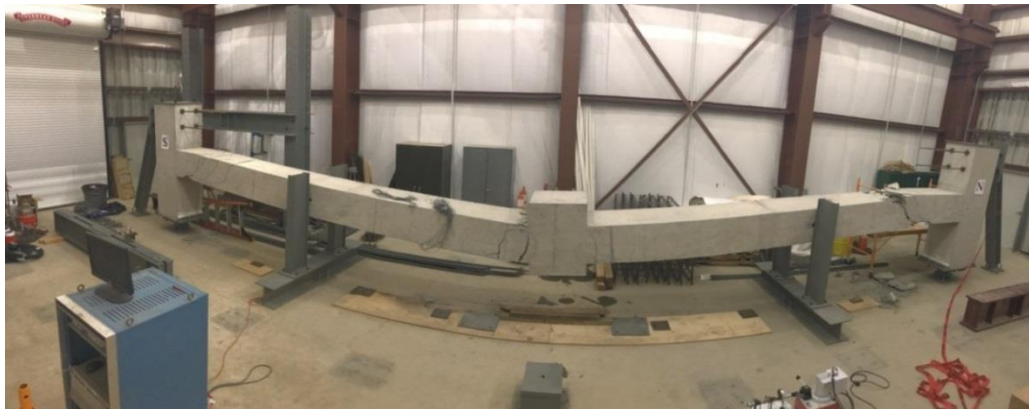
Figure 5.6: Specimen 1 condition at the end of testing after removal of force

further, and concrete spalling near the diagonal tension crack was observed at a 16.3 in. center column vertical displacement. Near full-depth diagonal tension cracks were observed at the beam near the north column with a maximum width of 0.5 in and accompanied by concrete spalling. Crushing of the concrete at the bottom of the beams occurred near the exterior columns. One flexural crack near the center column increased in width to 1 in. For safety, the test was stopped at this point because the beam started to deflect laterally and came in contact with the lateral supports. Figures 5.6 and 5.7 show the condition of Specimen 1 at the end of the test after the loading beam was removed. Also, Figure 5.8 shows the final crack pattern.

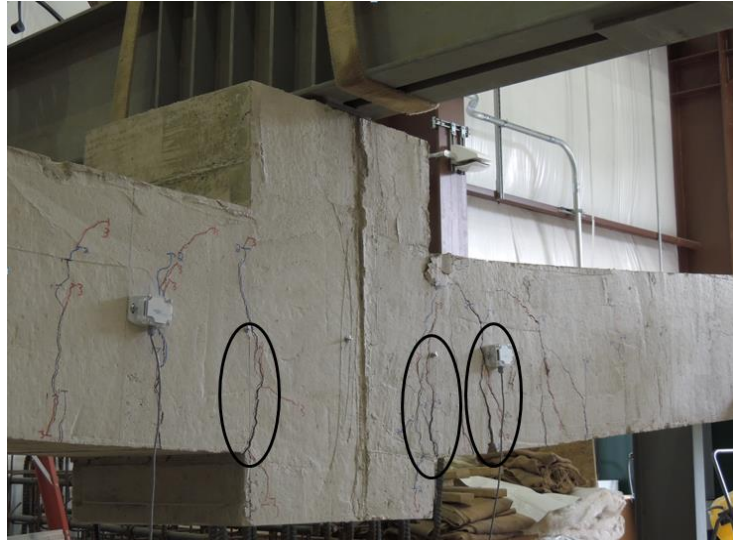
Figure 5.20: Critical flexural cracks near the center column (Specimen 2)

At 32 kip of applied force and a 1.0 in. vertical displacement of the center column, flexural cracks developed at the top of the beams near the exterior columns, and at the bottom of the beams near the center column. The maximum width of these newly formed cracks was 0.006 in. Three existing dead load cracks near the center column widened to 0.060 in., as shown in Figure 5.20. Figure 5.21 illustrates the crack pattern that the specimen exhibited at this force level.

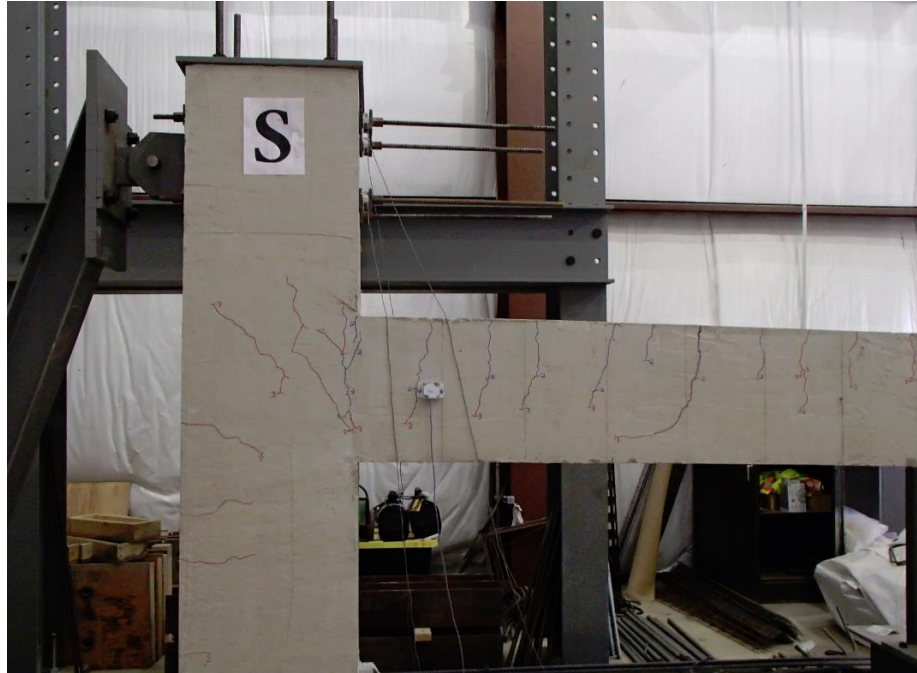
Figure 5.22: Cracks near the south column (Specimen 2)

As the applied force reached the maximum applied value of 50 kip (center column vertical displacement of 6.4 in.), diagonal tension cracks appeared at the beam ends at near the exterior columns. The maximum width of these observed cracks was 0.25 in. The critical flexural crack near the center column increased to a width of 0.25 in. Also, initiation of concrete crushing was observed at the top of the beams meeting at the center column. Shear and flexural cracks appeared at the joint and the exterior face of the exterior columns respectively. Figure 5.22 shows the cracks near the south column. Also, Figure 5.23 shows the crack pattern for this force level.

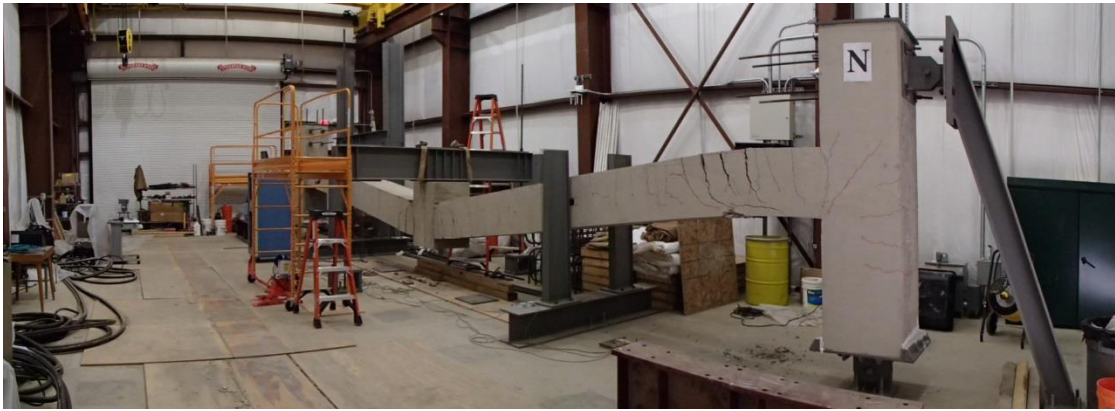
Figure 5.24: Specimen 2 condition at the end of testing after removal of force

force, full-depth diagonal tension cracks were observed at the beam near the south column with a maximum width of 2 in. and accompanied by concrete spalling. Crushing of the concrete at the bottom of the beams occurred near the exterior columns. One flexural crack near the center column increased in width to 0.75 in. For safety, the test was stopped at this point. Figures 5.24 and 5.25 show the condition of Specimen 2 at the end of the test after the loading beam was removed. Also, Figure 5.26 shows the final crack pattern.

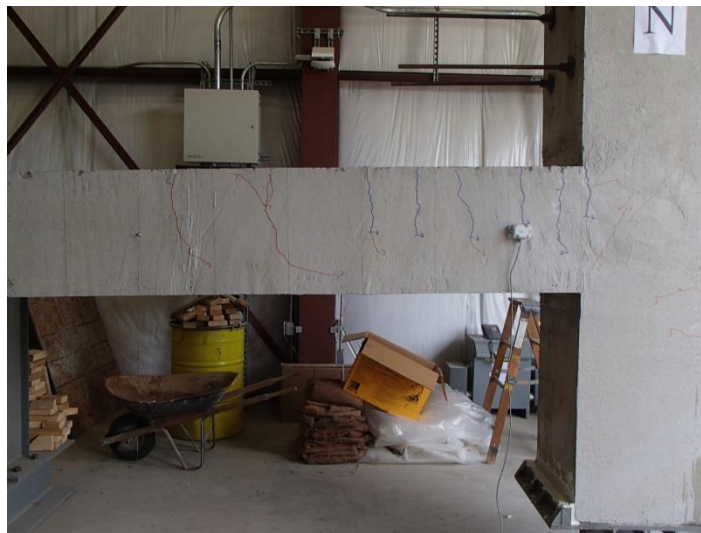
Figure 5.40: Cracks near the north column (Specimen 3)

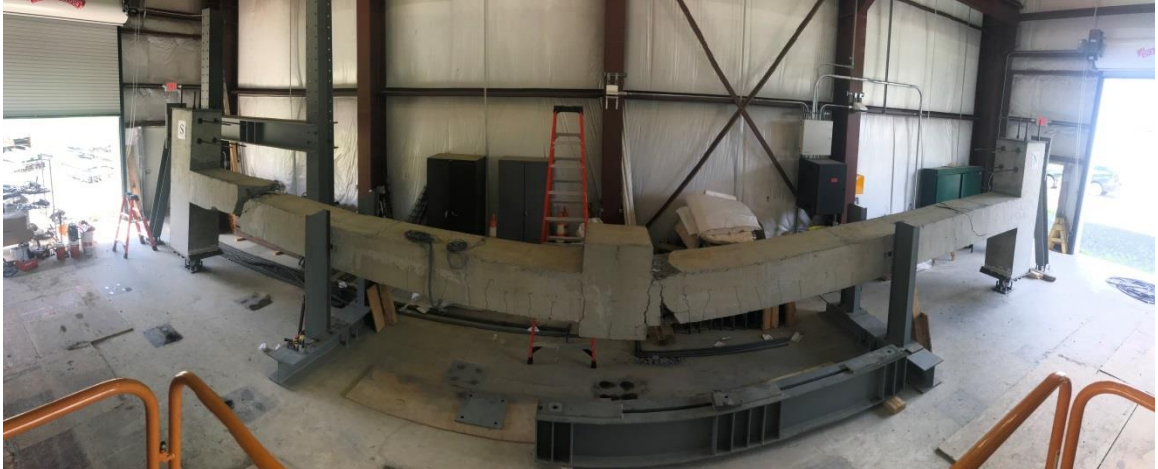
Figure 5.42: Specimen 3 condition at the end of the test

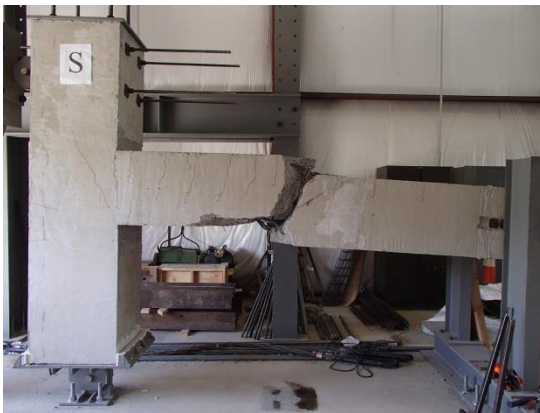
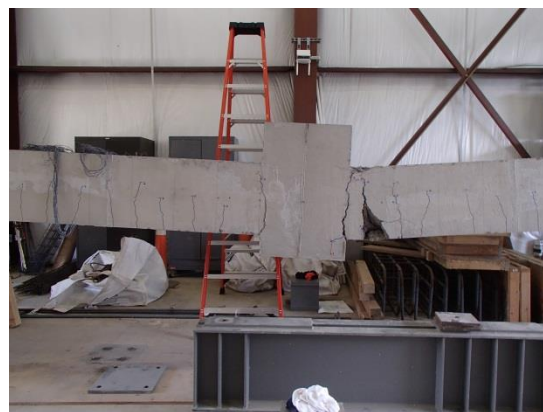
Figure 5.43: Specimen 3 condition at the end of the test a) near the south column, b) near the north column and c) at the center column

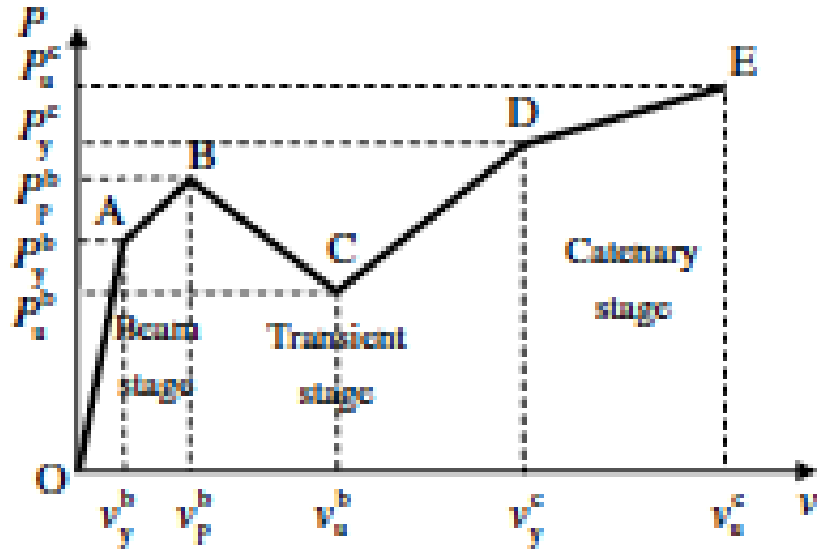
Figure 6.18: Simplified progressive collapse response curve developed by Jian and Zheng (2014)
