TECHNICAL ARTICLE

Low-tech riparian and wet meadow restoration increases vegetation productivity and resilience across semiarid rangelands

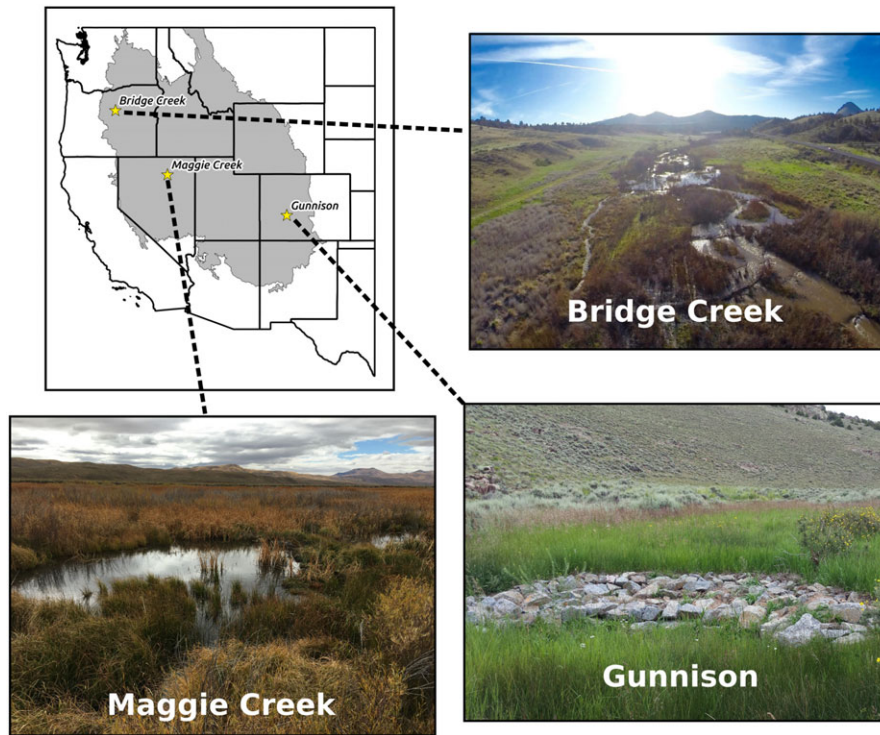
Figure 1. Locations of the three restoration projects with associated representative ground images of postrestoration conditions. The gray area in the map represents the general extent of the Intermountain West, United States.

(Fig. 1). Projects range in primary restoration technique applied (Zeedyk structures, beaver dam analogs [BDAs], and time-controlled grazing management), geography (Colorado, Oregon, and Nevada), and time since implementation. For two projects, we evaluate changes in NDVI before and after restoration, compare those to control reaches, and use aerial extent of greenness to identify annually when higher NDVI is most apparent. For the third project, we compare NDVI before and after restoration, and at early-, mid-, and long-term stages along a 22-year restoration continuum. Using these long-term data, we explore changes in vegetation sensitivity to precipitation as a metric of ecohydrologic resiliency to climatic variability.

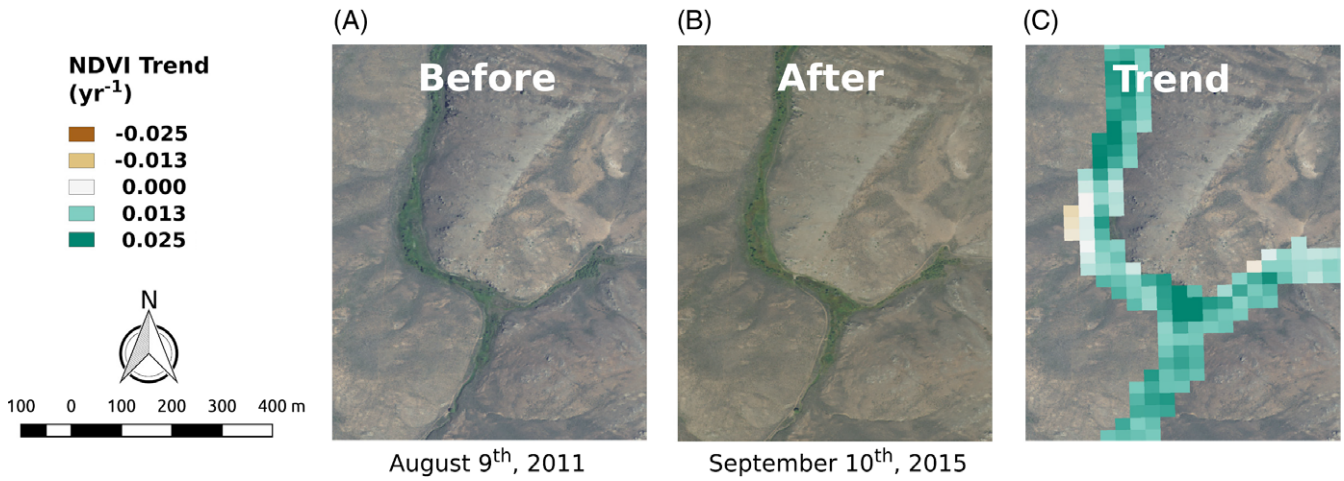
Figure 2. Aerial images of a Gunnison restoration reach where over 40 structures were originally installed. The image is from (A) before and (B) after restoration. (C) The linear trend in NDVI (calculated from Landsat satellite imagery) since restoration, representing increased vegetation productivity.

Productivity increased following restoration in all three projects (Figs. 2–4). Productivity increased by 24% at Gunnison (before: 0.41 ± 0.05 NDVI, after: 0.51 ± 0.02 NDVI; Fig. 5A),

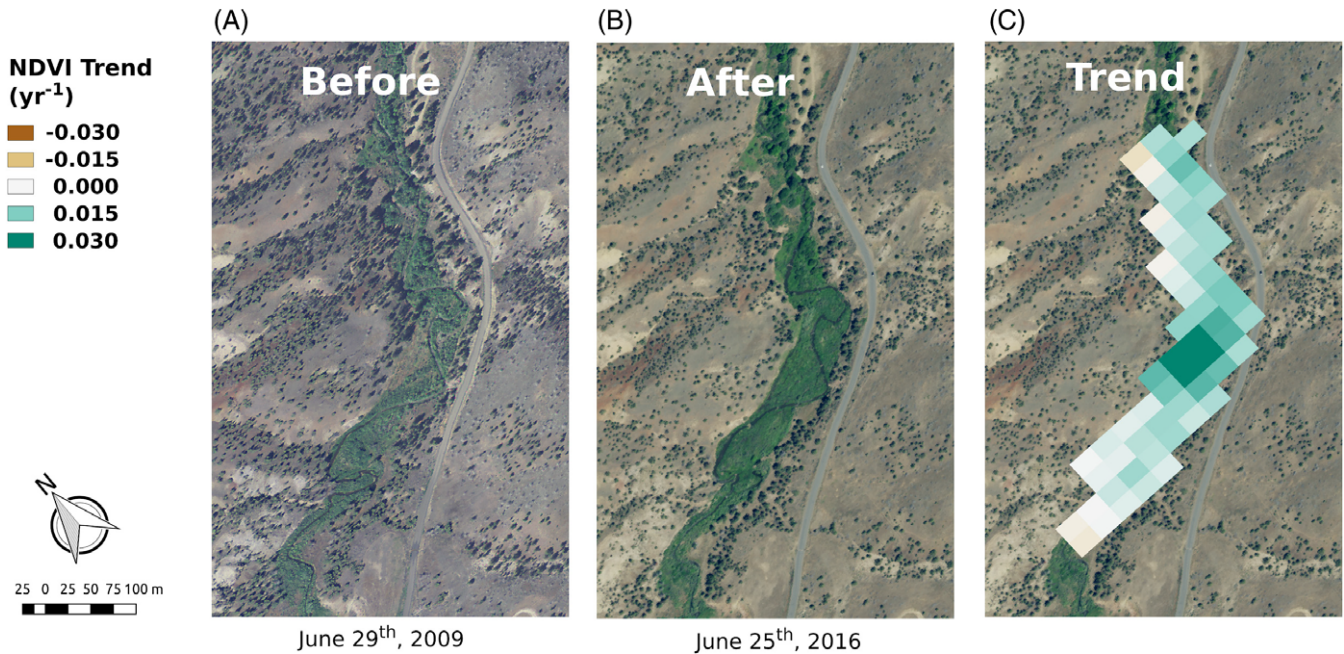
Figure 3. Aerial images of a Bridge Creek restoration site from (A) before and (B) after restoration over a 600-m stretch of the total 4 km treated reaches. (C) The linear trend in NDVI (calculated from Landsat satellite imagery) since restoration, representing increased vegetation productivity.

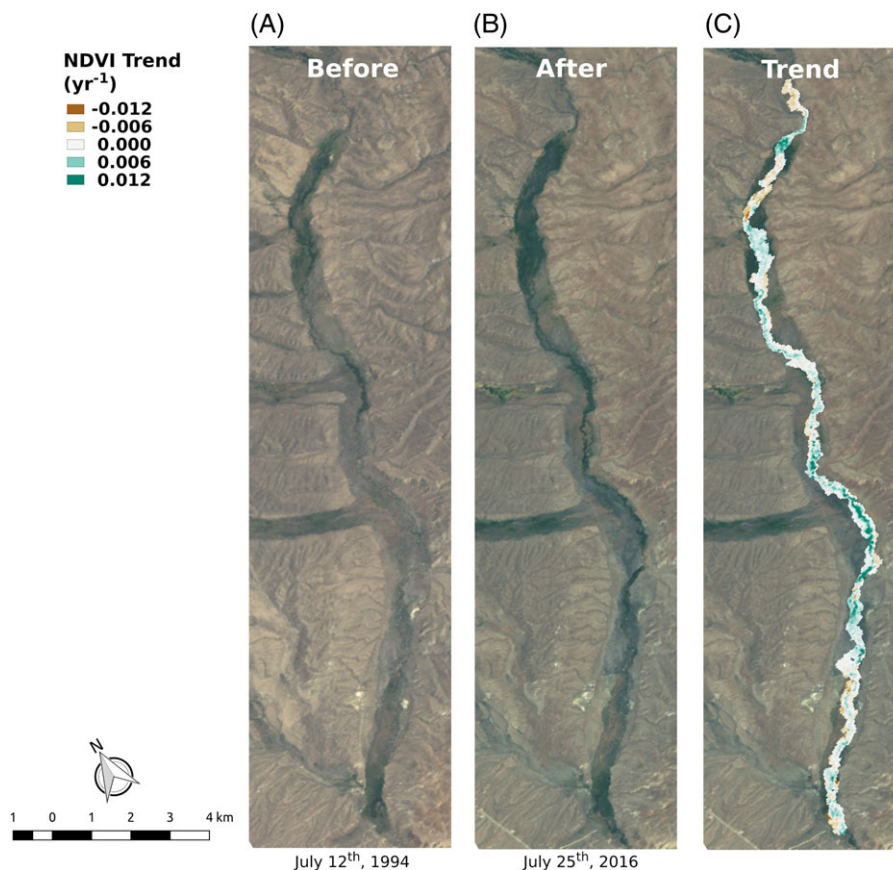
Figure 4. Aerial images of the Maggie Creek reach used in the evaluation from (A) before and (B) after restoration. (C) The linear trend in NDVI (calculated from Landsat satellite imagery) since restoration, representing increased vegetation productivity.

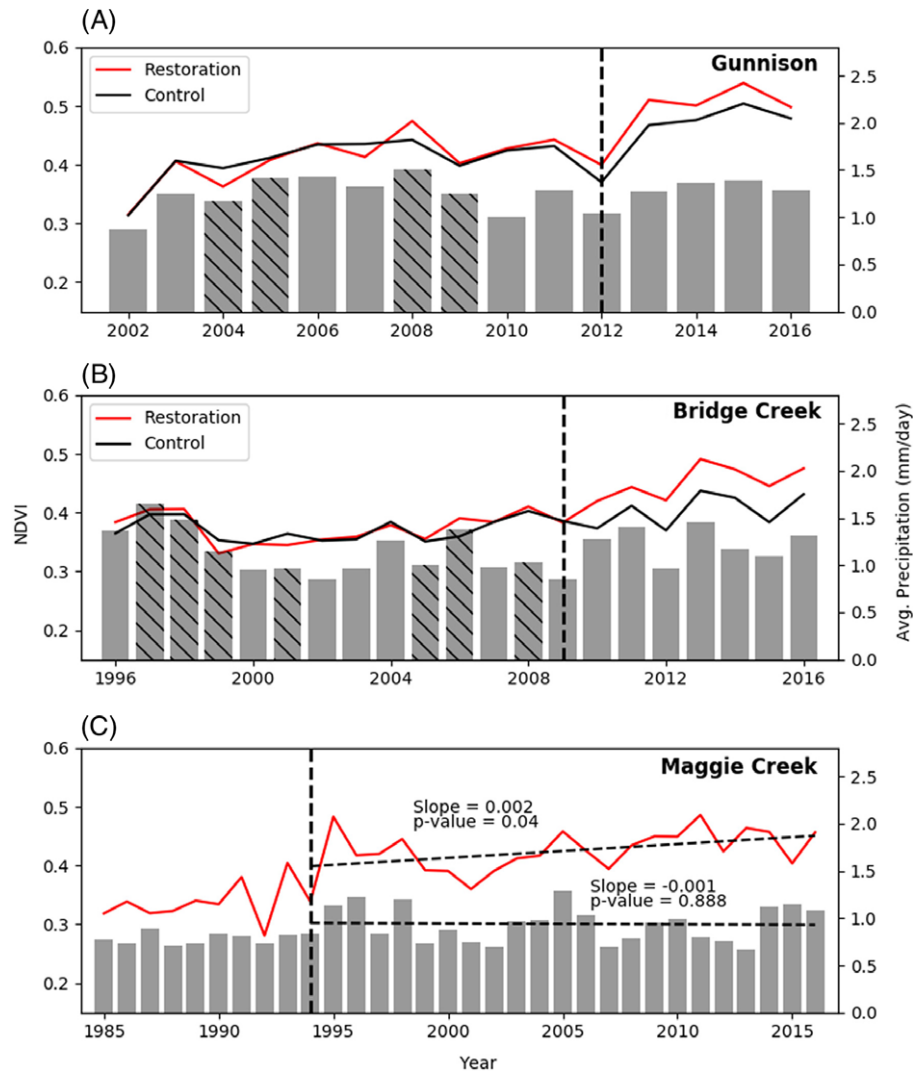
Figure 5. Annual late season (15 July to 30 September) mean NDVI for (A) Gunnison, CO, (B) Bridge Creek, OR, and (C) Maggie Creek, NV restoration sites. Where applicable, the red line represents the mean NDVI of the treated sites and the black line represents the mean NDVI of the control sites. The bar chart shows average annual daily precipitation for the region over the same time period. The hatched bars mark the years used to represent prerestoration conditions at Gunnison and Bridge Creek. The vertical dashed line represents the year that restoration activities commenced. For Maggie Creek, NDVI and precipitation trends are illustrated with a dashed line.

and by 20% at Bridge Creek (before: 0.38 ± 0.03 NDVI, after: 0.45 ± 0.03 NDVI; Fig. 5B). Treated sites showed immediate improvements over the control sites in productivity after restoration and consistently maintained higher levels (Fig. 5A & 5B). Furthermore, improvements between the treated and control sites, pre- and postrestoration, were statistically significant at the $p < 0.005$ level for both Gunnison and Bridge Creek. Interannual variability of productivity in the control and treated sites align well with the variability in the water-year precipitation. At the long-term site, Maggie Creek productivity increased by 22% in the first 11 years postrestoration (before: 0.34 ± 0.03 NDVI, after: 0.41 ± 0.03 NDVI) compared to the

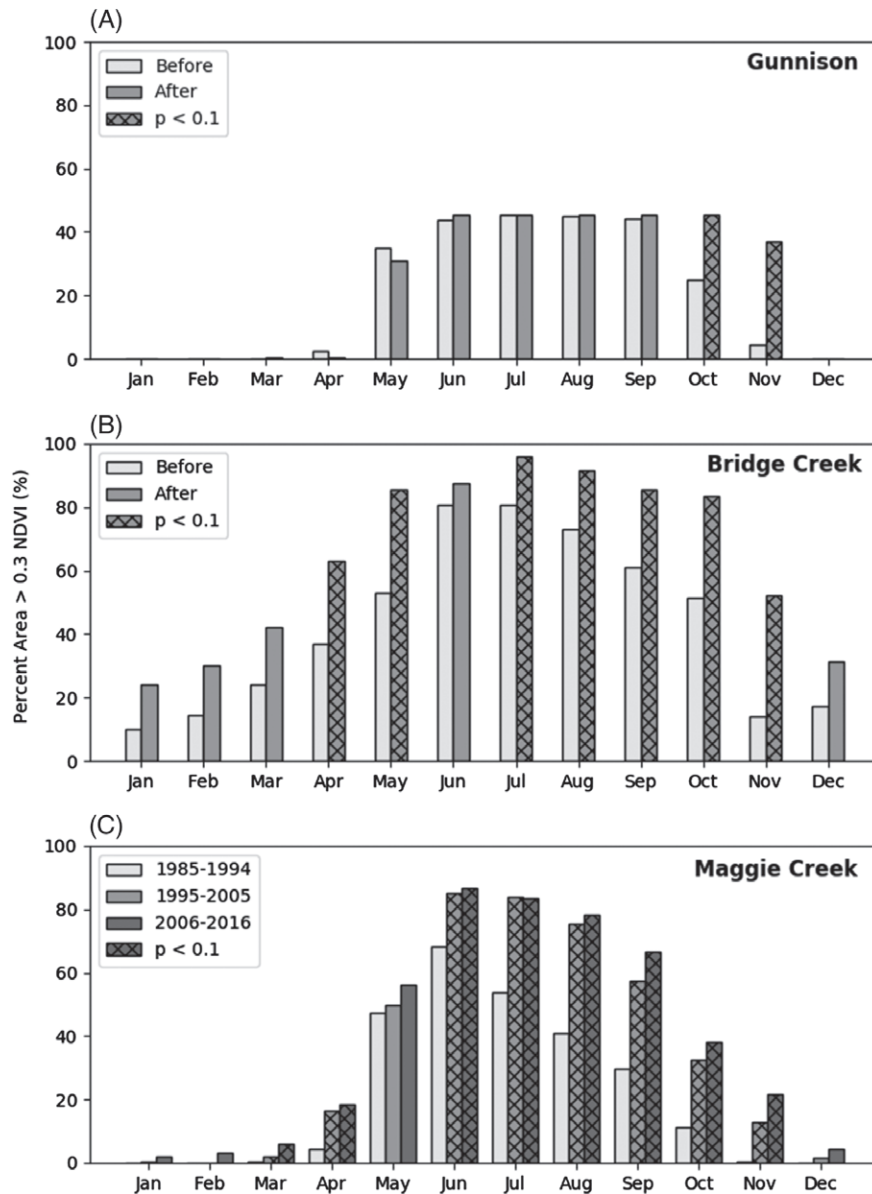
Figure 6. Monthly percent area of productive treated reaches (NDVI > 0.3) in (A) Gunnison, CO, (B) Bridge Creek, OR, and (C) Maggie Creek, NV restoration sites before and after restoration. For Maggie Creek, three different time periods are included: before restoration, first 11 years postrestoration, and second 11 years postrestoration. Hatched bars represent months where the increase in productive area was statistically significant ($p < 0.1$) compared to before restoration.

At all sites, restoration not only increased the overall vegetation productivity but extended such productivity longer into the growing season (Figure 6). At Gunnison, the proportion of productive mesic area (NDVI > 0.3 threshold) within treated reaches increased the most during October (83%) and November (721%) (Fig. 6A). At Bridge Creek, large increases in productive mesic areas are present in winter, spring, and fall, with

the largest increase occurring in November (276%) (Fig. 6B). At Maggie Creek, we delineated three separate time periods to evaluate percent productive mesic area of the treated reach through time (Fig. 6C). All months had increases in productive mesic area in the first 11 years after restoration. All months except July showed further increases in productive mesic area during the subsequent 11 years. The largest increases occurred during the first decade after restoration in the summer and fall months. All months except January, February, and May had increases that were statistically significant at the $p < 0.1$ level.

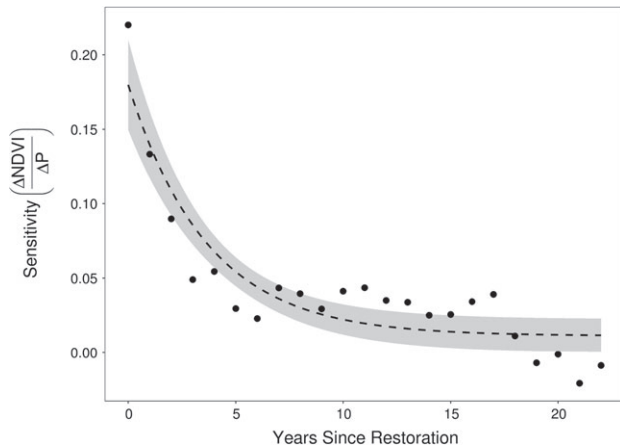
Figure 7. Sensitivity of NDVI to water-year precipitation relative to years since restoration for Maggie Creek. Values are calculated as a moving window linear regression using 5-years as the width of the window. Fitted line represents the best-fit exponential decay curve surrounded by 95% confidence intervals.

The extended time since restoration enabled us to evaluate sensitivity of changes in NDVI to changes in precipitation over time. We used a rolling linear regression with a 5-year window to examine the relationship between NDVI and precipitation. We normalized precipitation so that values were between -1 and 1 , matching the range of NDVI. By normalizing precipitation values we can interpret slope of the linear regression as unit change in NDVI per unit change in water-year precipitation (i.e. sensitivity) during the specified 5-year window. A value of one represents 100% sensitivity, meaning that any change in precipitation is expressed similarly in NDVI and a value of zero represents 0% sensitivity, meaning that any change in precipitation is not expressed in NDVI. We hypothesized that a reduction in sensitivity through time could be a signal of increased resiliency against impacts of drought and climate variability. To test this idea, we fit data as a nonlinear least squares model using an exponential decay function:

At Maggie Creek, sensitivity to precipitation decreases rapidly from 0.22 to around 0.03 over the first 10 years postrestoration and then levels off ($Y_0 = 0.188$ and $k = 0.273$; Fig. 7). Most improvements in sensitivity are made in this first decade after restoration. After which, a new equilibrium appears to be reached where productivity fluctuates very little with changes in precipitation, thus suggesting greater resiliency against the impacts of drought and climate variability.
