Non-Contact Evaluation Methods for Infrastructure Condition Assessment

NON-CONTACT EVALUATION METHODS FOR INFRASTRUCTURE
CONDITION ASSESSMENT

A dissertation submitted in partial fulfillment
of the requirements for the degree

Civil and Environmental Engineering

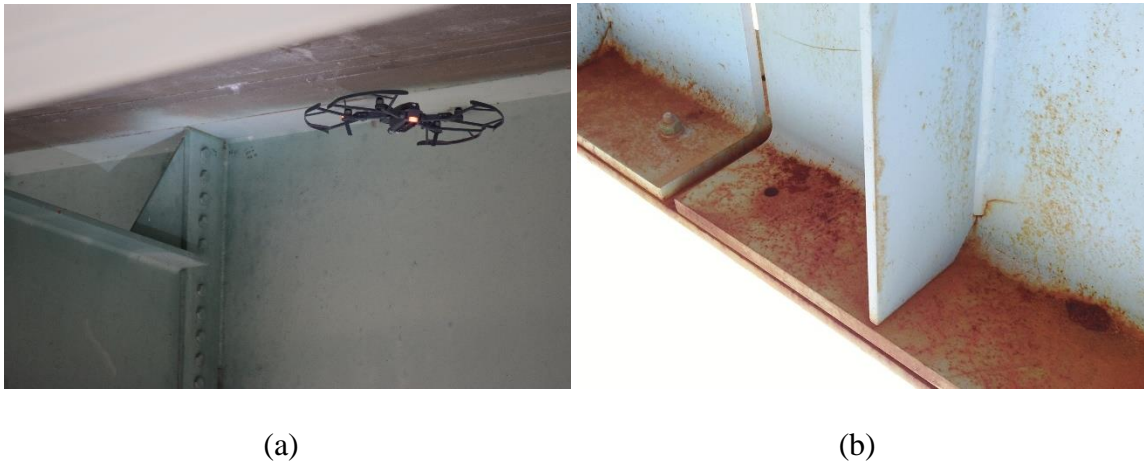
Fig. 2-5 (a) A UAS inspecting girders bridge under a bridge, (b) an image of a fatigue crack taken by a UAS from a bridge girder with fatigue crack

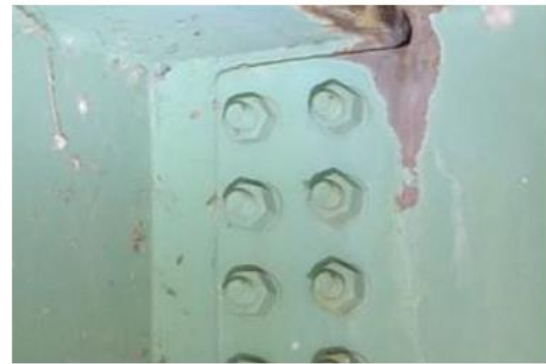
Fig. 2-6 (a) UAS-assisted FCM inspection (a) a location with fatigue crack, (b) a location without fatigue crack

girder splices, a girder web, a concrete barrier, and bottom flange two girders. The UAS-assisted inspection identified the presence of fatigue cracks in two floor beam connections. These cracks have previously been detected marked through hands-on inspections. The images from these fatigue cracks show the marker lines, but not the actual cracks (Fig. 2-6a). In addition, the UAS-assisted inspection ruled out the presence of fatigue cracks in other inspected regions (Fig. 2-6b). Other defects such as concrete delamination and efflorescence, and steel rust were detected in the UAS-assisted inspection. The UAS-assisted inspection took 4.5 hours with a net flight time of 1.5 hours (90 minutes). The inspection cost in this case was \$200 per hour. Considering a quarter of the bridge was inspected in 4.5 hours, the inspection costs extrapolated to whole bridge using the UAS would be \$1800. This case study shows the hourly cost of UAS inspection is almost half of the hourly cost of UBIT inspection, which agrees with previous studies [88, 120]. However, the extrapolated UAS inspection time was longer than the actual UBIT assisted hands-on inspection. The additional time made UAS-assisted inspection 15% more expensive than the hands-on inspection. It should be noted that the time and cost associated with using UASs is different for various situations as outlined in other places in this paper.

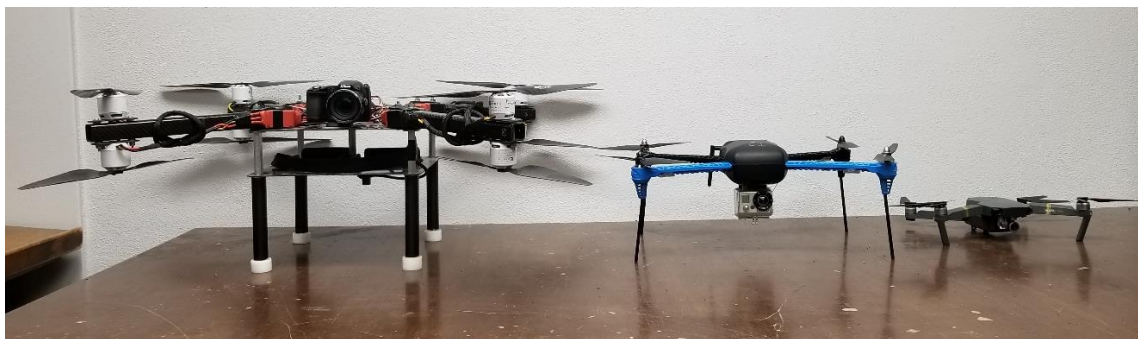
Fig. 3-1 Three UAS used for FCM inspections

Three UASs, shown in Fig. 3-1, were used for fatigue crack detection in this

study. Two UAS (DJI Mavic and 3DR Iris) were low-cost commercial models. A third UAS (The Goose) was custom made to carry heavier payloads (i.e. a standalone digital camera). UAS specifications are listed in Table 3-1. The cost of each platform is included in the table; even though costs will vary significantly with time, this information is included to set up a comparison of the relative cost of the three platforms tested here.

The cameras on the DJI Mavic was integrated on the platform by the DJI. In case of the 3DR Iris, the camera had to be light and small due to the limited payload. The GoPro Hero 4 was therefore selected to be mounted on the 3DR Iris. The Goose was capable of carrying a significant payload so a conventional digital camera, Nikon COOLPIX L830, was selected. Table 3-2 lists camera specifications. The cameras in this study had similar sensor type and size and comparable resolutions. Furthermore, these cameras represent similar off-the-shelf cameras that would be selected by inspectors using low-cost UAS for bridge inspections.

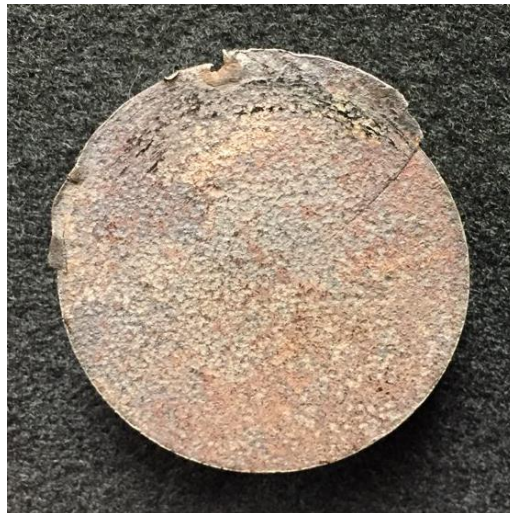
Fig. 3-2 Test piece with fatigue crack in 2-o'clock position

Using this test setup, the camera clearance to a 43-mm diameter steel coupon provided by Idaho Transportation Department (ITD) was changed until a fatigue crack could be identified. The identified maximum distance is reported as the maximum crack-to-camera distance (MCC). Fig. 3-2 shows the known fatigue crack, in the coupon. The crack length was approximately 14 mm and the crack width was approximately 0.04 mm (measured by a microscope). This specimen was provided by ITD.

MCC for each UAS camera was determined under each lighting condition. The UAS camera was first positioned at a distance of 1.2 m from the fatigue crack specimen (Fig. 3-2) and an image was recorded. The starting distance 1.2 m was selected because it is an easily achievable clearance for most commercial UAS. The operator observed the image and qualitatively evaluated if the known crack was visible. If the crack was not detectable at 1.2 m, MCC distance was reduced by 0.1 m. This procedure was repeated until the crack became visible in the recorded image. The distance at which the crack became visible to the operator under a specific lighting condition is reported as the MCC distance. This measurement is obviously subjective because it relied on the visual acuity of the operator. Furthermore, the operator was aware of both the presence and location of the crack. A single operator performed all of the tests in order to minimize variability (the same operator was also the inspector in mock and field inspections throughout this study). In addition to MCC, normalized MCC to pixel size was identified for each

The inspection team included a pilot and an inspector; the same inspection team performed all inspections. The fatigue-cracked specimen shown previously in Fig. 3-2 was positioned in various locations within each environment. The minimum distance that the pilot achieved between the UAS and the fatigue-cracked specimen was reported as the achieved crack-to-platform (ACP distance). The inspector estimated the ACP distance visually. Upon viewing the resulting image, whether in real-time or post-flight, the inspector qualitatively evaluates whether the crack is detectable.

The fatigue-cracked specimen shown in Fig. 3-2 was adhered to a steel test frame at an elevation of 3 m in the SMASH Lab at USU. The normal lighting condition was provided and verified in the same manner as discussed previously.

confined space. The fatigue-cracked specimen shown in Fig. 3-2 was adhered to a girder under the UWRL bridge in Logan, UT. The inspection was performed on the morning of January 10, 2017. KUTLOGAN25 weather station (located 5.5 km from the test location) reported that the wind speed was approximately 11 m/s (25 mph) at the time of testing (Weather 2017a). The maximum bridge clearance was approximately 2 m, which was deemed too narrow for access by the Goose. Therefore, inspections in the uncontrolled environment were only completed with the Mavic and the Iris.

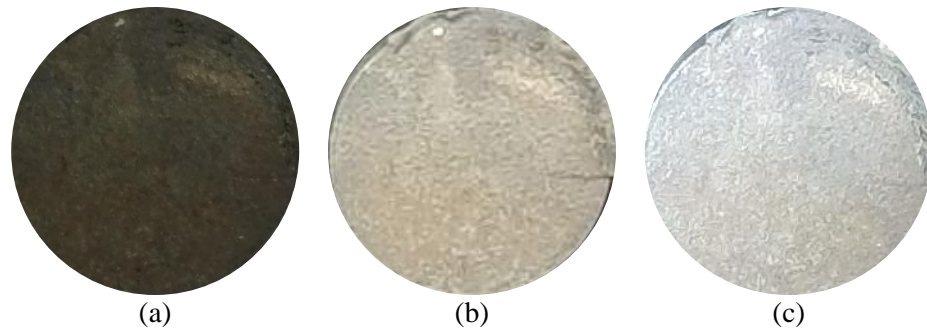
Fig. 3-4 GoPro images taken at MCC distances of (a) 0.2 m in dark, F2.8, ISO 400, (b) 0.6 m in normal, F2.8, ISO 400, and (c) 0.6 m in bright, F2.8, ISO 400.

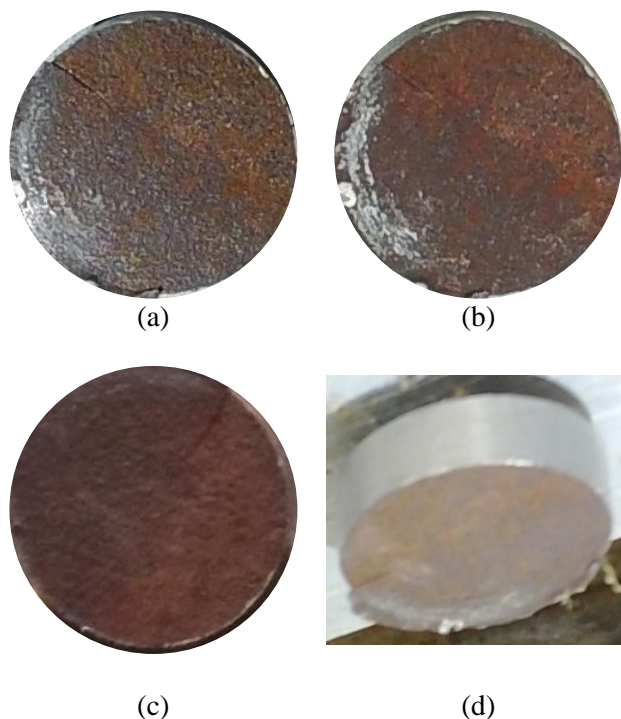
Fig. 3-7 Fatigue crack images taken by Mavic in (a) bright, (b) normal, and (c) dark lighting; and (d) at oblique angle (bright)

lighting condition got darker minimizing apparent differences in image brightness in this figure. The blurriness in the figures could have been due to combination of factors including adequate exposure control, GPS-denied operation, and UAS vibrations.

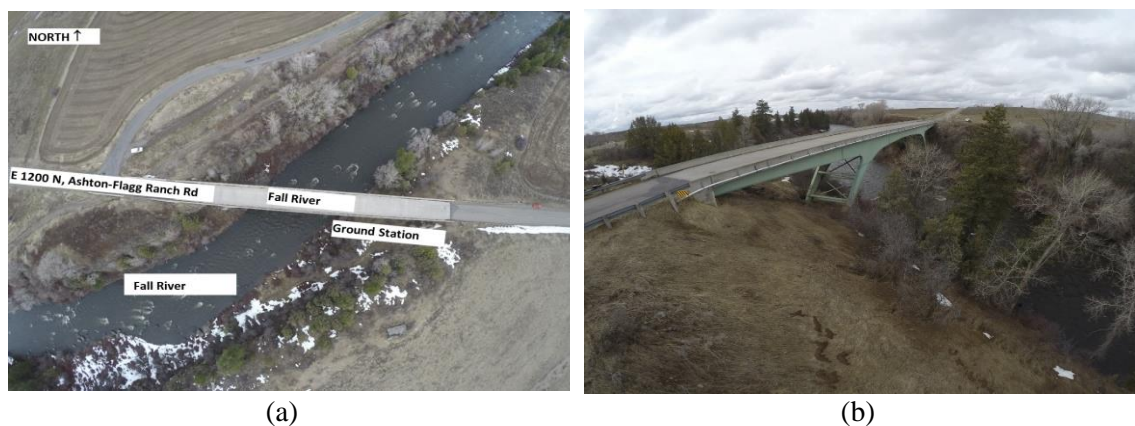
Fig. 3-8 Aerial (a) plan and (b) perspective view of Fall River Bridge in Ashton, ID (Images courtesy of Dan Robinson, AggieAir.)

Fig. 3-8 shows plan and perspective views of the Fall River Bridge. The bridge comprises two main longitudinal frames in East-West orientation and fifteen perpendicular transverse floor beams. The floor beams are connected to the girder webs by gusset plates. Inspection of the Fall River Bridge commenced at 11:30 AM on March 22, 2017. The nearest weather station, KIDASH08, was 35 km from the inspection site and reported a maximum wind speed of 7 m/s (16 mph) during the 90-minute inspection flight (Weather 2017b). However, the inspection team estimated that the wind gust speeds at the inspection location were considerably more. The inspection team was located at the Southern side of the bridge on the Eastern bank of the Fall River, shown on the right hand side of Fig. 3-8a as the ground station.

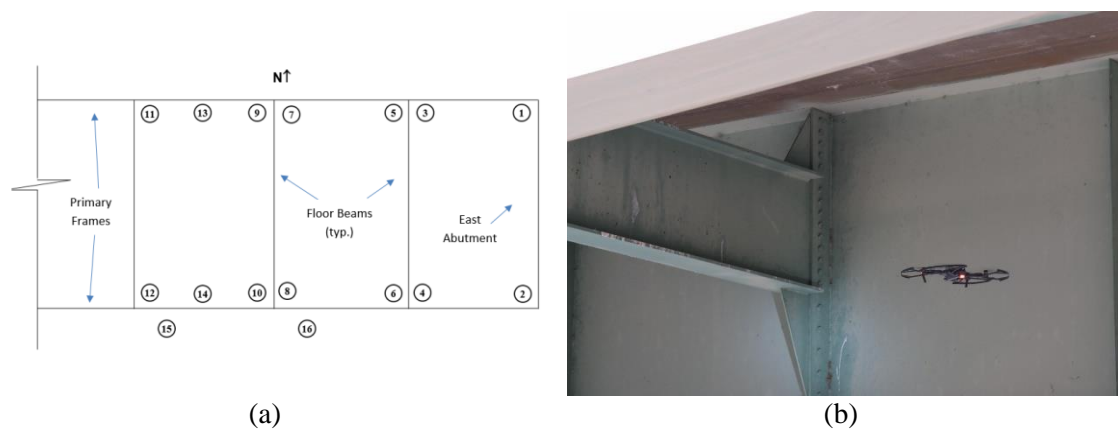
Fig. 3-9 (a) Inspection points on Fall River Bridge; (b) view of Mavic on approach to inspection points

points—11 and 12—are known to include fatigue cracks based on previous FCM inspections by ITD. The inspector and pilot knew which girders had fatigue cracks but the exact locations of fatigue cracks were not revealed to them. The inspection team verified that fatigue cracks were not present at inspection points 1–10 during both real-time (on 12-cm FPV monitor) and post-flight (on 60-cm computer monitor) inspections. Fig. 3-10 shows representative inspection images from inspection points 3 and 4, which clearly show that no fatigue cracks exist in those locations. Fig. 3-11 shows images taken at inspection points 11 and 12. It is impossible to detect fatigue cracks in the original images (Fig. 3-11a and 3-11b). With magnification (Fig. 3-11c and 3-11d) it is still difficult to identify the location of cracks, even though they are marked from previous inspections. This is due in part to the limited APC distance and camera resolution. Markings made by ITD inspectors during previous inspections also obscured the cracks, (i.e. black marker along crack length) making them more difficult to identify (Fig. 3-11c). b shows the FPV view of Mavic flying under the bridge and approaching a fatigue crack susceptible location. Marks from previous inspections indicating the presence of a fatigue crack are visible in the figure. The handheld spotlight, held by the inspector, served a dual purpose during the inspection: as a pointer to guide the pilot to the locations of interest, and to provide illumination. The ACP distance in the field condition was approximately 0.5 m, double that achieved during the mock inspections. During wind gusts, the ACP distance increased to 0.75 m.

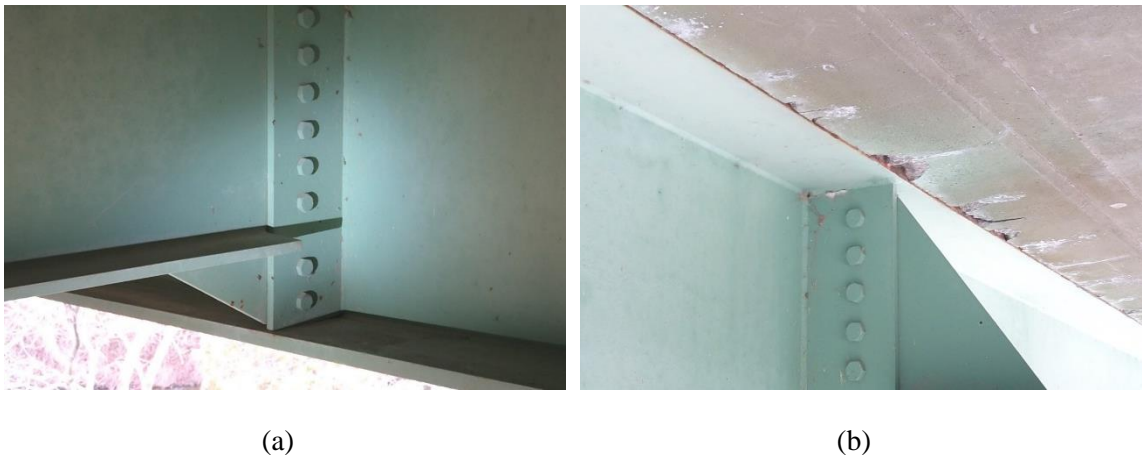
Fig. 3-10 Inspection images from Fall River Bridge points (a) 3 and (b) 4 showing no fatigue cracks

inspection points 3 and 4, which clearly show that no fatigue cracks exist in those locations. Fig. 3-11 shows images taken at inspection points 11 and 12. It is impossible to detect fatigue cracks in the original images (Fig. 3-11a and 3-11b). With magnification (Fig. 3-11c and 3-11d) it is still difficult to identify the location of cracks, even though they are marked from previous inspections. This is due in part to the limited APC distance and camera resolution. Markings made by ITD inspectors during previous inspections also obscured the cracks, (i.e. black marker along crack length) making them more difficult to identify (Fig. 3-11c).

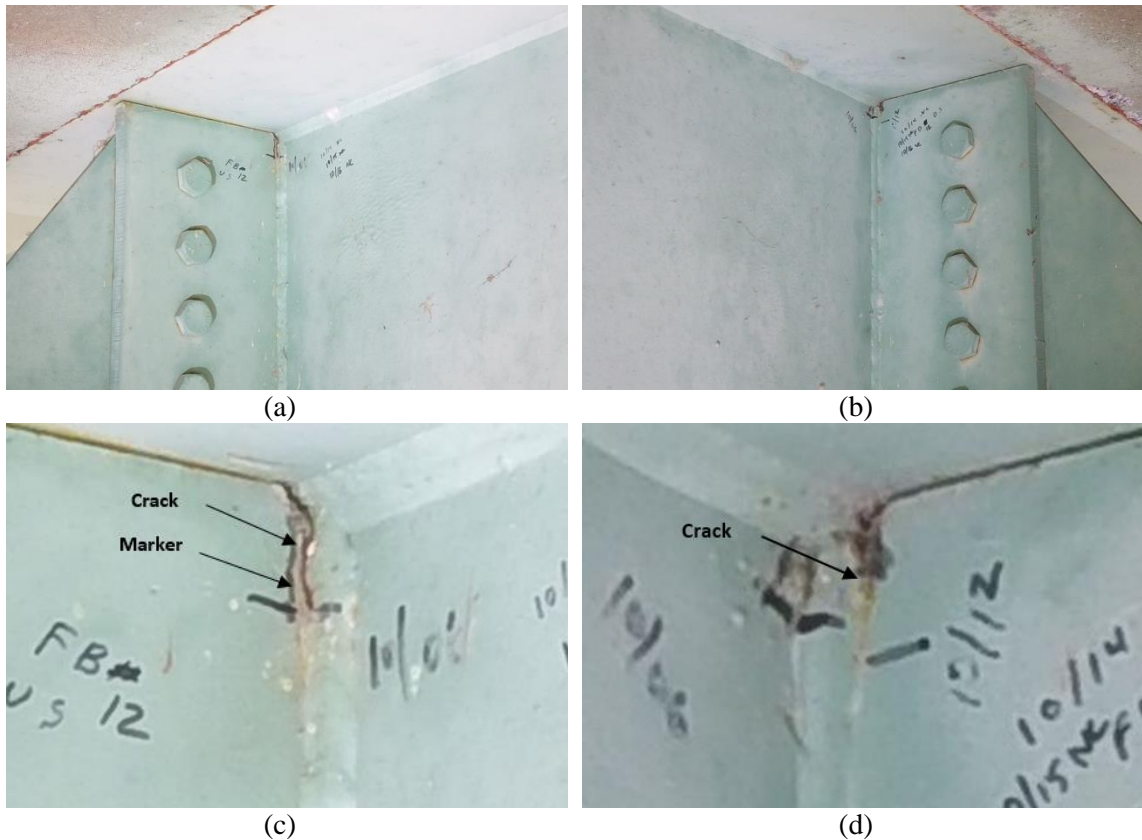
Fig. 3-11 Inspection images from Fall River Bridge points (a) 11 and (b) 12; and magnified inspection images from points (c) 11 and (d) 12

The inspector detected several other items of interest, including corrosion in the bottom flange of the Southern girder, efflorescence, concrete cracks, possible delamination in Southern barrier, and minor corrosion on the splice plate of the Southern girder in real-time. Real-time and post-flight inspection images were of sufficient quality to rule out the presence of fatigue cracks in locations 1 through 10. However, the FCM inspection was inconclusive because of the presence of the marker lines on the cracks.

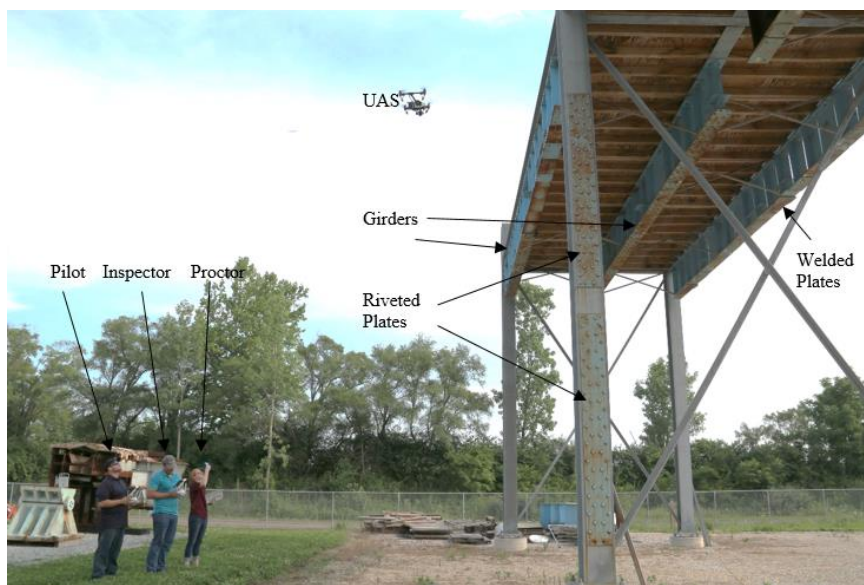
Fig. 3-12 Training POD frame at S-BRITE center, Purdue University

etc.). In total, the inspection team examined 72 girder specimens, 19 welded cover plate specimens, and 8 riveted plate specimens. A facility proctor joined the inspection team.

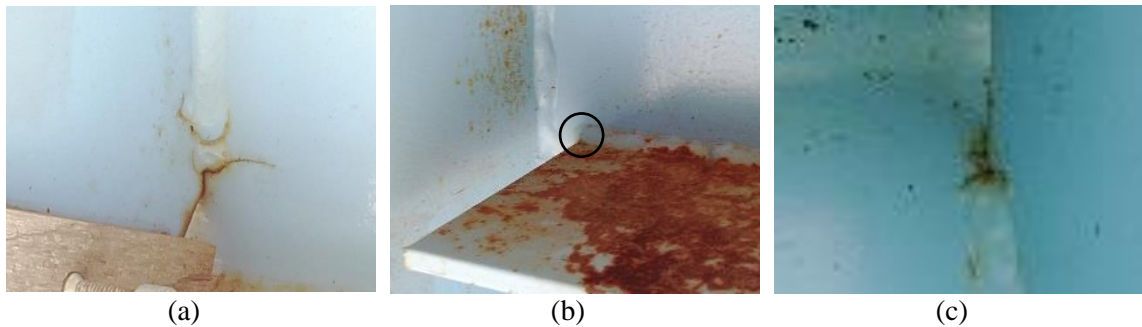
Fig. 3-14 Girder inspection images: (a) true positive (hit), (b) false negative (miss), and (c) false positive

resulted in 159 calls. Eighteen of these were hits for a hit-to-call ratio of 11% and a FPR of 89%. The proctor reported 10 misses, for a TPR of 64%. Fig. 3-14 shows examples of true positive, false negative, and false positive images from the Mavic girder inspection. Fig. 3-14a shows a 9.2-cm fatigue crack that the inspector detected. Fig. 3-14b shows a 2.7-cm fatigue crack that the inspector missed, and Fig. 3-14c shows a spot of rust staining that the inspector erroneously identified as a fatigue crack.

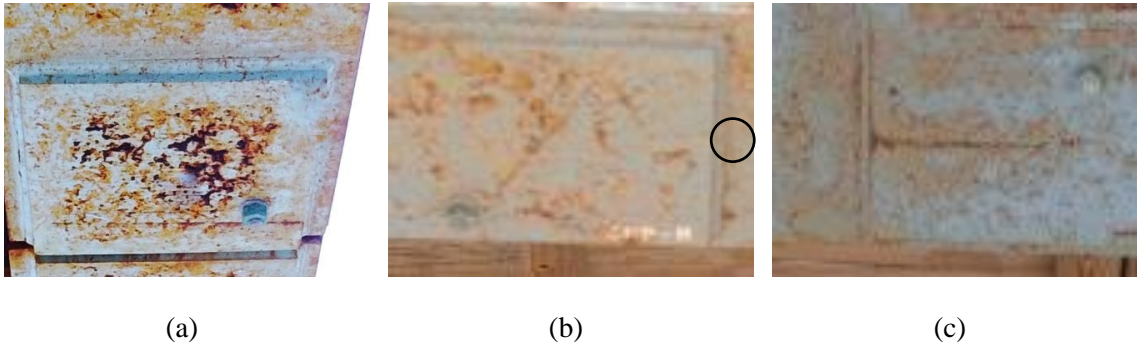
Fig. 3-15 Welded plate inspection images: (a) true positive (hit), (b) false negative (miss), and (c) false positive

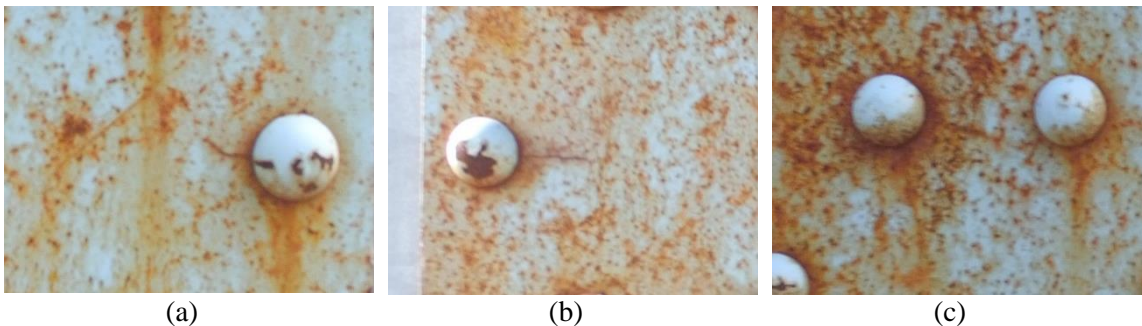
Fig. 3-16 Riveted plate inspection images: (a) true positive (hit), (b) false negative (miss), and (c) false positive

inspector did not detect. Fig. 3-16c shows a rust line that the inspector erroneously reported as a crack.

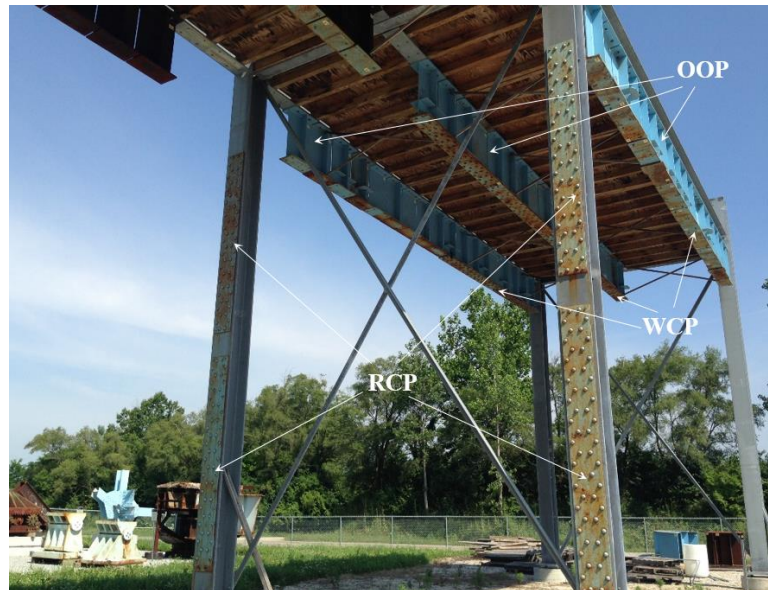
Fig. 4-1 Three types of specimens mounted on the POD frame located at Purdue University

The inspected POD frame is shown Fig. 4-1. The specimens mounted on the POD frame were produced at the Bowen laboratory at Purdue University. The POD structure is intended to mimic a 120 m, two-span highway bridge with three lines of girders elevated approximately 8 m above the ground. Each girder spans approximately 12 m with 3 m of

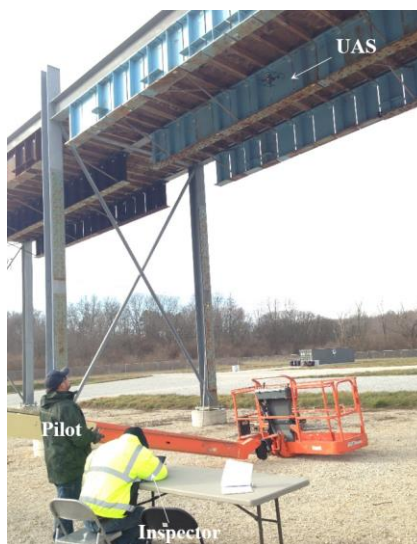
Fig. 4-2 The setup for the field inspections

Four bridge inspectors performed the field inspections of the POD frame between December 18th and December 21st, 2018. A pilot from Utah State University and a proctor from Purdue University accompanied the inspectors on each inspection day. Each field inspection started with a 30-minute inspection tutorial that taught the inspector how to use a 12-cm FPV monitor for recording and camera adjustments. The proctor provided a binder of blank inspector sheets for each specimen. For each specimen, the inspector marked the crack(s) on the corresponding specimen sheet (or indicated that the specimen did not have any cracks) while the pilot flew the UAS near the inspected specimen. Fig. 4-2 and Fig. 4-3 show the typical setup for the field inspections. The wind speeds during the field inspection days were obtained from KLAf weather station at the Purdue University airport (Weatherunderground, 2017) and are presented in Table 4-2. This table also reports a start time (including the tutorial) and an end time for each day of inspections. As seen in Table 4-2, the inspection time varied each day due to either the loss of sunlight or the inspector's unavailability in the afternoons. In addition to the field inspection forms, the inspectors were asked to complete the questionnaire, NASA TLX, and vision tests forms, as well.

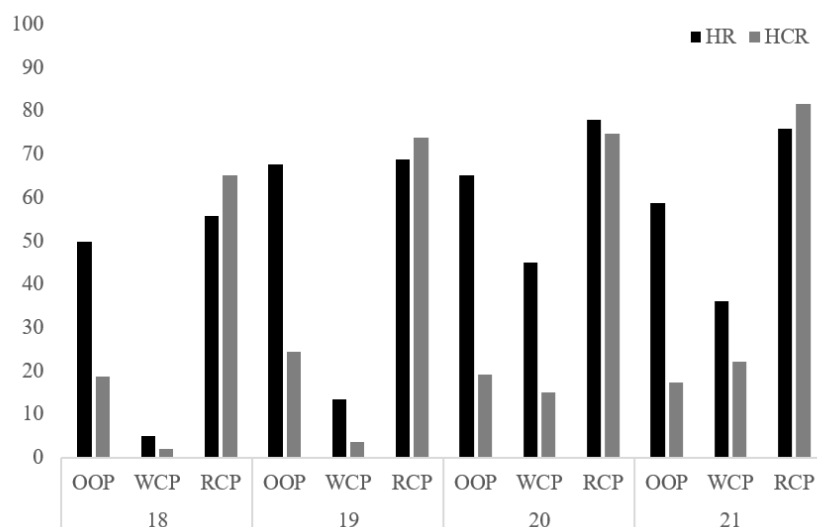
Fig. 4-6 A summary of the average HR and HCR for each set of inspection videos

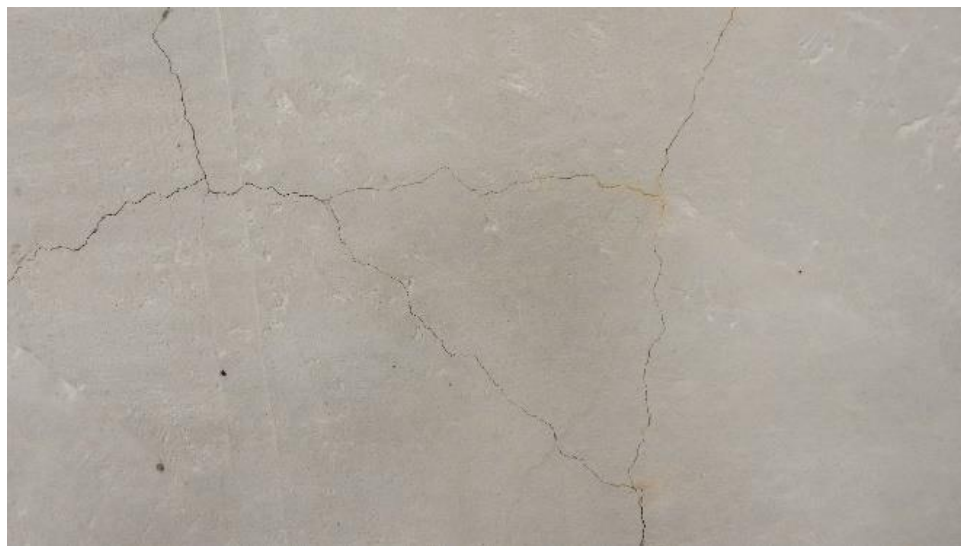
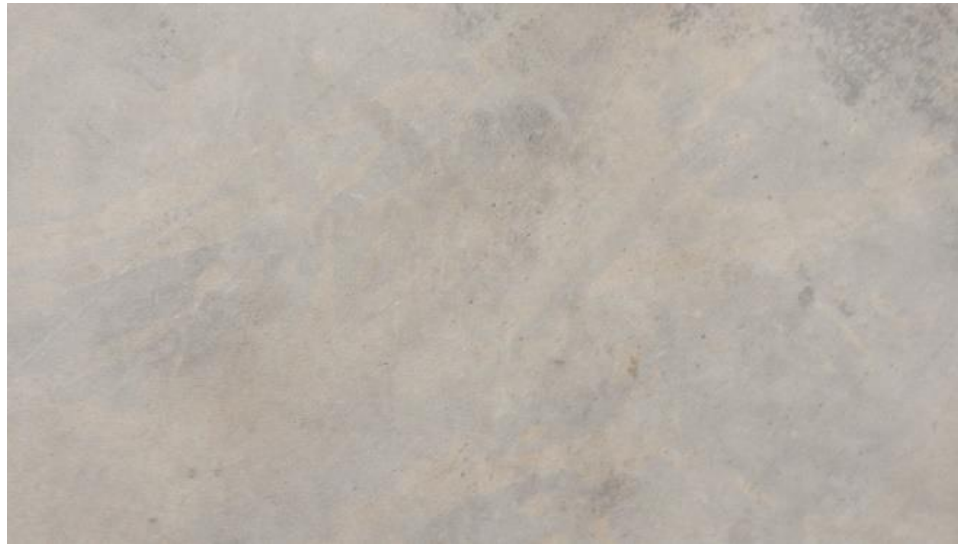
Fig. 5-3 Representative images of (a) defected and (b) sound concrete

In order to test the crack detection algorithm discussed above, researchers gathered fifty images of sound concrete and fifty images of cracked concrete from several previously tested concrete panels at the Systems, Materials, and Structural Health Laboratory (SMASH Lab) at Utah State University [39]. Images were taken with a 12 MP digital camera with focal length of 35 mm. The distance between the lens and the surface was 1.0 m. The surface illumination, as verified by a Digi-Sense data logging light meter with NIST traceable calibration, was 150–250 lx. The image resolution was 2592×4608 px and the approximate field size was 1.0×1.2 m. RGB images were saved in JPEG format. Image processing was performed in MATLAB on a 64-bit operating system with 32 GB memory and 3.40 GHz processor. Fig. 5-3 shows representative images of defected and sound concrete. Images were processed in six iterations, corresponding to the four spatial domain edge detectors and two frequency domain edge detectors.

Table 5-2 presents a comparison of the range of pixel intensities in the enhanced edge image E_e , the pixel thresholds T_1 and T_2 used for construction of the first- and second-level binary images B_1 and B_2 , and the noise-to-signal ratio N/S observed in sound dataset using the six edge detection methods. Fig. 5-10 presents a direct comparison of second-level binary images from analysis of the image in Fig 3-5a, a member of the defected dataset. Similarly, Fig. 5-11 shows a direct comparison of the second-level binary images from analysis of the image in Fig. 5-3b, a member of the sound dataset.

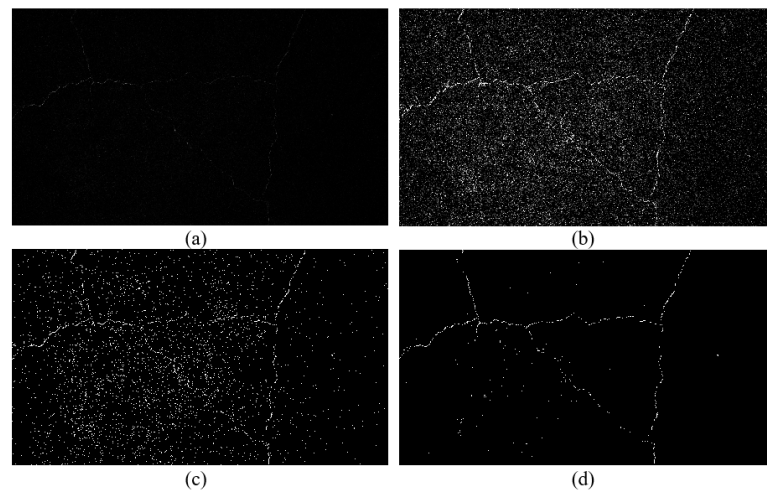
Fig. 5-4 (a) Edge, (b) enhanced edge, (c) first-level binary, and (d) second-level binary images; defected dataset, spatial domain, Roberts filter

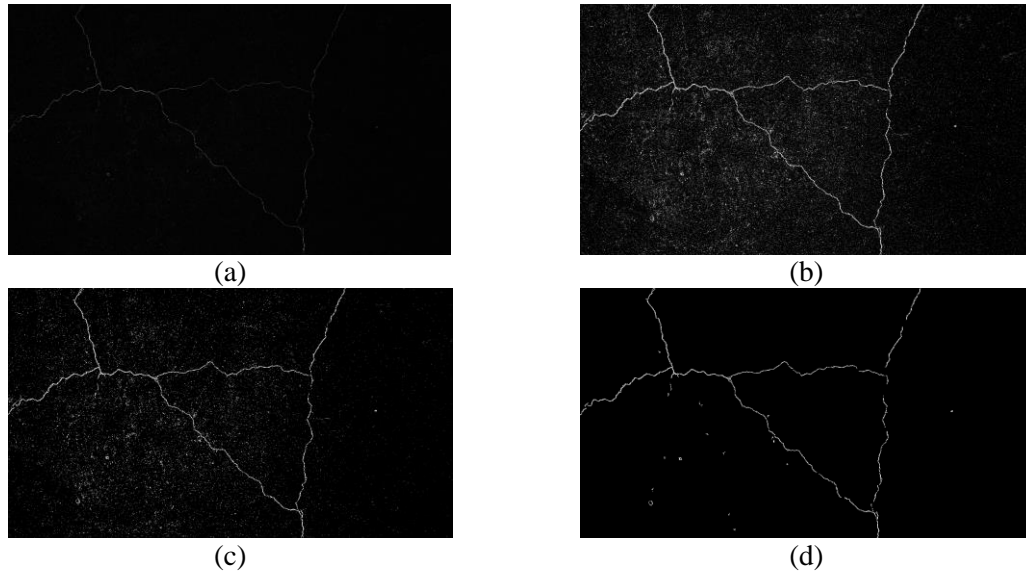
Fig. 5-5 (a) Edge, (b) enhanced edge, (c) first-level binary, and (d) second-level binary images; defected dataset, spatial domain, Prewitt filter

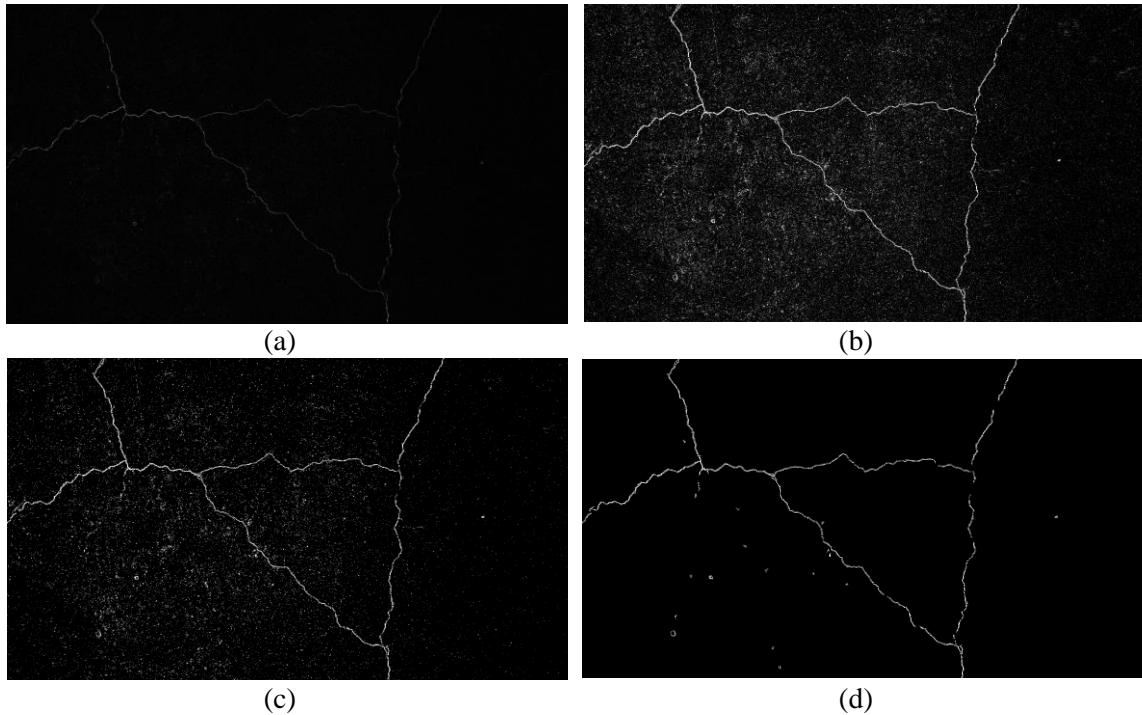
Fig. 5-6 (a) Edge, (b) enhanced edge, (c) first-level binary, and (d) second-level binary images; defected dataset, spatial domain, Sobel filter

Crack detection in the spatial domain using Sobel filter resulted in the second highest number of hits (86%) and the second highest fallout (16%). Thus, while the Sobel filter was among the most accurate (85%) it was also among the least precise (84%). The minimum detectable crack width was 0.2 mm and the processing time (1.4 s per image) was among the shortest. Fig. 5-6 shows representative edge, enhanced edge, first-level binary, and second-level binary images from spatial domain edge detection of an image from the defected set using Sobel filter.

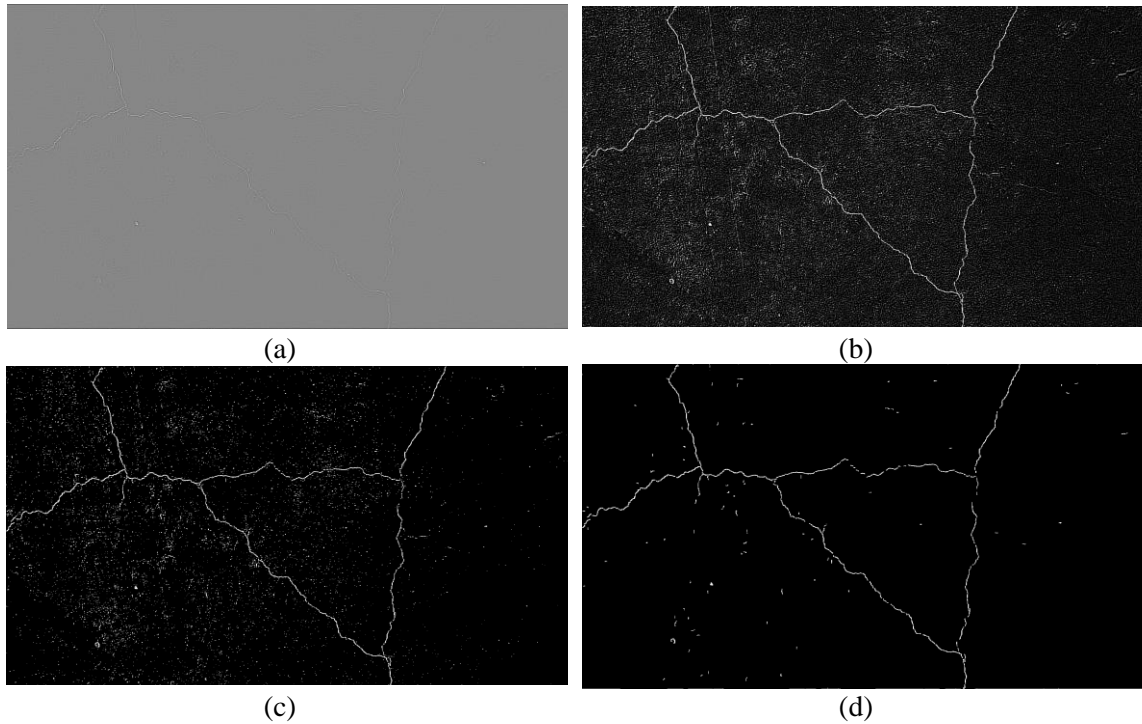
Fig. 5-7 (a) Edge, (b) enhanced edge, (c) first-level binary, and (d) second-level binary images; defected dataset, spatial domain, LoG filter

Crack detection in the spatial domain using the LoG filter resulted in the highest number of hits (98%), with only one miss in fifty defected images. The fallout (14%) was near the median for the six methods evaluated. Nevertheless, the LoG filter was the most accurate (92%) and the most precise (88%). Furthermore, the LoG method has the narrowest minimum detectable crack width (0.1 mm) and the shortest processing time (1.18 s per image). Fig. 5-7 shows representative edge, enhanced edge, first-level binary, and second-level binary images from spatial domain edge detection of an image from the defected set using LoG filter.

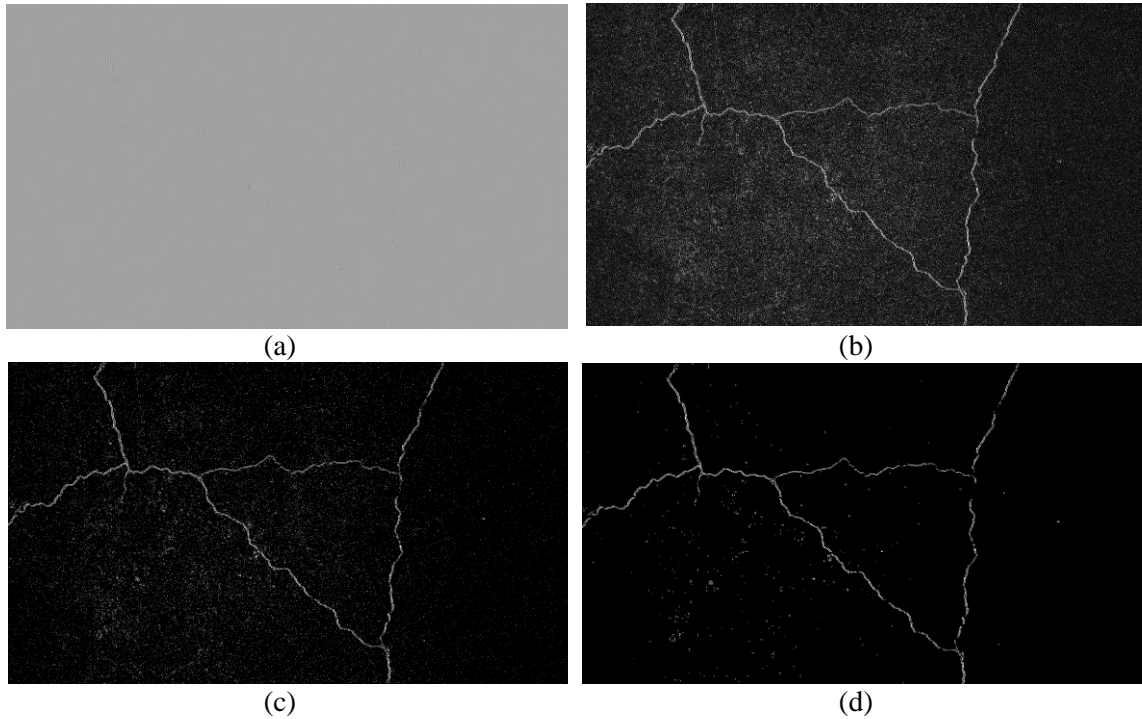
Fig. 5-8 (a) Edge, (b) enhanced edge, (c) first-level binary, and (d) second-level binary images; defected dataset, frequency domain, Butterworth filter

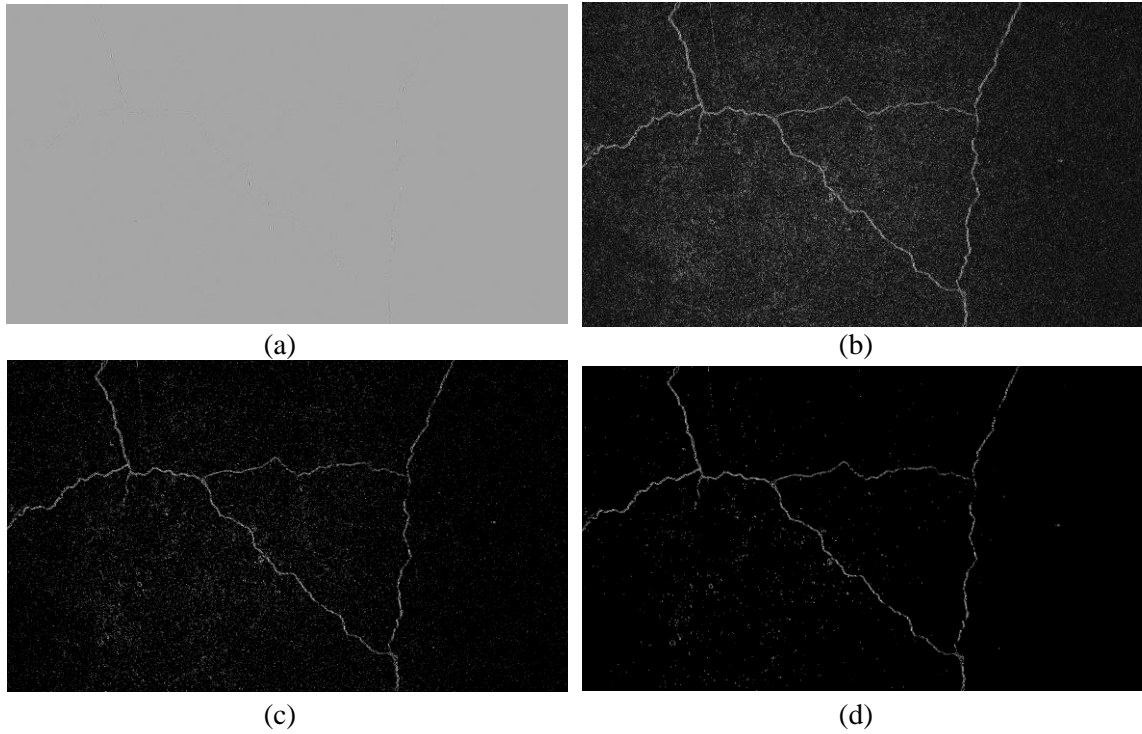
Fig. 5-9 (a) Edge, (b) enhanced edge, (c) first-level binary, and (d) second-level binary images; defected dataset, spatial domain, Gaussian filter

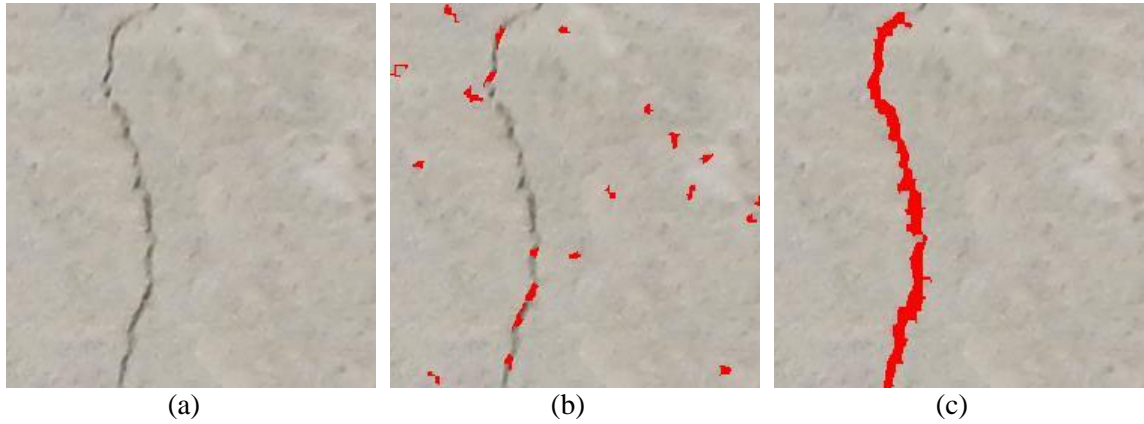
Fig. 6-2 The effect of edge enhancement on the final image of the edge detectors, Sobel, (a) original image, (b) final binary image superimposed on the original image (b) without the edge enhancement, (c) with the edge enhancement

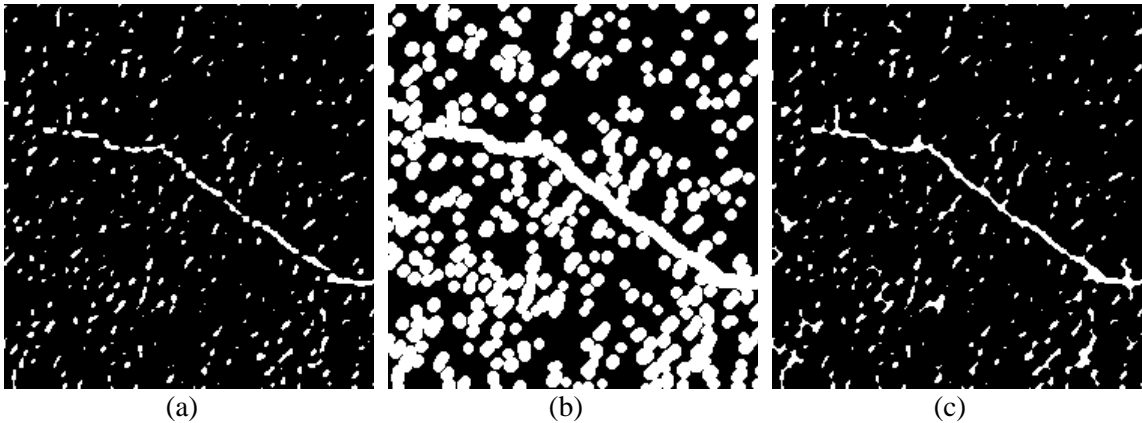
Fig. 6-3 Closing operation illustration (a) first level binary image, (b) dilation, and (c) erosion using a disk structuring element with diameter of 4 px. (LoG edge detector).

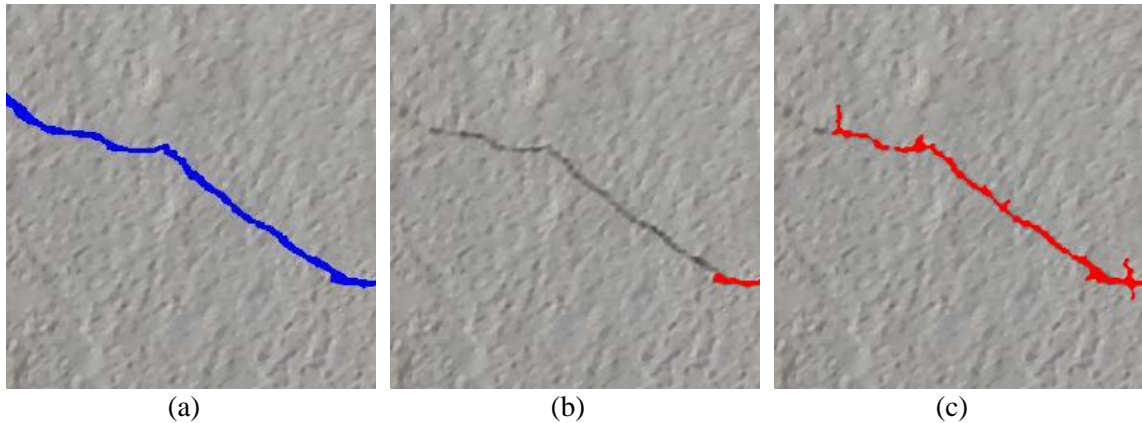
Fig. 6-4 Crack in the (a) ground truth, 1391 px, (b) without the closing operation 391 px correct detection (c) with closing operation 1215 px correct detection (LoG edge detector)

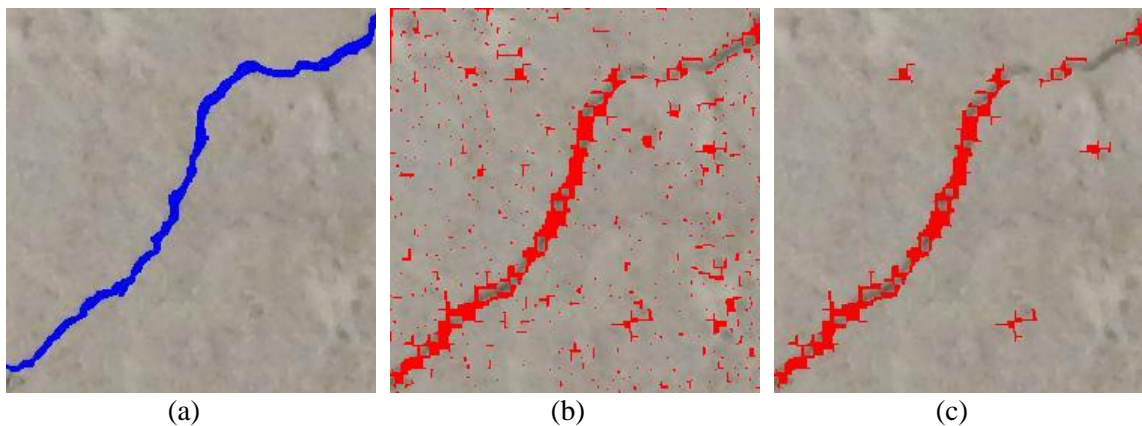
Fig. 6-5 Crack in the (a) ground truth, 2325 px, (b) without second level threshold operation 3672 pixels false detection (c) with second level threshold operation: 214 px false detection (Gaussian edge detector)

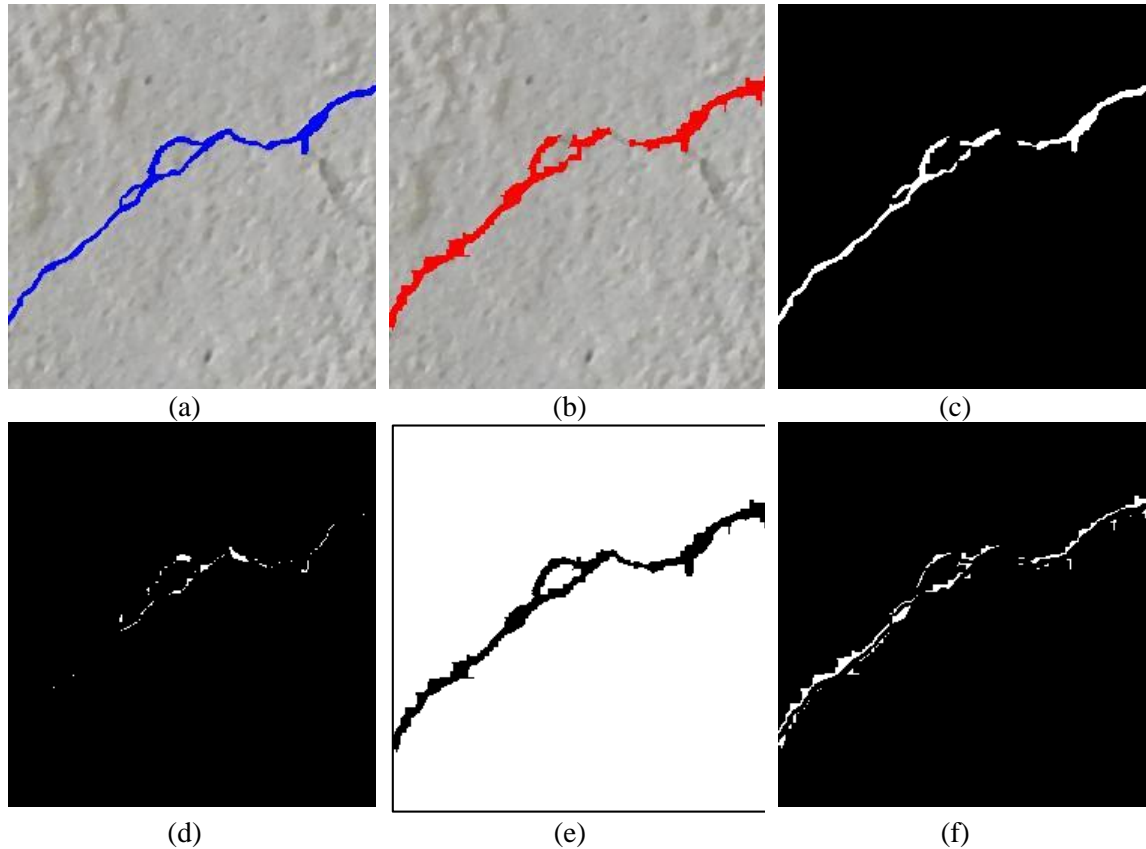
Fig. 6-7 Examples of metric, (a) ground truth, $C_p=1,582$ px, $U_p=63,954$ px, (b) final binary image using Roberts edge detector, $C_p=2276$ px, $U_p=63,260$ px (c) $TP=1367$ px, (d) $FN=215$ px, (e) $TN=63,045$ px, (f) $FP=909$ px (Roberts edge detector)

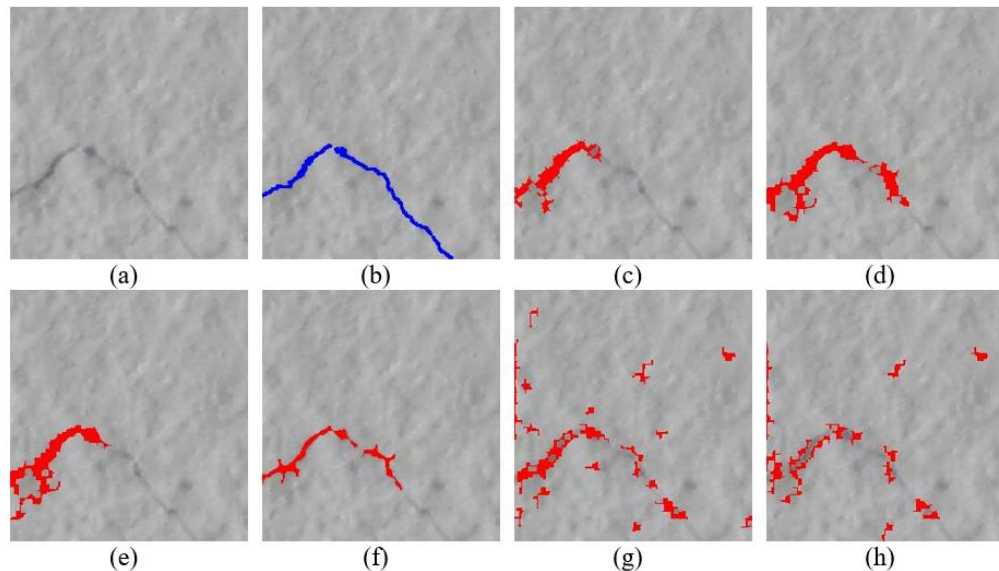
Fig. 6-9 An example of edge detector performance on a 0.02 mm crack (a) original image, (b) GT=1145 px, (c) Roberts, TPR=39% (d) Prewitt, TPR=60%, (e) Sobel, TPR=55%, (f) LoG, TPR=71%, (g) Butterworth, TPR=38%, (h) Gaussian, TPR=17%

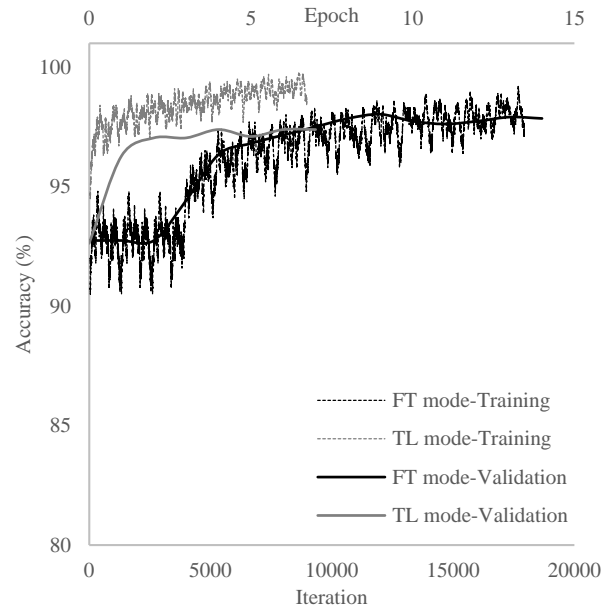
Fig. 6-10 DCNN accuracy during training and validation

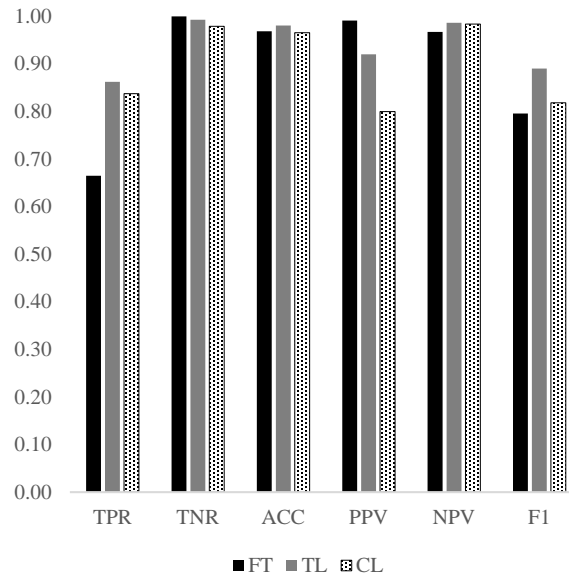
Fig. 6-11 Metrics for the DCNN in FT, TL, and CL modes

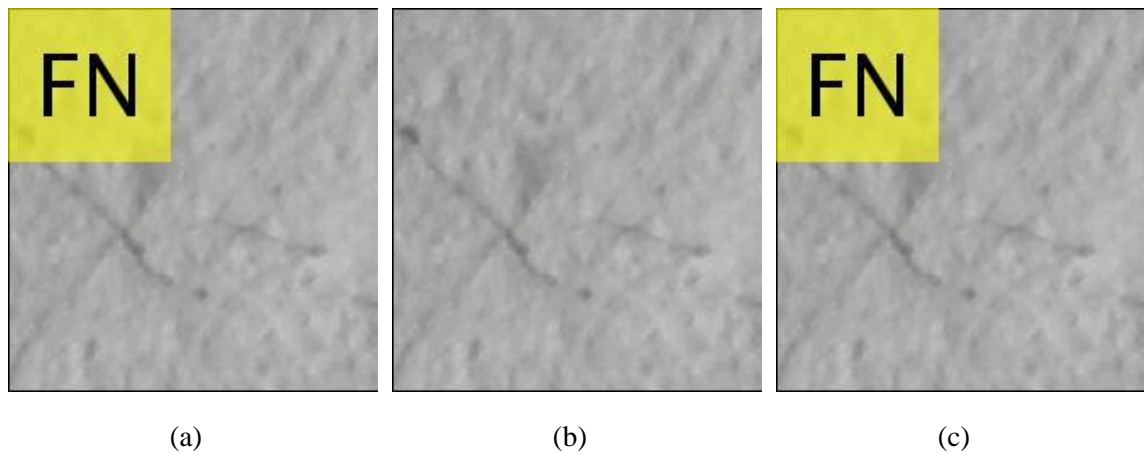
Fig. 6-12 DCNN results for a crack of width 0.08 mm: (a) FT mode, (b) TL mode, and (c) CL mode
