Non-Contact Evaluation Methods for Infrastructure Condition Assessment

NON-CONTACT EVALUATION METHODS FOR INFRASTRUCTURE
CONDITION ASSESSMENT

A dissertation submitted in partial fulfillment
of the requirements for the degree

Civil and Environmental Engineering

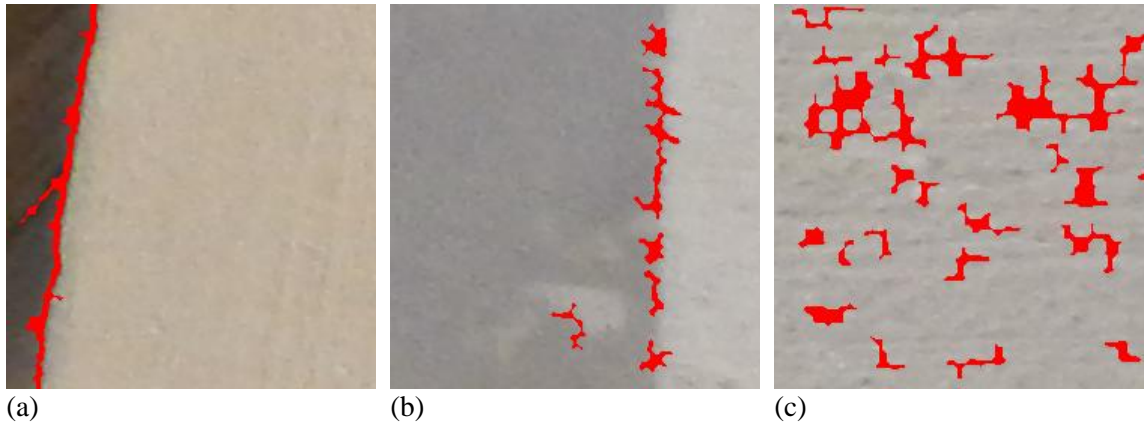
Fig. 6-14 Examples of FNs in the U class images (a) non-crack edge, (b) different surface finish, (c) noise due to the coarse concrete surface

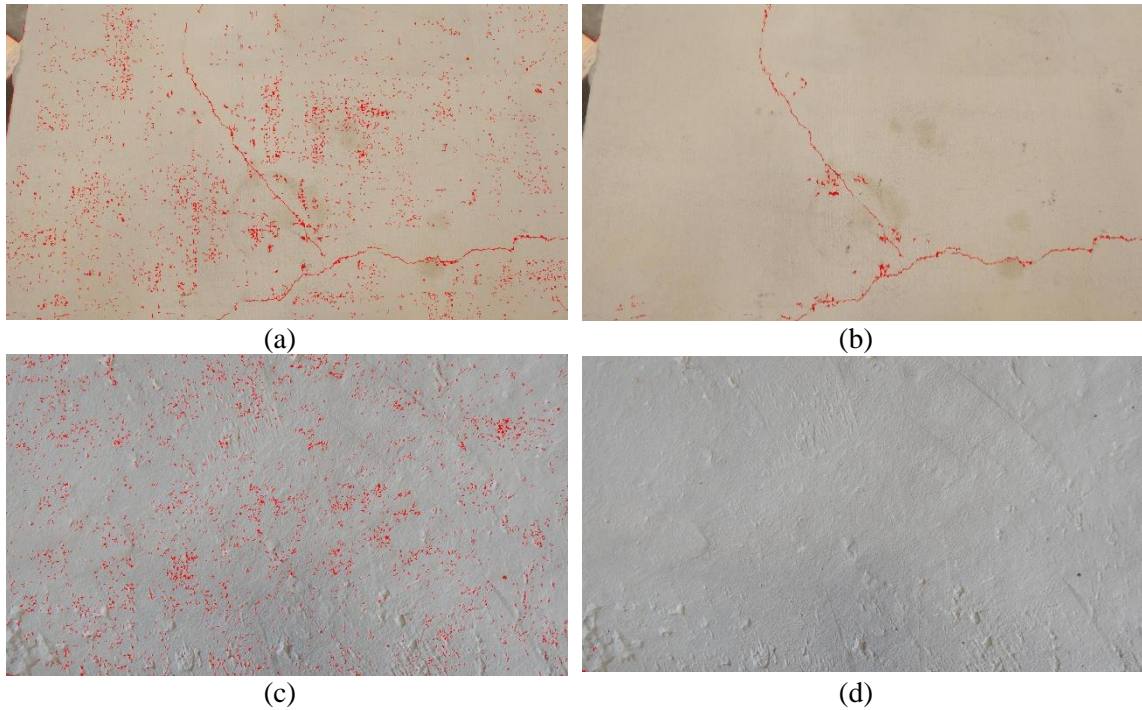
Fig. 6-15 Combination of DCNN and edge detectors (a) the superimposed image with crack using LoG on all sub-images, (b) the superimposed image with crack without using LoG on U class sub-images, (c) the superimposed image without crack using LoG on all sub-images, (d) the superimposed image without crack without using LoG on U class sub-images.

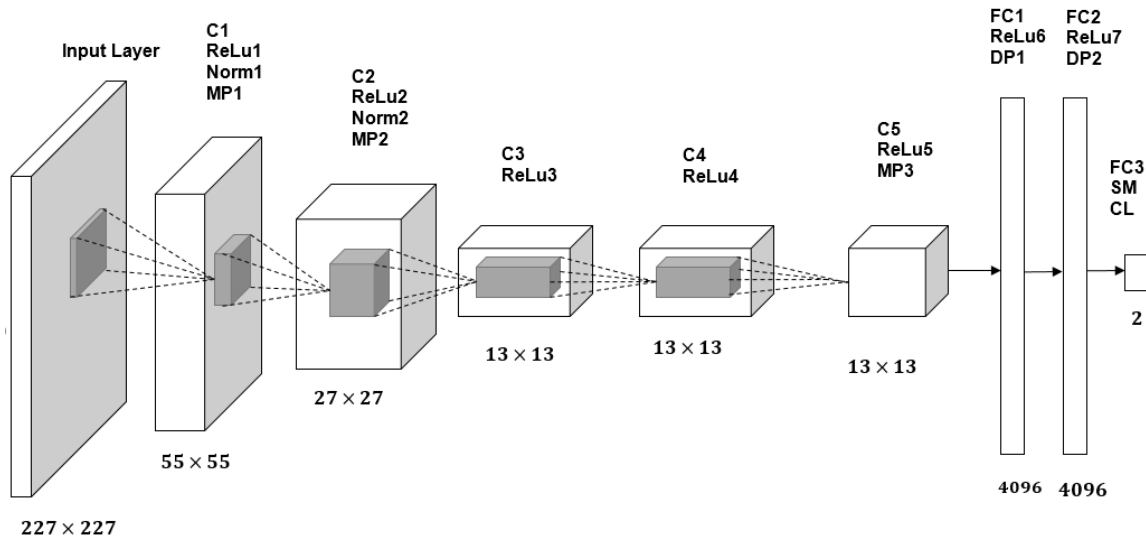
Fig. 7-1 The architecture of AlexNet adopted from [41]

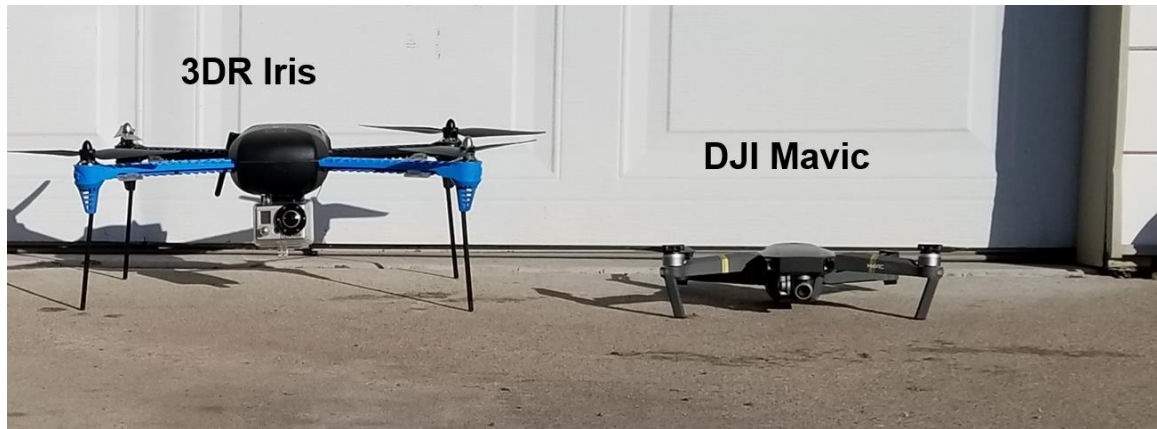
Fig. 7-2 The sUAS used for inspection

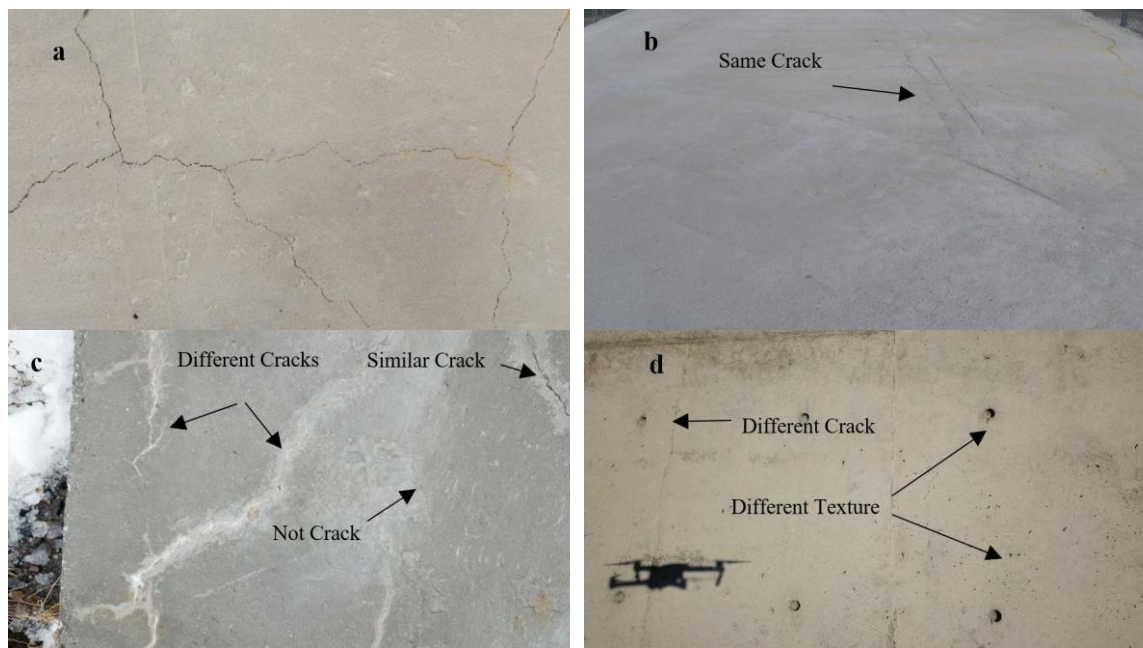
Fig. 7-3 Representative original images of (a) training dataset, (b) 1st testing dataset, (c) 2nd testing dataset, (d) 3rd testing dataset

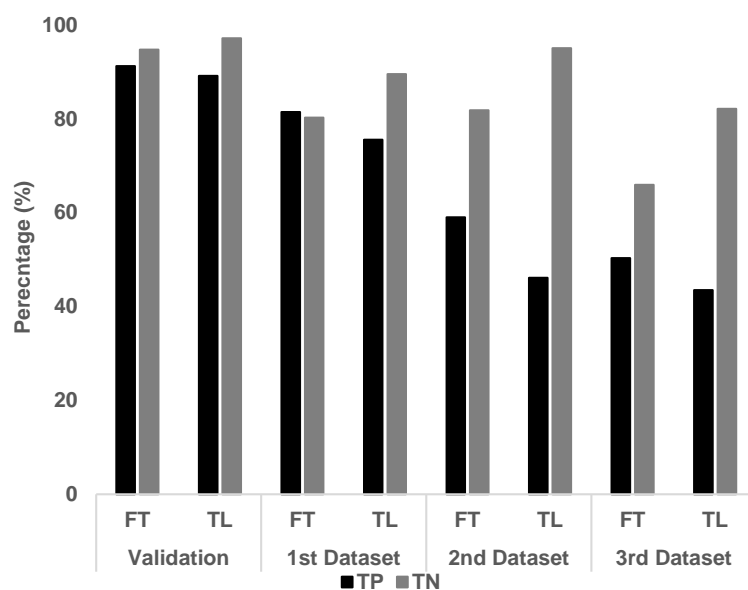
Fig. 7-5 The TP and TN rates for all datasets in both network modes

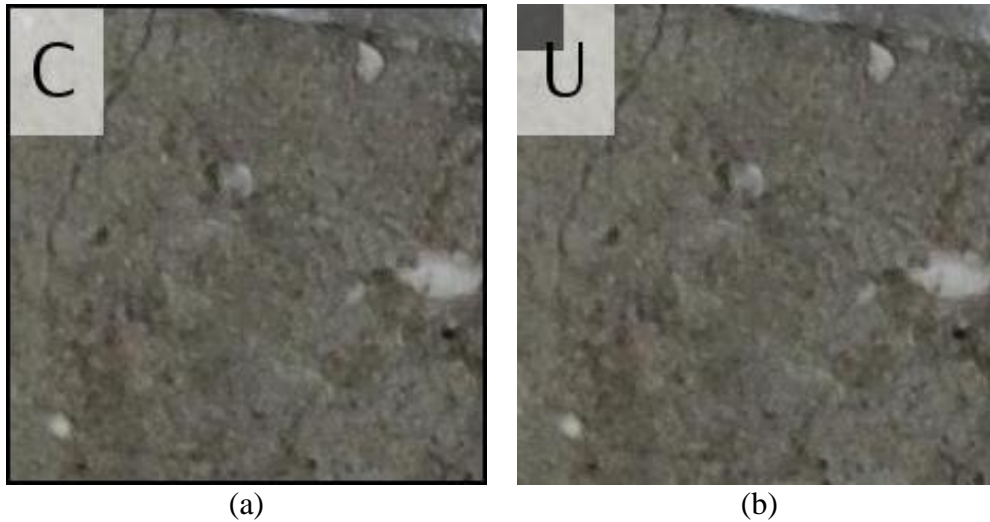
Fig. 7-7 Comparing TP reports in the 2nd training dataset for, (a) FT mode correct label and (b) TL mode wrong label

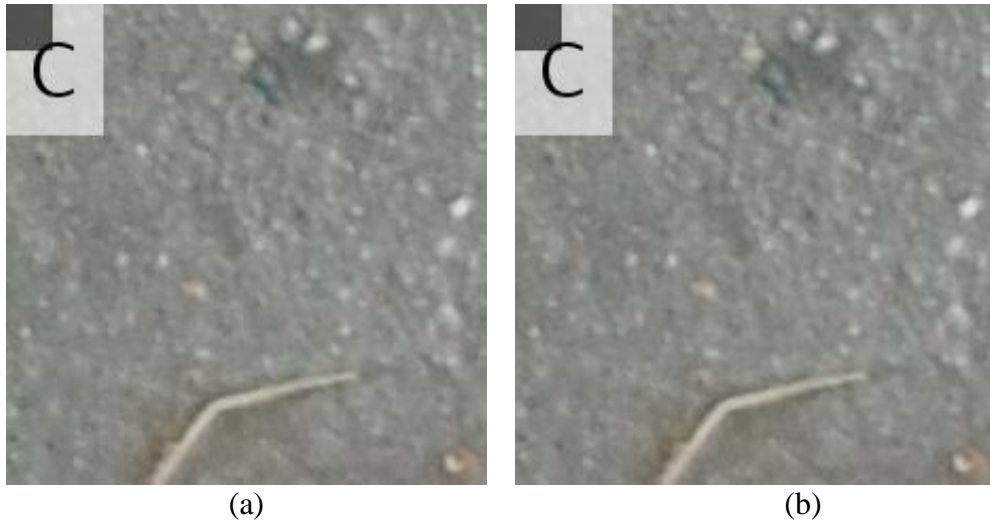
Fig. 7-8 False positives due to presence of irrelevant objects, (a) FT mode wrong label, (b) TL mode wrong label

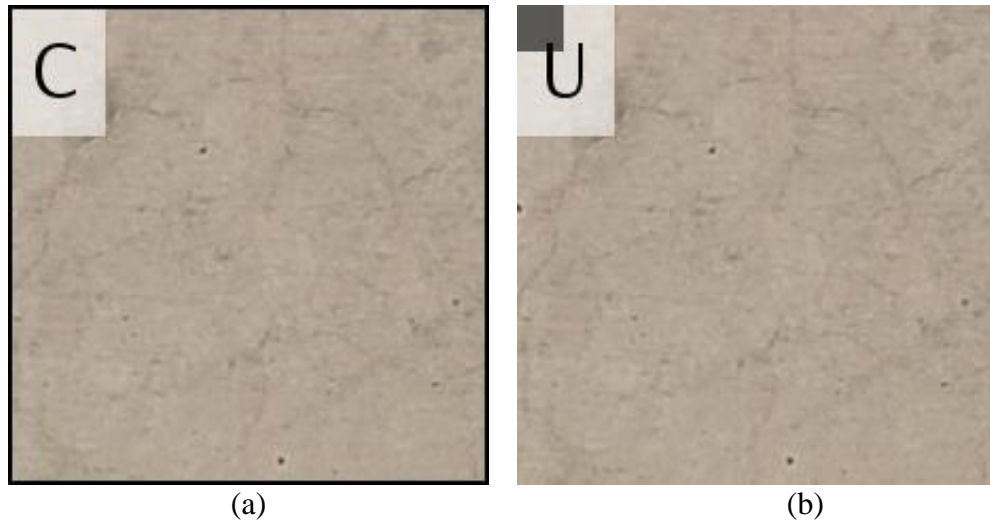
Fig. 7-9 Comparing TP reports in the 3rd training dataset for, (a): FT mode correct label, (b): TL mode wrong label

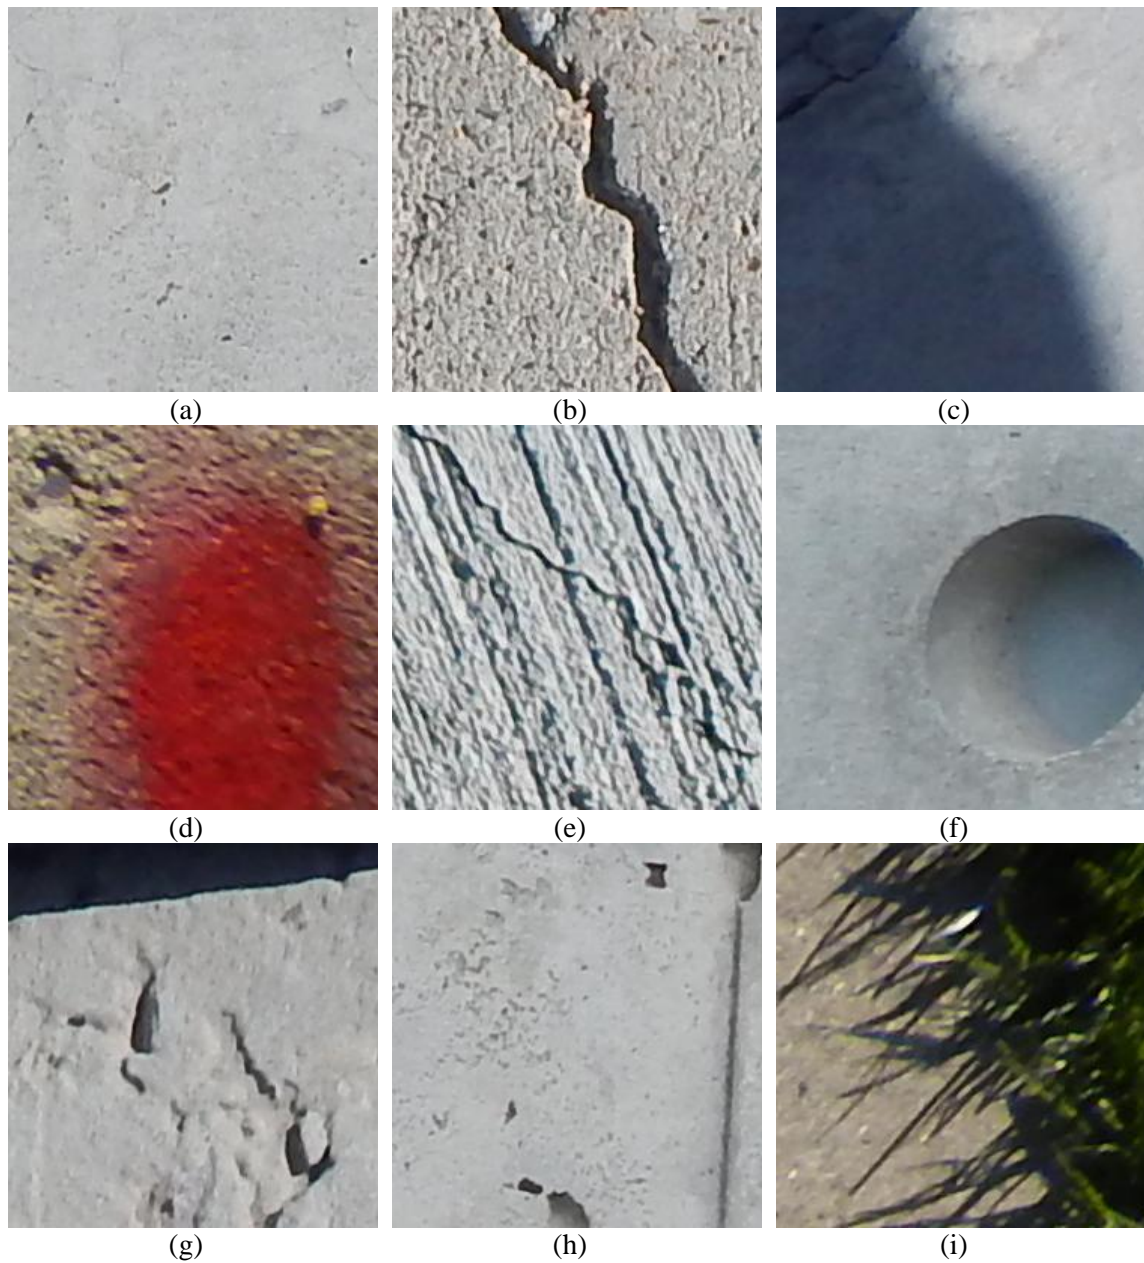
Fig. 8-1. SDNET2018 images include (a) fine cracks, (b) coarse cracks, (c) shadows, (d) stains, (e) rough surface finishes, (f) inclusions and voids, (g) edges, (h) joints and surface scaling, and (i) background obstructions

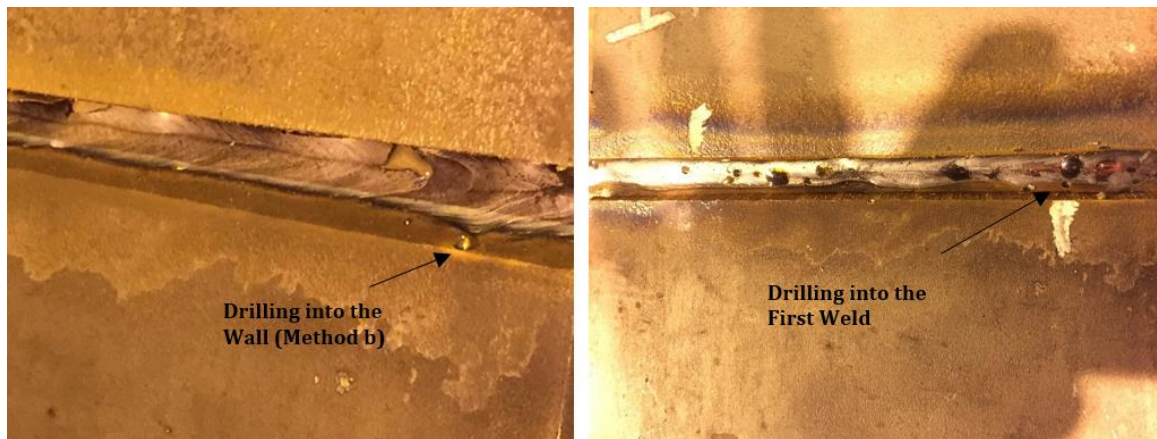
Fig. 9-3 Manufacturing inclusion in the welds using drilling (method b and c)

Fig. 9-2 shows the process of inclusion manufacturing using method (a), i.e. putting slags in the welding bed. Fig. 9-3 shows the inclusion manufacturing using methods b and c.

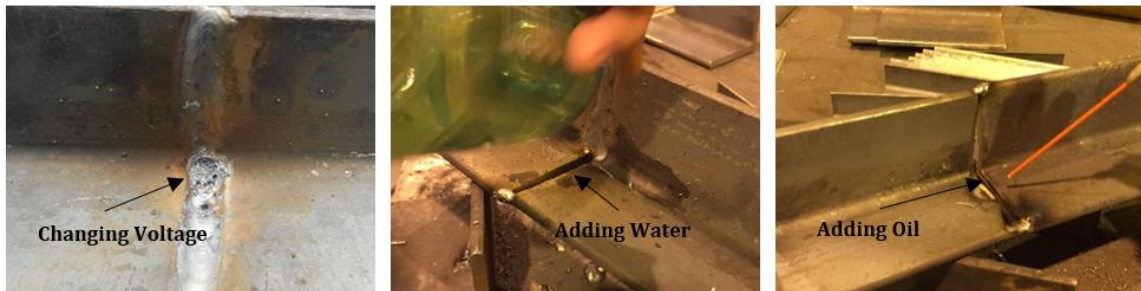
Fig. 9-4 Manufacturing porosity in the welds by changing the voltage (method a), adding water (method b), and adding oil (method c)

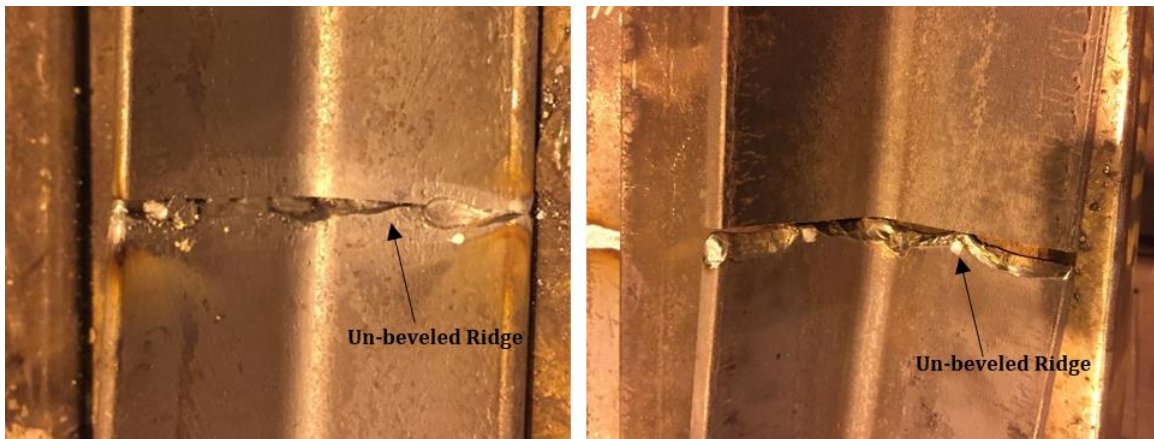
Fig. 9-5 Manufacturing cracks in the welds by leaving out a part of the bevels

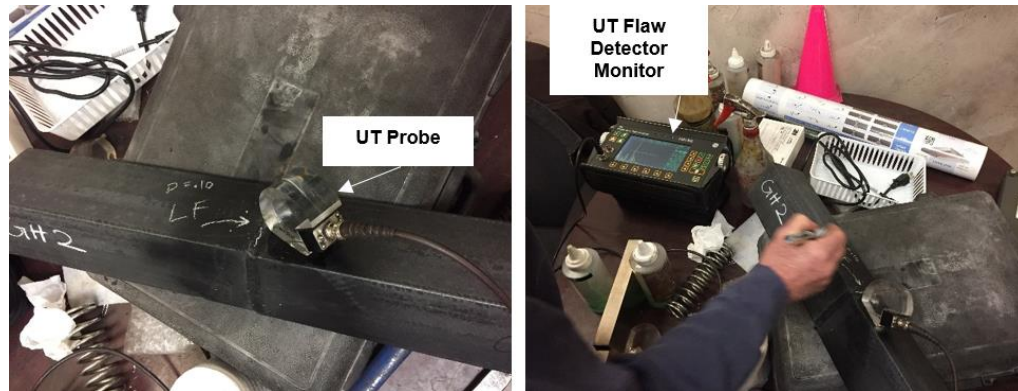
Fig. 9-6 USN 58 L Ultrasonic flaw detector

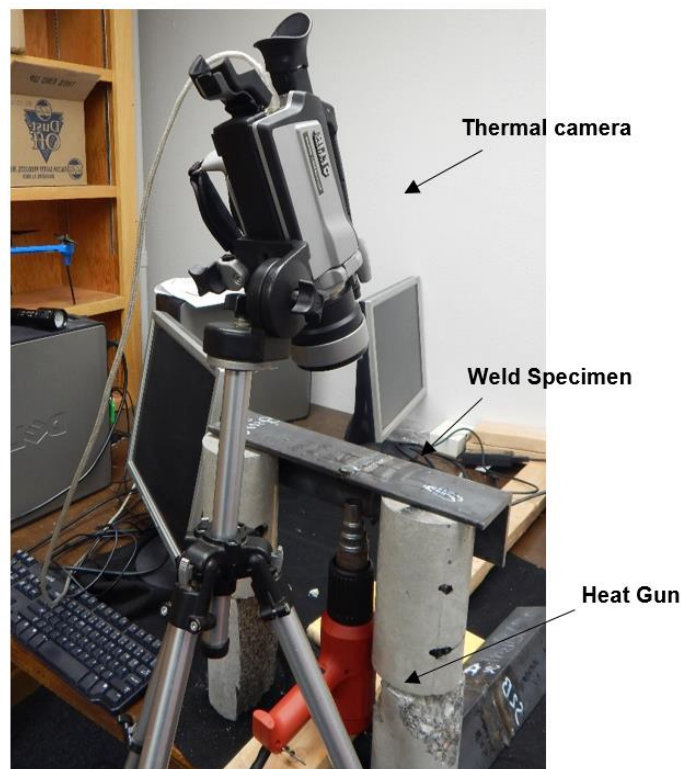
Fig. 9-7 Weld inspection in a lab setting

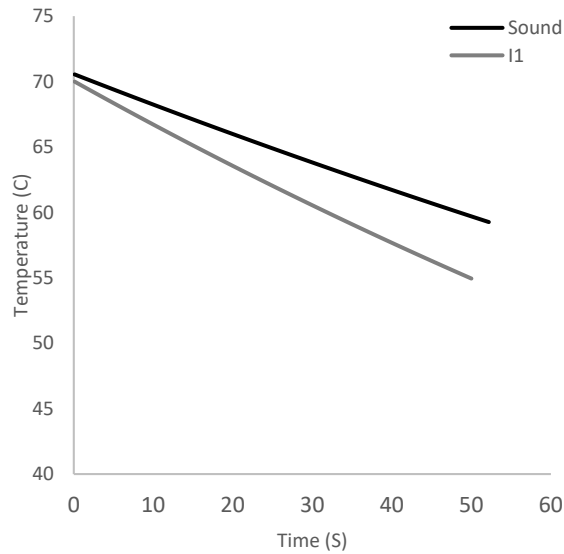
Fig. 9-10 Temperature decay in sound weld and IHa4A with inclusion

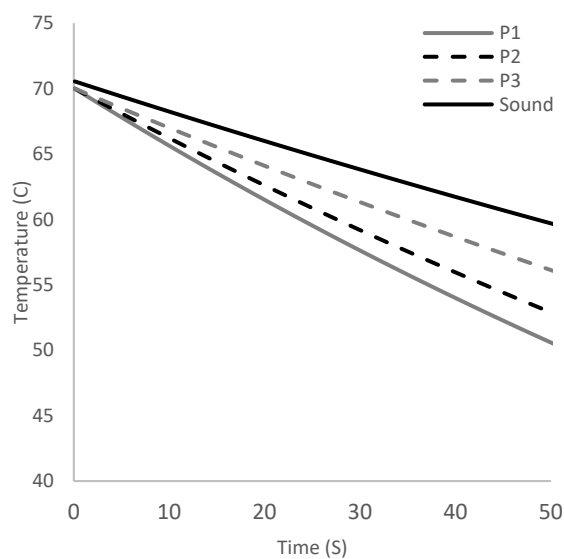
Fig. 9-11 Temperature decay of PHa1A, PHa2A, and PHa2B specimens with porosity (manufactured by changing voltage) and sound welds

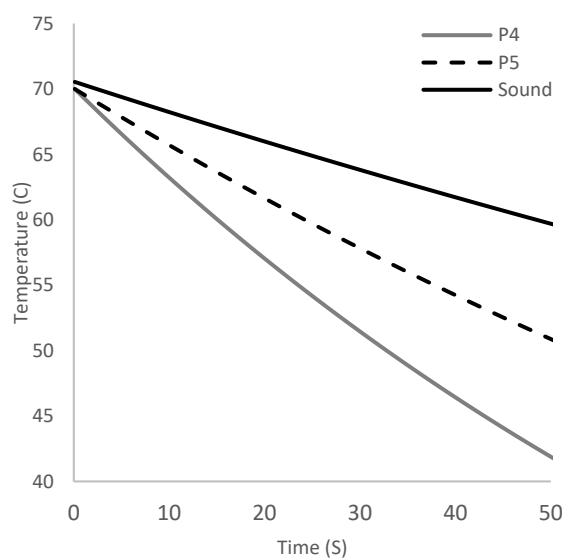
Fig. 9-12 Temperature decay of CH1A and CH1B specimens with porosity (manufactured for cracking) and sound welds

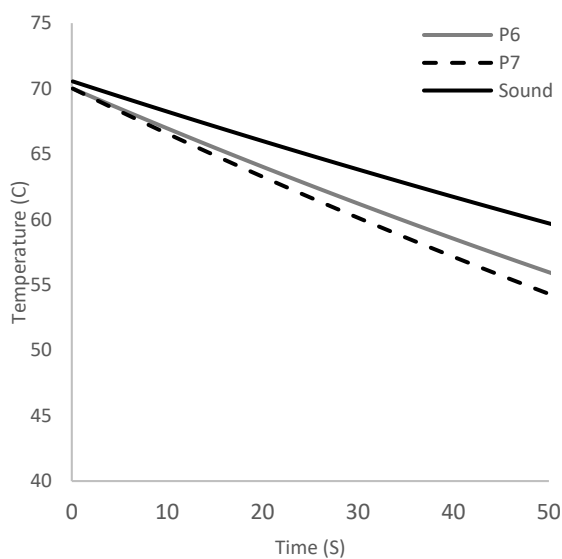
Fig. 9-13 Temperature decay of IHa3A and IHa4B specimens with porosity (manufactured for inclusion) and sound welds

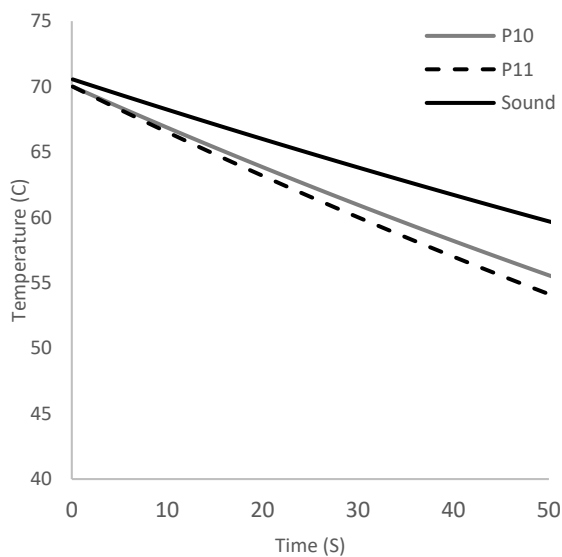
Fig. 9-15 Temperature decay of PHc1 and PHc2 specimens with porosity caused by oil and sound welds

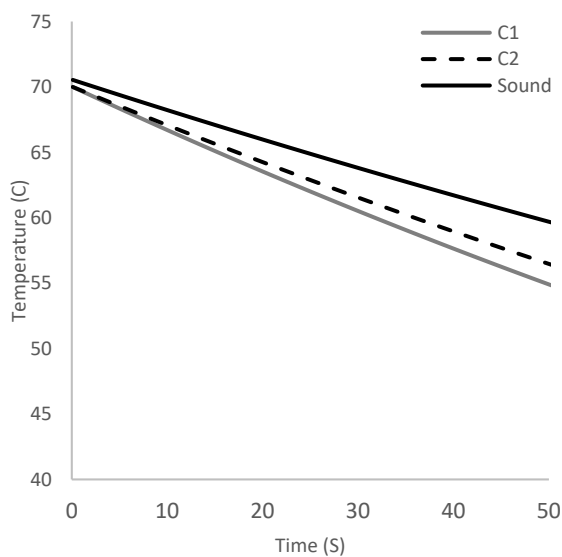
Fig. 9-16 Temperature decay of CH2A and CH2B specimens with cracks and sound welds

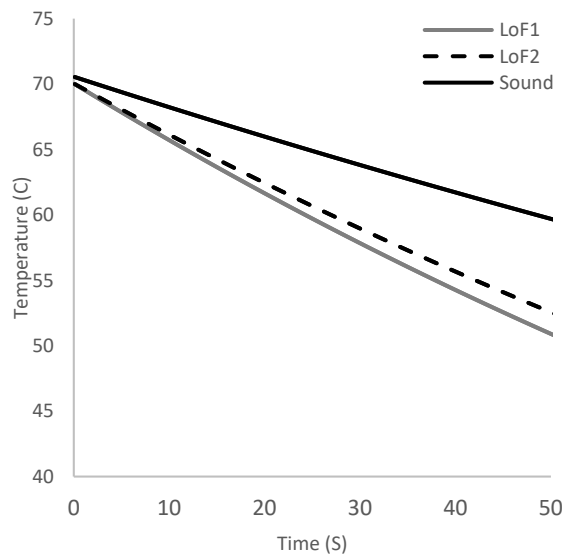
Fig. 9-17 Temperature decay of GH2A and GH2B specimens with lack of fusion in good welds and sound welds

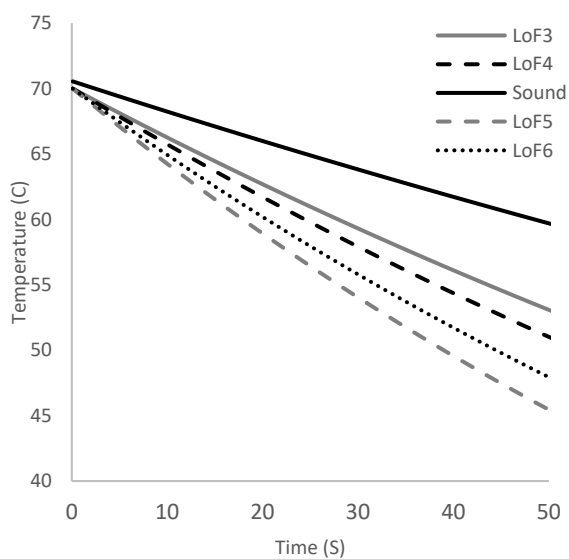
Fig. 9-18 Temperature decay of IHa1A, IHa1B, IHa2A, and IHa2B specimens with lack of fusion (intended to have inclusion) and sound welds

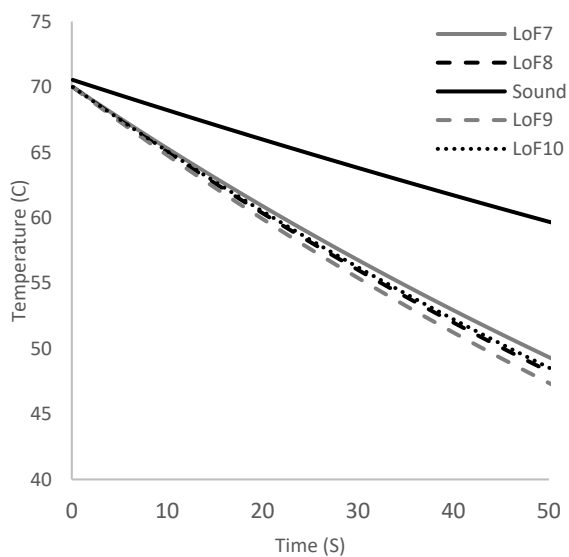
Fig. 9-19 Temperature decay of NH1A, NH1B, NH2A, and NH2B specimens with lack of fusion in normal welds and sound welds

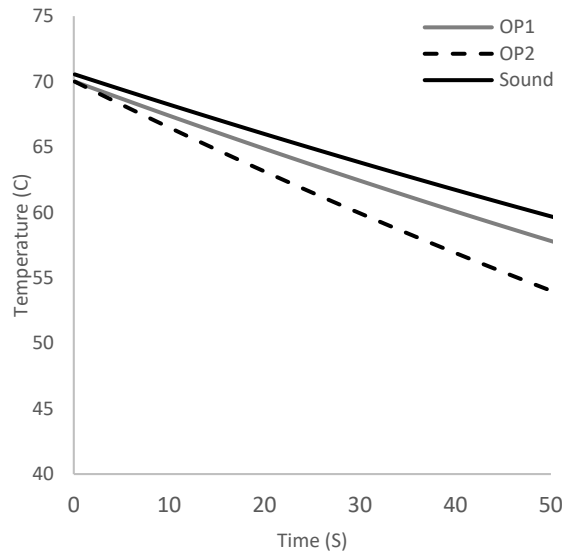
Fig. 9-20 Temperature decay of IHa3B and PHa1B specimens with lack of fusion and sound welds

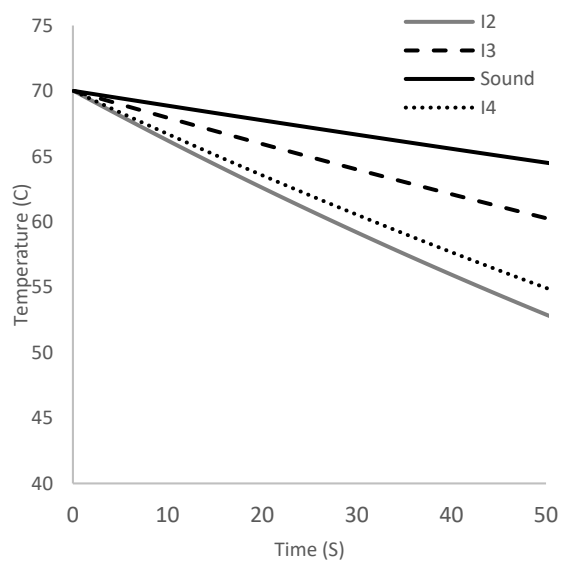
Fig. 9-21 Temperature decay of IHc1-1, IHc1-2, and IHc1-3 specimens with inclusions and sound weld

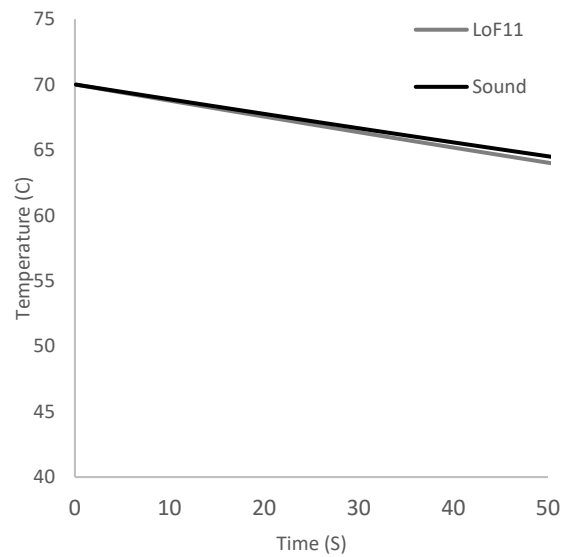
Fig. 9-22 Temperature decay of IHc2 specimen with lack of fusion and sound weld

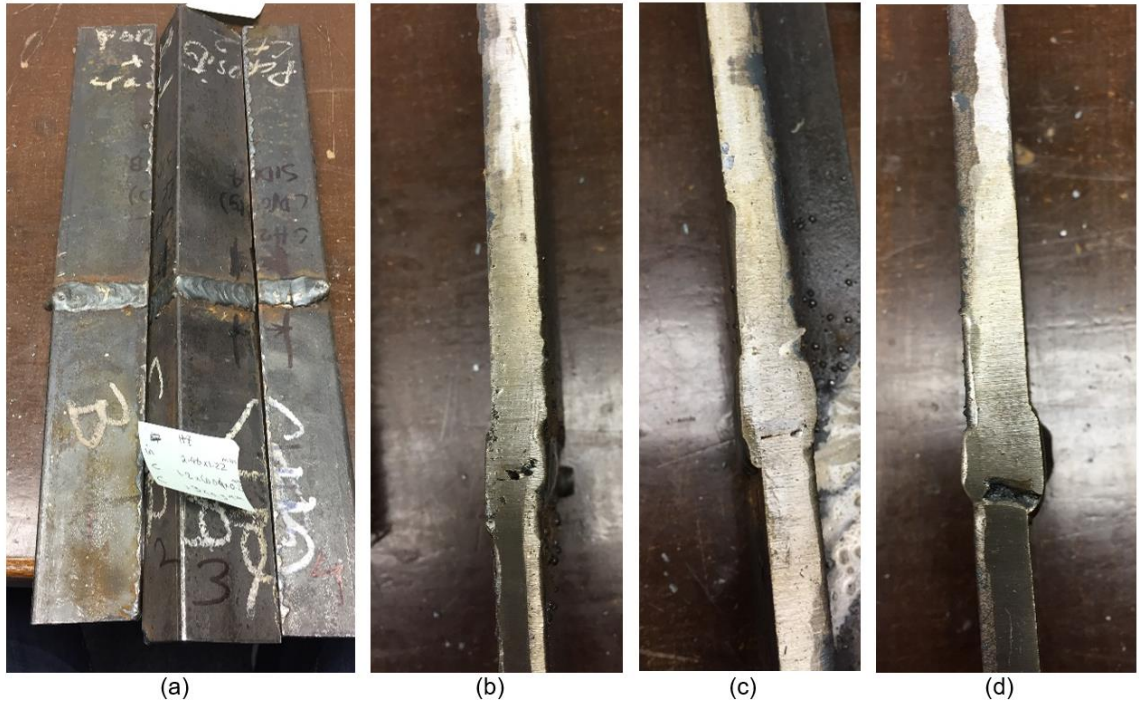
Fig. 9-29 Specimens CH1A and CH1B (a) cutting, (b) inclusion (c) crack, (d) inclusion

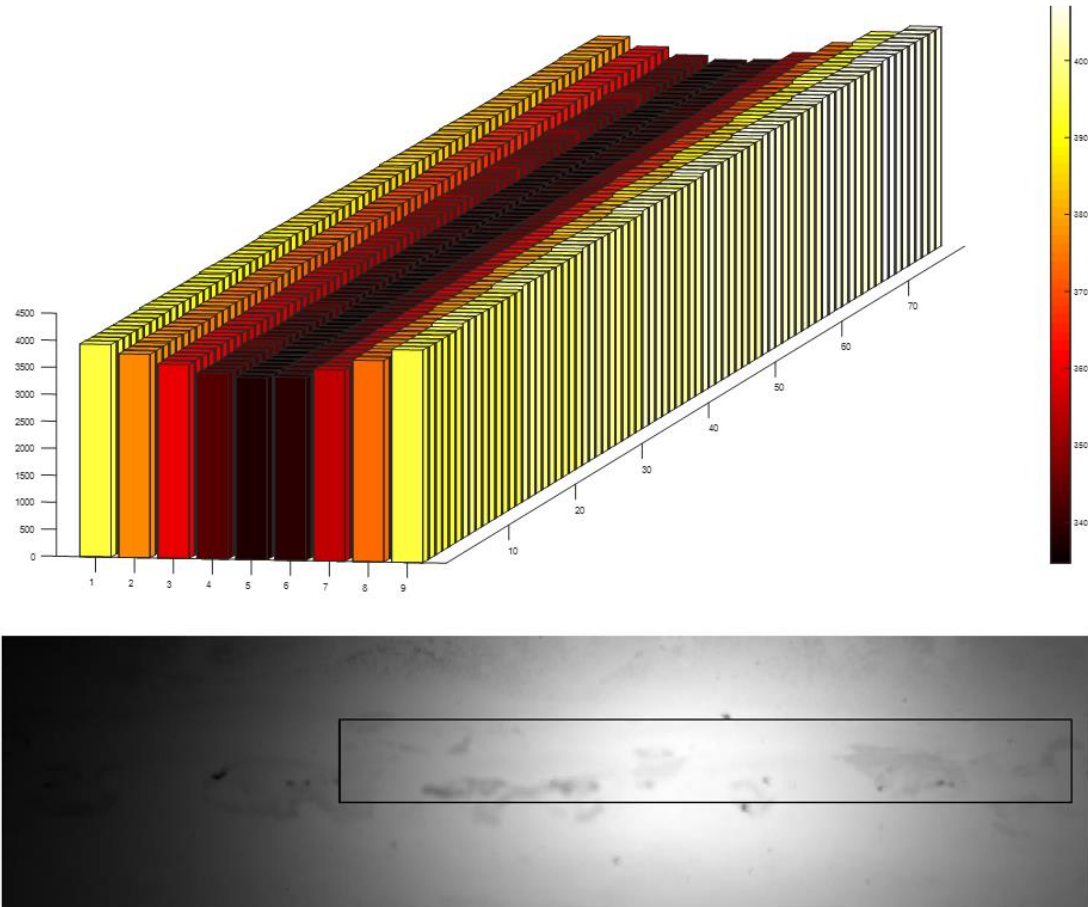
Fig. 9-30 The An values for specimen IHc1

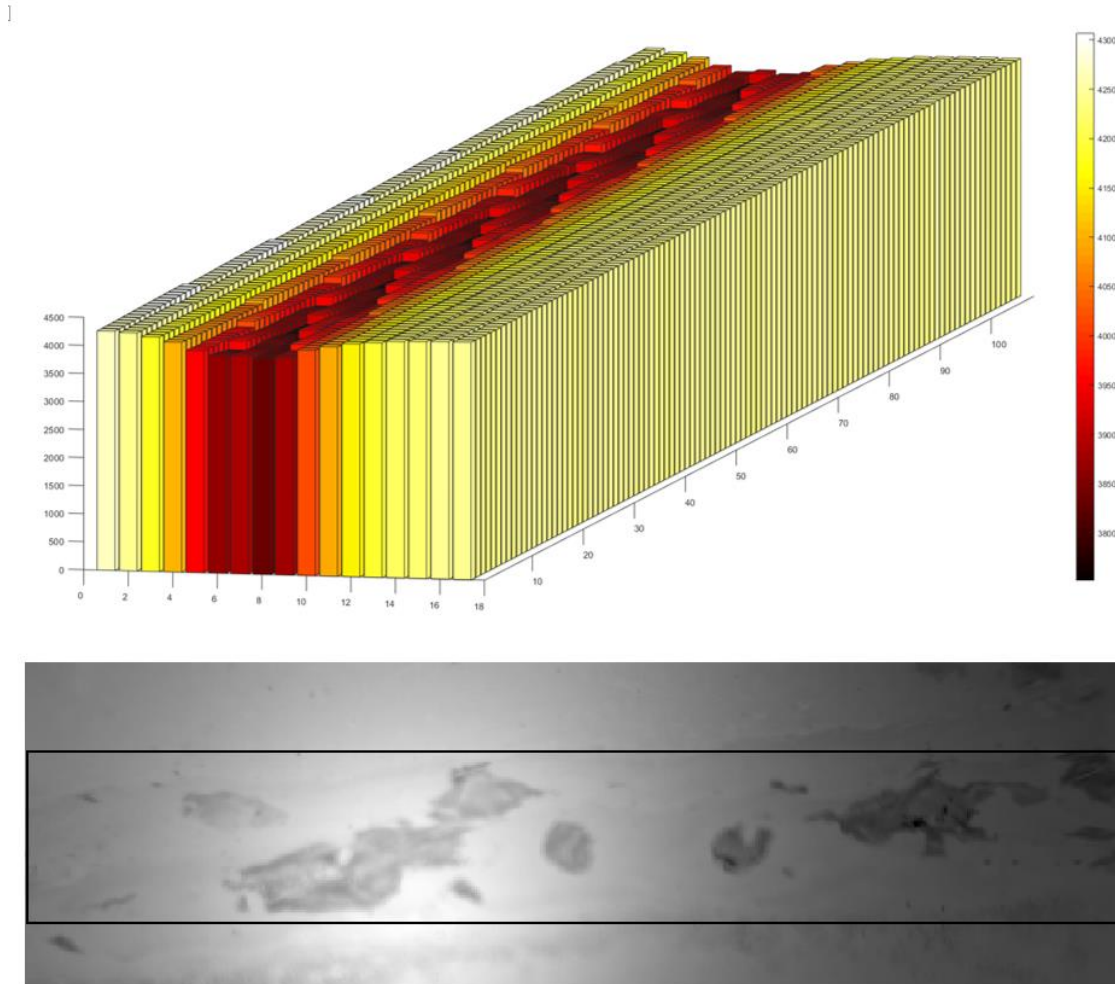
Fig. 9-31 The An values for specimen IHc2

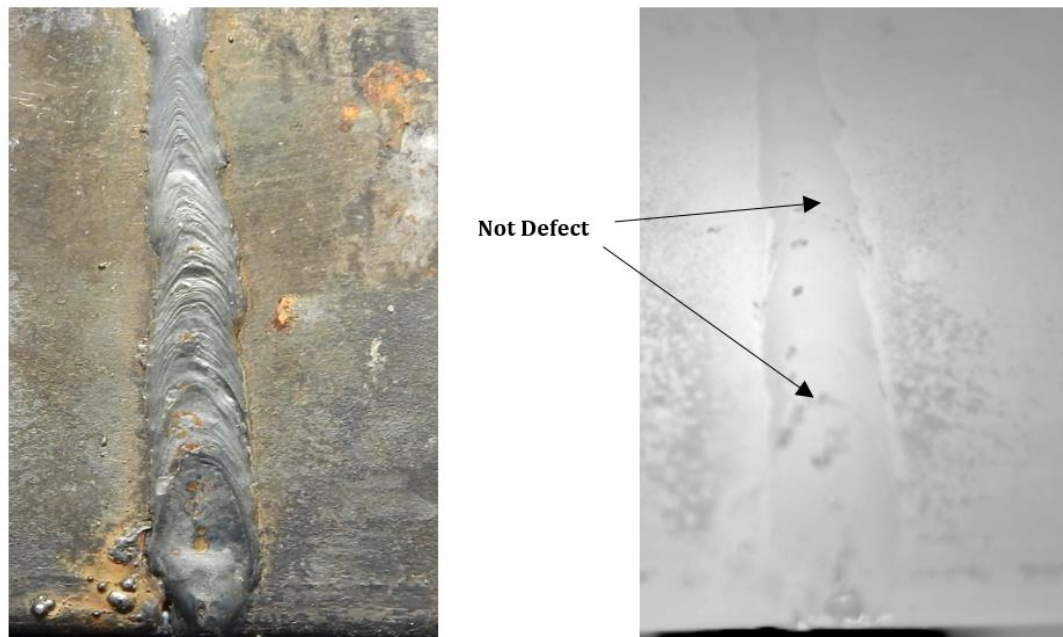
Fig. 9-33 Misleading surface clutters: left visual, right thermal
