STANDARDS TO CONTROL FRACTURE IN STEEL BRIDGES THROUGH THE USE OF HIGH-TOUGHNESS STEEL AND RATIONAL INSPECTION INTERVALS

**STANDARDS TO CONTROL FRACTURE IN STEEL BRIDGES THROUGH
THE USE OF HIGH-TOUGHNESS STEEL AND RATIONAL INSPECTION
INTERVALS**

A Dissertation

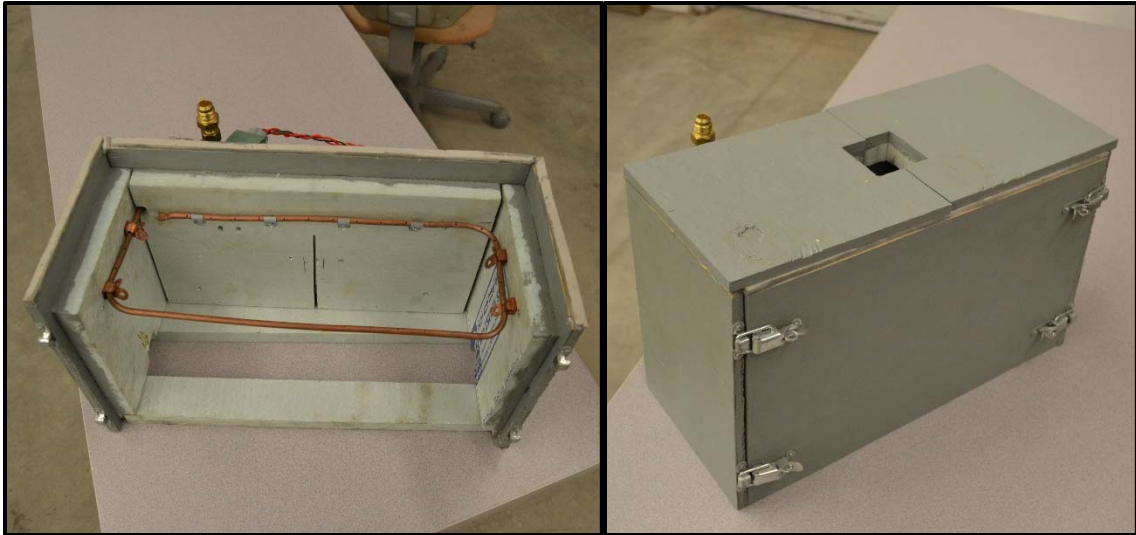
E1820-15a requires specimen temperature to be within ± 5 °F for a minimum of 30 minutes for each inch of specimen thickness (ASTM, 2015a). Photographs of the temperature chamber are shown in Figure 3.9. Guidance on selecting an initial test temperature for reference temperature determination testing is described in ASTM E1921-13a (ASTM, 2013b).

Figure 3.9: Fracture mechanics testing temperature chamber

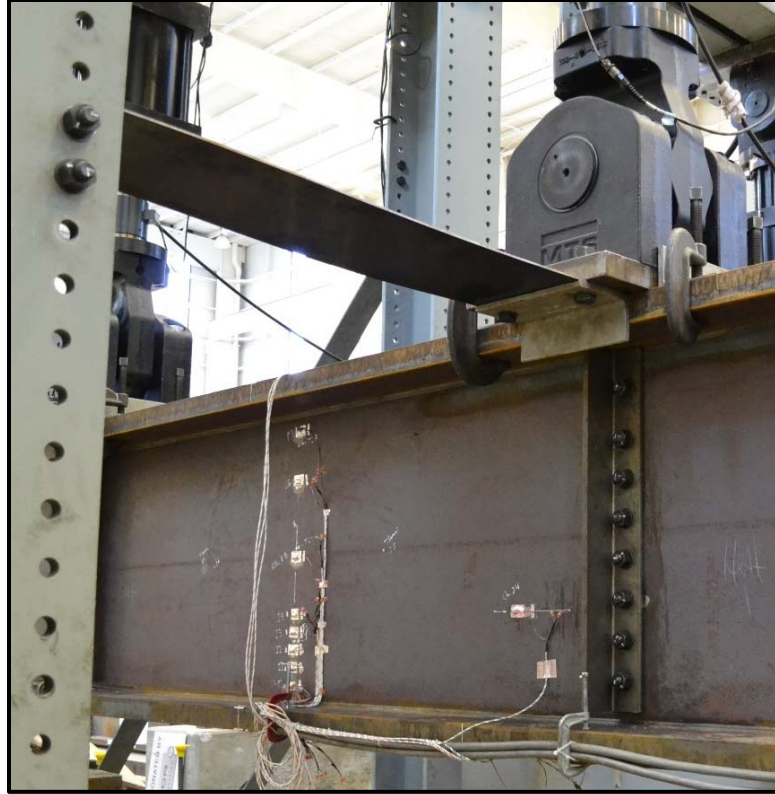
Lateral torsional buckling bracing was located on each side of the top flange at the load points for each bending specimen. The bracing consisted of a 12 in. x 3/16 in. steel plate fastened between the load frame column and the actuator loading plate as shown in Figure 3.19. Lateral forces were resisted through tension in the brace on one side of the specimen, while the brace on the opposite side of the specimen buckled. Due to the plate thickness, the LTB braces provided negligible vertical stiffness and minimally reduced the load from the actuators to the specimen.

Figure 3.19: Lateral torsional buckling bracing

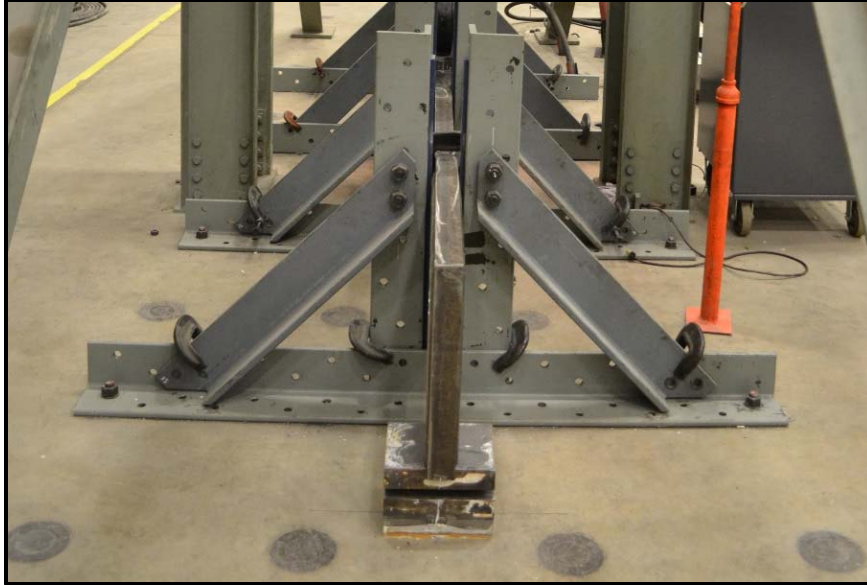
Bracing provided lateral stability during fatigue cycling. Four sets of braces were installed for each axial specimen. A set of braces were placed near each support and two sets of braces were placed near the load point. Braces were constructed from 6 in. x 4 in. x $\frac{3}{4}$ in. and 6 in. x 6 in. x $\frac{3}{4}$ in. angles and were connected by high strength bolts and bridge clamps. Using clamps allowed the braces to adapt to a variety of specimen thicknesses. Impact resistant slippery UHMW polyethylene bars were attached to the braces to minimize the load lost to friction. Figure 3.22 is a photograph of a set of lateral bracing.

Figure 3.22: Axial fatigue test setup lateral bracing

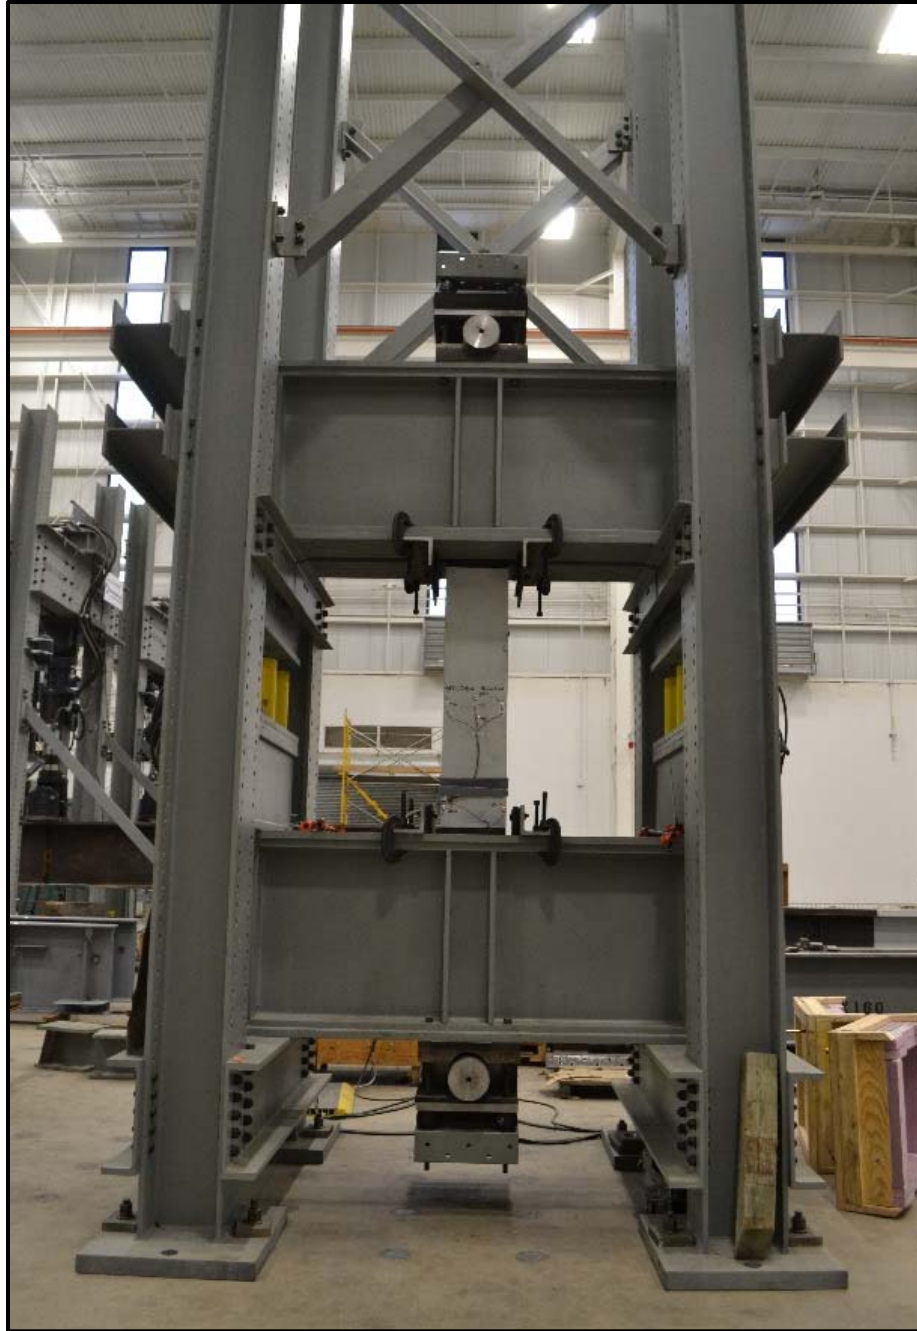
Figure 3.24: Axial test fracture setup

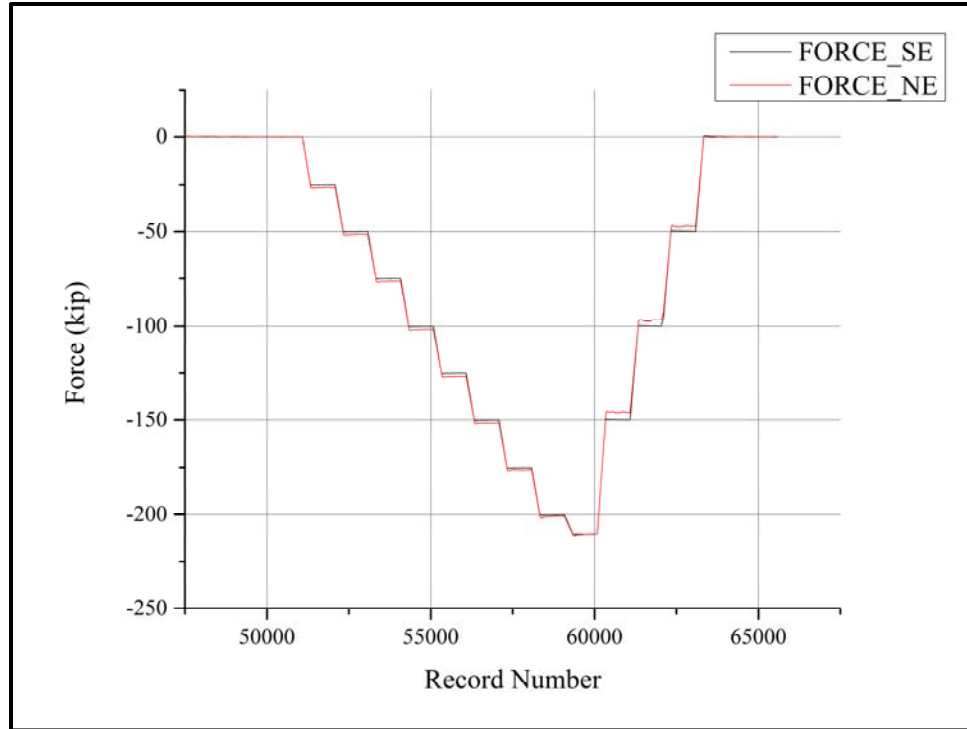
The bending load frames allowed for the entire test sequence to be performed in a single test frame. Prior to notching, static load tests were performed on the bending test specimens. Static tests provided baseline data as well as provided an opportunity to ensure the beam and test setup were performing as expected. Load was applied in steps of 25 kips per actuator up to the target fracture load. A minimum of three static tests were performed to confirm data consistency. Typically, data were recorded at a rate of 50 Hz during the static tests. A representative static load sequence can be found in Figure 3.35 with the resulting longitudinal stresses presented in Figure 3.36.

Figure 3.35: Representative static test load

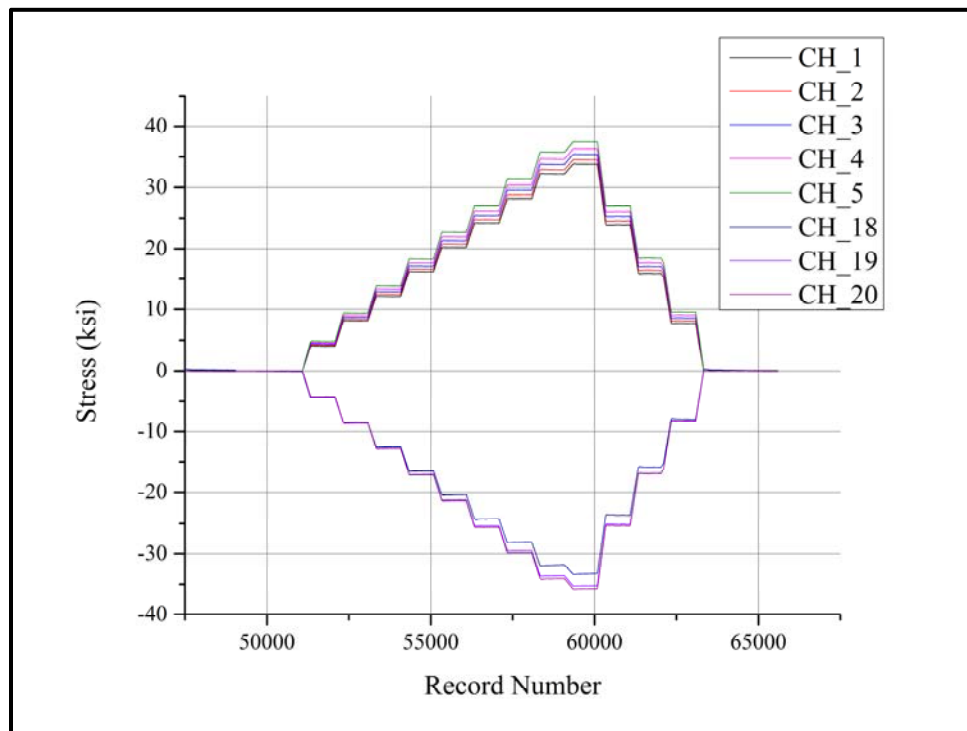
Figure 3.36: Representative static test longitudinal stress

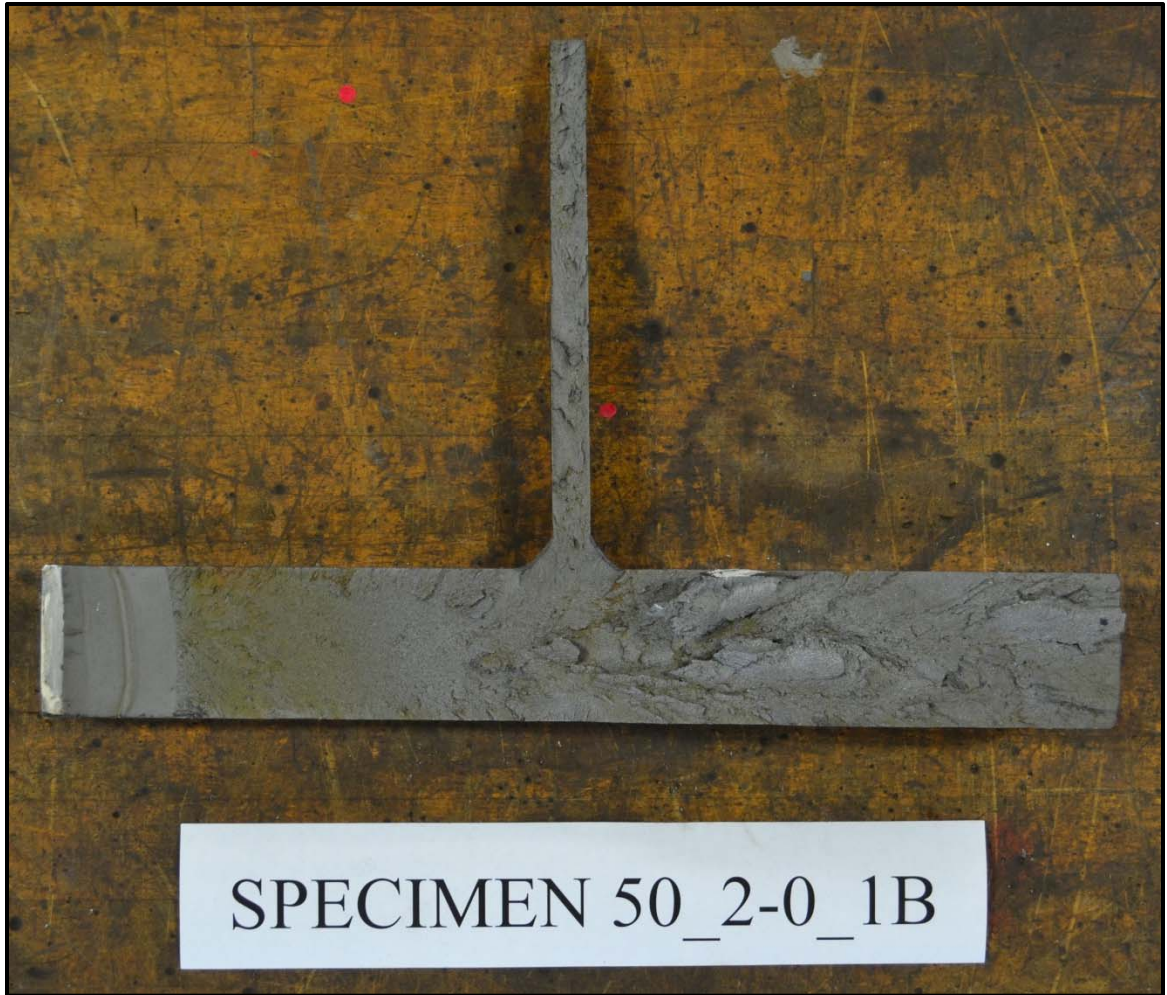
Specimen 50_2-0_1B was the first large-scale specimen tested. The bottom flange was notched to 0.25 in. with an angle grinder. A fatigue crack was grown to a length of 0.5 in. and a fracture test was performed. The test did not result in a fracture. At a length of 1.0 in. a second fracture test was performed and no fracture resulted. The crack was extended to 1.6875 in. and tested a third time resulting in a fracture of the bottom flange and web. The fracture arrested after severing the web and did not jump into the built-up components of the compression flange. An average actuator load of 149.2 kips was recorded at the time of fracture resulting in a bottom flange longitudinal stress of 26.3 ksi. A general photograph of Specimen 50_2-0_1B taken after fracture can be found in Figure 3.38. Figure 3.39 is a photograph of the fracture surface from Specimen 50_2-0_1B.

Figure 3.38: Specimen 50_2-0_1B

Figure 3.39: Specimen 50_2-0_1B fracture surface

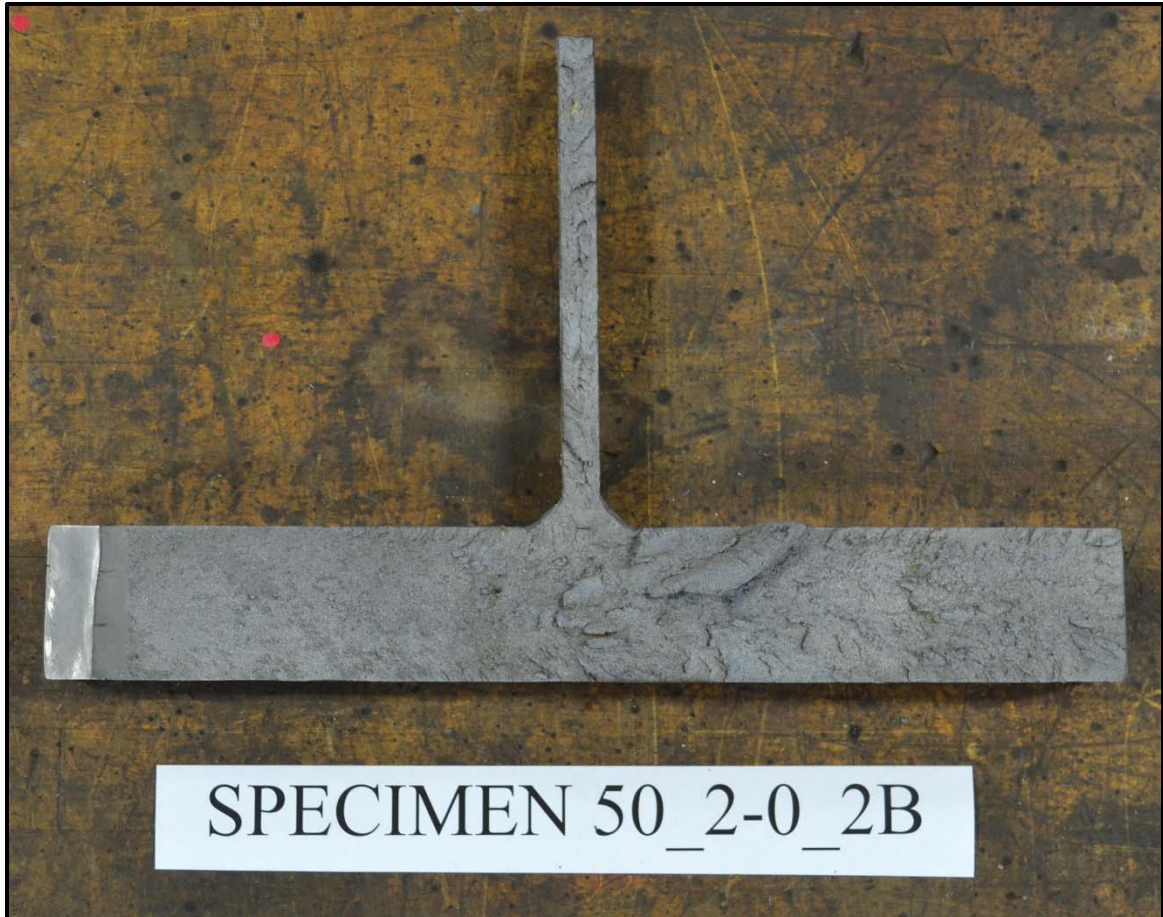
Specimen 50_2-0_2B was initially notched to 0.625 in. with an angle grinder. A fatigue crack was grown to 1.0625 in. and a fracture test was performed. The fracture test resulted in complete fracture of the tension flange as well as the web. The fracture did not jump to any of the built-up components of the compression flange. At fracture, the average actuator load was 128.6 kips. The calculated bottom flange stress was 22.6 ksi. A general photograph of Specimen 50_2-0_2B taken after fracture can be found in Figure 3.40. Figure 3.41 is a photograph of the fracture surface from Specimen 50_2-0_2B.

Figure 3.40: Specimen 50_2-0_2B

Figure 3.41: Specimen 50_2-0_2B fracture surface

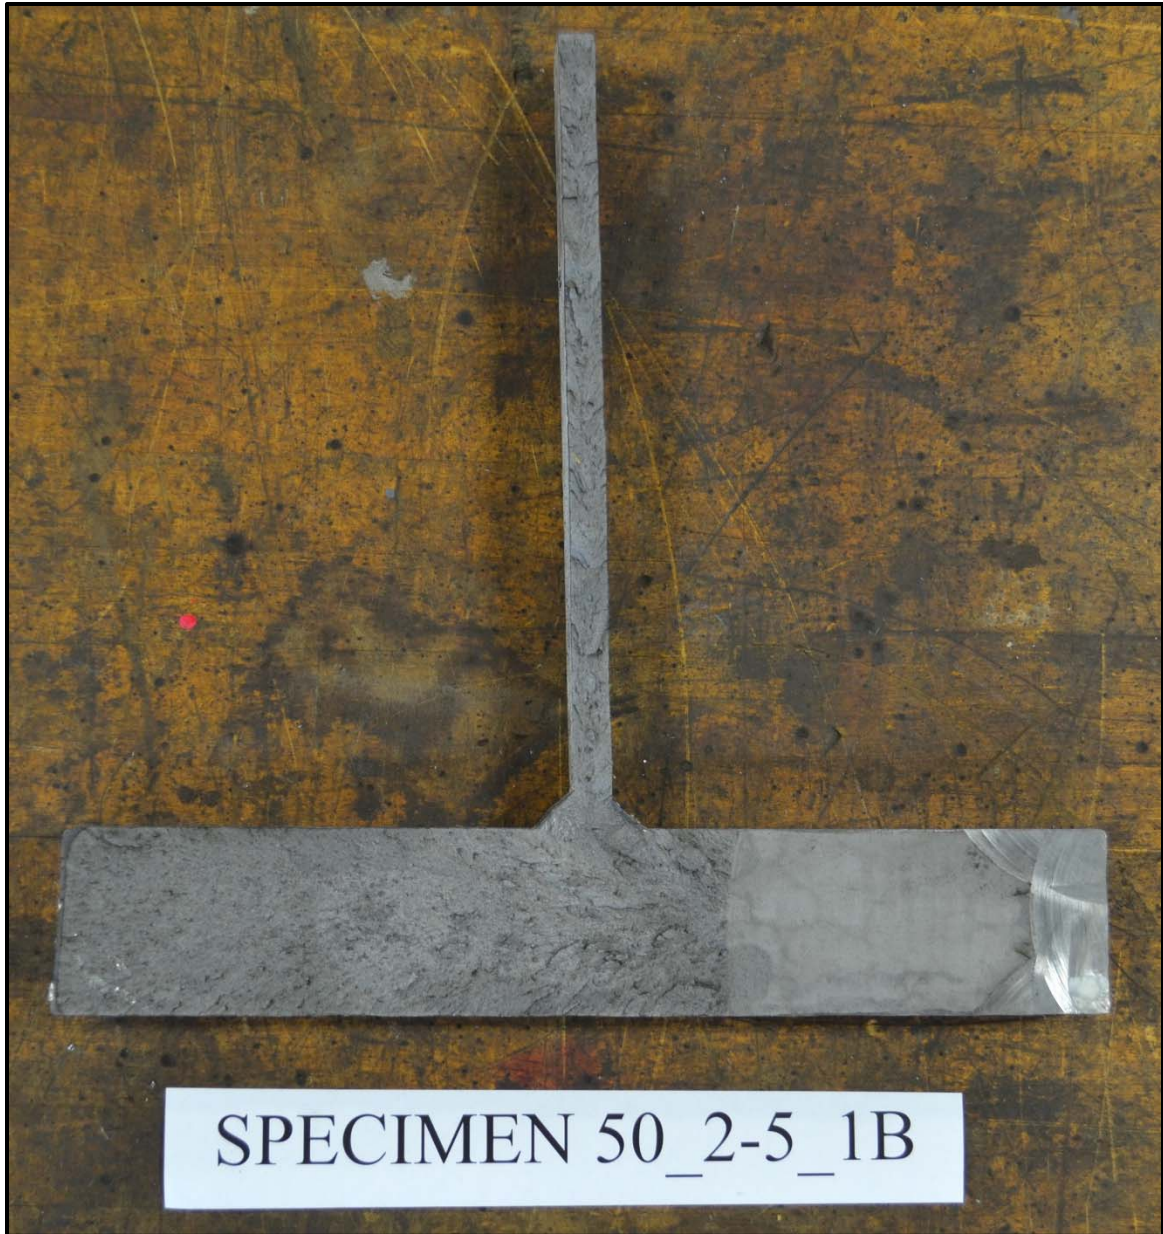
The final fatigue crack of Specimen 50_2-5_1B was grown to 5.0 in. Fracture occurred at an average actuator load of 104.6 kips. The resulting bottom flange stress was 18.7 ksi. Complete specimen fracture was prevented by the dog-bone detail. A general photograph of Specimen 50_2-5_1B taken after fracture can be found in Figure 3.43. Figure 3.44 is a photograph of the fracture surface from Specimen 50_2-5_1B.

Figure 3.43: Specimen 50_2-5_1B

Figure 3.44: Specimen 50_2-5_1B fracture surface

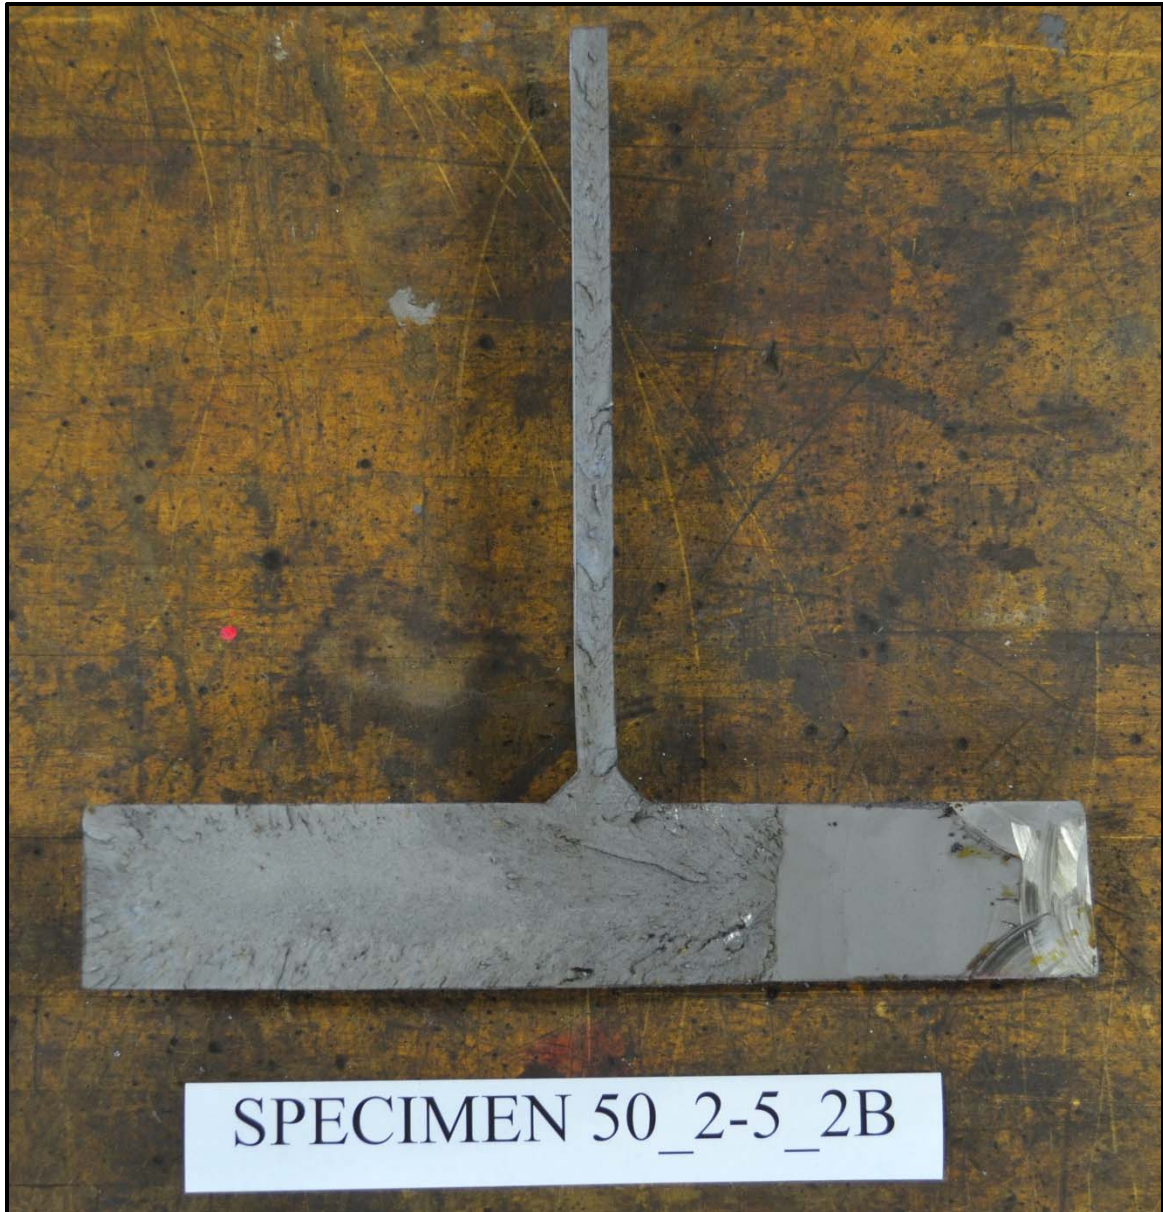
detail. The fracture was arrested by the detail. At fracture, the average actuator load was 163.3 kips. The resulting bottom flange stress was 29.2 ksi. A general photograph of Specimen 50_2-5_2B taken after fracture can be found in Figure 3.45. Figure 3.46 is a photograph of the fracture surface from Specimen 50_2-5_2B.

Figure 3.45: Specimen 50_2-5_2B

Figure 3.46: Specimen 50_2-5_2B fracture surface

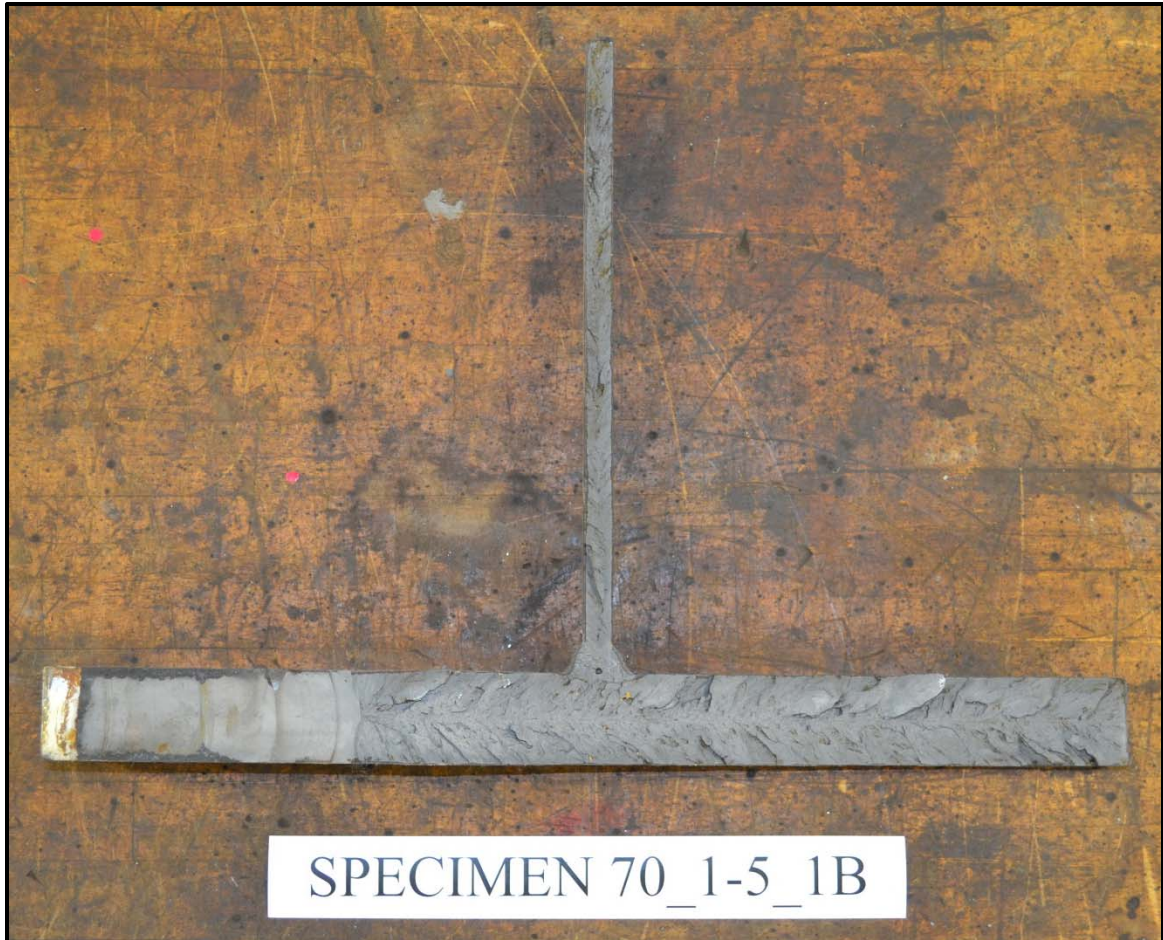
Specimen 70_1-5_1B was notched with a 0.625 in. through-thickness straight notch. The center-to-center hole spacing of the dog-bone detail was 36 in. for Specimen 70_1-5_1B. Unsuccessful fracture attempts were made at fatigue crack lengths of 1.0 in., 2.5 in., and 3.625 in. Specimen 70_1-5_1B fractured at a fatigue crack length of 5.0625 in. The average actuator load was 160.4 kips at fracture. The resulting bottom flange stress was 40.4 ksi. Complete specimen fracture was prevented by the dog-bone detail. A general photograph of Specimen 70_1-5_1B taken after fracture can be found in Figure 3.47. Figure 3.48 is a photograph of the fracture surface from Specimen 70_1-5_1B.

Figure 3.47: Specimen 70_1-5_1B

Figure 3.48: Specimen 70_1-5_1B fracture surface

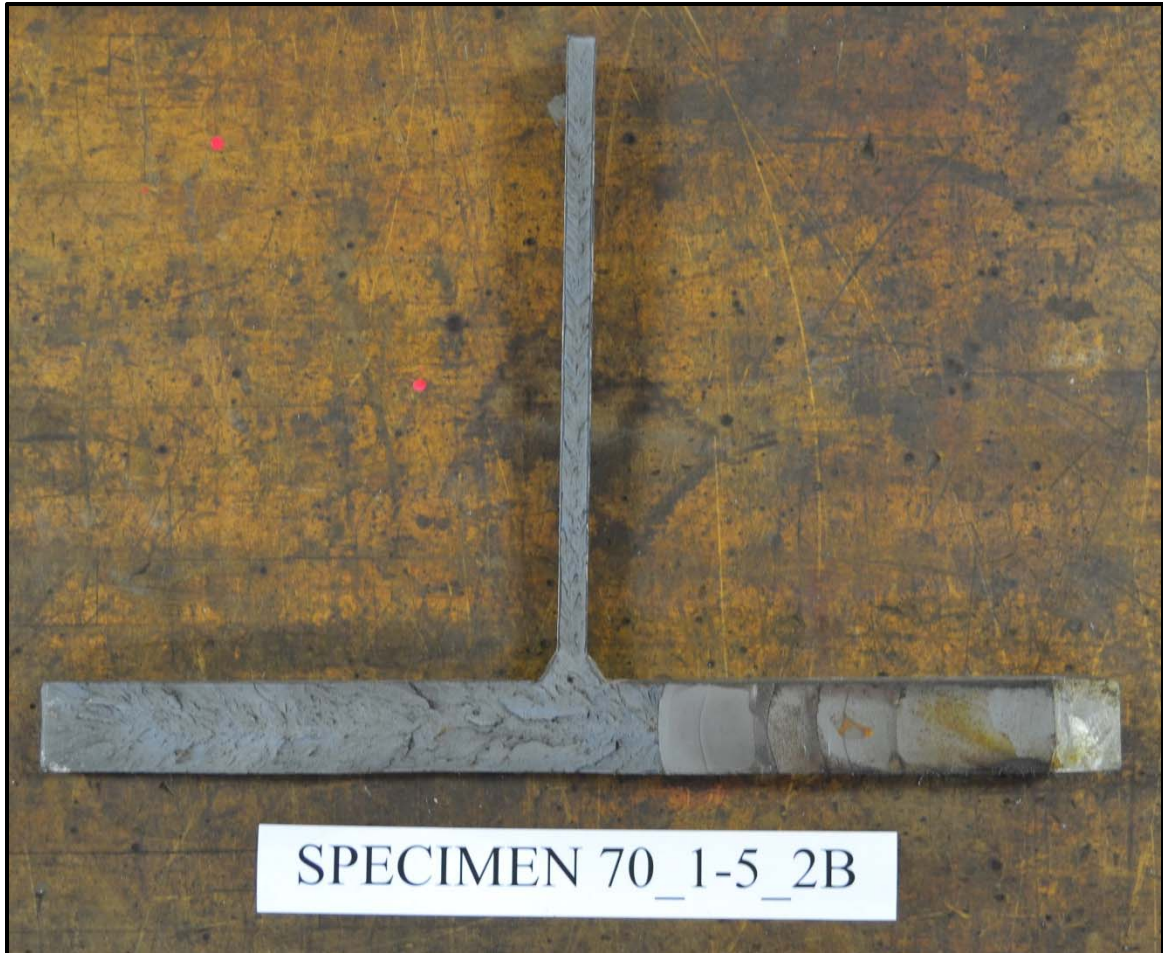
Specimen 70_1-5_2B was notched with a 1.125 in. through-thickness straight notch. The center-to-center hole spacing of the dog-bone detail was 18 in. for Specimen 70_1-5_2B. Unsuccessful fracture attempts were made at fatigue crack lengths of 3.625 in., 5.0 in., and 5.75 in. Specimen 70_1-5_2B fractured at a fatigue crack length of 7.5 in. The average actuator load was 164.6 kips at fracture. The resulting bottom flange stress was 41.5 ksi. Complete specimen fracture was prevented by the dog-bone detail. A general photograph of Specimen 70_1-5_2B taken after fracture can be found in Figure 3.49. Figure 3.50 is a photograph of the fracture surface from Specimen 70_1-5_2B.

Figure 3.49: Specimen 70_1-5_2B

Figure 3.50: Specimen 70_1-5_2B fracture surface

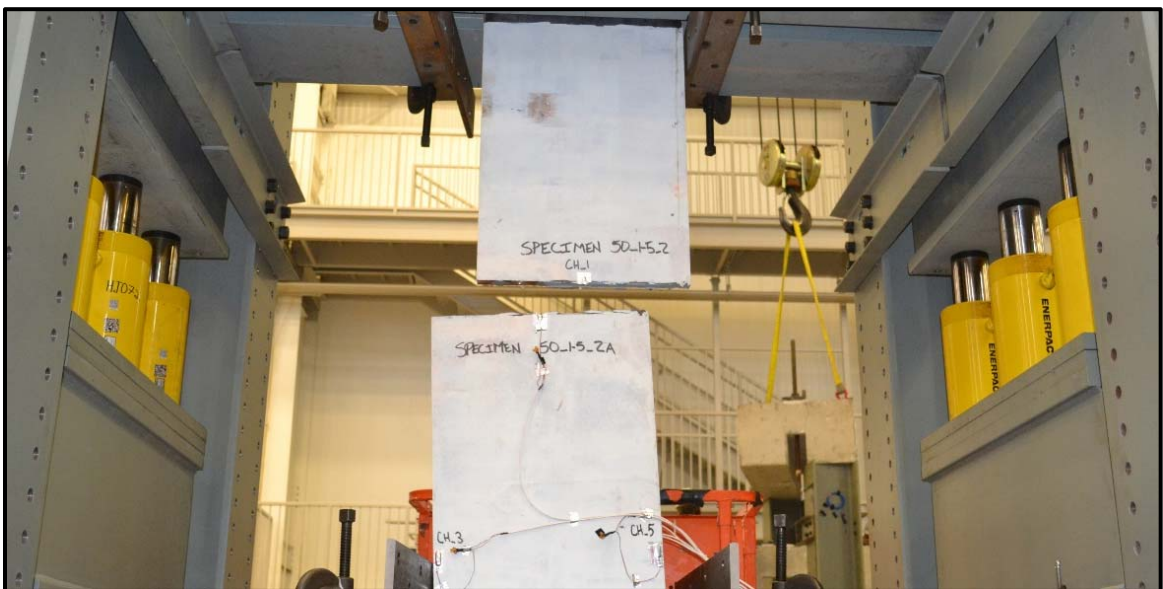
further. After difficulty growing through the plastic zone created during the initial fracture test, a grinder was used to notch the specimen. The notch was extended with the grinder to a length of 6.5 in. A fatigue crack was grown to a final length of 6.9375 in. for the second fracture attempt. Fracture occurred at a load of 728.3 kips. The resulting stress was 22.1 ksi. A general photograph of Specimen 50_1-5_2A taken after fracture can be found in Figure 3.53. Figure 3.54 is a photograph of the fracture surface from Specimen 50_1-5_2A.

Figure 3.53: Specimen 50_1-5_2A

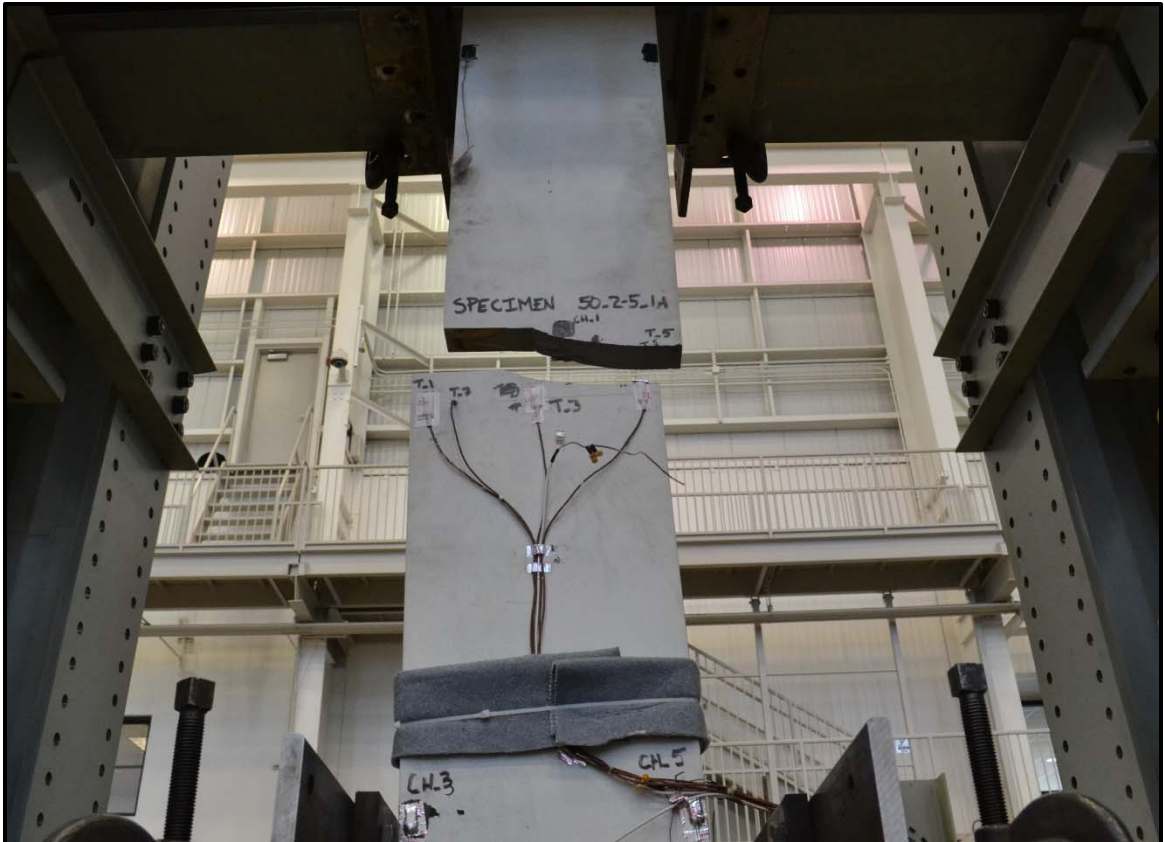
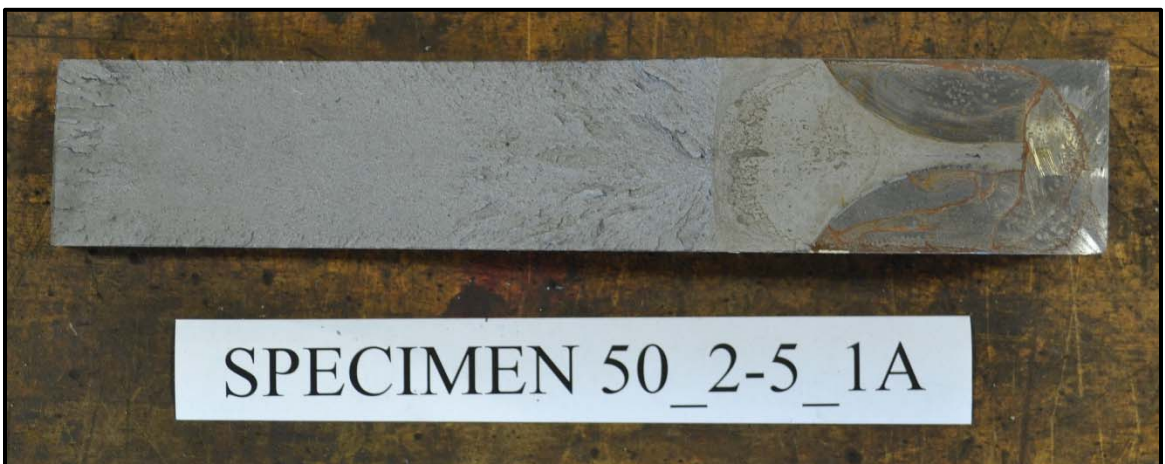
An initial v-notch with a trapezoidal front was cut into Specimen 50_2-5_1A. The notch had a through-thickness length of 1.125 in. The trapezoidal front tapered to a final surface length of 3.875 in. The final fatigue crack for Specimen 50_2-5_1A was grown to 4.9375 in. and fracture occurred at a load of 581.7 kips. The resulting stress was 16.6 ksi. A general photograph of Specimen 50_2-5_1A taken after fracture can be found in Figure 3.55. Figure 3.56 is a photograph of the fracture surface from Specimen 50_2-5_1A.

Figure 3.55: Specimen 50_2-5_1A

Figure 3.56: Specimen 50_2-5_1A fracture surface

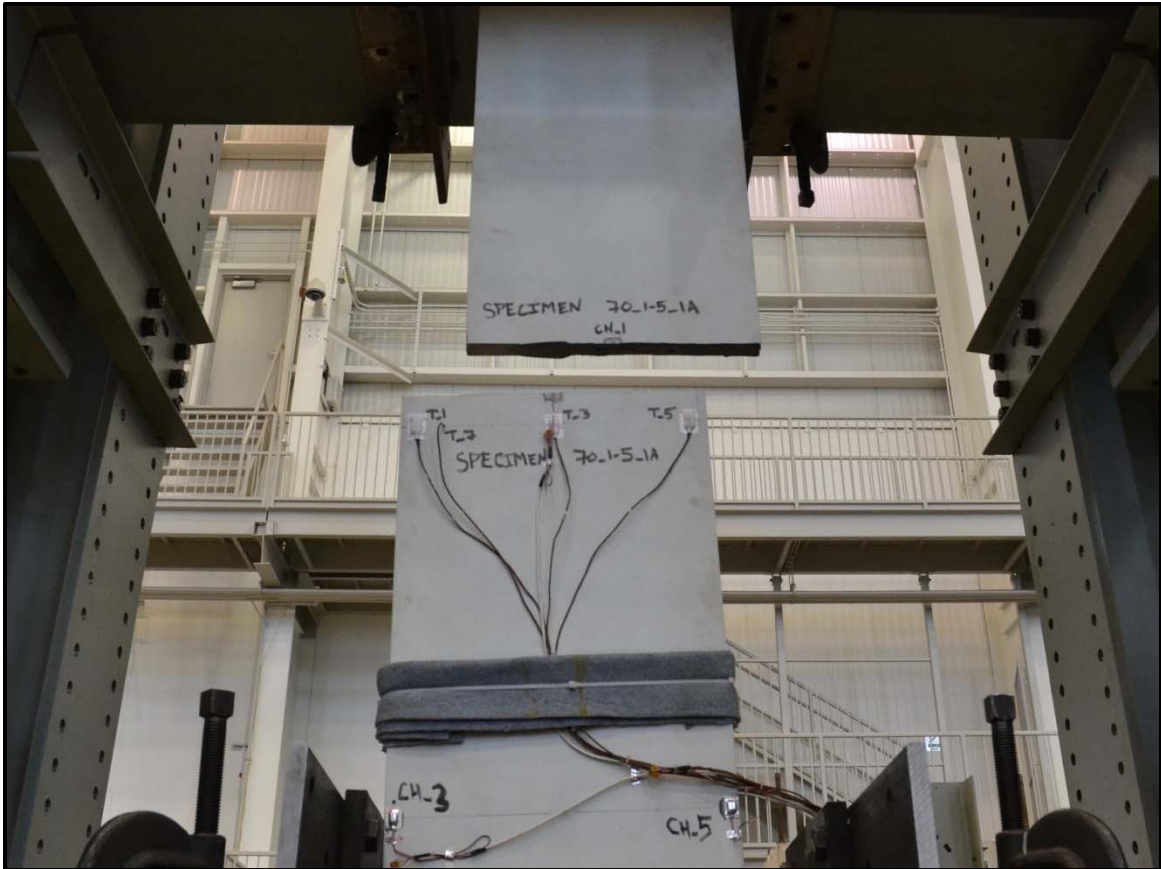
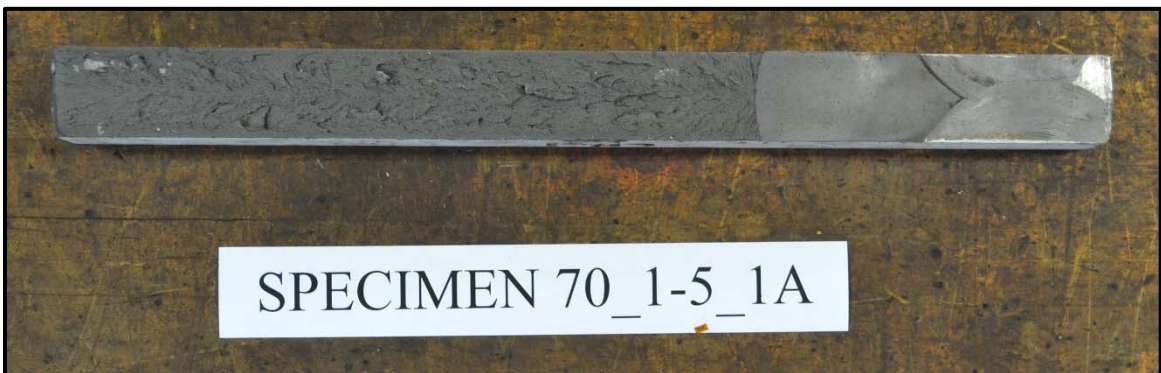
An initial v-notch was cut into Specimen 70_1-5_1A. The notch had a through-thickness length of 2.5 in. and a v-notch tapered to a surface length of 3.25 in. The fatigue crack for Specimen 70_1-5_1A was grown to 6.0 in. Fracture occurred at a load of 424.4 kips. The resulting stress was 15.7 ksi. A general photograph of Specimen 70_1-5_1A taken after fracture can be found in Figure 3.57. Figure 3.58 is a photograph of the fracture surface from Specimen 70_1-5_1A.

Figure 3.57: Specimen 70_1-5_1A

Figure 3.58: Specimen 70_1-5_1A fracture surface

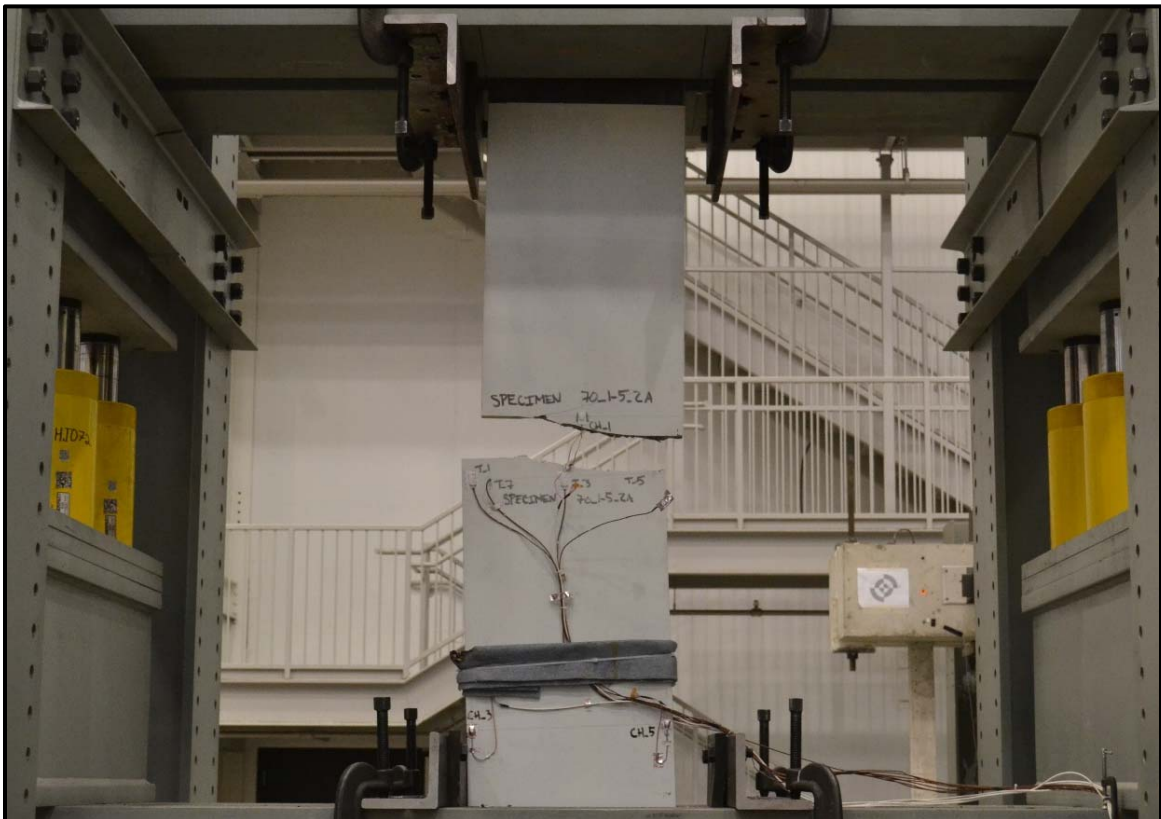
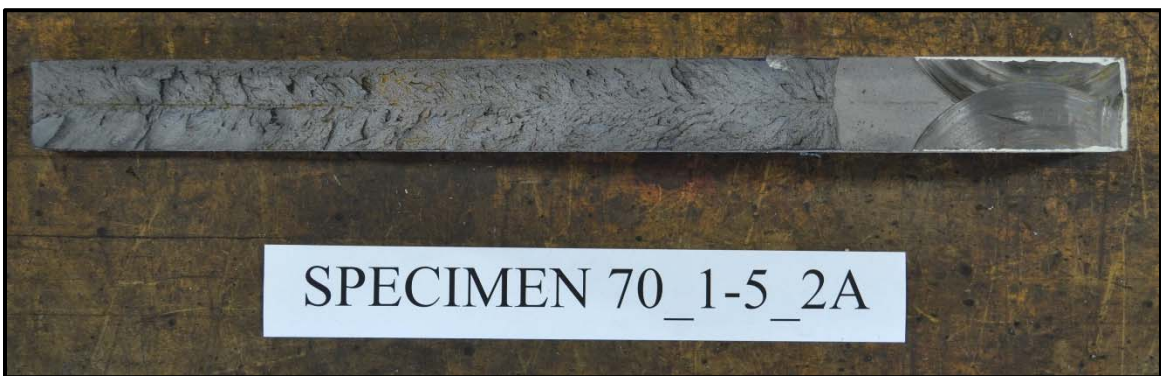
crack for Specimen 70_1-5_2A was grown to 4.625 in. Fracture occurred at a load of 871.0 kips with a resulting stress of 32.3 ksi. A general photograph of Specimen 70_1-5_2A taken after fracture can be found in Figure 3.59. Figure 3.60 is a photograph of the fracture surface from Specimen 70_1-5_2A.

Figure 3.59: Specimen 70_1-5_2A

Figure 3.60: Specimen 70_1-5_2A fracture surface

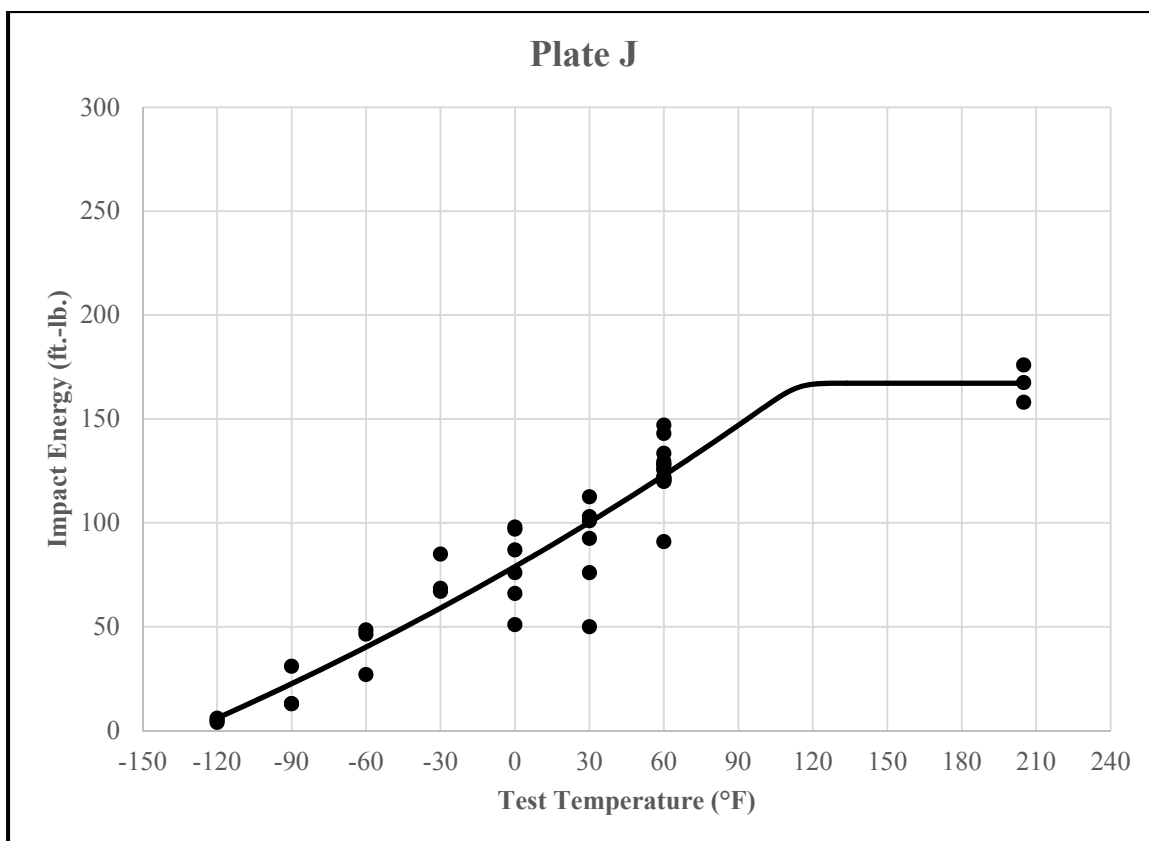
At the completion of large-scale testing, additional CVN impact specimens were prepared from each test plate. The additional specimens were used to evaluate the CVN impact variability throughout the test specimens. All five parameter sigmoidal fits were updated to include all tested CVN impact specimens for a given plate. The CVN impact results for all tested plates, including the raw data as well as the plots and five parameter sigmoidal fits, can be found in Appendix F. Figure 3.62 depicts a representative plot of CVN impact data for Plate J with the five parameter sigmoidal fit.

Figure 3.62: Representative CVN impact data with sigmoidal fit

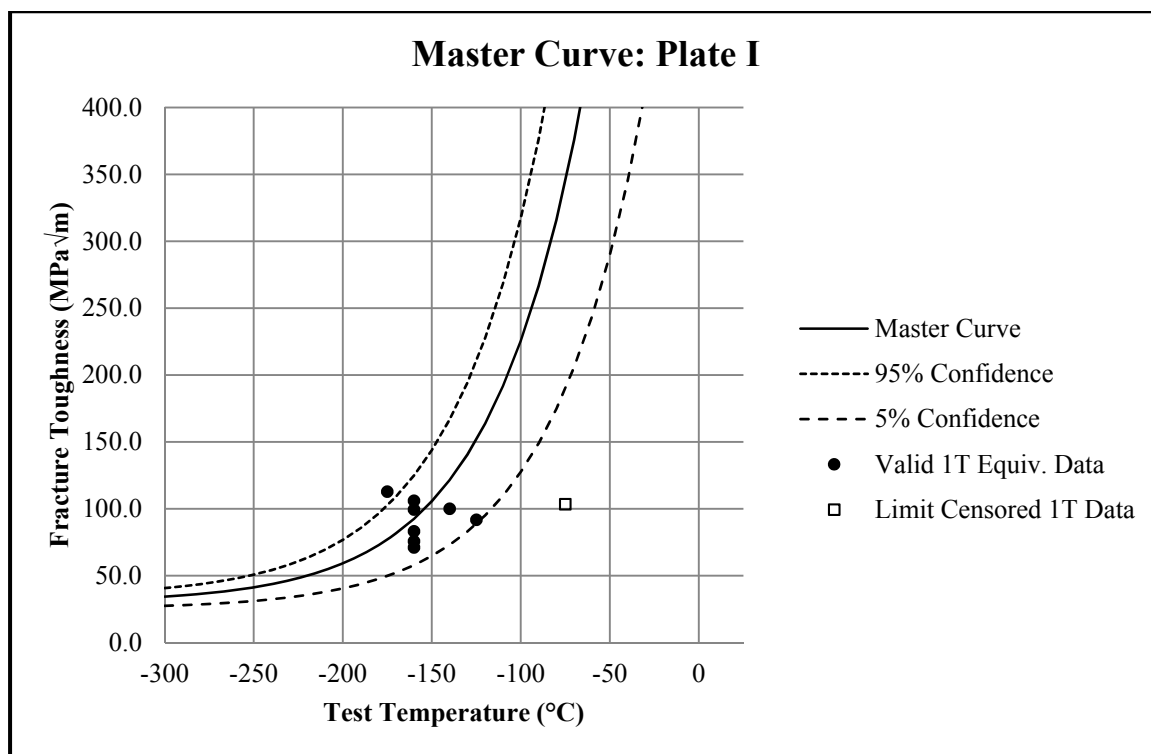
Figure 3.63: Representative master curve

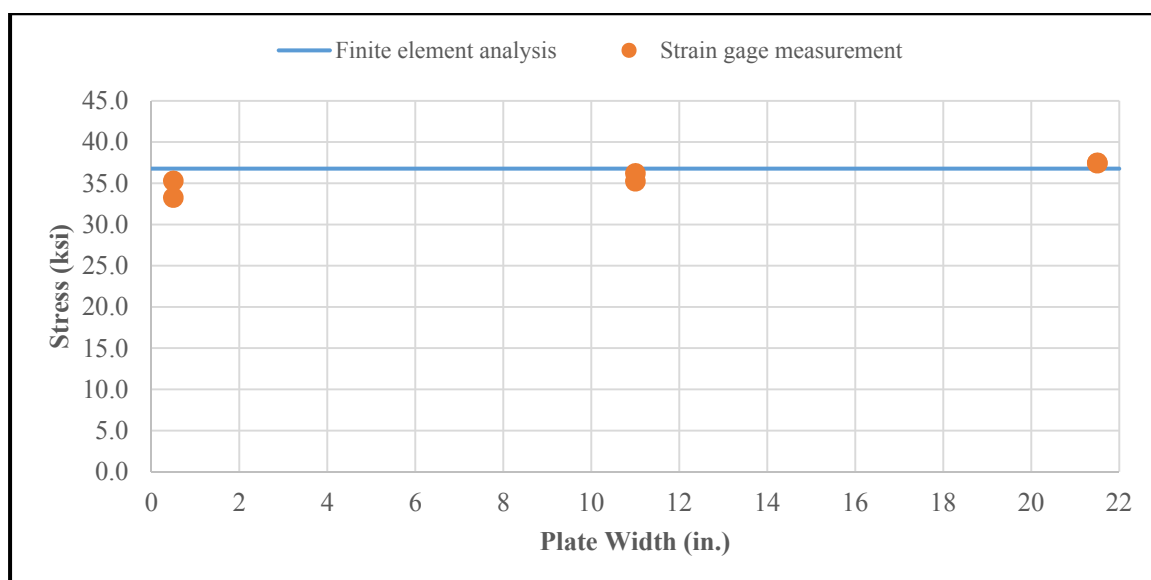
Figure 4.19: Specimen 50_1-5_1A longitudinal stress at midpoint
