Incidence of an Astronaut Not Sealing the Pressure Garment Visor on Reentry

Smith, Cameron M. and Tresch, Trent (2019) "Incidence of an Astronaut Not Sealing the Pressure Garment Visor on Reentry," *Journal of Human Performance in Extreme Environments*: Vol. 15 : Iss. 1 , Article 1.

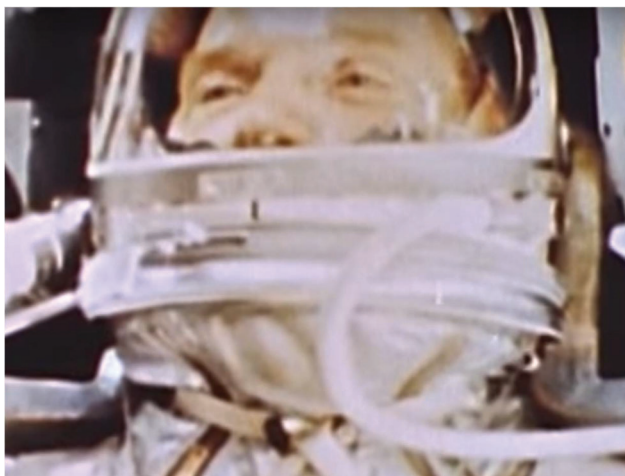
Figure 2. MA-6 pilot at 20 seconds to SECO, visor closed. Sealant strip visible in Figures 1a and 1b not visible, here obscured by metal visor perimeter strip seen in Figure 1a. Image: NASA.

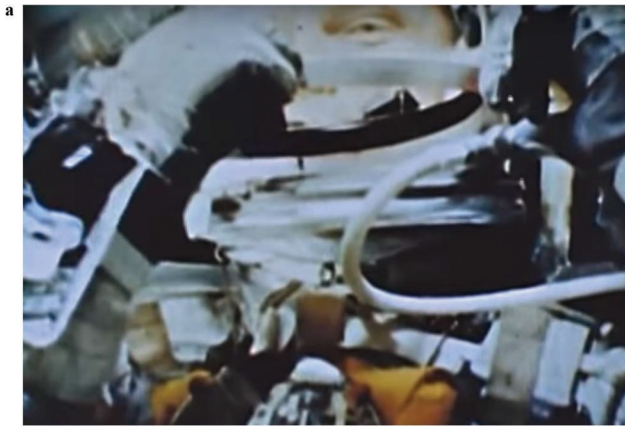
Figure 3. (a) MA-6 pilot opening visor *ca* 20 minutes into flight. (b) Pilot consuming xylose (sugar) pill. Image: NASA.

In Figure 3a, the pilot is opening the visor to take a xylose (sugar) pill at MET 0:21:59. In Figure 3b, the pill is being consumed, and in Figure 4 the visor is closed again, just a few seconds after it was opened to take the sugar pill. At MET 00:52:00, Capcom asks the pilot to confirm that his visor is closed (line eight of Table 1); the pilot confirms this, indicating that he was closing the visor as it had been opened for some unreported time. At MET 01:13:09, the pilot reports opening the visor to eat; somewhat over a minute later, he reports having eaten (apple sauce from a tube) and that he is again closing the helmet visor. The next video footage pertinent to the subject of this brief is seen at MET 04:33:09, during the deorbit burn; here (see Figure 5) the visor is clearly open, with no metal band covering the black sealing strip identified in other figures.

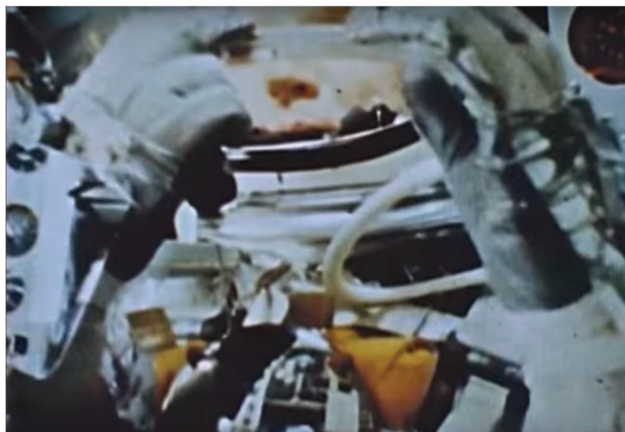
Figure 4. MA-6 pilot closing visor after consuming xylose (sugar) pill while in orbit with hard vacuum beyond pressurized cabin hull. Image: NASA.

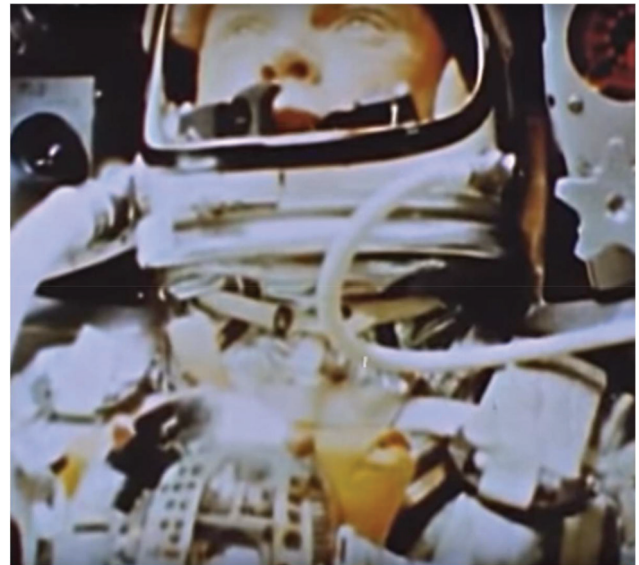
Figure 6. MA-6 pilot reporting “A real fireball outside” during reentry (MET 04:43:47), with hard vacuum outside pressure cabin and helmet visor open, altitude >100,000 ft above MSL. Image: NASA.

Figures 6, 7, 8, and 9—all time-stamped to altitudes between orbit and 7,000 ft MSL—show an open visor. Viewing the continuous video footage through this period shows that the visor remained open though deorbit burn and landing (NASA, 1962a).

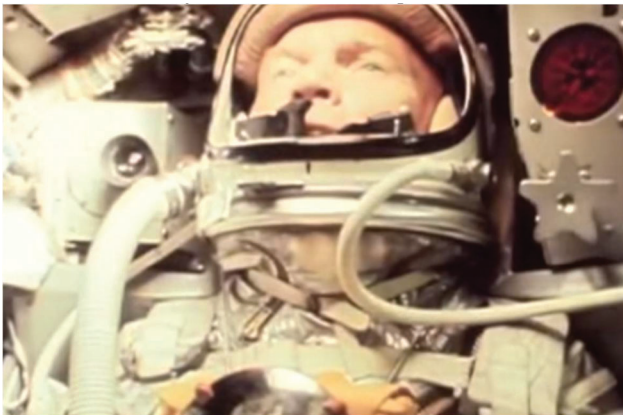
Figure 8. MA-6 pilot reporting “Altimeter off the peg indicating eight zero thousand” during reentry (MET 04:48:07), with <0.0 psia ambient pressure outside pressure cabin and helmet visor open, altitude 80,000 ft above MSL. Image: NASA.

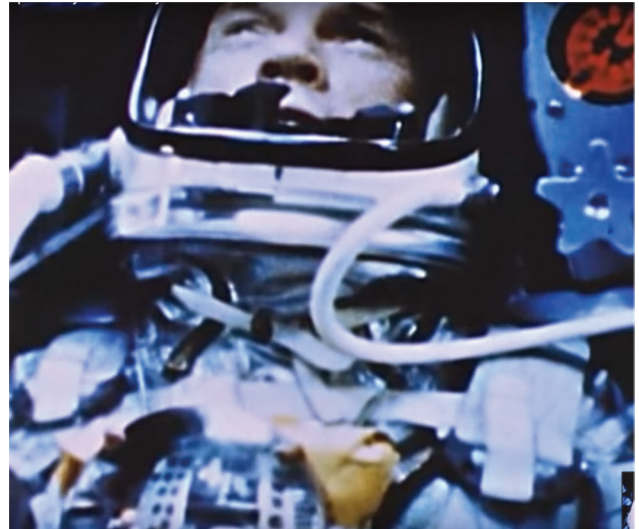
Figure 9. MA-6 pilot reporting “...drogue [parachute] came out at 30,000...” during reentry (MET 04:49:20), with “only just physiologically safe” ambient pressure of 4.3 psia outside pressure cabin and helmet visor open, altitude *ca* 30,000 ft above MSL. Image: NASA.

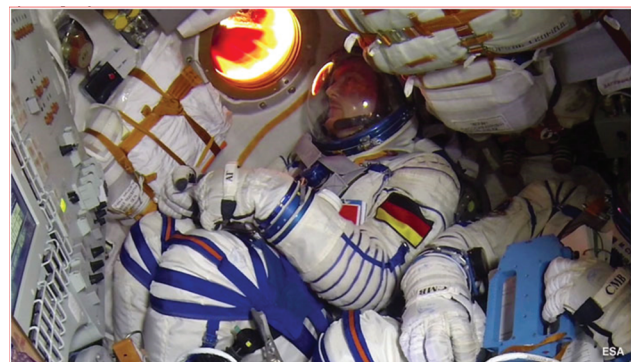
Figure 12. Soyuz capsule reentry, crewmember with helmet visor sealed. Image: European Space Agency.

Our third conclusion derives from the discussion above and our noting that currently Soyuz crews both ascend to orbit, and return to Earth, entirely with the suit pressurized and the visor closed (this tradition began after the *Soyuz 11* disaster) (Shayler, 2009) (see Figure 11). This is a simple way to ensure that the pressure suit can carry out its function of keeping the crew alive and conscious in case of cabin loss of pressure. Flying in these phases of a mission with the visor closed is simple enough; but as we have seen in this paper, it will always require an up-to-date checklist,
