# *Fluvial Geomorphology and Bank Stabilization – White River at Stotts Creek Confluence*

Jessica Eichhorst, P.E.  
Purdue Road School  
March 5, 2019

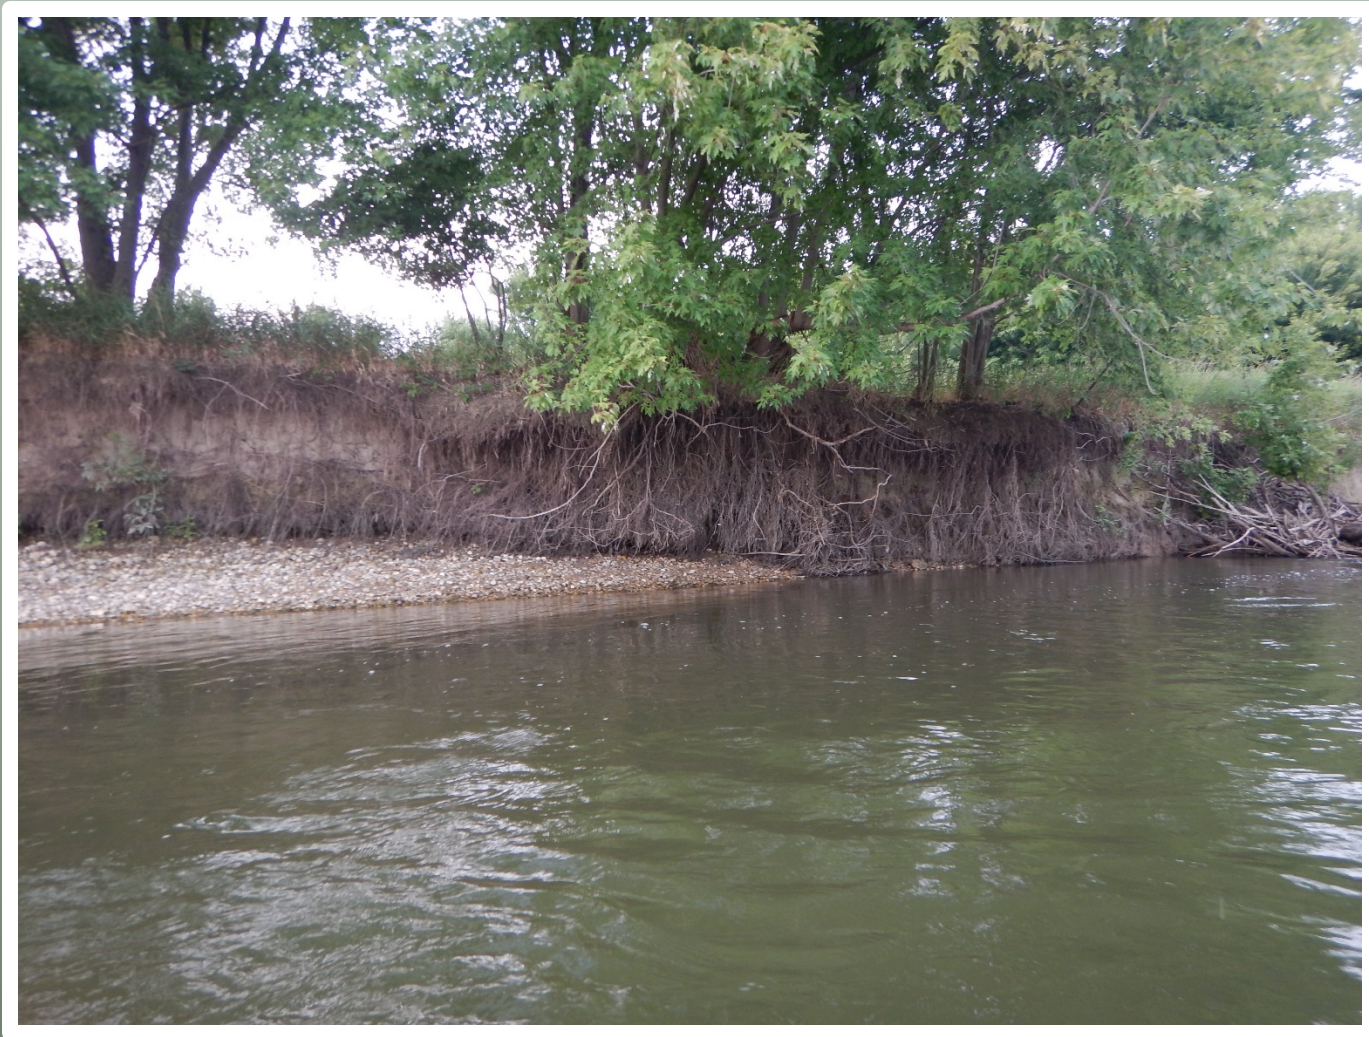
# Exposed Roots

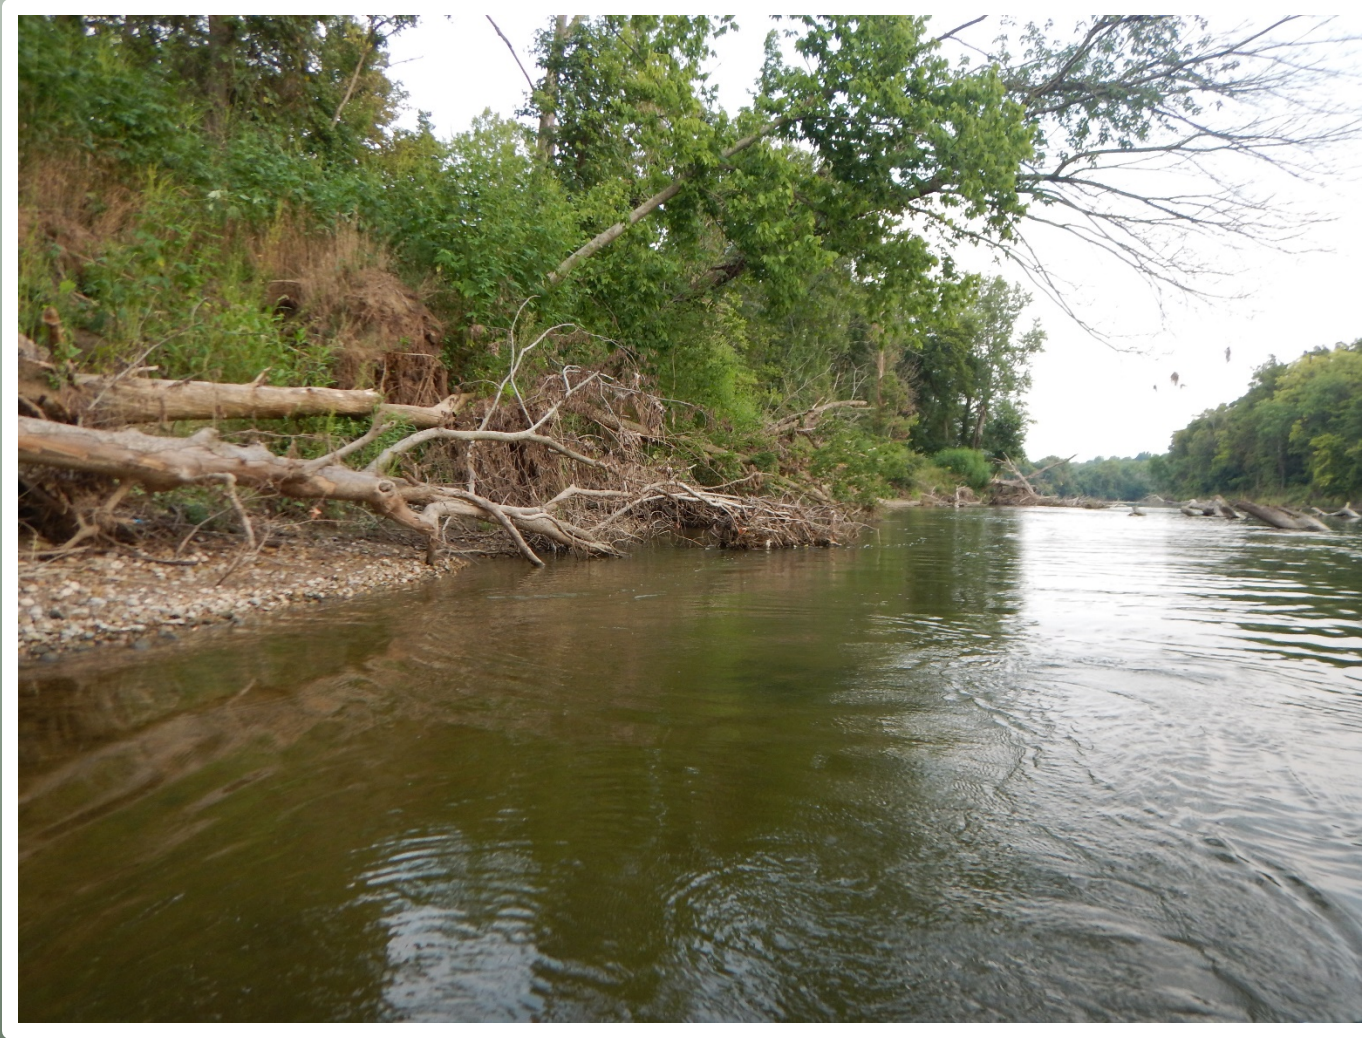
# Fallen Trees

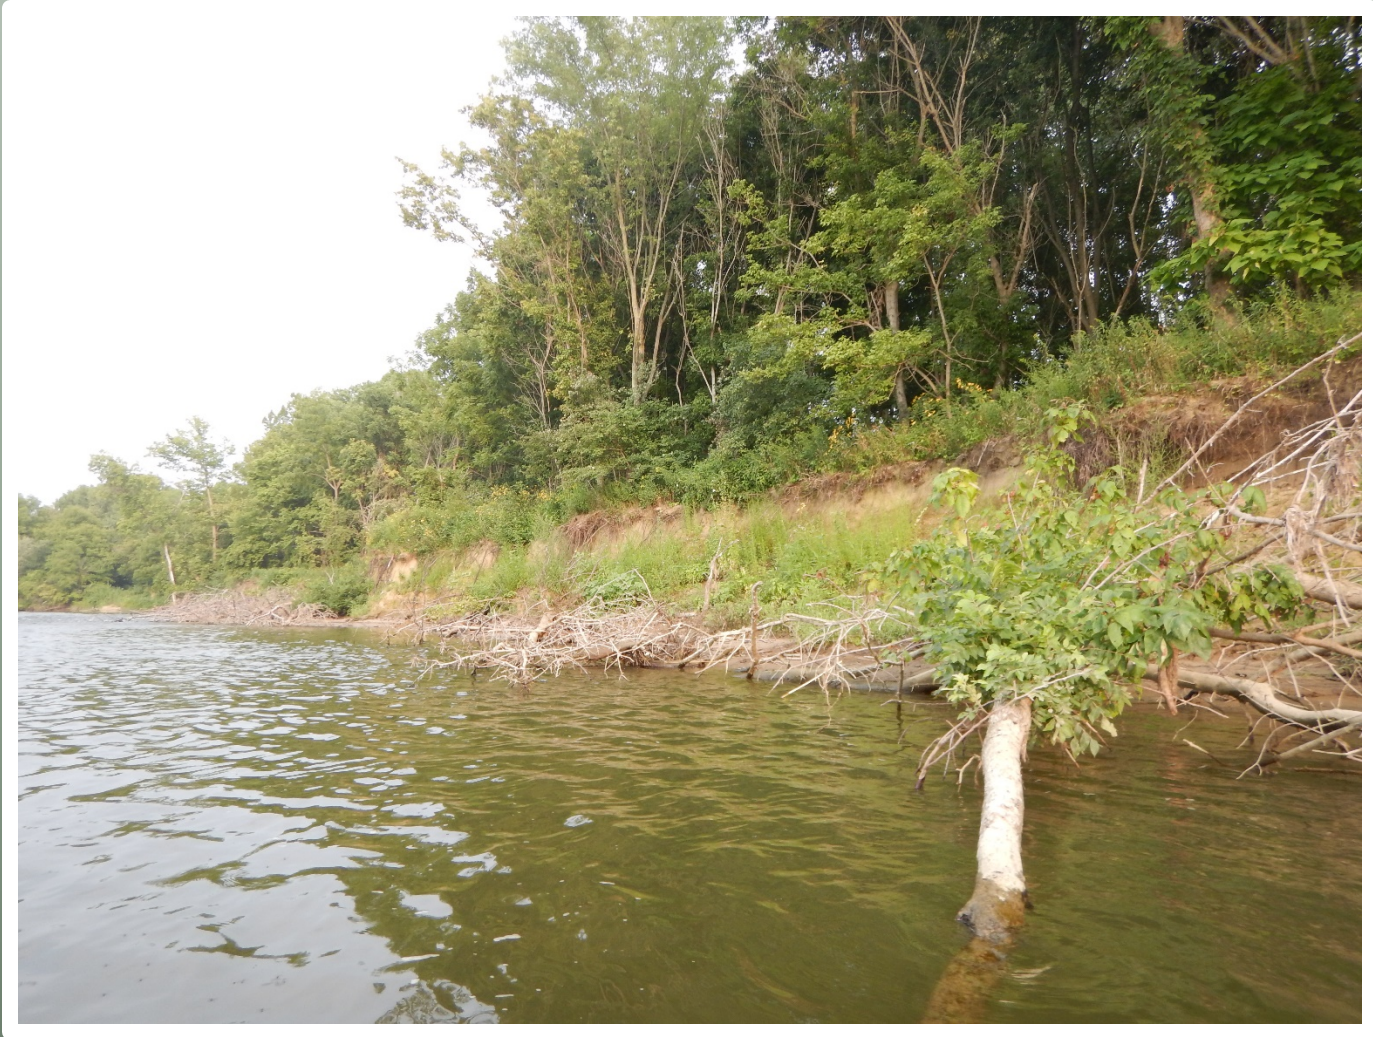
# Cut Bank near SR 37

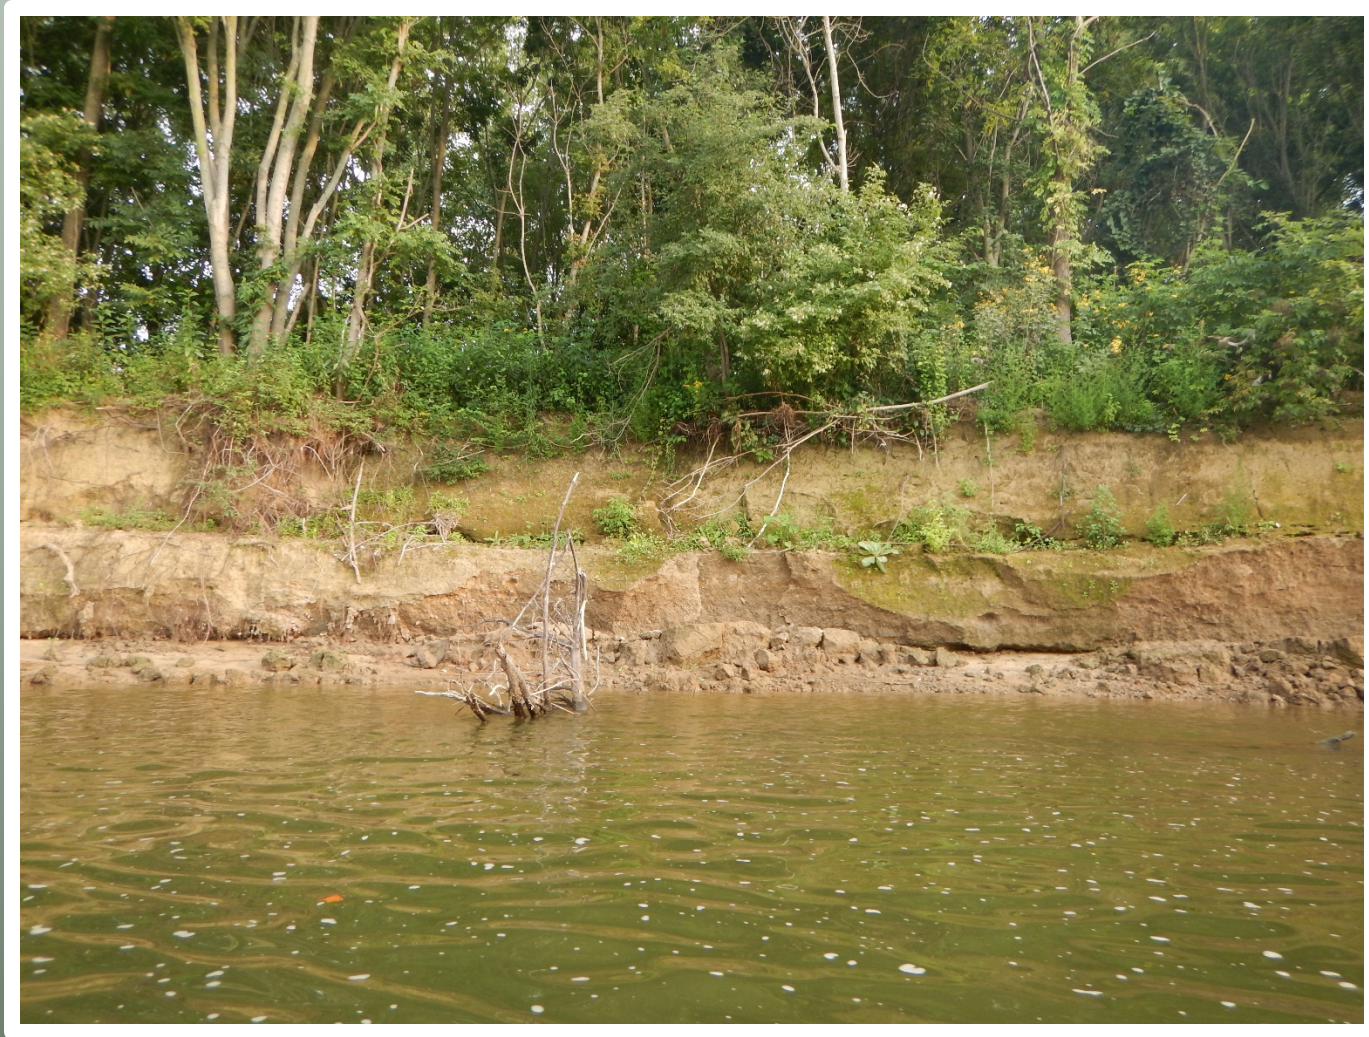
# Significant Erosion near SR 37

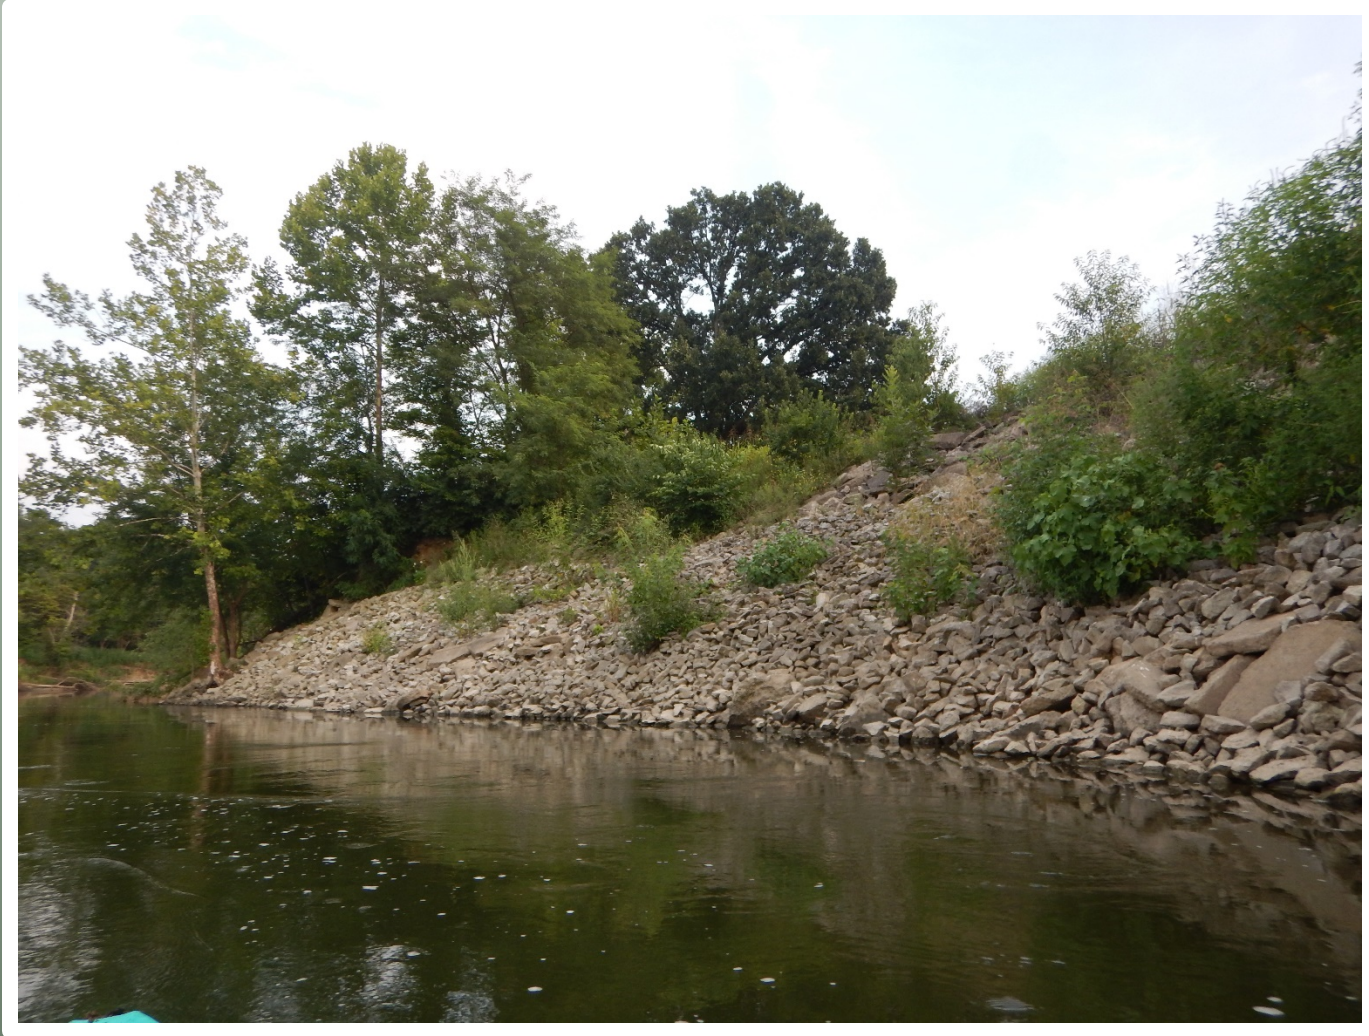
# Existing Protection In-place

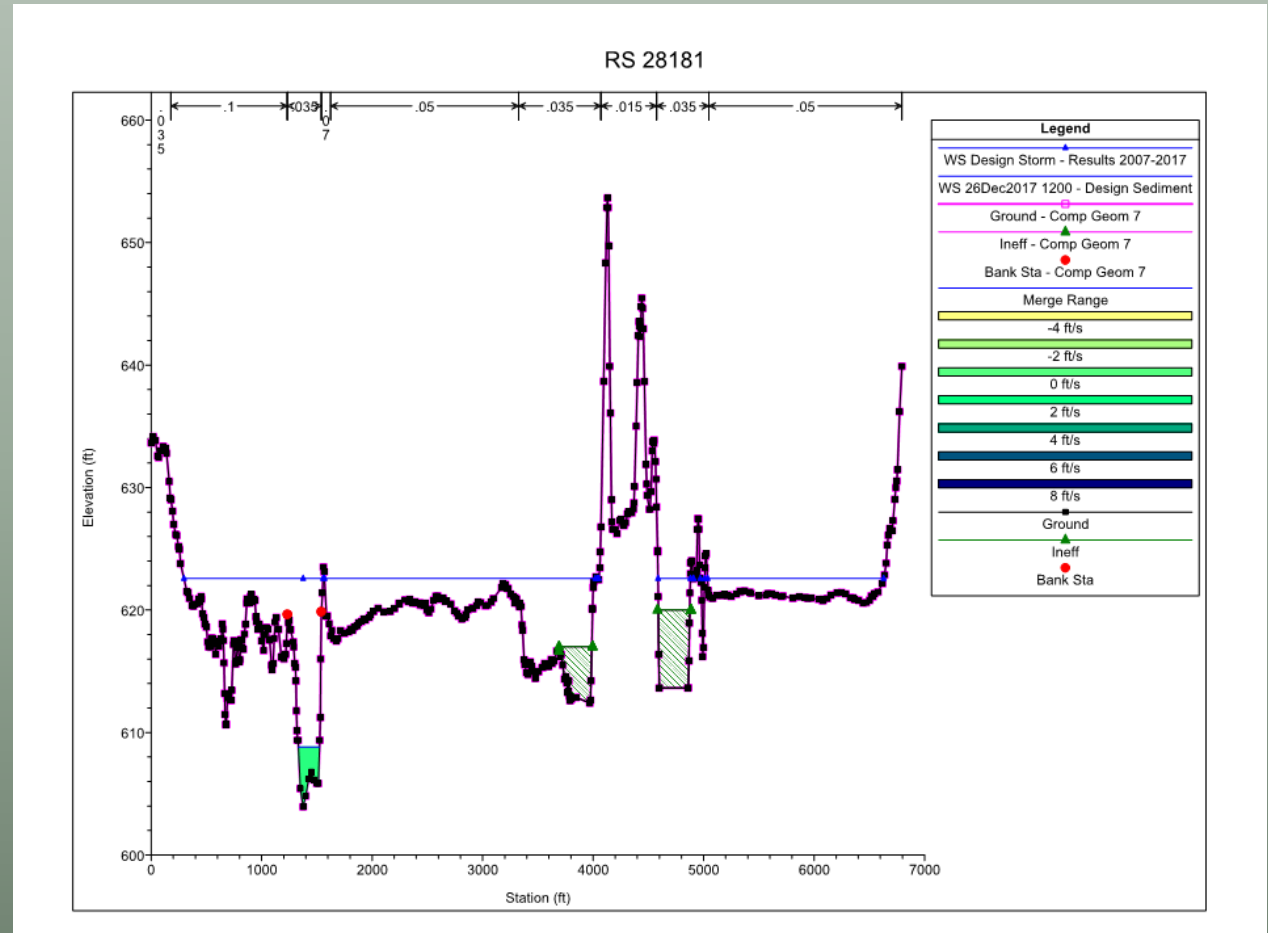
# Sediment Transport Modeling Results

- Stabilizing bank at SR 37 did not result in changes to the other cross sections

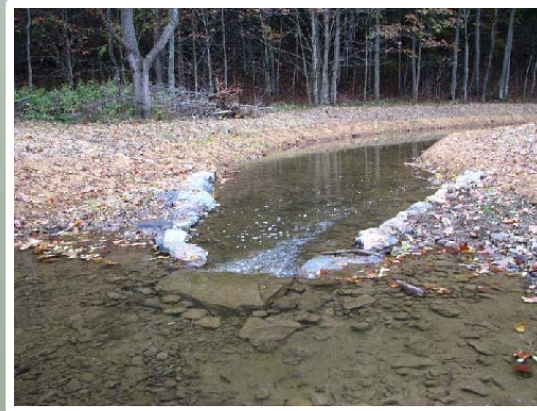
Cross-Vane, [www.montgomerycountymd.gov](http://www.montgomerycountymd.gov)

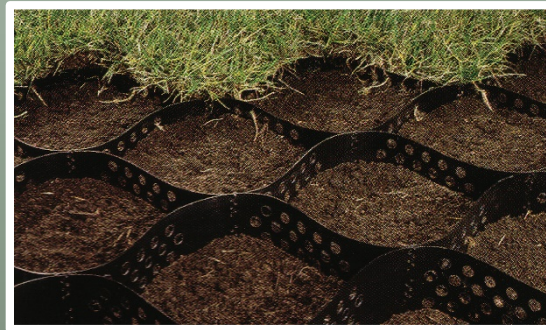
Geoweb, [www.acfenvironmental.com](http://www.acfenvironmental.com)

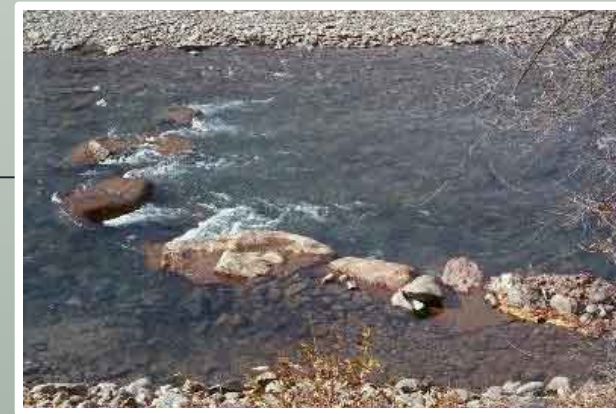
J-Hook, [www.Carleton.edu](http://www.Carleton.edu)

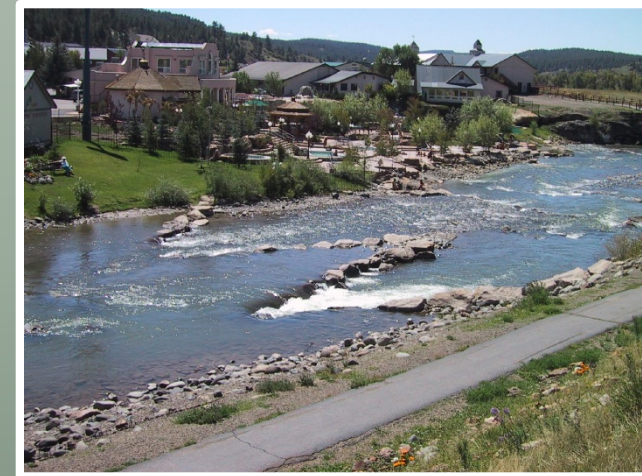
W-Weir, [www.conejoscanyonranch.com](http://www.conejoscanyonranch.com)

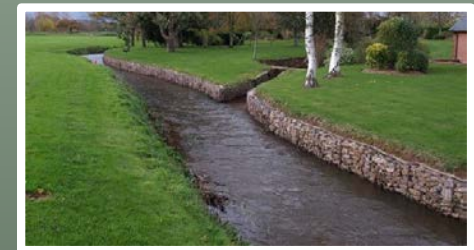
Gabian Baskets, [www.gabions.co.nz](http://www.gabions.co.nz)

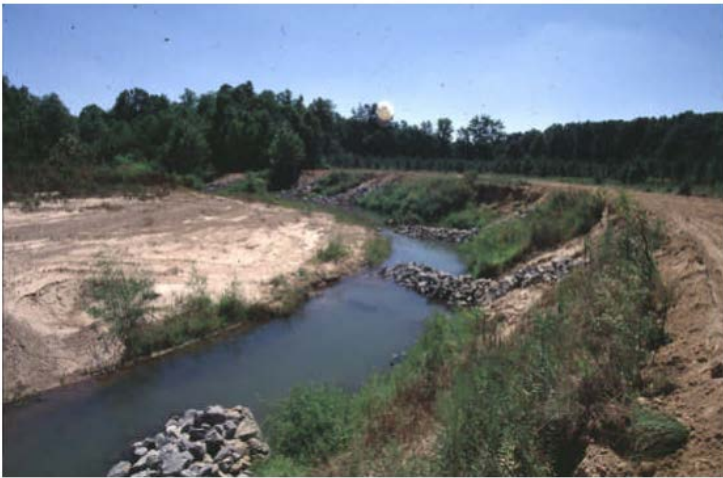
(a) Bendway Weirs on Harland Creek

- a.k.a Stream or Bank Barbs
- Flow Deflector
- Used with Stone Toe Protection
- Intended to be overtopped
- Better for larger streams
- Environmentally friendly
- Keyed into bank, more stable
- FHA HEC 23 for design

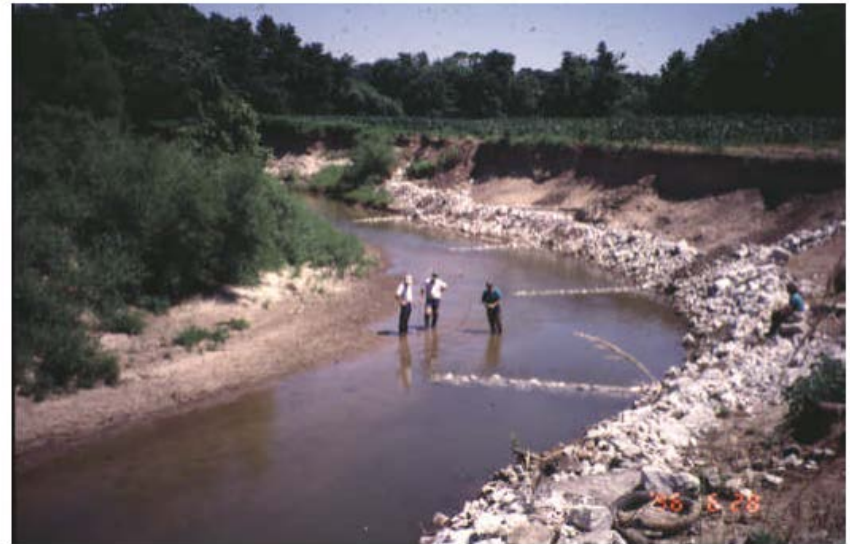
(b) Bendway Weirs in Combination with Longitudinal Peaked Stone Toe Protection

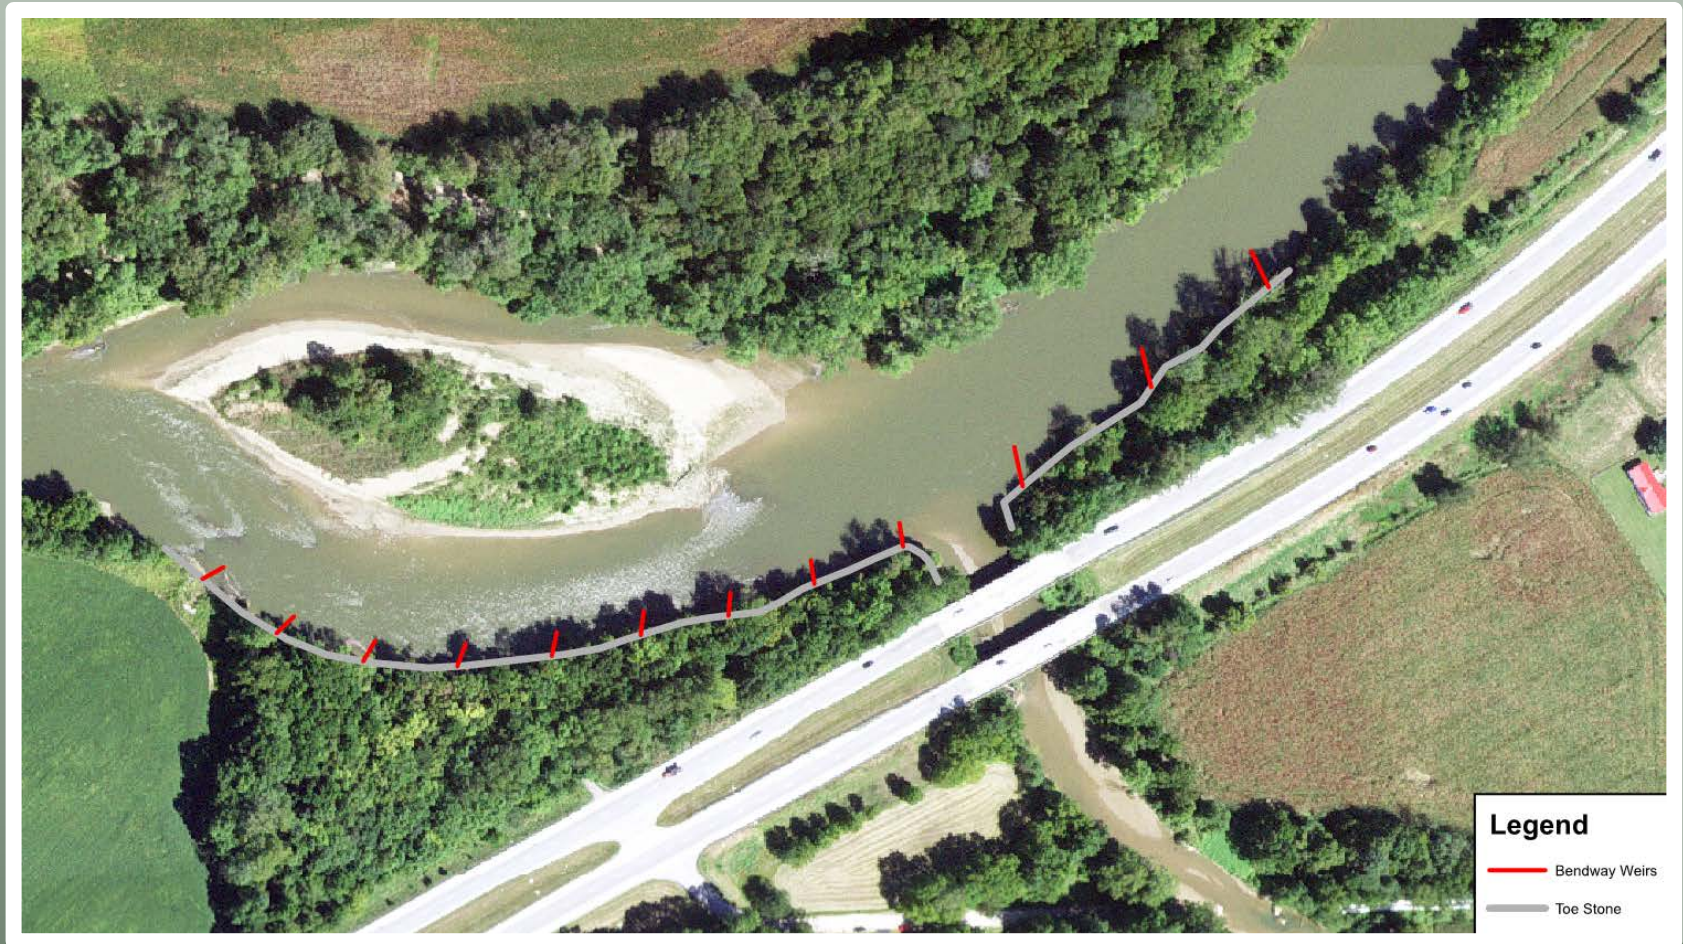
# Bendway Weirs Plan View
