Comparative building performance evaluation of a ‘sustainable’ community centre and a public library building

Abstract

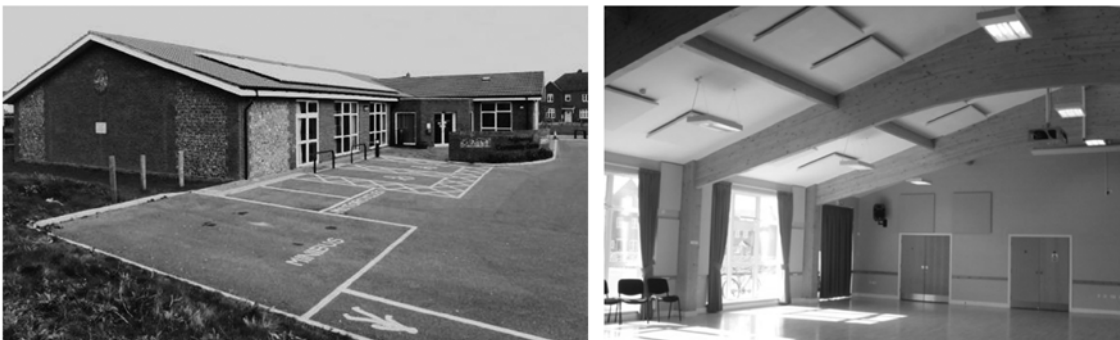
The Community Centre is a one-storey cavity wall masonry building with exposed interior timber structural elements. The internal floor area of the community centre is 563 m² which includes a multi-purpose hall that can seat 200 people, two meeting/activity rooms, an entrance hall and a kitchen (Figure 1). Its construction was completed in September 2009 and it was fully occupied in May 2010.

Figure 1 (Left) External view of the community centre. (Right) Main Hall of the community centre.

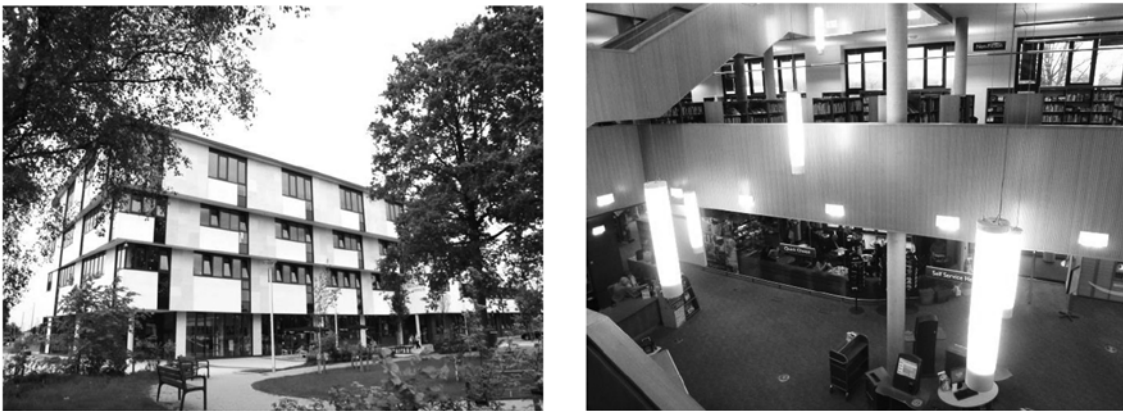
register services, and 378m² public social services and 910m² administration). While the library covers the first three floors of the four-storey volume, the upper floor accommodates council social services arranged in an open plan office space (Figure 2). The two-level volume includes the social service cellular offices and register services offices and ceremony rooms. The building opened its doors in December 2008.

Figure 2 (Left) External view of the Library. (Right) Main atrium of the Library.

The Library building is bigger with more complex functionality, designed to provide a range of county council services including a central library and offices and accommodation for administrative and social services. The building is four-storeyed (stepping down to two storeys at the rear) and arranged around a central atrium with cantilevered floors that provide some shading to lower floors. The gross internal floor area is 4,468m² (2,678m² library , 502m²

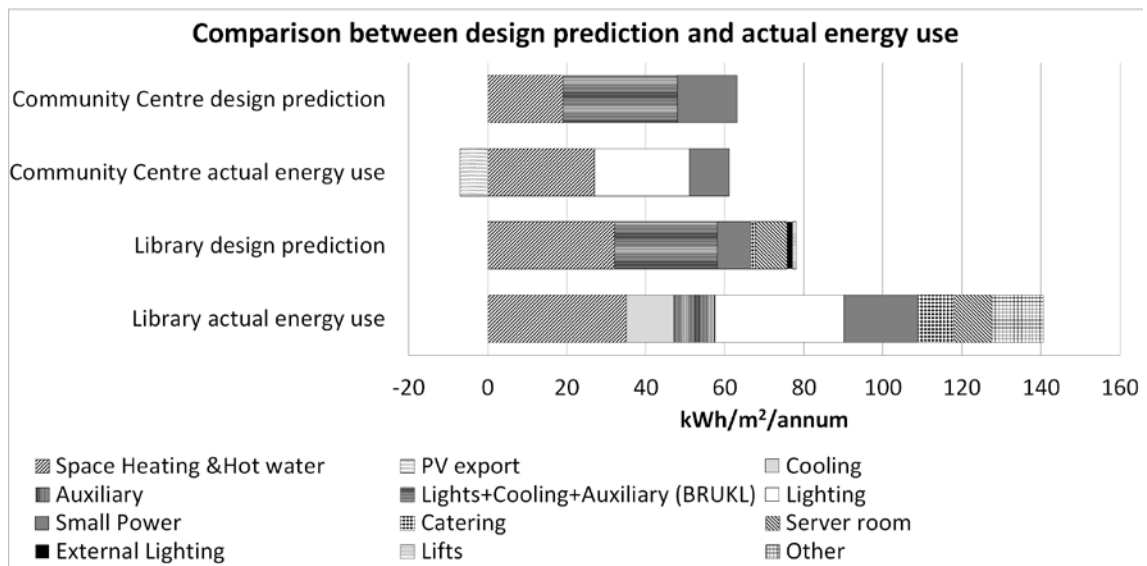
Figure 5 Comparison between design prediction and actual energy use. The design prediction was calculated using BRUKL estimate and extending it using TM54.

Comparison of the actual energy use of the buildings with a design estimate¹ is shown in Figure 5. In the case of the Community Centre, there is no discrepancy between the design prediction and the total actual metered energy use. It can be observed that the actual energy use for heating is slightly higher than the design estimate, but this is counterbalanced by the fact that actual energy use for small power is lower than the predicted. In the case of the Library however, actual energy use appears to be higher than the design estimate by a factor of 1.8. Figure 5 shows that the energy use for lighting, cooling, catering and servers is much higher than the design prediction.

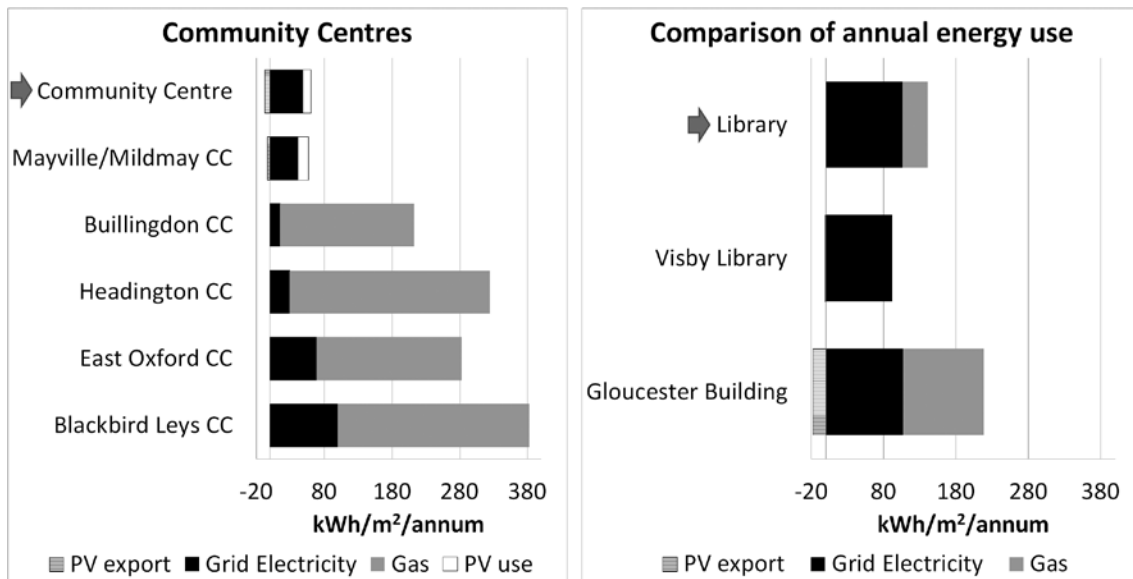
Figure 7 Comparison with other buildings

Comparison with other buildings of similar use is shown in Figure 7. The Community Centre uses far less energy than most other Centres, which were studied between 2006-2007 (all except Mayville/Mildmay Community Centre) and were found to have poor fabric performance in terms of insulation and air leakage. The Library building is compared to two other library buildings²⁴ and uses more energy than Visby library (Sweden) but nonetheless performs better than the Gloucester Building that suffers from low air-tightness and poor management.

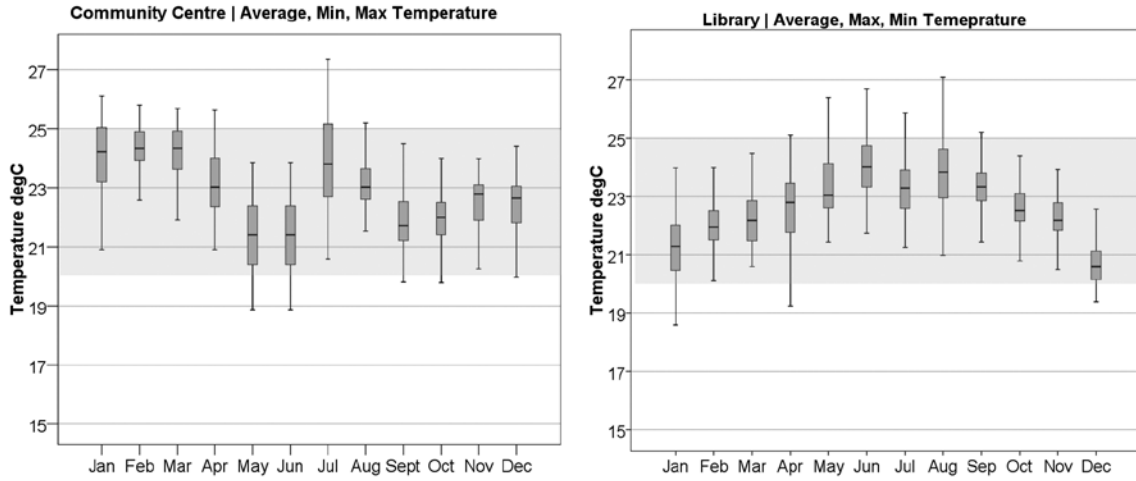
Figure 9 Monthly average, maximum and minimum temperatures in the buildings (January 2013-December 2013)

maximum temperatures during winter reach 26°C (Figure 9), indicating there is potential for energy reductions. Summer temperatures in the Community Centre rarely exceed the comfort band (Figures 9, 11), and no instances of overheating were reported. Interviews revealed that occupants involved in light and sedentary activities are satisfied with the temperatures in the building, whereas occupants involved in more intensive activities (dancing, sports etc.) find the spaces warm and open the windows and use portable fans to cool themselves down. The Centre would benefit from the installation of ceiling fans in some of the spaces as well as zoning for tighter control of indoor temperatures. It is recommended that some spaces are kept at lower temperatures depending on occupancy and use. Tighter control over temperatures would help in increasing comfort levels and reducing energy consumption. External shading in the south facades and night-time ventilation would also help prevent high temperatures during summer.

temperatures during the monitoring period range between 21-24°C, mostly remaining around 21°C during the winter months (Figure 9). Average hourly winter temperatures are lower than those recorded in the Community Centre, ranging between 19-23°C (Figure 11). Minimum temperatures recorded during the winter months range from 17-19°C. These temperatures in addition to the cold draughts reported to be coming from the ventilation ducts and the sedentary activities (low metabolic rate) of the Library users could explain why almost half of the respondents of the BUS survey reported feeling cold during winter. CO₂ levels remain below the limit of 1000ppm throughout the year indicating good air quality (Figure 10). The sense of stuffiness expressed by some occupants seems to be more related with the low relative humidity levels (Figure 11) and could also be partially attributed to the lack of perceived control over the windows and ventilation.

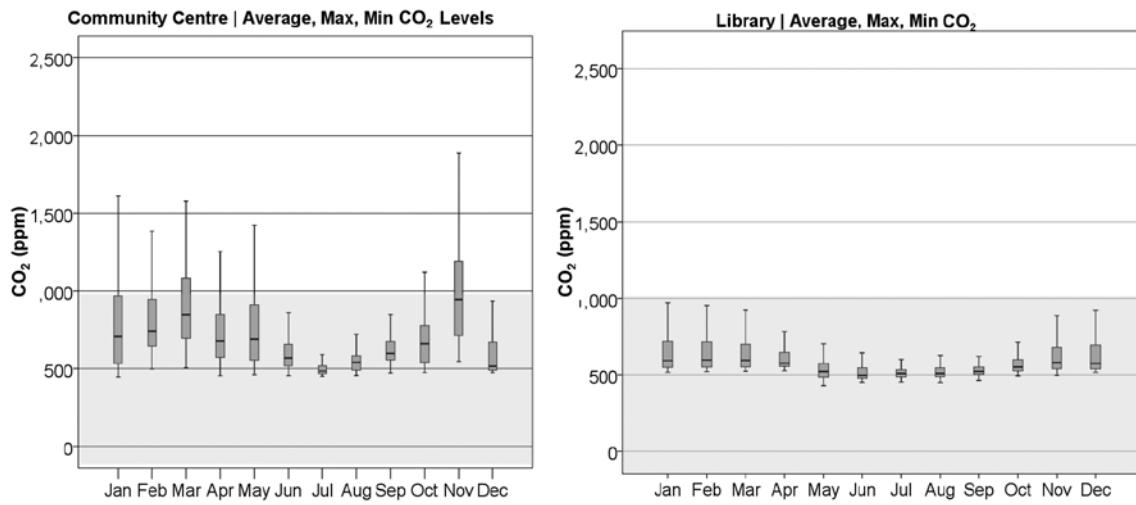
Figure 10 Monthly average, maximum and minimum CO₂ levels in the buildings (January 2013-December 2013)

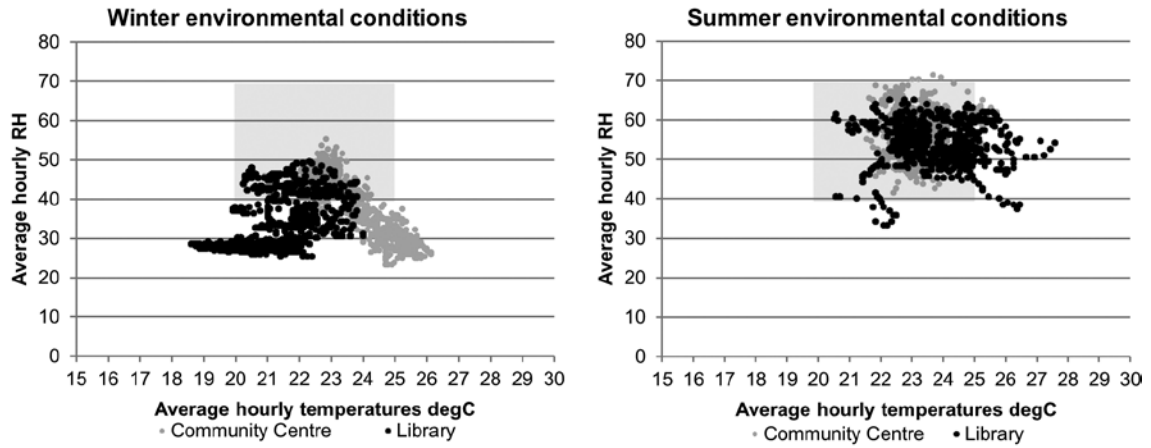
Figure 11 Average hourly temperatures and RH levels during winter (January 2013) and summer (August 2013).

Building users pointed out that the air can get dry during the winter. Relative humidity levels during winter fall below the recommended limit of 40% indicating that the air in the building can get dry when internal temperatures are high and windows are mostly kept closed (Figure 11). Mean CO₂ levels range between 700-900 ppm during winter months (Figures 10, 12). During times of large congregation, CO₂ levels may go above 1000ppm but that only occurs for 12% of occupancy hours and does not point to any significant air quality problems.

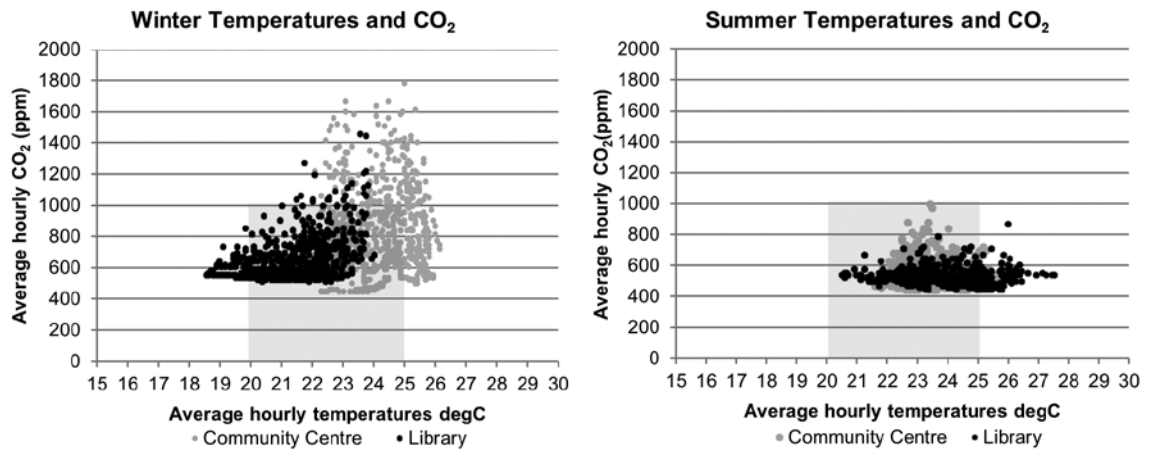
Figure 12 Average hourly temperatures and CO₂ levels during winter (January 2013) and summer (August 2013)
