Title: Empirical evaluation of the energy and environmental performance of a sustainably-designed but under-utilised institutional building in the UK

Authors: Rajat Gupta and Matt Gregg

Abstract: This paper presents a systematic, socio-technical and empirical evaluation of the actual energy and environmental performance of a sustainably-designed institutional building (Southeast England), intended to be a teaching tool and 'living laboratory' of sustainability. Despite the building being designed to high sustainability standards (Energy Performance Certificate rating of A, low reliance on fossil fuels, natural ventilation and rainwater harvesting) and also being under-utilised during the in-use stage (lower hours of occupation and number of occupants), its actual energy-related carbon dioxide-equivalent emissions are four times more than predicted. This is due to poor energy management of the building, underperformance of the biomass boiler and wasteful energy practices in terms of excessive winter overheating in the atrium, inappropriate lighting controls, and electrical equipment being left on standby. Due to lack of training and understanding of the energy manager, the buildin

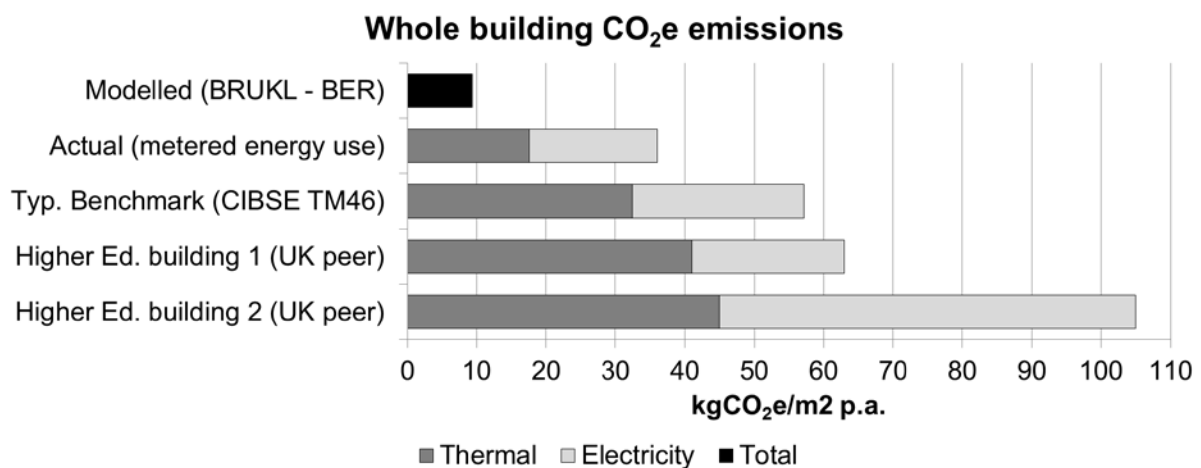
Figure 7 CO₂e emissions (typical CIBSE benchmark [31]; Higher education benchmarks [32])

and 124tCO₂e (84%) compared to an existing building (pre-1995). This aligned the project with the UK Government's 2050 target of an 80% reduction in national CO₂e emissions compared with 1990 levels. However, the supplied (actual) CO₂e emissions rate is found to be nearly four times greater than the building emissions rate (BER) (design aspiration) despite the fact that the building was under-used. To be considered:

Comparison of the CO₂e emissions of the buildings with the design estimate and benchmarks is shown in Figure 7. For reference, Higher education building 1 (BREEAM *Very Good*) is similar to the case study building in that they both house architectural/ construction workshops, office and meeting rooms. The case study building is distinct in its large atrium and openness to public visitors. Note that due to unavailability of modelled energy breakdown, only the total CO₂e emissions are given for the modelled building.

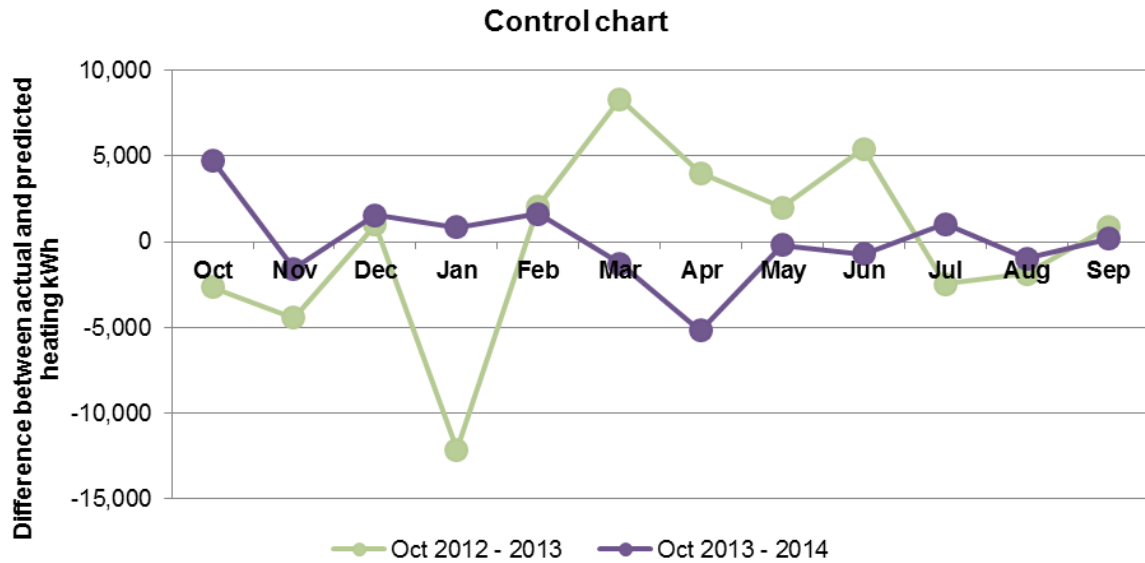
Figure 9 Control chart

Looking at two years of energy data, the case study building was found to manage space heating in relation to weather more effectively as time progressed. As can be seen in figure 9, in relation to heating degree days, the first year was more erratic than the second, whereas the least control appears on Oct 2013 and Apr 2014, cancelling each other out. The remaining months in the second year remain relatively close to zero difference between actual and predicted heating consumption. Though year one was more erratic than year two, overall energy consumption at the end of both years evened out to equal zero annual cumulative sum of the difference between actual and predicted heating requirement.

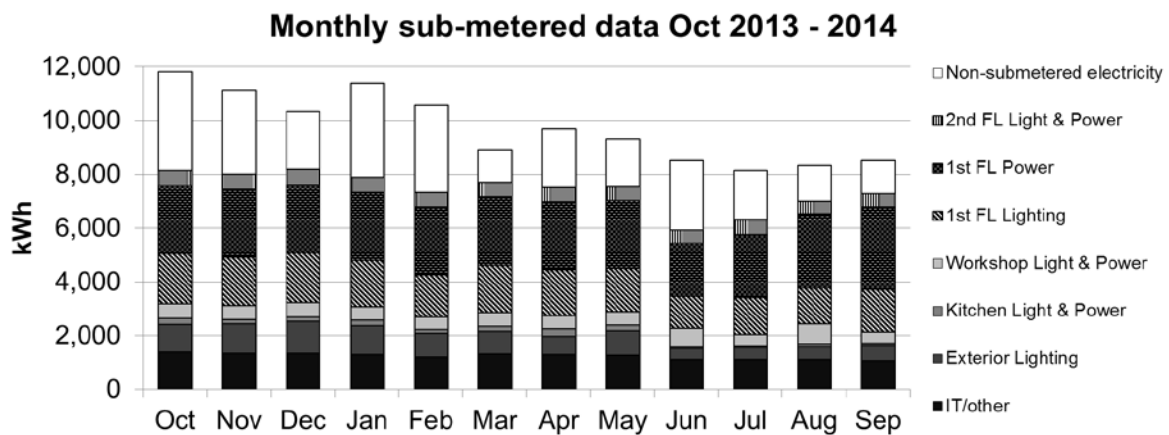
Figure 10 Monthly sub-meter breakdown Note: IT/other covers the server room, the lift and plant MCC; the server is responsible for a majority of consumption in this category.

- The single largest (metered) electricity consuming sub-meter is the first floor power distribution board (26%). This covers the offices which are the most regularly occupied and used spaces. First floor lighting (17%) is second in consumption.
- Roughly one-quarter of electricity consumption falls among the remaining un-connected sub-meters: ground floor light and power, fire alarm system, surge suppression system, and rainwater harvesting pumps.

As mentioned earlier, summer consumption is lower; reduced summer consumption is greatest in exterior lighting and the café. Ground floor light and power is also expected to be lower as this is where most teaching and meeting rooms are located, however, these data (including both regulated and unregulated loads) were not metered (i.e. *non-submetered electricity* in figure 10)

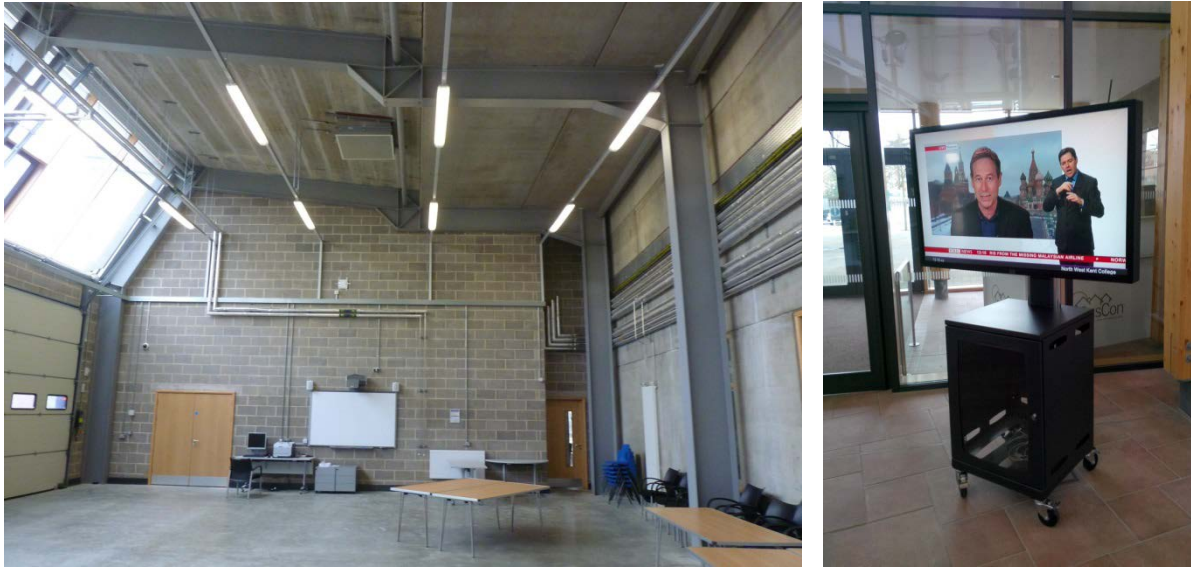
Figure 11 Workshop (left), TV in atrium (right)

In most meeting/teaching rooms (including the workshops) equipment was found to be left on in rooms not used, including computers, projection system and audio systems. In almost every room, all equipment is left on standby (at least); wall switches were in the on position. This would not be as problematic in rooms occupied regularly; however, meeting rooms can go weeks without being used. As examples, in one ground floor computer lab, three of the 16 computers and the audio system were left on. According to the room booking schedule, this room has not been occupied (officially) since November 2013 and was not scheduled for use through to the end of March 2014. Estimated energy waste of 698kWh_{electric} over the unoccupied period. In the first floor computer lab all of the 17 computers were left on. According to the room booking schedule, this room has not been occupied (officially) since November 2013 and was not scheduled for use through to the end of March 2014. Estimated energy waste of 3,917kWh_{electric} (standby) over the unoccupied period. A mini-refrigerator in an unoccupied office was left plugged in and on though the office (and the fridge) have been unused for nine months. Estimated energy waste 323kWh_{electric} over the unoccupied period of the office.

The FM team and reception staff have expressed from the beginning concern that the underfloor heating in the atrium is a high energy consumer. The mean winter temperature (24 hours/day) in the atrium is 23°C. This is between 2-4°C above the CIBSE [33] recommended operative temperature for this type of space. This operative temperature could be reduced during occupied hours and should be reduced further outside of occupied hours. In addition, the atrium is heated 24/7; the need for continual heating is questioned by both BPE team and users. In the atrium lights are also on when daylight is sufficient for the space: 210W per post x 10 posts and a television is left on in atrium (figure

11) which is a questionable use of energy even if the atrium space was heavily occupied which it is often not.

1. Involve reception in this localised energy management, e.g., first thing in the morning, turn on radiators at thermostatic radiator valves in rooms that are to be occupied that day (and turn off at end of day or ideally after the meeting or use) or,
2. Retrofit radiators with 'smart' radiator valves which allow scheduling. These can be installed over existing radiator valves.

For meeting and teaching rooms, as with managing heating by room scheduling, the receptionist could manage lighting, computers and equipment. A more costly solution would involve installing typical light switches in the rooms for visitors.

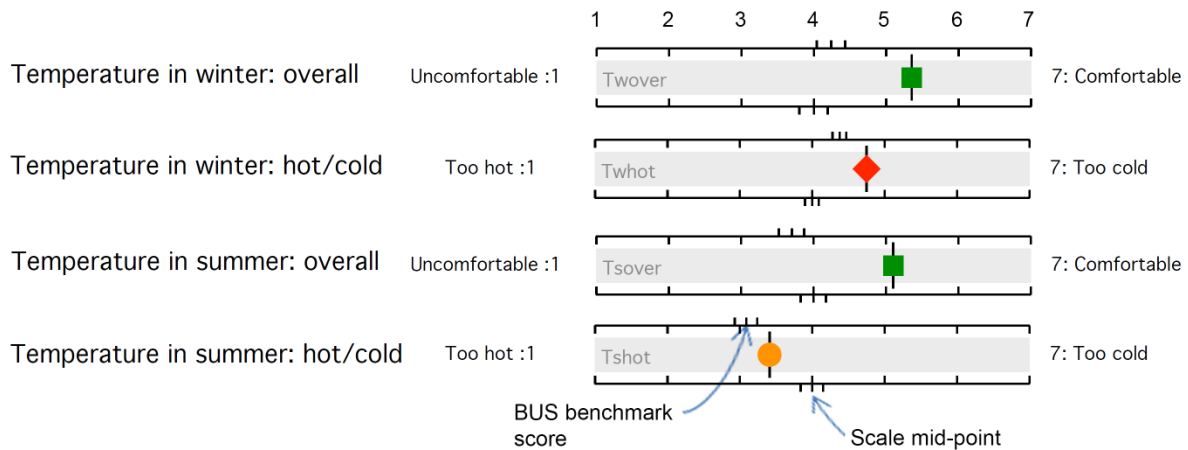
Figure 12 BUS temperature results. *Note: square is above, circle is within, and diamond is below the BUS benchmark.*

Overall summer and winter temperatures are perceived to be 'comfortable' and better than the benchmark (figure 12). However, when investigated deeper with directed questions toward too hot, too cold, etc., the responses are less desirable. In depth interviews found that heating within the offices is found to be uneven. Occupants sitting near the radiators are too hot and those further away are cold. Those occupants that consider it 'cold' use portable heaters. For in-location control of

heating, the radiator valves provide a good level of control and are intuitive, accessible and easy to use. The room thermostats which are controlled by the BMS, on the other hand are confusing for the occupants as they provide no indication of purpose, control or responsiveness. Regardless, BUS responses indicate occupants feel they have a poor level of control over heating.
