Collapse and recovery process of the sand spit at the Tenryu River mouth on the Pacific Coast of Japan

Yoshimitsu Tajima, Tomohiro Takagawa, Shinji Sato & Satoshi Takewaka

Sand spit; morphology change; storm wave; flood; image-based monitoring

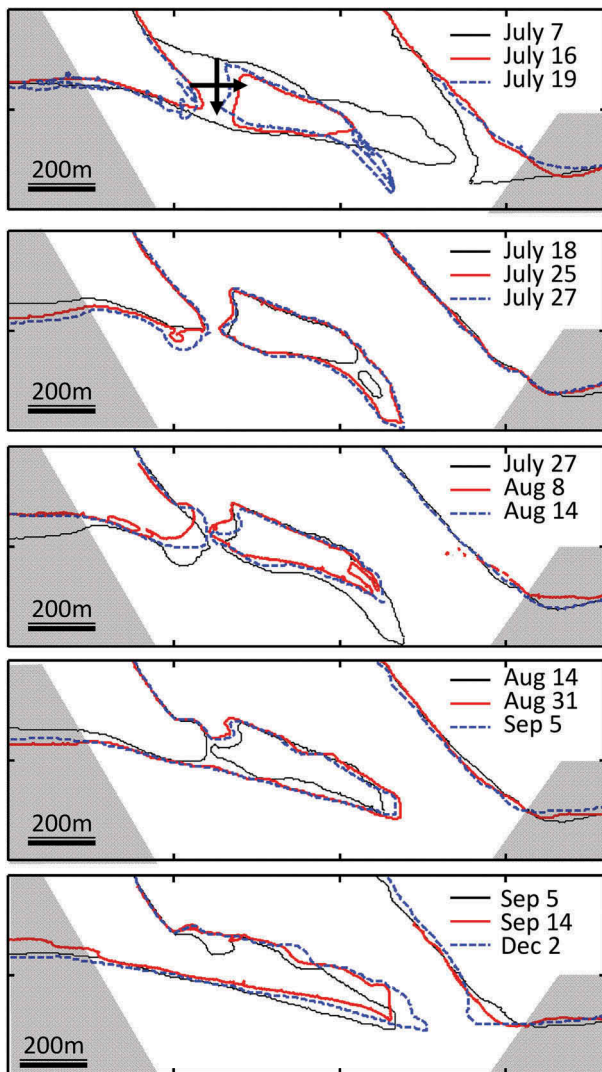
To overview characteristic topography change before and after the attacks of Man-Yi and Fitow, shoreline profiles were quantitatively extracted from obtained images around the river mouth through the following procedures: (i) select images recorded when the tide level was at T.P. +0 m; (ii) rectify selected images based on horizontal XY-coordinates at the elevation, T.P.+0 m; (iii) combine rectified images recorded at the same time (Figure 3); and (iv) extract XY-coordinates of shoreline profiles from the obtained image. Here, the shoreline location in each image was determined around the land–sea boundary where the cross-shore variation of the pixel brightness reaches its peak. Figure 4 compares shoreline profiles extracted from these images recorded on different days from July to December 2007. Shaded areas shown on both side of the figure indicate the domains where the shoreline location was extracted from the X-band radar image recorded at respective time. The shoreline change analysis discussed in the following section is based on the shoreline extracted from the 10-min-averaged camera images as shown in Figure 3. Although 10-min-averaged images reasonably cancel the error of extracted shoreline location due to instantaneous wave runup, extracted shoreline locations are still affected by spatial variation of the mean water level induced by other hydrodynamic features such as wave setup, tidal current, and river flow. According to the comparison of the water levels at landside and at seaside of the sand spit, as discussed later with Figure 10, the difference of these

Figure 4. Comparison of extracted shoreline profiles from July 7 to December 2.

As seen in Figure 4, the shoreline profile of the sand spit was largely deformed from July 9 to 16, i.e. during the

attack of Man-Yi. It is also found that the shoreline on the upper side, i.e. upstream side, of the spit moved seaward, while the shoreline on the seaside of the spit had little movement. It should also be noted that the shoreline on the landside of the spit showed little movement after

July 16 until September 4, i.e. just before the landfall of Fitow. It is also confirmed from the top panel of Figure 6 that a significant decrease of the land area in rectangular domain #2 occurs only from July 7 to 16. These observed features indicate that collapse of the sand spit was dominantly induced by the river discharge.

Comparison of the shoreline profiles on July 16 and 19 shows that the eastern tip of the sand spit quickly developed and extended southeastward within 3 days. It can be deduced from this feature that a large amount of discharged sand was deposited relatively close to the river mouth and was quickly transported back to the shore.

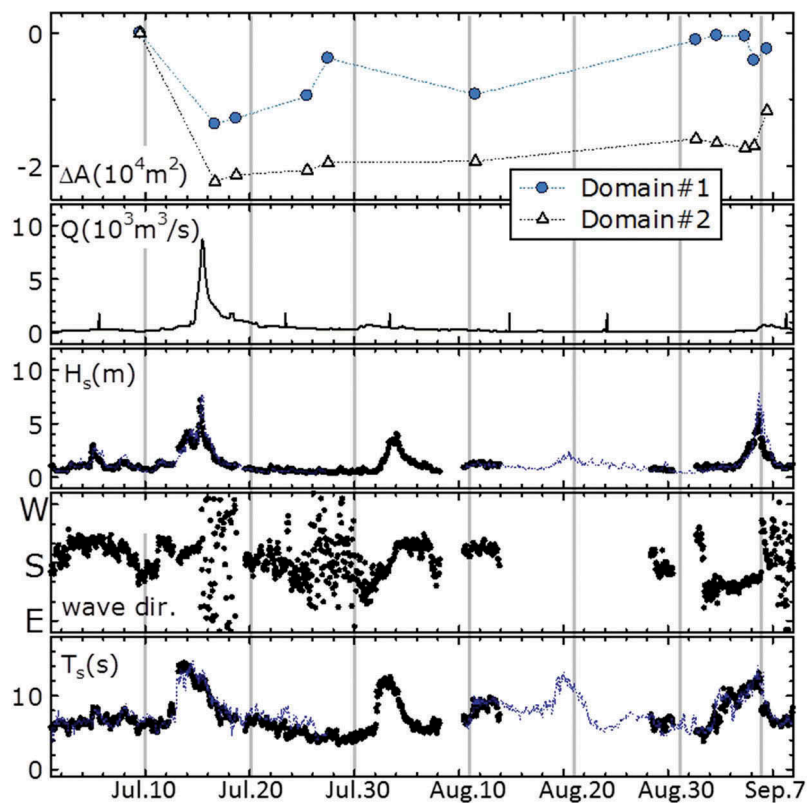
Figure 6 shows the time-varying wave conditions and river discharge. The second panel of Figure 6 is the time-varying river discharge at the Kashima water level station located approximately 25 km upstream from the Tenryu River mouth. The river discharge shown in the figure is based on the measured water level and the stage-discharge rating curve at Kashima station. Since there are no major inflows from Kashima to the river mouth, the flow rate at Kashima should be nearly equivalent to the one around the river mouth, although there should be certain time lags. The bottom three panels of Figure 6 show the time variations of significant wave height, directions, and period, respectively, measured by the wave gauge installed at approximately 5 km offshore from the Tenryu River mouth with water depth of 40 m. In these panels, the wave data measured at Irozaki, located approximately 100 km east of the Tenryu River mouth, were also plotted in thin blue dashed lines to cover the missing data at the offshore of the Tenryu River mouth. For comparison, the top panel of Figure 6 also shows the time variations of the land area in the rectangular domains of 1 and 2 shown in Figure 2. The land area in each rectangular domain was computed based on the shoreline profiles shown in Figure 4, and the top panel of Figure 6 shows the change of the land area based on the one recorded on July 9, just before the attack of Man-Yi.

Figure 6. Time series of (1) land area in the rectangular domain #1 and #2 shown in Figure 2; (2) river discharge at Kashima; (3) significant heights, (4) principal directions, and (5) significant period of waves recorded at the offshore wave gauge at the Tenryu River mouth.

As seen in Figure 6, no event of significant river discharge was recorded over the study period from July to December 2007, except the one on July 15, when Man-Yi approached the Tenryu River mouth and caused the peak river discharge of approximately $8700 \text{ m}^3/\text{s}$. Equally large wave heights were observed around July 15 and September 8 when Man-Yi and Fitow, respectively, hit the site, while the peak wave directions of these two events, SSW under Man-Yi and SSE under Fitow, were different. Relatively high waves

After the event of Man-Yi, as seen in Figure 6, the observed significant wave height was as high as 1 m until the end of July. Under these relatively mild waves, the eastern tip of the sand spit was extended in the southeastward direction and the land area in rectangular domain #1, A_1 , shown in Figure 2, was quickly increased. From August 1 to 3, relatively larger waves with significant wave height of approximately 3.5 m were observed and the land area, A_1 , was decreased due to the retreat of the entire shoreline on the seaside of the sand spit. From August 3 to the beginning of September, observed significant wave heights were from 1 to 2 m and A_1 was gradually increased. In contrast to the change of A_1 , the land area in rectangular domain #2, A_2 , had less time fluctuations and showed a gentle and simple increasing trend. Since domain #2 is not exposed to the near-shore waves, this feature may indicate that wave-associated onshore sediment transport dominantly contributed to the refill of the breached part of the

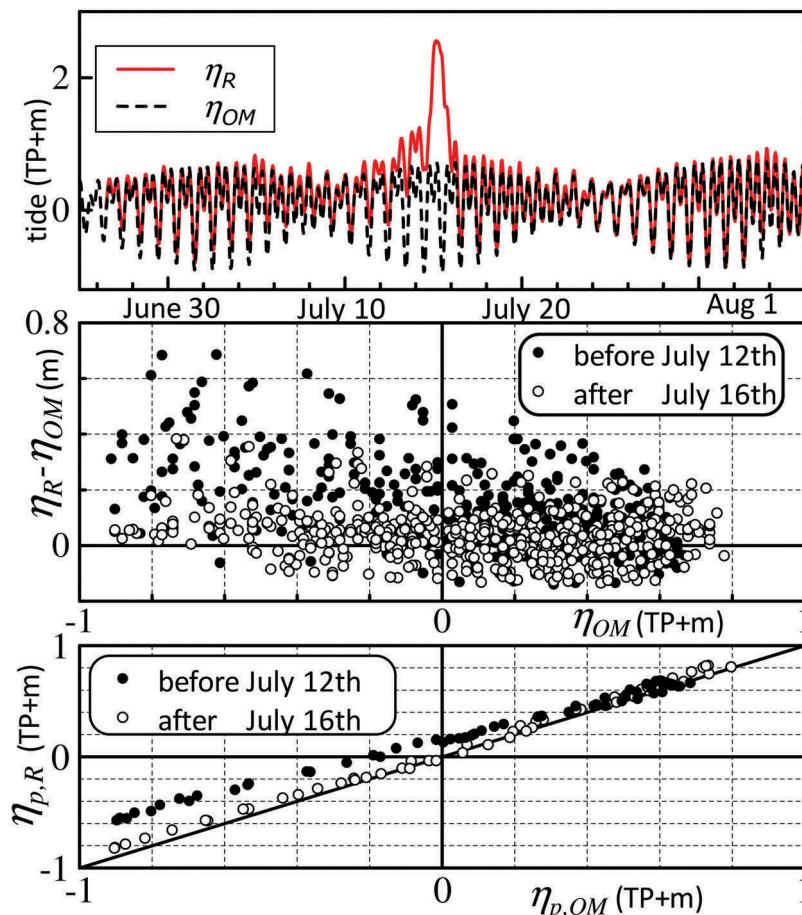
While the discussions above mainly focused on the impact of changing hydrodynamics on morphology changes, it should also be noted that observed hydrodynamic characteristics are also interactively affected by the changing morphology around the river mouth. On July 15, for example, the peak U_s significantly decreased from 10:00 to 12:00 when the river mouth was widened, and both $\Delta\eta$ and U_s dropped from 14:00 and 17:00 when the western part of the sand spit was breached. Such an influence of the river mouth morphology can also be seen in the tidal characteristics inside the estuary. The top panel of Figure 10 shows a time series of tides at the Ryuyo water gate, η_R , and Omaezaki tidal station, η_{OM} , located approximately 40 km east from the Tenryu River mouth along the Enshu-nada coast. It was confirmed that phases and peaks of the tide recorded at Omaezaki station were nearly equivalent to those measured at the wave gauge offshore of the Tenryu River mouth before the event induced by Man-Yi. The data at Omaezaki was used in this figure simply because a part of the data at the offshore wave gauge was missing after Man-Yi. The middle panel of Figure 10 shows the instantaneous difference of these tide levels, η_{R-OM} as a function of η_{OM} . Blank and solid circles in the figure distinguish the data before and after the bleaching event. As seen in the figure, the water-level difference becomes smaller after the bleaching, i.e.

after July 16 and the water-level difference is at most 30 cm after the bleaching when the tide level at Omaezaki is around T.P. +0m. To exclude the influence of the phase lag of observed tidal water levels at these two gauges, the bottom panel of Figure 10 compares peak water levels during both high and low tides at Ryuyo, $\eta_{p,R}$ and Omaezaki, $\eta_{p,OM}$, before and after the event. Harmonic analysis was respectively applied for estimations of peak tide levels. Before the storm, the difference in peak water levels at Ryuyo and Omaezaki was as high as 25 cm during the low tide. After the storm, on the other hand, the tidal profiles at Ryuyo and Omaezaki are nearly equivalent to each other. The lower water-level difference after the bleaching reduces the seaward flow velocity around the river mouth, and the wave-induced landward sediment transport dominantly causes the redevelopment of the sand spit. This feature indicates that the monitoring of tidal water-level change both at inside and outside of the sand spit can be a good indicator for evaluation of the development of the sand spit.

Figure 10. Comparison of tide level and peak tide levels recorded respectively at Ryuyo water gate and at Omaezaki (top: time series, middle: instantaneous tide level at every 10 min, and bottom: peak tide levels).

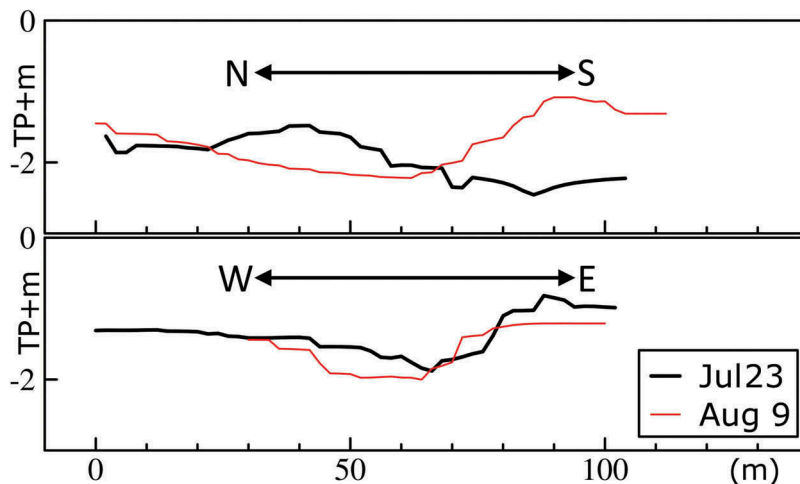
Figure 12. Measured bed level along the arrows shown in Figure 4 at the breached part of the spit: cross-shore direction (top) and along-shore direction (bottom).

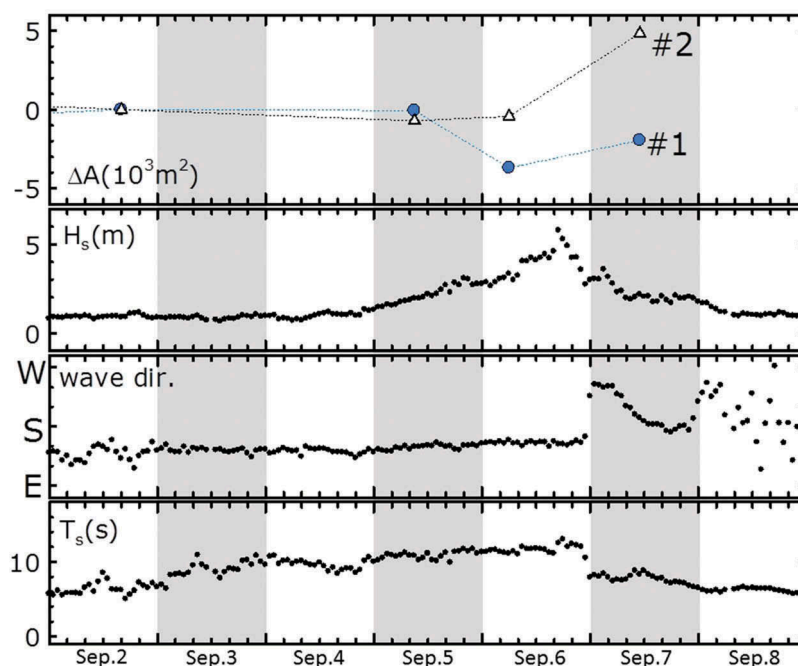
Figure 13. Time-series of the area change in the rectangular domains #1 and #2 shown in Figure 2 and wave properties recorded at the offshore wave gauge of the river mouth.
