Protection and relocation of frescoes during construction at the Harvard Art Museums

Teri Hensick, Anthony Sigel, Henry Lie, Narayan Khandekar, Kate Smith,
Francesca Bewer, Angela Chang, Louise Orsini and Erin Mysak

Three frescoes painted in the 1930's by social realist artists Lewis Rubenstein and Rico Lebrun needed to be consolidated, protected and moved during major renovations to the Harvard Art Museums between 2009 and 2014. During construction, the frescoes, measuring a total of 22.3 m², would be subject to relocation, shock and vibration, climate extremes and structural intervention. Conservators devised a cyclododecane (CDD) facing as part of a multi-layered system of protection designed to remain in place for several years. Two of the fresco walls, weighing many tons, were cut from the existing masonry and moved by crane, while one of the frescos remained in situ on the inside of an exterior wall, protected from the elements by a purpose-built housing.

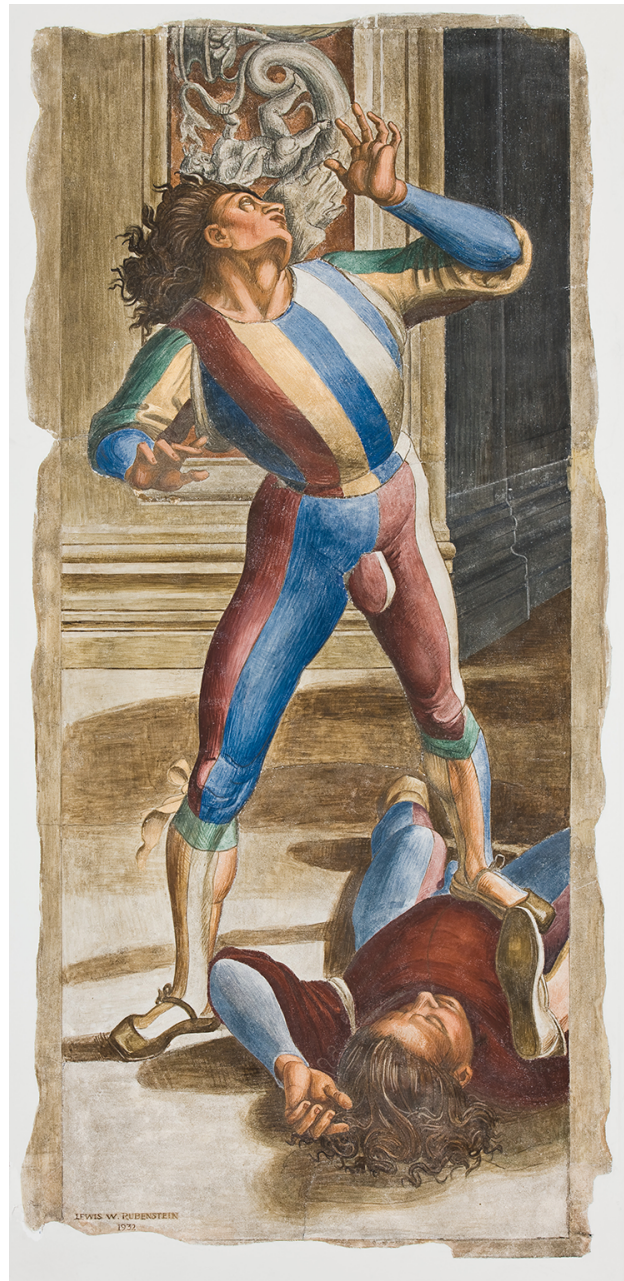
Figure 2 *End of the World* (1933,1932). Fresco painted on the inside of an exterior wall by Louis Rubenstein after a detail of Signorelli's *End of the World* fresco in Orvieto. Photo: ©President and Fellows of Harvard College, photographed by the Imaging Department.

Although conservators removed the Marvelseal barrier from *End of the World* on 11 July 2013, the fresco was kept enclosed throughout the construction period in its plywood housing, to be replaced later with a glass-fronted vitrine. Beginning in August 2013, the vitrine was opened as the construction schedule allowed, and fans and heaters were set up to speed the sublimation. As conservators were not always at the construction site, an on-site Skanska project engineer monitored the sublimation progress weekly on an Excel log.¹⁰ This speeded the sublimation process by ensuring that fans were

running, providing vigilant protection of the murals. Conservators found that weakened plaster interlayers on *End of the World* also required reattachment with Paraloid B72 as above. With the CDD still intact and providing its stabilising function as a facing, the top half and edges of the fresco were reattached without incident. Sublimation of *End of the World* took approximately seven months. At that time, conservators found that preexisting weak underlying plaster had detached further in the centre and lower part of the mural. These areas were reattached by injecting B72 through holes drilled through the front of the fresco, then applying pressure with foam blocks compressed between the fresco and the closed vitrine door. Without the advantage of a stabilising CDD facing, this procedure was considerably more worrisome, but the outcome was successful. The holes were later filled and inpainted.

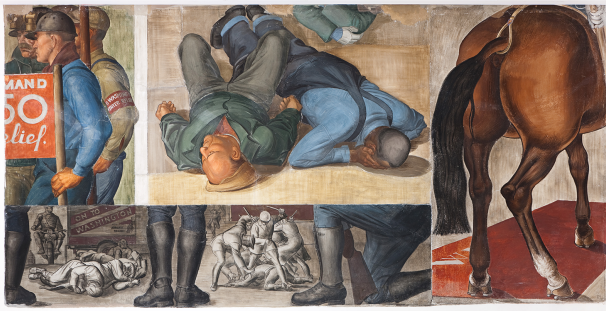
Rubenstein and Lebrun painted the second Fogg fresco, *Hunger March*, the following year in the same fourth-floor studio space (Figure 3). The subject was a collage of scenes based on their experience of the US Army's forcible removal of an estimated 15,000 destitute and out of work World War I veterans who staged a hunger strike in Washington, DC in 1932 in the hope of forcing the government to pay out a reward bonus they had been promised by Congress in the 1920s. In *Structure* (1935), which filled the

Figure 3 *Hunger March* (1933.192). Fresco painted by Rubenstein and Rico Lebrun on an interior terracotta tile wall, fourth floor of the Fogg building. Photo: ©President and Fellows of Harvard College, photographed by the Imaging Department.

As many of the conditions and operations for the three frescoes were similar, we will present a more detailed description of the steps taken to protect and move one of them, *Hunger March*. The plan for *Hunger March* was to remove it, along with its entire terracotta box-tile supporting wall from the building. To prepare the painting for facing, the condition of the fresco was assessed and digitally mapped; its surface was cleaned with deionised water rolled over the surface on cotton swabs; and its underbound passages were consolidated with Paraloid B72 (2–2.5% w/v in 3:1 acetone:Shell Cyclosol 53).²

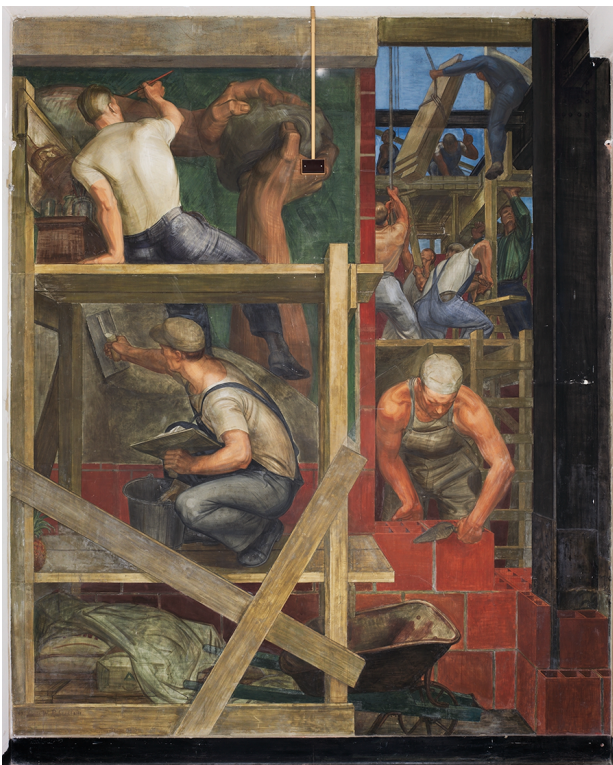
Figure 4 *Structure* (1935.33). Fresco painted by Lewis Rubenstein on the lower level of the Fogg building. Photo: ©President and Fellows of Harvard College, photographed by the Imaging Department.

wall at the end of a basement corridor where staff, students, and museum visitors would have seen it, Rubenstein depicted the stages of constructing the very wall in the basement of the Fogg that he painted upon (Figure 4). It shows workers laying blocks, plastering, and, through a *trompe l'oeil* hole in the upper right, positioning steel girders for the construction of a (then) new wing of the Fogg building. As an added flourish, he depicted himself on scaffolding, seen from the back, in the process of painting the fresco.

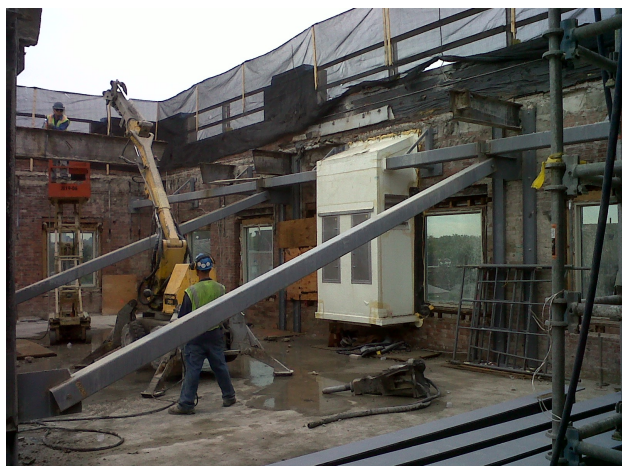
Figure 5 *End of the World* in its protective housing after removal of the roof of the building. Photo: ©President and Fellows of Harvard College, photographed by the Straus Center for Conservation.

The three frescoes presented different, but equally extreme, engineering and conservation challenges. The choice of CDD as a facing material was born out of concern for what the frescoes would undergo during the project. After protection was put in place, *End of the World* remained in situ during the demolition and reconstruction of the building, while sheltered in an insulated, heated protective enclosure high on its (now) exterior wall, and exposed to the harsh New England climate for over three years (Figure 5). *Structure* was faced and protected, and specialist contractors cut its three-foot thick masonry wall with an abrasive, water-cooled cable saw. The fresco was enclosed and stored in a plywood structure within the building during construction. It was relocated later in the project with a crane. Together with its steel beam cradle, the package weighed about 32,000 lb (14,515 kg) (Figure 6).

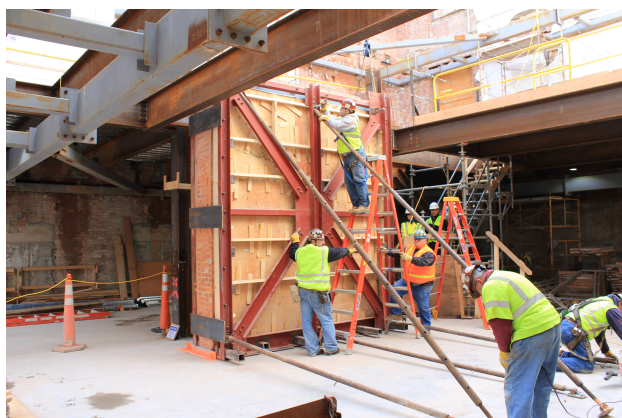
Figure 6 Structure being moved by crane, showing the left side cut of the brick supporting wall. Photo: ©President and Fellows of Harvard College, photographed by the Straus Center for Conservation.

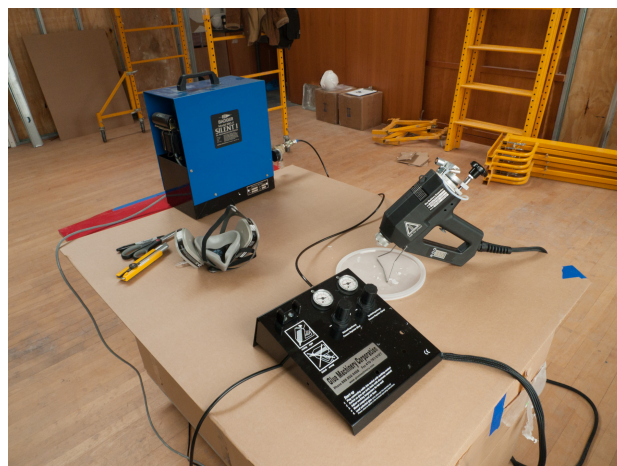
Figure 7 The Champ 10S LCD Hot Spray Gun, a device normally used to spray hot-melt adhesives. Photo: ©President and Fellows of Harvard College, photographed by the Straus Center for Conservation.

The idea of using a heated spray gun to rapidly apply and build thick coatings of molten CDD on sizeable, vertical surfaces was appealing. In small-scale tests, the spray gun quickly produced a thick, homogenous layer. Most tests were carried out on pieces of blueboard, which does not at all replicate the texture of a fresco; this would have consequences later when working on the actual fresco. We noted that achieving an even layer depended on being able to consistently control temperature, speed of spray, pressure and distance to the surface. Though CDD reportedly melts at 60–71 °C, we found the hot spray gun significantly easier to work with at the 80–85 °C setting. At higher temperatures, CDD clogged the gun less frequently. Curiously, on some of the test panels the CDD applied at the higher temperature settings developed tackiness as it began to sublime. There was no way of verifying the actual temperature of the CDD inside the gun chamber and the digital readout indicating the 80–85 °C setting may not have represented the actual temperature of the CDD. We were concerned about the tackiness and suspected that it was temperature-related.

The Champ 10S LCD Hot Spray Gun achieved the most rapid, homogenous films on our test panels in the controlled environment of the spray booth. On the actual frescoes, however, we experienced several problems with its use. The spray application allowed some of the material

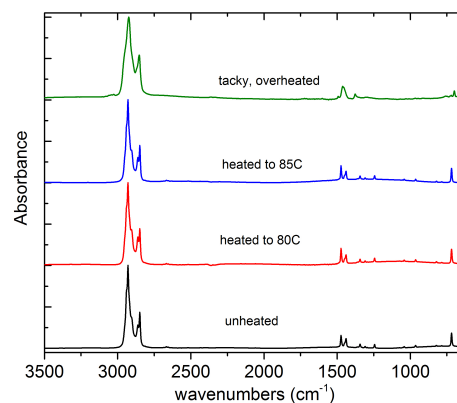
Figure 8 FTIR spectra of unheated CDD (Kremer) (black trace), CDD heated on a hotplate to 80 °C (red trace), CDD heated on a hotplate to 85 °C (blue trace), and CDD heated in a spray gun set to 85 °C, which has become tacky (green trace). The lower three traces of CDD have the same FTIR spectra, whereas the upper tacky sample shows a different FTIR spectrum.

CDD (Kremer) at room temperature; samples of CDD heated to 80 °C and 85 °C on a hotplate; and a sample that had been sprayed through the heated spray gun at the 85 °C setting. For analysis by Fourier-transform infrared spectroscopy (FTIR), the samples were flattened between two diamond windows in a diamond micro compression cell. Spectra were measured in transmission while the sample was supported on a single diamond window using a Thermo Continuum infrared microscope coupled to a Nicolet 6700 bench-top spectrometer. The spectra suggested that three of the CDD samples – unheated, heated to 80 °C and heated to 85 °C on the hotplate – appear to be the same (Figure 8). However, the CDD that was (presumably) overheated in the hot spray gun underwent a molecular change, and is different from the unheated molecule in both the aliphatic stretching (Figure 9) and bending (Figure 10) regions of the spectrum. FTIR analysis confirmed that some aspect of the spray gun use, possibly its overheating due to an inaccurate thermostat, caused a molecular change in the CDD. An organised research project that included more samples heated to a range of higher temperatures on a hot plate as well as through a heated spray gun would be necessary to better understand this alteration. Our analysis was in response to a practical problem encountered during preparation for treatment, so it did not proceed any further.

As a practical result of the analysis, we decided to keep the thermometer-measured heated water bath and spray gun setting at or under 80 °C during the project. We did not want to risk creating tacky CDD that could adhere to overlying barrier layers, making them difficult to remove when necessary. The analysis reassured us that CDD could be safely heated to 80 °C degrees on a hotplate, the temperature we found most workable for brushing it onto the fresco surfaces, without degrading the molecular structure.

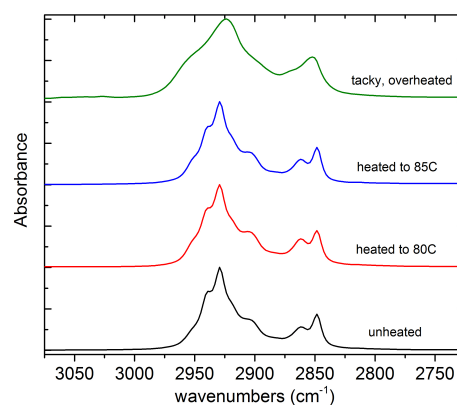
Figure 9 FTIR of the aliphatic stretching region of the four samples of CDD.

molecular change, as evidenced by the changes in the aliphatic stretching and bending regions of the overheated CDD samples noted with FTIR analysis.

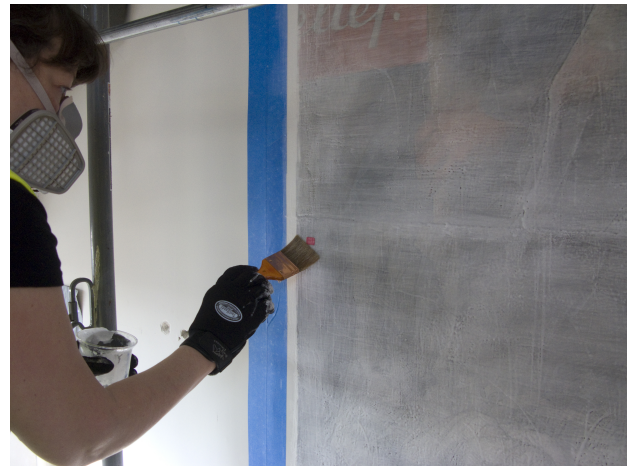
Figure 11 Jill Hari applying CDD to *Hunger March* with a hog hair brush. Photo: ©President and Fellows of Harvard College, photographed by the Straus Center for Conservation.

Ultimately, brushes proved the most efficient means for applying molten CDD (Figure 11). We chose inexpensive 2-inch wide hog hair 'chip' brushes, which were superior to softer, denser-haired (and more expensive) brushes that held less material and tended to clog up more quickly. We put approximately 300 ml CDD into each of four 500 ml Pyrex beakers in a heated water-filled container. The bath contained a thermometer to ensure that the water did not exceed 80 °C. The beakers were rotated into use as the CDD reached a liquid consistency. When applied, the CDD reverted from a water-thin consistency to a solid almost as the brush met the surface of the fresco, leaving very little working time. With practice, conservators found rapid application controllable, albeit messy. Conservators working in groups of two or three built up the CDD by thin layers into a thick, opaque white coating. It took approximately 90 person hours to apply a 3/8-inch (9.5 mm) layer of CDD to *Hunger March*, the surface of which measures 120 inches × 60 inches (50 square feet, or 4.64 m²). Two layers of cheesecloth were incorporated into the layer of CDD to impart strength and structural support to the face of the fresco. We were concerned by the possibility of interlayer plaster separation, already a problem for *Hunger March*. The thick facing would keep the surface layer together if the underlying plaster failed during the various stages

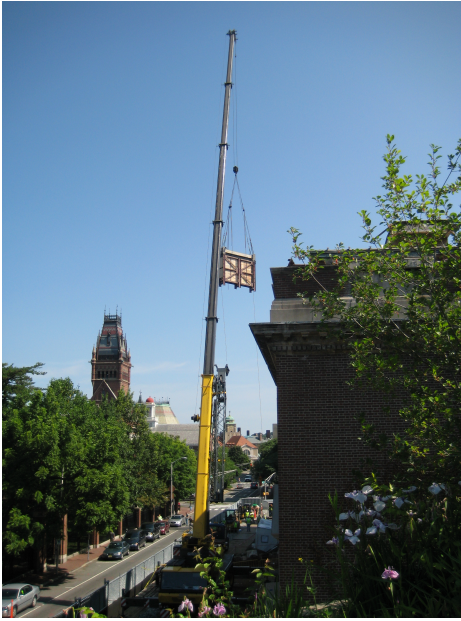
Figure 13 Crane removing *Hunger March* from the Fogg building, 24 June 2010. Photo: ©President and Fellows of Harvard College, photographed by the Straus Center for Conservation.

At this point the fresco was fully supported and could be freed from the building structure. Contractors using a diamond chain saw had cut the sides of the fresco free previously. The cut on the right side, now left exposed, revealed the sub-plaster layer below the arriccio and intonaco layers, on top

of the terracotta box-tile. This sub-layer was found to be weakened, crumbling and lifting up to 1 cm away from the tile in areas several centimetres deep. Conservators consolidated these gaps with Paraloid B72 (50% w/v in a mixture of acetone and ethanol). Finally, a wet saw was used to cut through the supporting steel beam overhead. The mural was carefully lifted through the roof of the building by crane and placed on a flat bed truck for transport to a storage facility. Years later, it would be transported back and moved by crane through the front door of the building and to its new location in the Museum's Social Realism Gallery (Figure 13).
