## Coastal landslide monitoring at Aldbrough, East Riding of Yorkshire, UK.

P.R.N. Hobbs, L.D. Jones, M.P. Kirkham, C.V.L. Pennington, D.J.R. Morgan &  
C. Dashwood

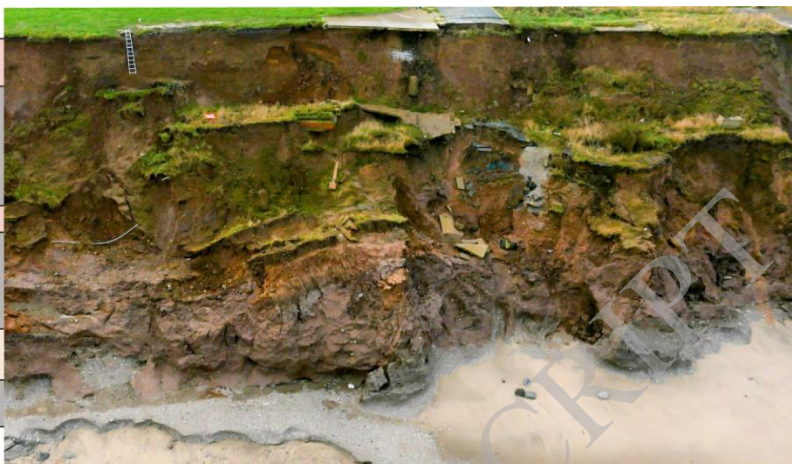
The lithostratigraphy at the site is summarised in Fig. 2; a fuller description provided in (Hobbs *et al.* 2019a). From an engineering geology viewpoint the major till units, belonging to the Withernsea, Skipsea Till and Bridlington Members of the Holderness Formation, represent fissured, lightly to heavily over-consolidated materials having similar geotechnical properties that are in general agreement with Bell & Forster (1991), Bell (2002) and Powell & Butcher (2003). However, the laminated, silty, clayey (and glaciectonised) Dimlington Bed between the Skipsea Till and Bridlington members, at around 15 m depth, combines low strength and high average permeability with high plasticity and compressibility. Evidence from exposure on the cliff, when compared with the borehole logs, suggests that the Dimlington Bed is prone to liquefaction and may have undergone extrusion and thus thinning of the bed at the cliff. It is unclear whether or not minor observed (pre-landslide event) subsidence close to the cliff edge can be attributed to this.

Hornsea M.(HM)
Withernsea M. (WM)
Mill Hill Bed (MHB)
Skipsea Till M. (SKTI)
Dimlington Bed (DIMS)
Bridlington M.

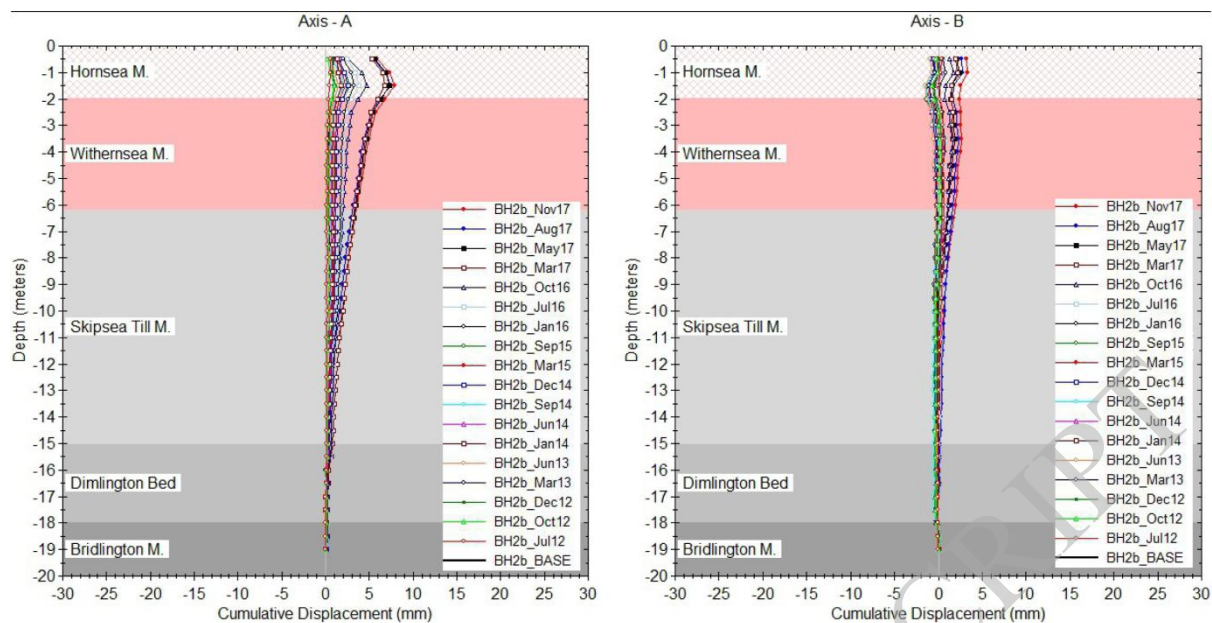
Equivalent data for Borehole 2b (up to August 2017) are shown in Fig. 11. to the same scale. Here displacements were greatly reduced compared with BH1b; a maximum cumulative northerly displacement of 7 mm having been reached at a depth of 1.5 m in the Hornsea Member. Lateral displacements occurred above a depth of 16 m and increased gradually uphole. It is noted that here the A-axis displacement, albeit small, exceeded that of the B-axis when compared with BH1b, possibly indicating some form of stress rotation. *NOTE: this dataset has an April 2012 baseline.*

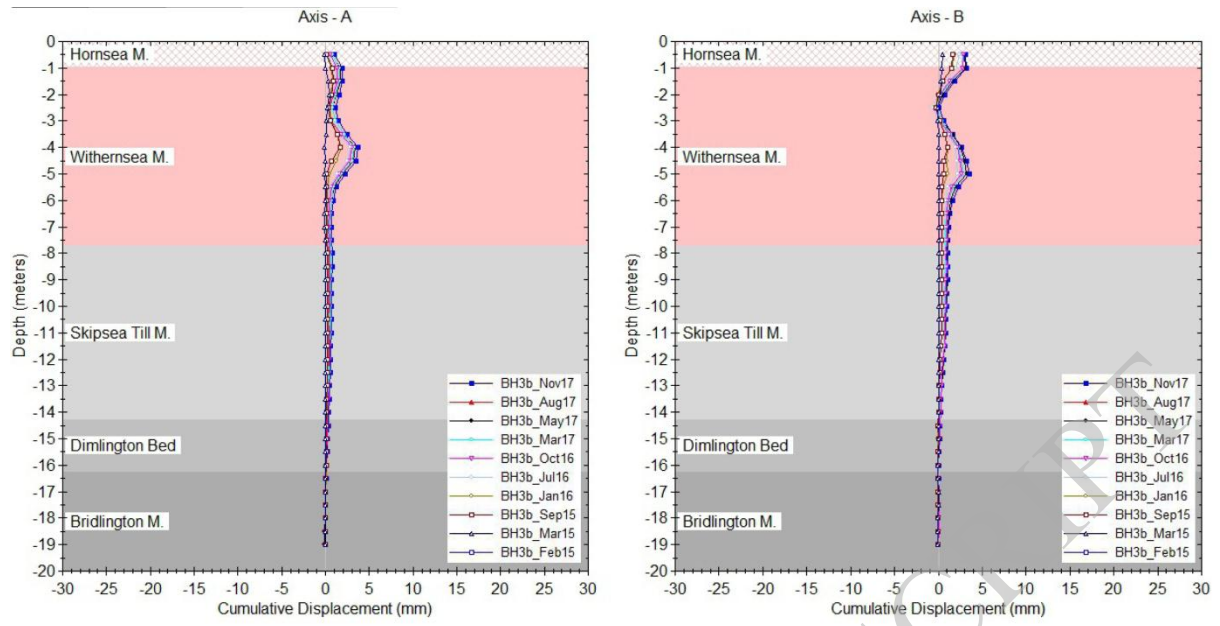
Equivalent data, but over a shorter period, for Borehole 3b (up to August 2017) are shown in Fig. 12 to the same scale. Here only very small displacements were seen, initiating above 13.5 m depth and peaking at 3 mm at a depth of 5.0 m within the Withernsea Member. Displacements on both axes were comparable in amount. *NOTE: this dataset has a March 2015 baseline.*

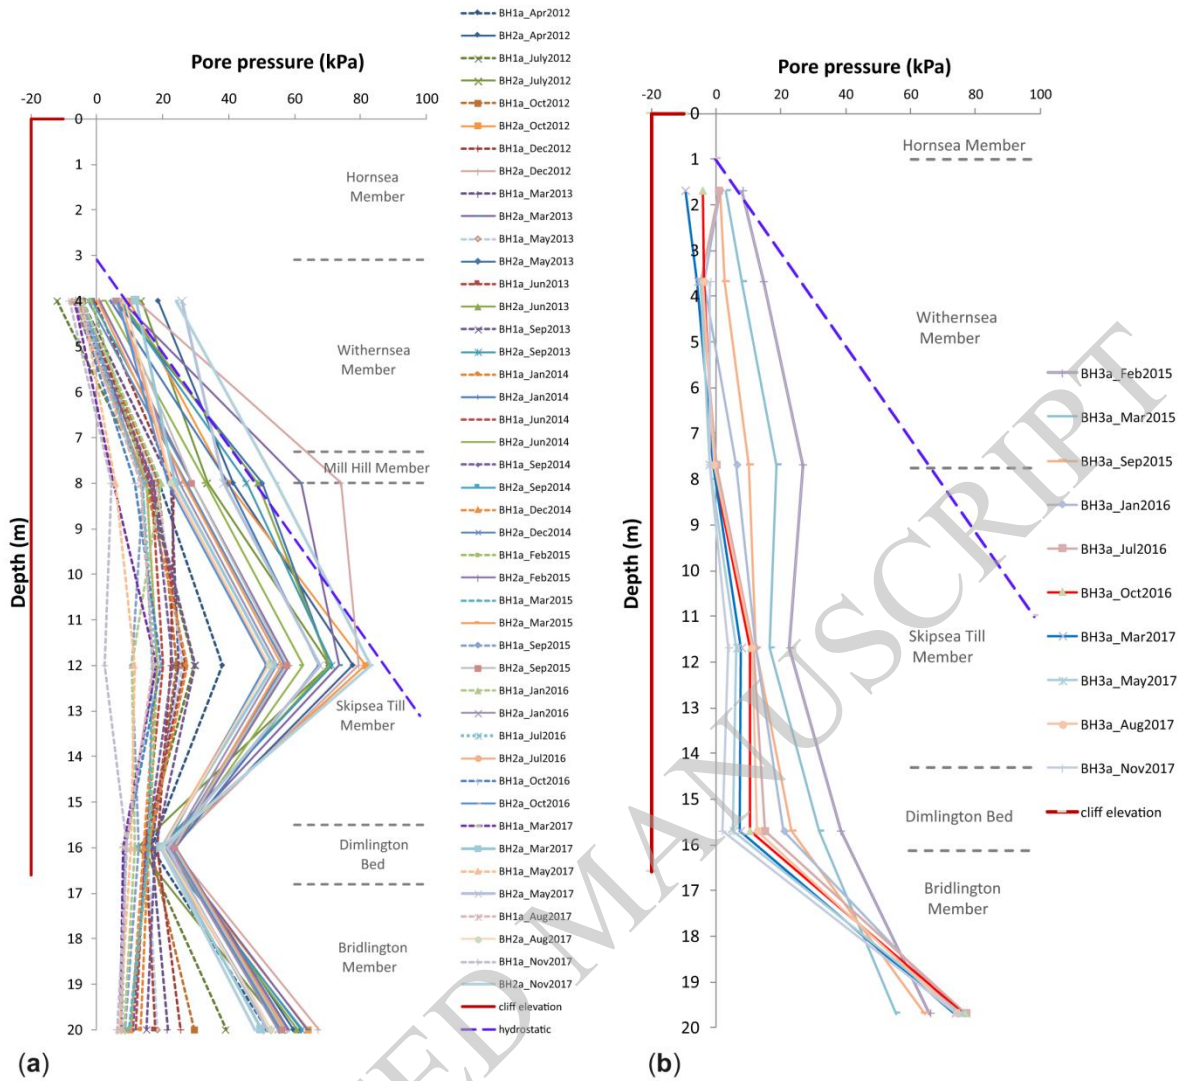
Plots of piezometer borehole profiles for each site visit are shown in Fig. 15. These emphasise the markedly sub-hydrostatic nature for BH's 1a and 3a but less-markedly sub-hydrostatic in BH2a down to 12 m. Similar 'depressed' pore pressures were described for the London Clay Formation cliffs at Warden Point (Dixon & Bromhead 2002). The Dimlington Bed, at least in BH's 1a and 2a, acts as a minor source of water to the lower cliff, whereas the Skipsea Till Member in BH2a does not. The Dimlington Bed also saturates the upper parts of the underlying Bridlington Member. Observations of the cliff slope indicate that the Mill Hill Bed is a major source of water to the mid and lower cliff and, hence, to landslide deposits on the cliff. Pickwell (1978) described "land springs" as the chief cause of the landslides at Aldbrough. Any mechanism whereby drainage from the Mill Hill and Dimlington Beds is blocked by landslide deposits on the cliff slope is likely to be transient and difficult to observe and quantify. The data indicate that hydraulic continuity with the cliff and between boreholes is in an enhanced state compared with the situation further inland, due mainly to the presence of persistent joints within the till members and their 'opening-out' with time as a result of progressive stress relief as discussed earlier.

NOTE 1: No sensors present in BH's 1a & 2a at 2 m depth; NOTE 2: Purple dashed lines represent idealised hydrostatic profiles.

The pore pressures at 20 m depth within the boreholes diminish toward the cliff from 75 kPa to 10 kPa and readings are relatively constant when compared with the shallower sensors.

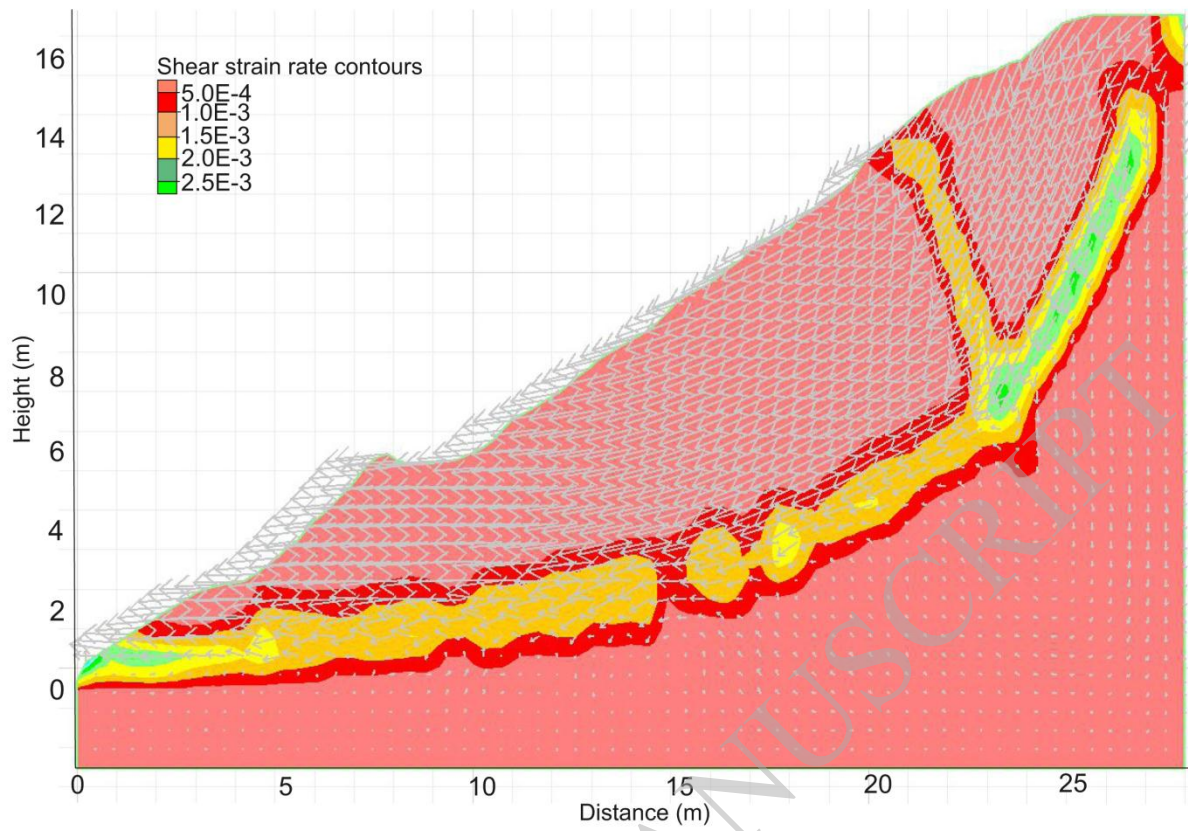
and under-drainage pathways are complex and time-dependent as they are prone to disruption by landslide activity on the cliff. The slip surface input to ‘Galena’ (Fig. 17) is based on observation, TLS data and the FLACslope model, and is considered representative of the subsequent major fresh event (February 2017) which daylighted at the cliff within the Dimlington Bed and with a cliff-top recession of 3 m on the ‘b’ borehole alignment. Whilst the FLACslope example shown (Fig. 18) reflects the observed landslide profile of February 2017, the model is very sensitive to the position of the phreatic surface; small changes resulting in wide differences in the pattern of displacement and hence ‘suggested’ landslides with very different scales and mechanisms.
