## Visual documentation process of historic building refurbishment

### “Improving energy efficiency by insulating wall cavity”

This paper is based on a historic building energy improvement case study financed by the European commission and the Scottish Government. The pilot study consists of insulating an 18th century house using an innovative product and method. The project was a response to a call by the CIC start (Construction Innovation Club), aiming to establish a link between SMEs and the Universities. The project saw the day in collaboration with Icynene Canada, KDL Kishorn (see full list in the acknowledgment).

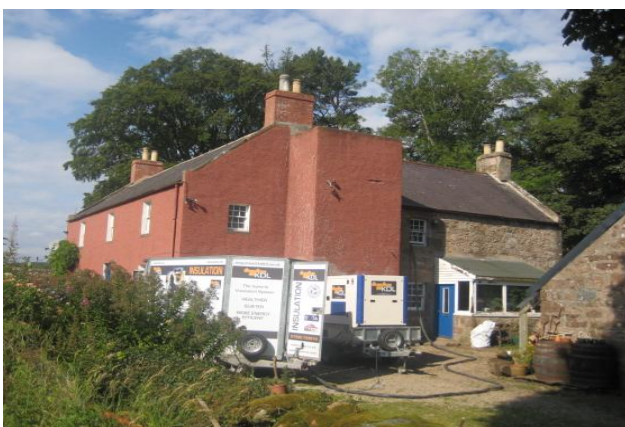
Figure 1. View of the house during the insulation process  
For the Scottish context this research/experiment will concentrate on existing load-bearing masonry construction with internal plastered lath lining.

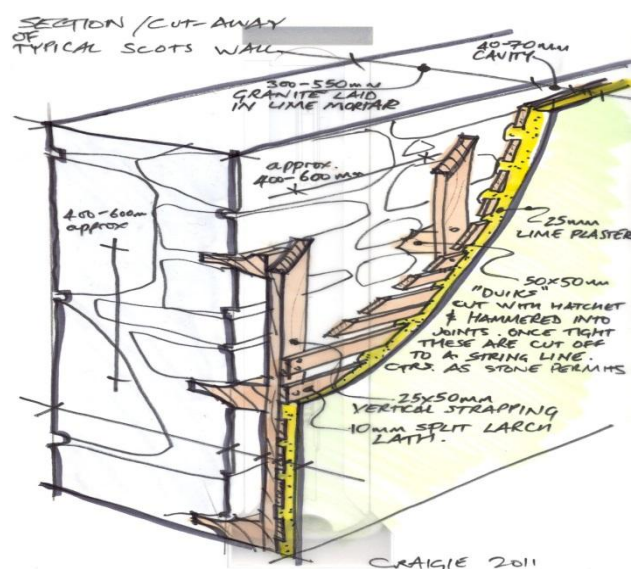
Figure 2. Illustration of wall details

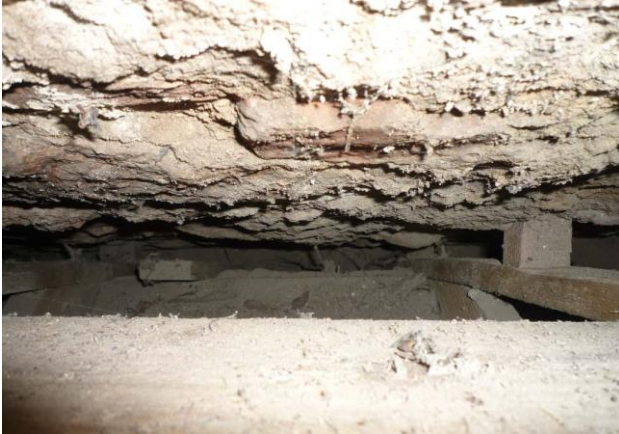
Figure 3. View inside the cavity wall before insulation

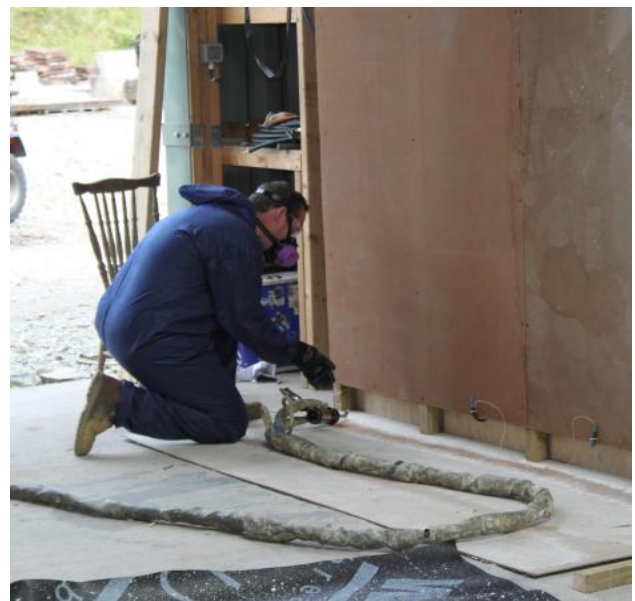
Figure 5. Trial in the workshop

- A physical model of the wall cavity at scale 1/1 which simulated the masonry wall, 40mmX40mm battens spaced of the ply by 20mm and fixed vertically at 600mm centres, to simulate the vertical studs carrying the lath and plaster, 4mm hardboard lightly fixed to the studs to simulate the lath and plaster. The hard board was fixed up off the floor by 150mm to simulate the void which would be left after the removal of the skirting boards.

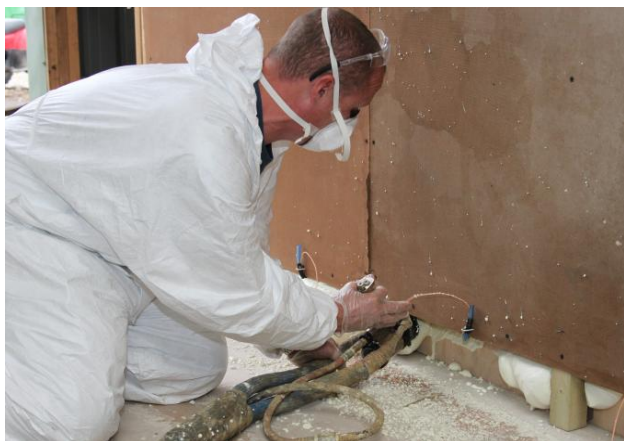
Figure 6. Injection of the foam

- Results/Findings: - The spray foam sealed the area behind where the skirting boards would be fixed, resulting in no loss of pour material. The pour material was capable of being injected down a 2800mm pipe and expanded vertically between and behind the vertical studs, leaving no voids. No deflection in the hardboard was detected. This trial was deemed to be successful, and a decision was made to adopt this method at house at Fettercairn.

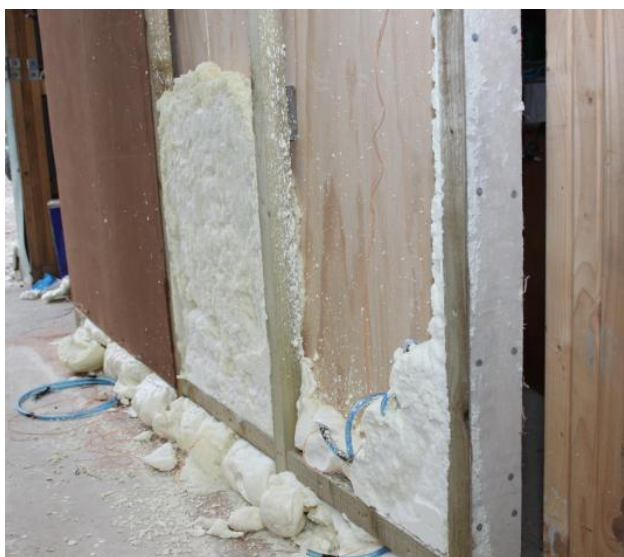
Figure 7. Observation of the outcomes

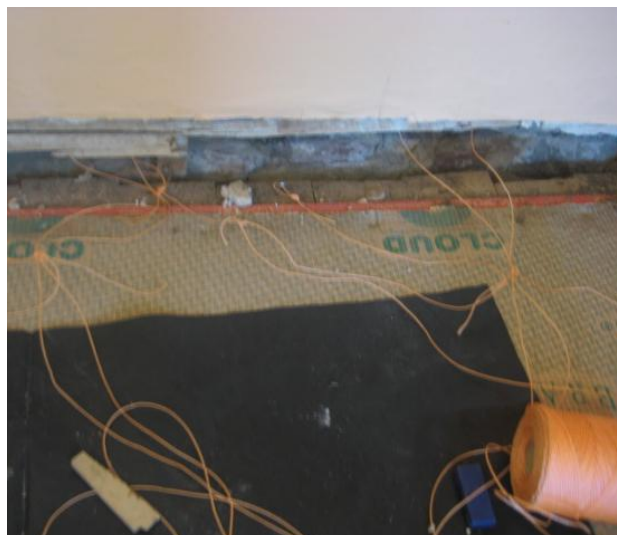
Using fibreglass probes the draw cords were inserted from the attic area until they emerged at the open void, behind where the skirting boards would be positioned. The involvement of the introduction of cords was abandoned later on, as it shows inappropriate.

Figure 8. Cords put in place

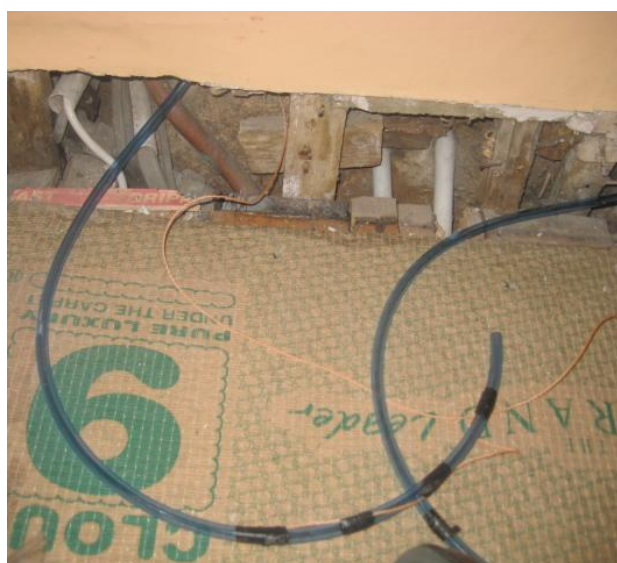
The draw cords were attached to the 10mm polyurethane pipes and the pipes pulled down, and then retracted 200mm, then secured. A pipe was inserted between each stud. The site supply of polyurethane pipe ran out and the only available pipe, locally, of the same diameter was a PVC pipe, this was used to 4 bays. This type of pipe appeared later on to be more difficult the previous one to work with.

Figure 9. Pipes attached to cords

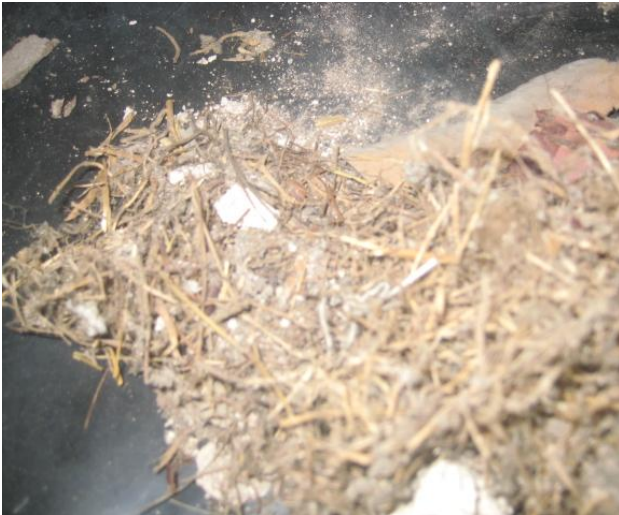
As the pipes were installed it was noted that debris was falling down when disturbed. To ensure no bridge within the cavity was caused, which could lead to damp problems in the future, it was decided to clean the cavity. This was achieved by moving the fibreglass probes around to dislodge trapped debris, assisted by an airline inserted into the cavity. The result was that approximately a pale full of debris was removed, which consisted of plaster lumps, fine dust and wooden twigs, presumably put there by birds making nests. The void was then cleaned by vacuum and brushing. This method was the appropriate for this type of buildings, however other methods have been elaborated for other type of construction and climates (Haupt, Fechner & Petzold 2002) and (Vadodaria et al. 2010).

Figure 10. Sample of debris removed from the wall during this phase of the trial despite the cleaning prior to the start

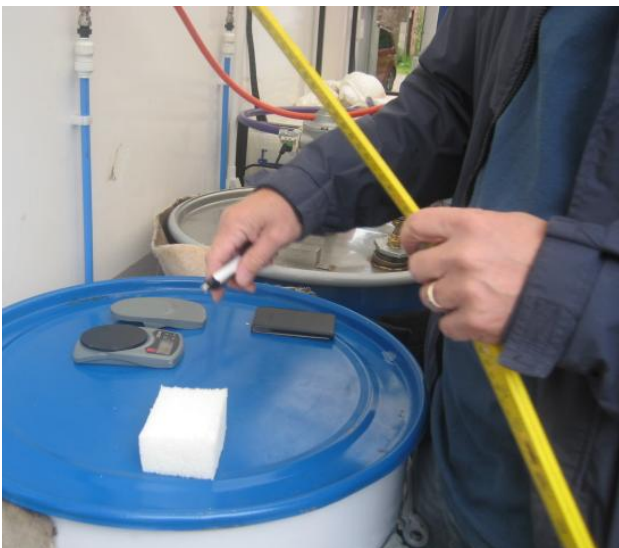
The equipment was changed over from the spray foam material to the pour foam material, and samples taken to prove the correct rate of expansion.

Figure 11. Quality check of the foam

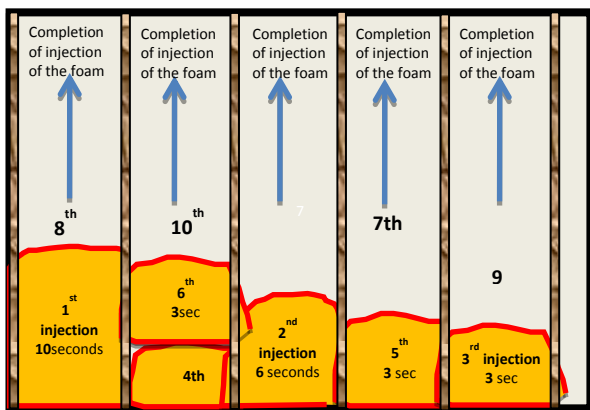
Figure 12. Injection of the foam in the bays in alternative way

Pour foam was then injected down the pre installed pipes in durations of 10 seconds, the pipes were withdrawn 500mm after each injection and blown through with the airline. The process of injecting alternate bays was adopted to ensure the least possible outward pressure was applied to the wall. The wall was monitored at all times for movement. It was noted that there were small areas where the pour foam leaked out while still in liquid form, these areas were plugged using expanded spray foam pieces.

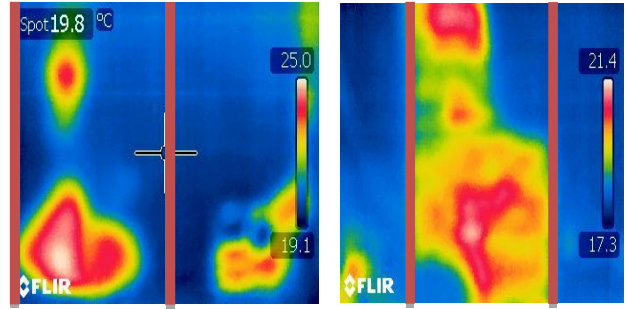
Figure 13. Alteration between bays

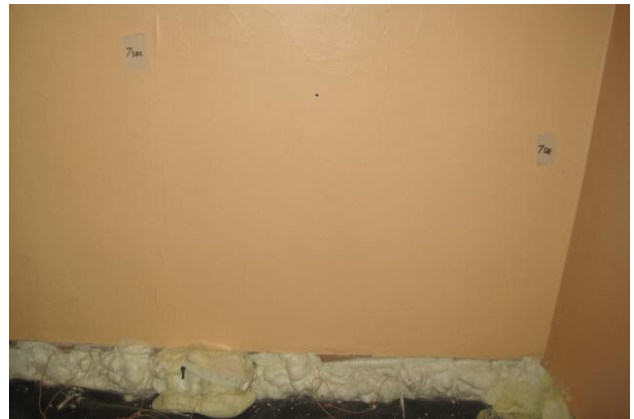
Figure 14. Leak of the foam at the bottom part of the wall

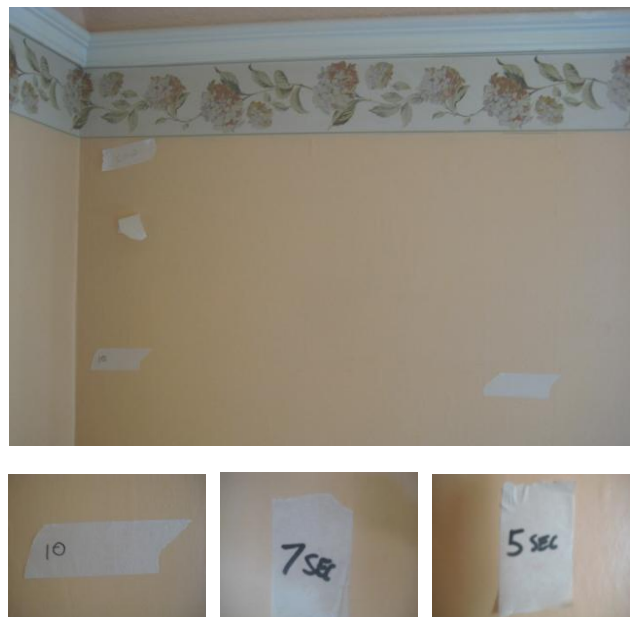
Figure 15. Alteration of bays and localisation of the foam level on the wall

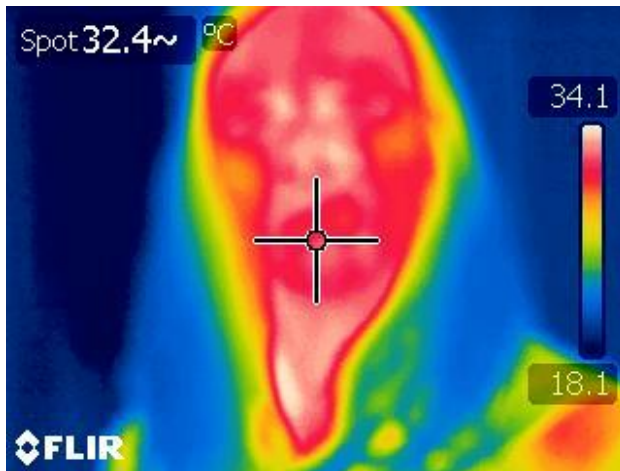
An infra red camera available on site gave some indication where the material was injected, but this was not conclusive, and only showed the body of the pour foam in liquid form and not the area as the expansion took place.

Figure 16. Monitoring the foam expansion with infra red camera

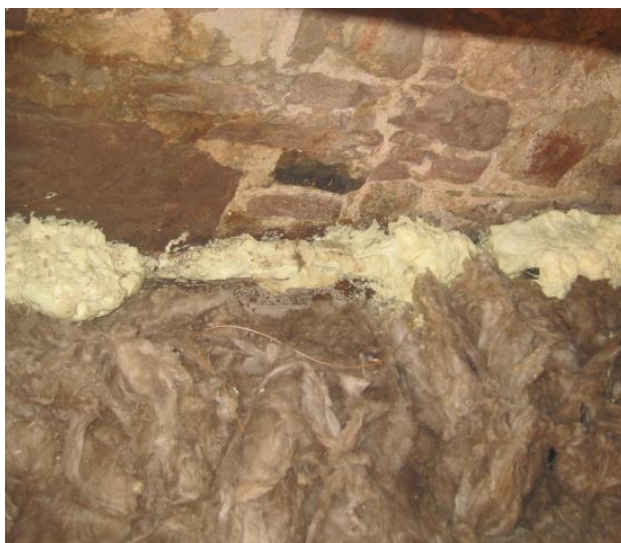
The process was repeated until the pour foam was visible in the attic space. Once this was achieved the material was changed back to spray foam and in the area of the comb, spray foam was installed to join the existing fibreglass insulation to the newly placed Icynene.

Figure 17. Top of the gable wall, foam seen from the attic

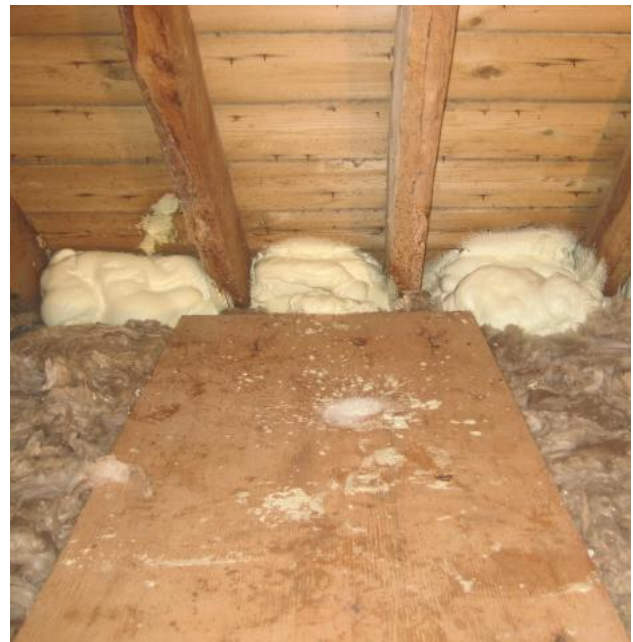
Figure 18. Foam seen at the eave level
