Giardina, G, Marini, A, Riva, P & Giuriani, E 2019, 'Analysis of a scaled stone masonry facade subjected to differential settlements', *International Journal of Architectural Heritage*.  
<https://doi.org/10.1080/15583058.2019.1617911>

# Analysis of a scaled stone masonry façade subjected to differential settlements

## ABSTRACT

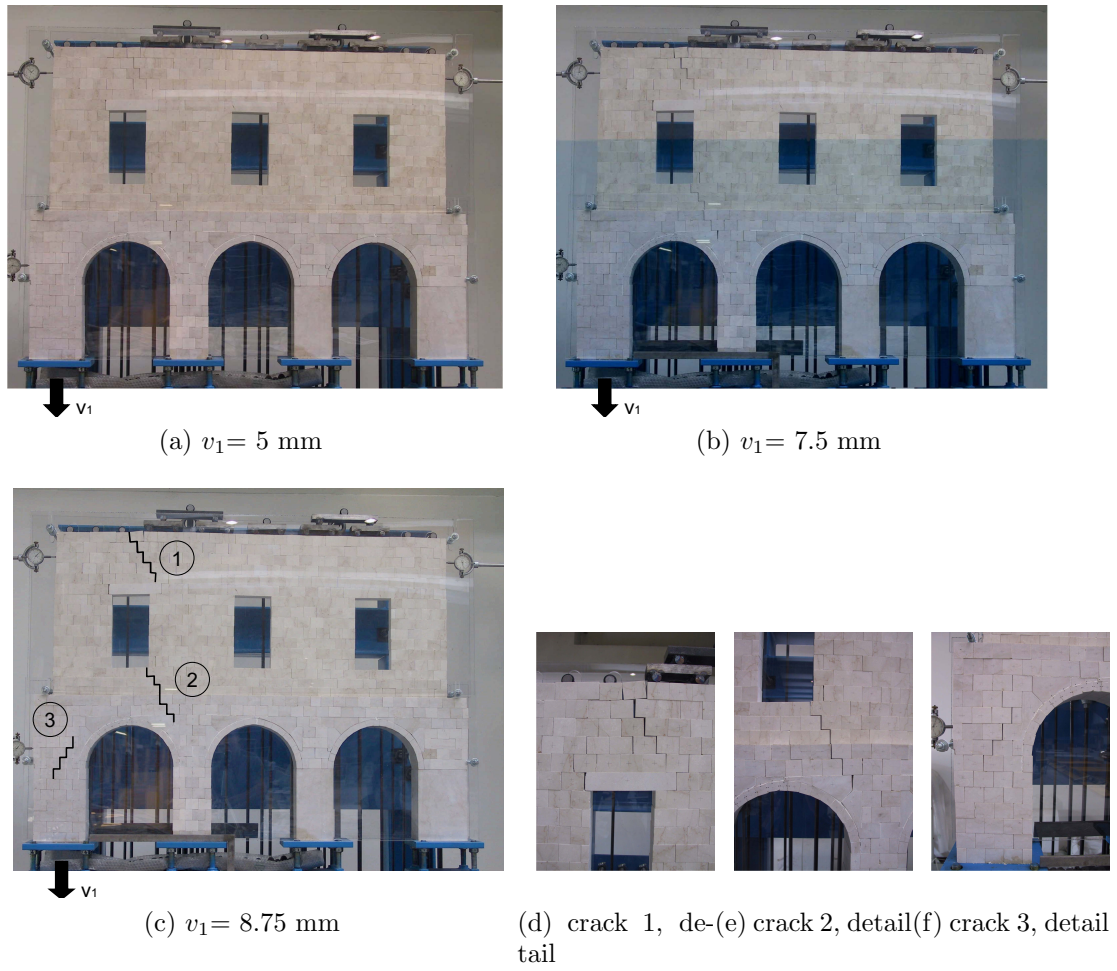
FIG. 8: Test 2: Crack pattern evolution, façade without mortar, test with amplified loading.

Figures 8a-c show the crack pattern development in the last phase of the test. The damage was localised in three areas on the left side of the façade (Fig. 8d-f): above the window (crack 1), between the window and the second column from the left (crack 2) and in the left end column, at the arch spring level (crack 3). Figure 8d shows the detail of the large crack arising from the façade top. This crack significantly opens only after a relatively high value of applied displacement ( $v_1 > 4.2$  mm). The location of the crack onset is affected by the load distribution device, which confines the blocks underneath it. Figure 8e shows the crack developing from the lower corner of the window. The crack

is well defined and grew at an angle of approximately  $60^\circ$  with the horizontal direction.

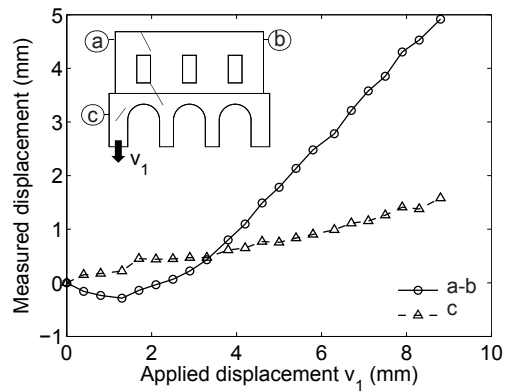
FIG. 9: Test 2: Monitored displacements, façade without mortar, test with amplified loading.

Figure 9 illustrates the relation between the applied displacement and the crack width progression of the principal cracks. The curve corresponding to the crack at the façade top exhibits an initial negative slope; this was due to the initial perturbation caused by the applied displacement and resulting in a compaction of the blocks in the horizontal direction. After the first three steps of settlement application, the curve shows a change of slope, which becomes positive; this indicates the crack onset. Around the eighth step of settlement, the curve slope increases, indicating an increase in the crack opening rate. This slope, approximately linear, remains constant until the end of the test, when the crack width was about a half of the applied settlement. Figure 9 also shows the horizontal displacement measured by the mechanical dial gauge c. This displacement was mainly due to the opening of the crack onset at the left end column at the arch spring level. This crack was relatively small and its opening rate, almost linear, was lower than the one of the crack measured by the dial gauges a-b.

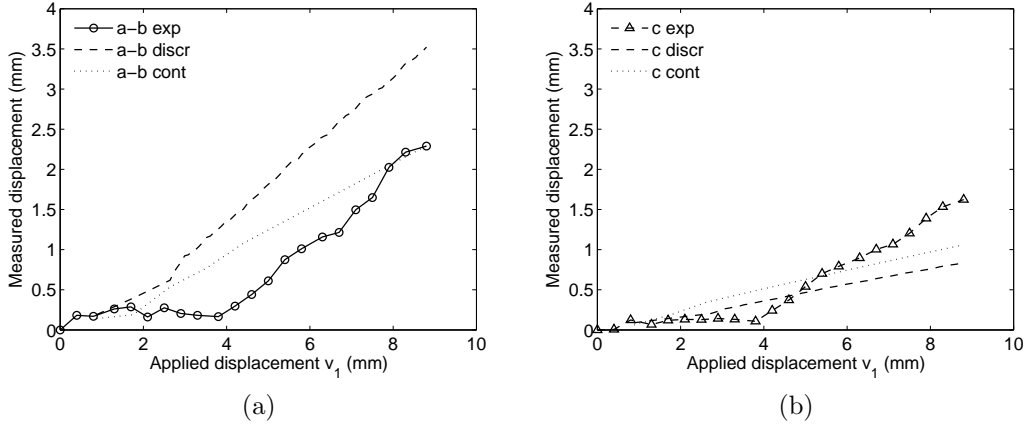
FIG. 16: Monitored displacements (a) a-b and (b) c, façade with mortar, test with amplified loading: settlement of the left end column.

Figure 16 compares the numerical and experimental results in terms of horizontal displacements of the monitored points. Both the models can reproduce the order of magnitude of total crack width that was experimentally observed.
