MORPHOLOGICAL/ANATOMICAL INVESTIGATION OF
CATTAIL TRANSPLANTS AND BOG VEGETATION

FINAL REPORT

BY: R.W.Scribailo and M. Kalin

March 31, 1989

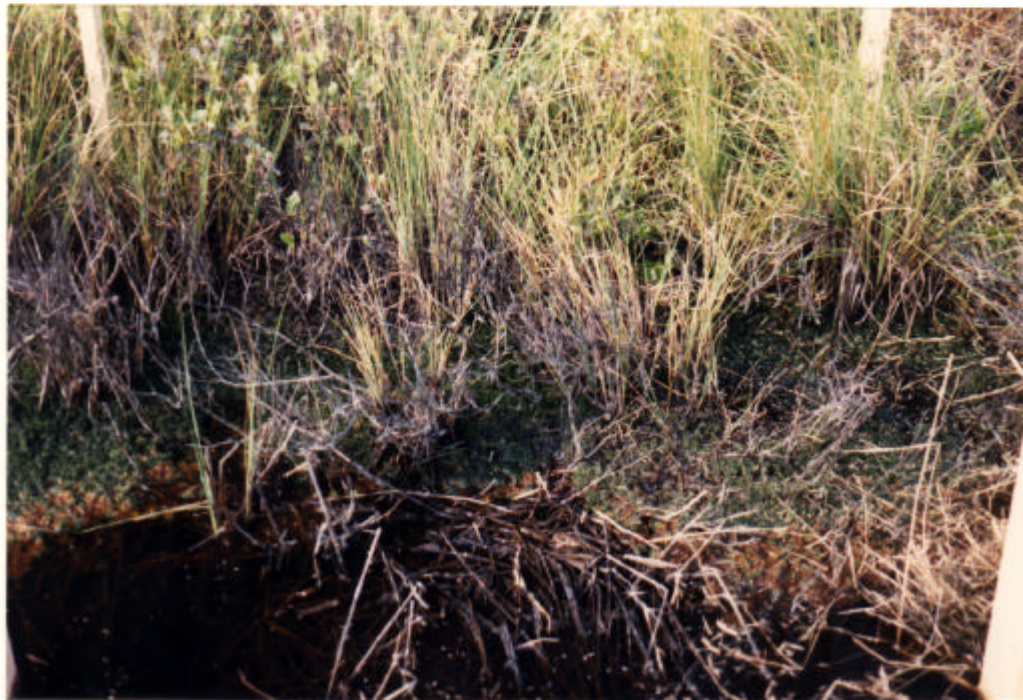
Plate 2: Photograph of Plot A

In the hollows, the prominent species present was Juncus canadensis but all biomass seen was dead plants heavily encrusted with ochre. The moss Sphagnum fibriatum also showed extensive signs of acid stress (Plate 2). It was noted that the dieback of Sphagnum fibriatum occurs only at the edges of the mat as it extends out into the water and becomes submerged.

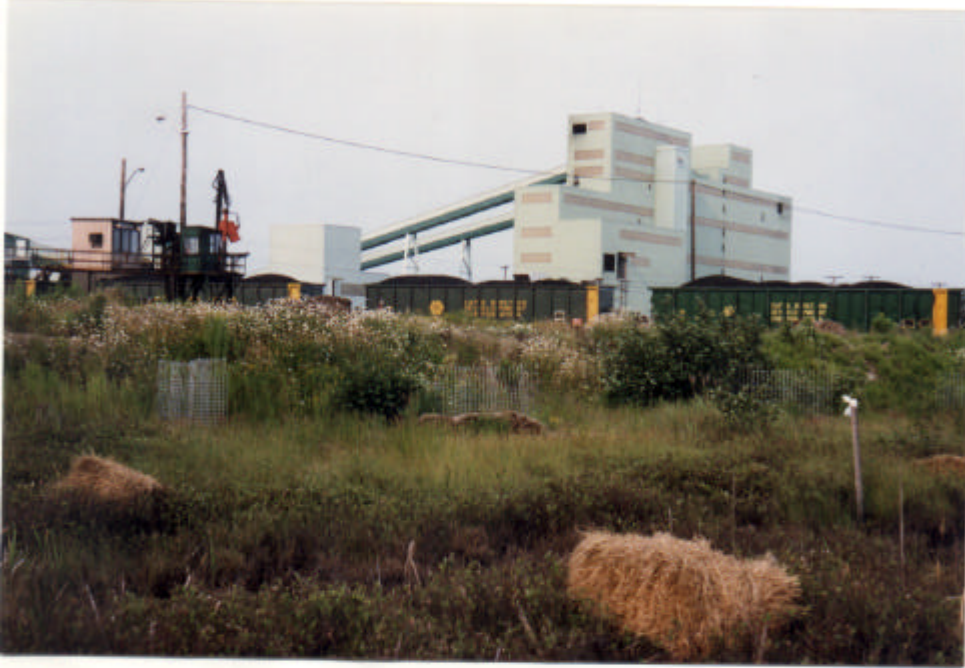
Plate 4: View of the Old bog in foreground

Throughout the Old bog (Plate 4), lower zones occur at three distinct troughs which almost run the length of the bog from the northwest to the southeast (Plate 5). At the southwest corner of the bog where water inflows from Grand Lake, there is a small strip of open water, dominated along its margin by cattails. The old bog is distinct from the New bog as extensive hummock formation has occurred with localized high (hummock) and low spots (hollow) (Plate 6). The majority of low spots contained, in July, either very slowly flowing or standing water.

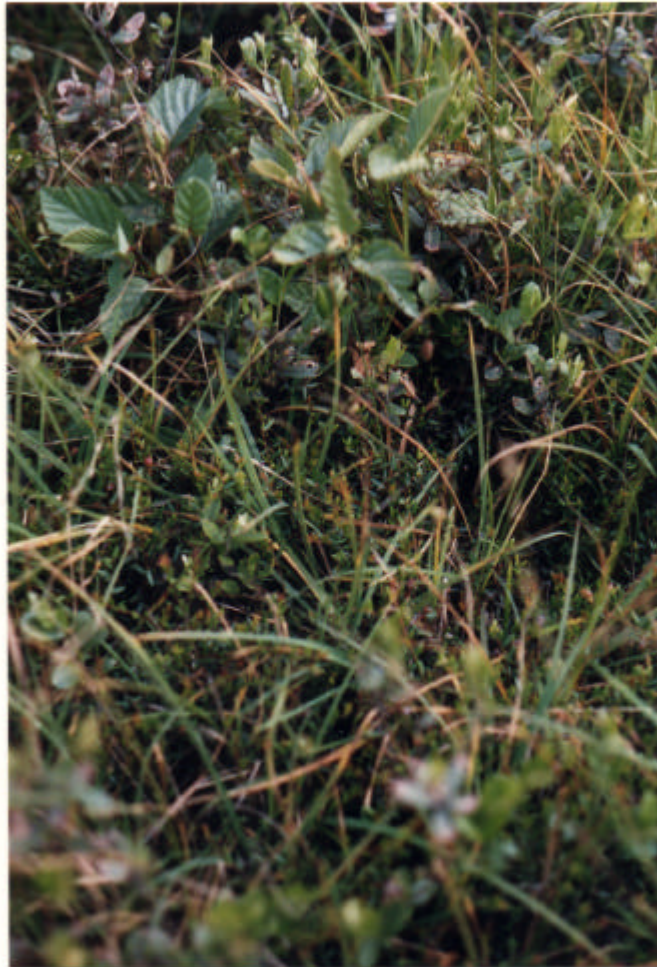
Plate 7: A typical hummock association

On hummocks, a much greater diversity of species was observed in comparison to the hollows with the majority of natural species listed in Table 1 occurring (Plate 7). The mosses on these sites

appeared healthy and showed signs of extensive growth. Of interest was the fact that a species replacement appeared to be occurring on the hummocks. The two species that were observed to be flourishing were Juncus inflexus and Calamagrostis canadensis. These weedy species replace the woody dwarf shrub community intolerant to the acid conditions depicted in Plate 7.

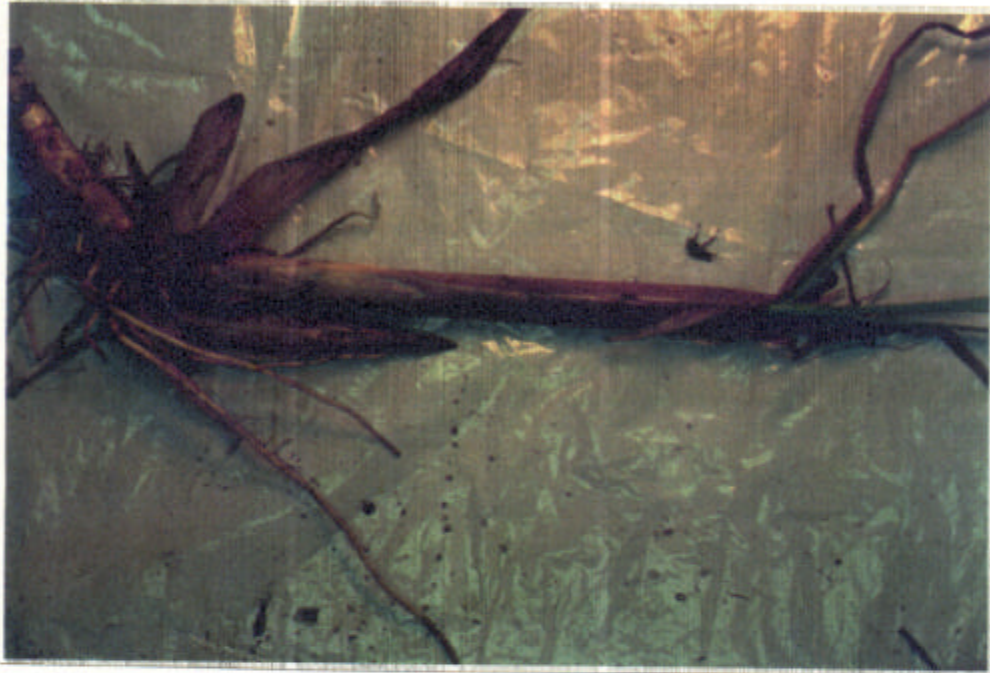
Plate 8: Cattail roots from the control bog

In the Old bog, the rhizomes of the cattails showed a greatly reduced production of both lateral and adventitious roots. Few newly initiated roots were present on the rhizomes compared to controls (compare Plates 8 and 9). Many of these roots appeared to have been initiated but did not emerge from the rhizome. In anatomical characteristics, both types of roots often failed to show the typical aerenchyma type of development which is characteristic of healthy roots.

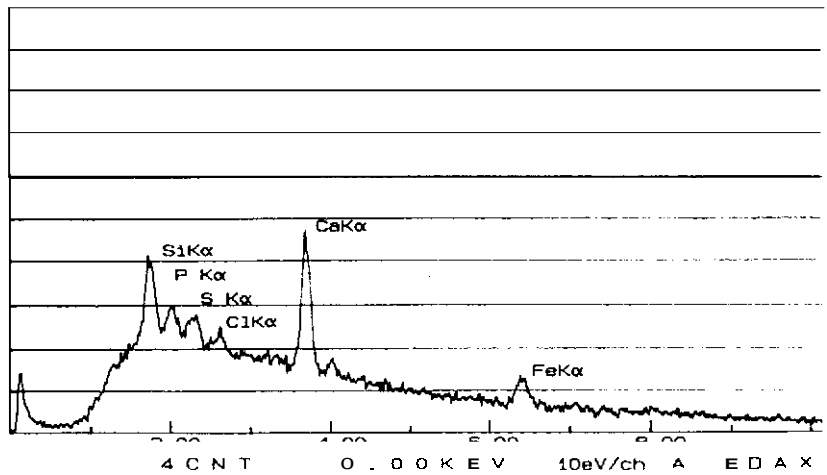
Figure 18 a, b, and c

Within the control site the most prominent peaks in the hypodermal layer are for calcium and silica with a small iron peak. The calcium peak reflects high levels of structural cell components. The high silica component is somewhat harder to explain. The low levels of iron and sulfur suggest a small amount of iron plaque buildup. All elements drop off in the cortex with only a high calcium peak, once again indicating a structural component. In the endodermis (EN, Fig. 11), which represents the barrier between the cortex and central vascular cylinder (VC, Fig. 13). In the endodermis and through the vessel elements (Figure 18 D) and tracheids (Figure 18 E) of the vascular tissue calcium continues to drop off as do all other elements.

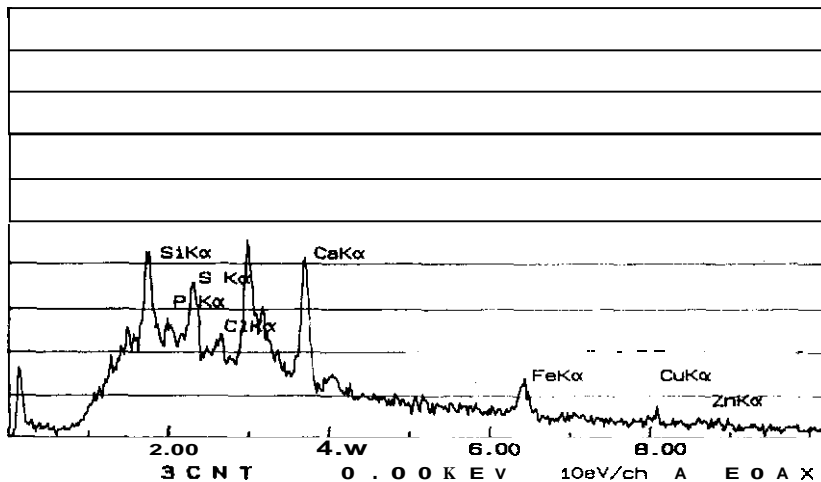
Figure 19: X-ray Microanalysis scan for control adventitious root

15-FEB-90 15:32:25 EOAX READY
RATE = 13CPS TIME = 51LSEC
FS = 1026CNT PAST = 500LSEC
A = LAT.ROOT CONTAOL
