Mastodon Tusk Analysis Project

Analysis of Mammut americanum Tusk for Asbestos

Analysis of Mammut americanum Tusk for Asbestos Madeline C. Roach, Joshua A. Sebree

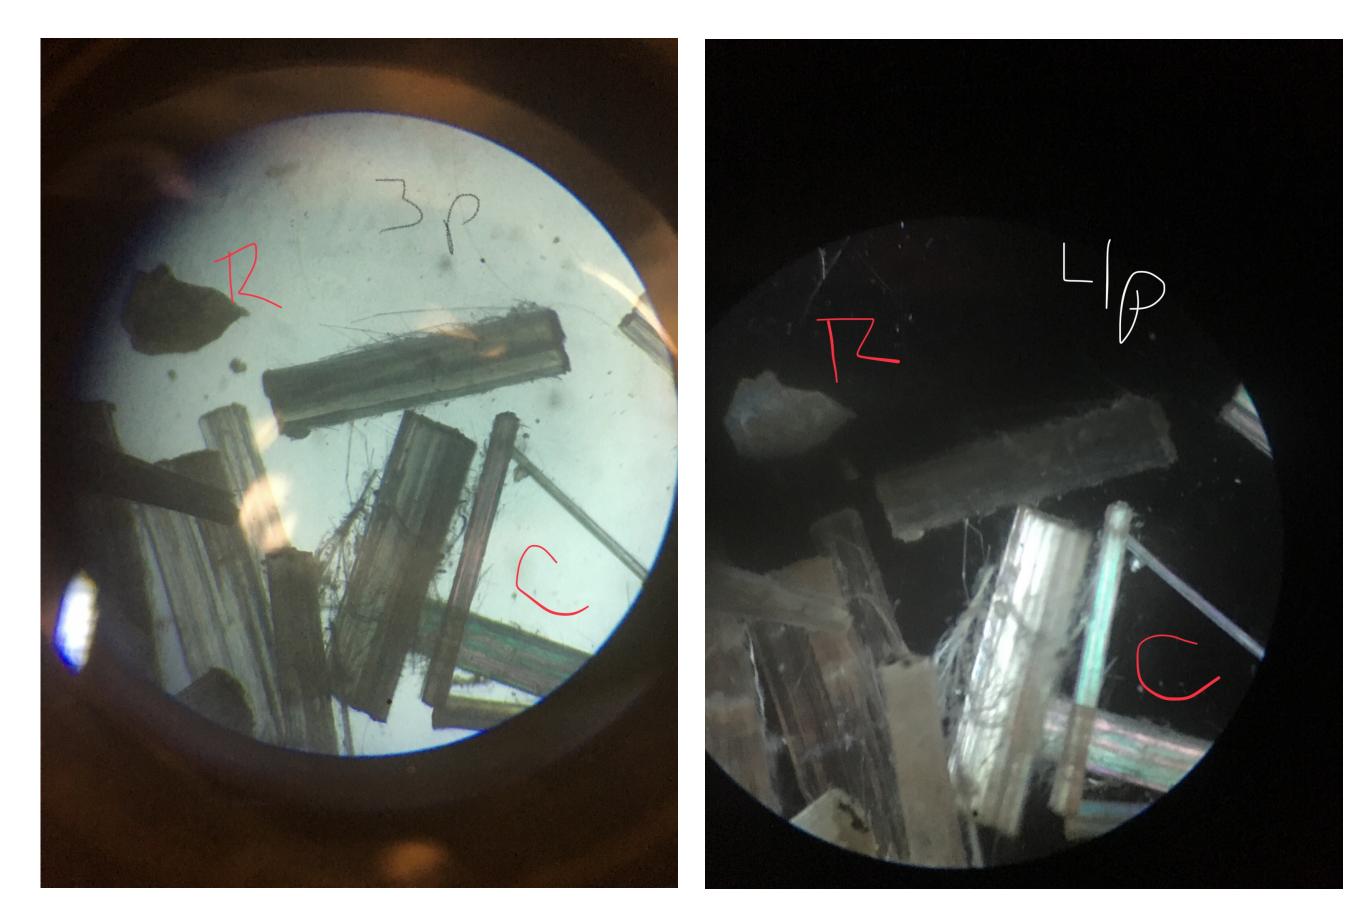
• Pure Asbestos crystals were analyzed by PLM

- Top left figure: crystal and rock samples under non-polarized light. Rock sample marked with an "R" and crystal sample marked with a "C"
- Top right figure: crystal and rock sample under polarized light. Rock sample marked with an "R" and crystal sample marked with a "C".
- Bottom left figure: crystal samples under non-polarized light
- Bottom right figure: crystal samples under polarized light

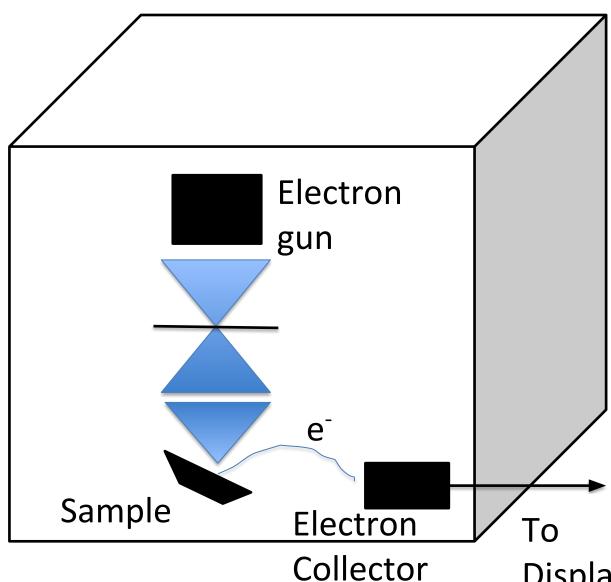
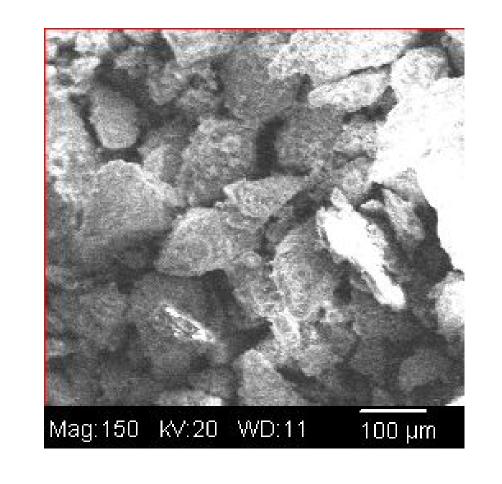
SEM/EDX

• To confirm our negative findings, the sample was run on the SEM.

Due to the lack of asbestos in the PLM samples, and the lack of detected silicone from the SEM experiments, it can be concluded that our tusk is asbestos free.

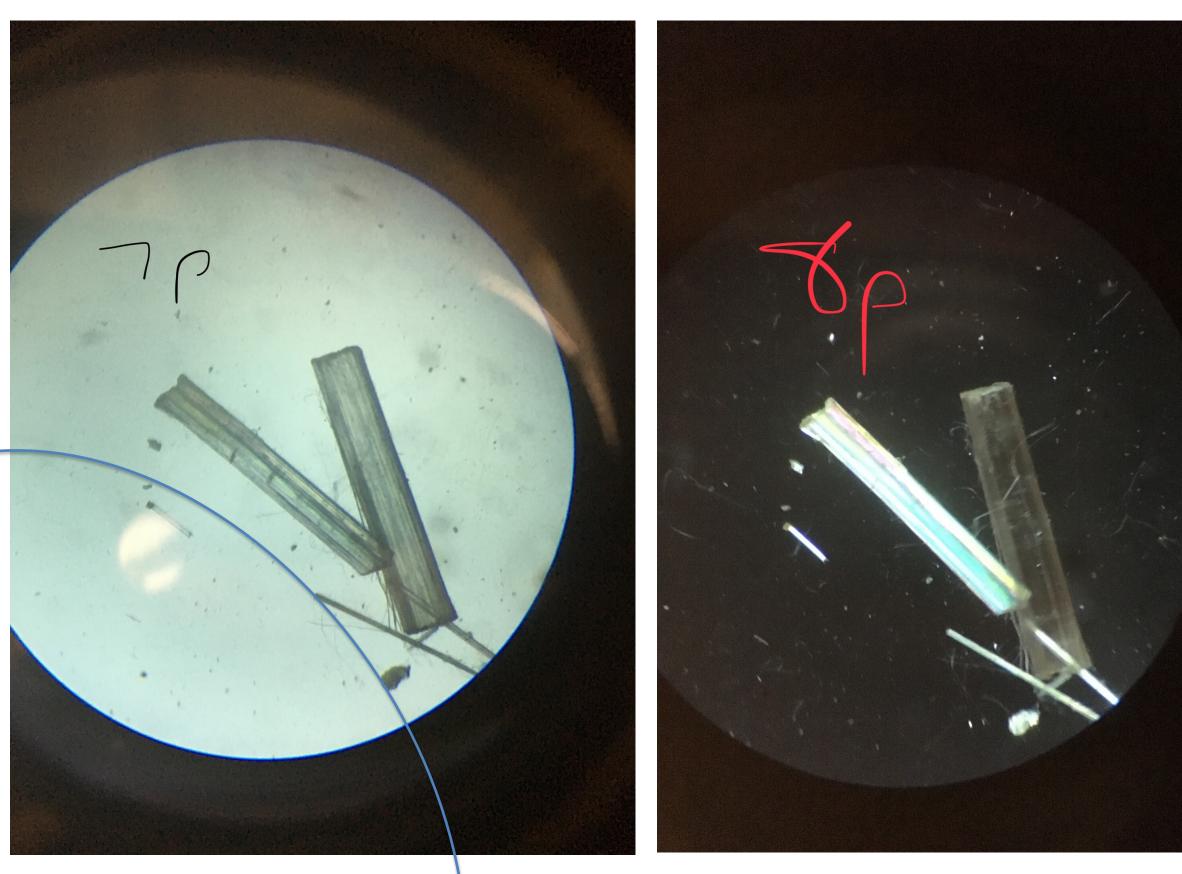
Polarized light microscopes are designed to observe samples that are visible due to their antistrophic nature. Two polarizing filters are positioned in the light path: one before the specimen (the polarizer) and one between the sample and the observation tubes (the analyzer). The light that passes through the polarizer is limited to the light waves vibrating along the polarizing axis to completely pass through. The analyzer then is inserted at a 90-degree angle to the axis of the polarizer, and no light passes through. When the filters are adjusted, light passes through and different aspects of the specimen will be shown. Antistrophic samples reflect the light making it appear brighter than isotropic samples. Antistrophic samples also have a range of refractive indices and act as beam splitters for light rays.⁶ • PLM is an extremely classic method for analyzing asbestos.⁷

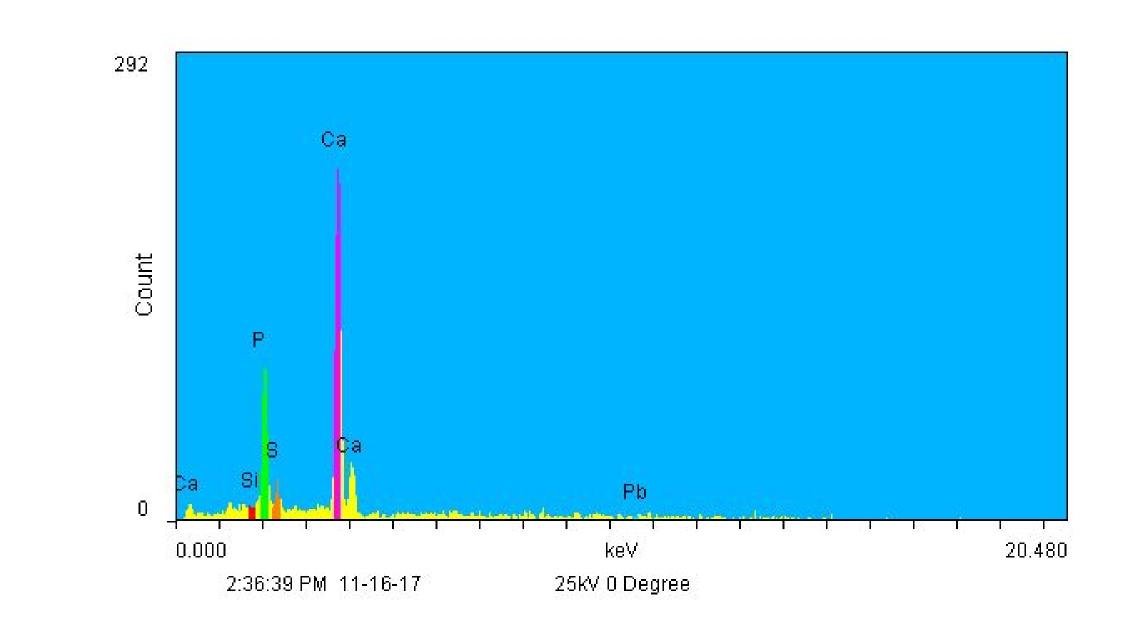
• No silicon was detected on the EDX (spectrum above), confirming the negativity of the results

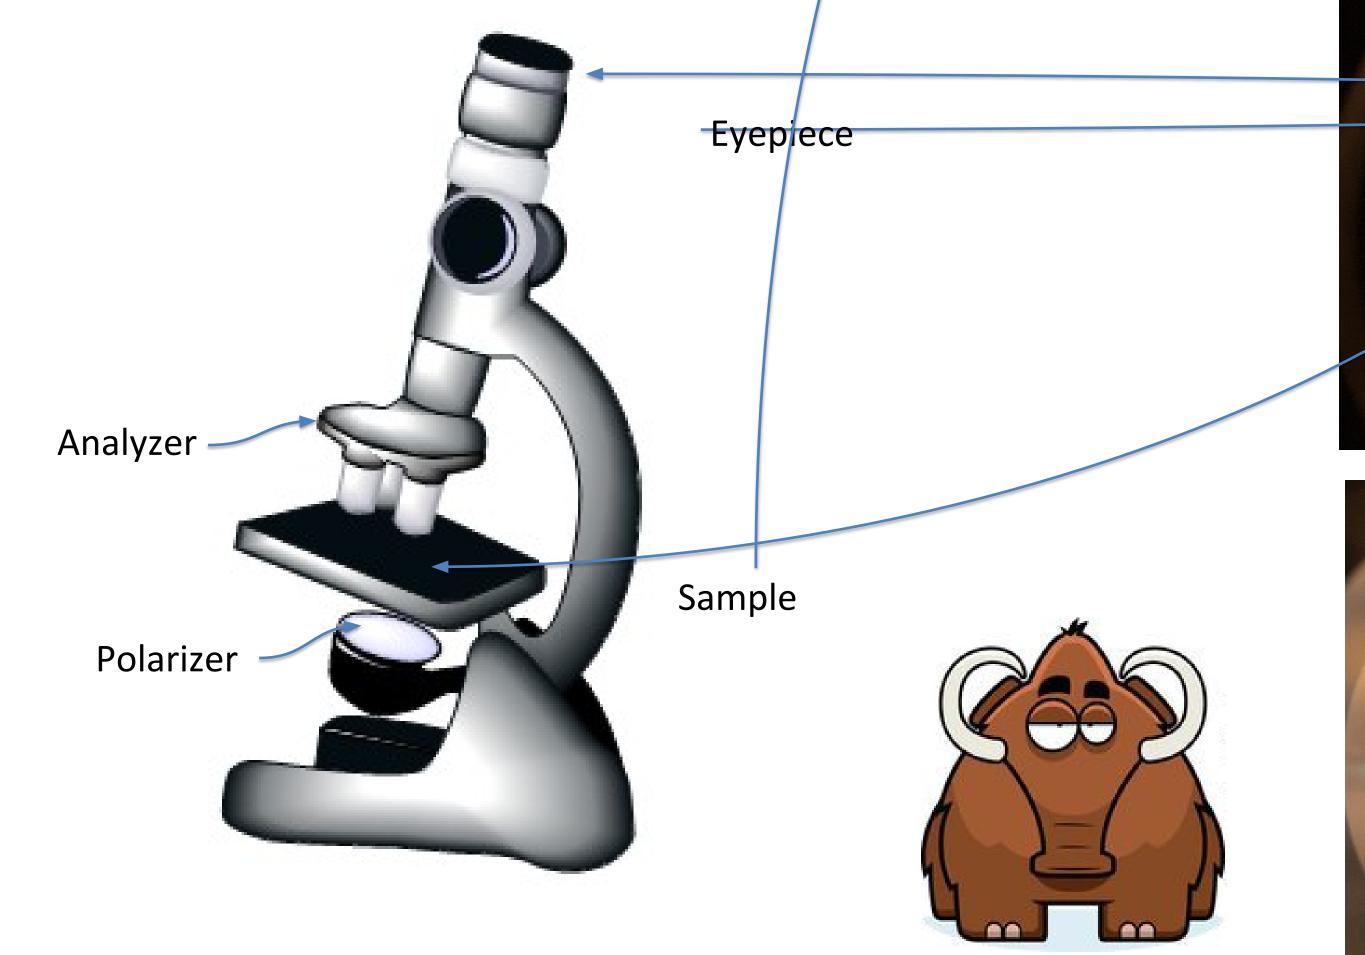
- After pure samples were analyzed, samples of tusk plaster were analyzed using the same setup. Three separate samples were analyzed to comply with OSHA guidelines
- Below: samples analyzed from plaster. Left is not polarized, and right is polarized
