STRUCTURAL ANALYSIS AND MAPPING OF HISTORICAL TOMBS IN AHLAT DISTRICT (BITLIS, TURKEY)

Scientific paper / Znanstveni rad

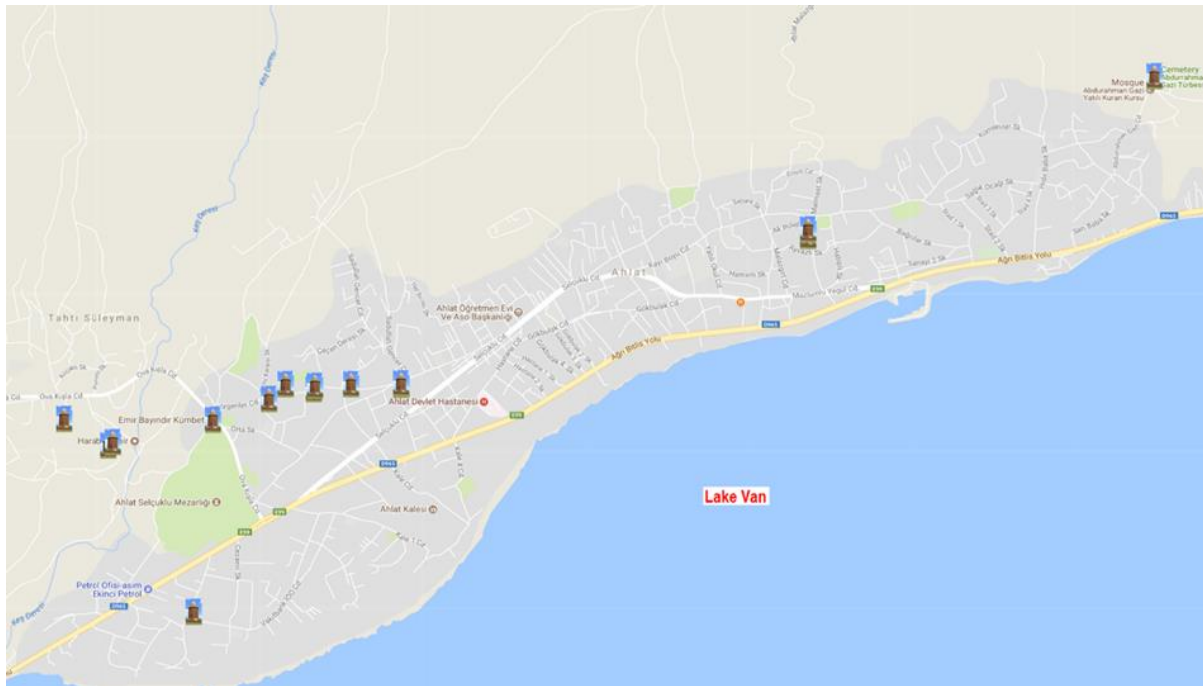
Figure 2 Presentation of the tombs in the Ahlat district

Maps can be thematic or topographical with different scales for general information, culture, and usage. Mapping is one of the most important aspects of civil engineering applications. It requires a sufficient and necessary number of parameters to be expressed in numerical terms [24, 25]. According to the determined ID numbers, the geometrical positions in Point Sense were made separately for each group. During the mapping process, the tombs in the Ahlat district, which were the subjects of this study, were considered. For mapping, it is necessary to determine the boundaries and obtain the geometrical details. The obtained historical building location data were transferred to the computer. Determination of the geometrical positions of the structures and their mapping allows their healthy monitoring. Additionally, it will allow local and foreign tourists to visit through alternate routes without any guidance. Route selection may be planned more easily. The map of the subject, the Ahlat tombs, is the first comprehensive tombs map prepared for the district (Figure 2). The fact that some tombs are very close to each other owing to their geometrical position caused them to overlap on the map. At the town entrance of Ahlat, densities appear concentrated. Thirteen of the fifteen tombs are very close to each other. Table 1 shows some characteristics of the tombs examined in the study.

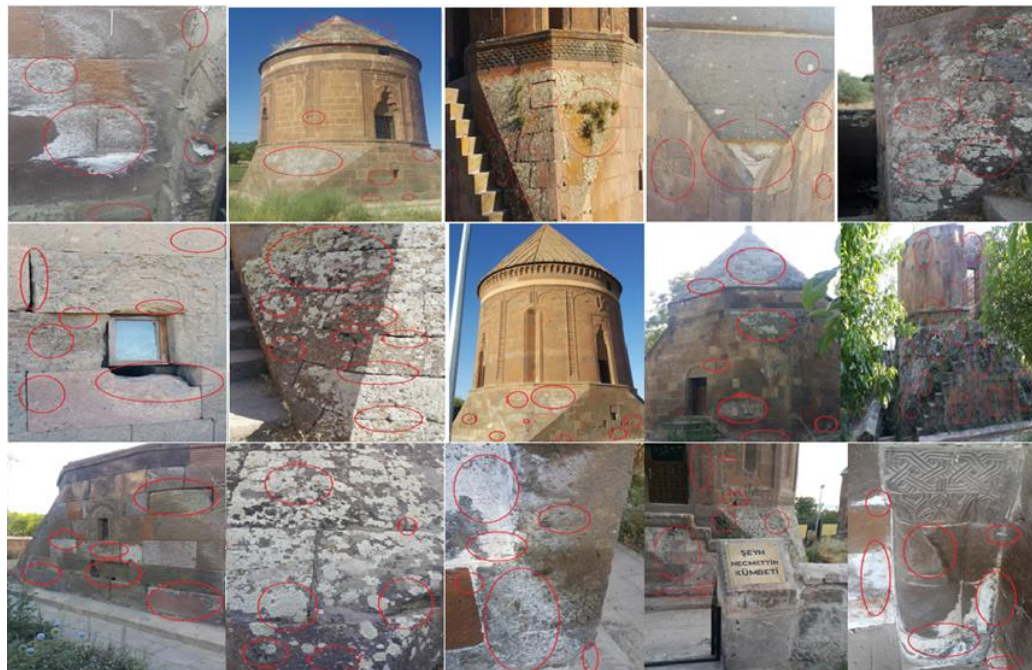
Figure 4 Different types of damages in different tombs

The stones obtained from the stone quarries in the Ahlat district, called the Ahlat stone, were used in the buildings after cutting processes for different purposes. One of the general characteristics of the Ahlat stone is discoloration and color change due to effects of the natural conditions with time. Discoloration and color change were observed in almost all of the examined structures. The area where the buildings are located experiences heavy snow and rain. Excessive rainfall has led to calcification in some of the investigated structures. Additionally, the use of excess water in garden irrigations in the settlements close to the structures has negatively impacted these structures. Some of the stones used in the structure have abrasions and ruptures. Abrasions were observed in some of the joints used for joining the stones. Sealing of joints was not observed. The joints were constructed with the method of diversion to increase the engagement of the stones forming the wall under loads. As the ground properties were good in the examined buildings, it was observed that there were almost no settling effects with time. A basement floor model was designed for each structure. A section similar to the basement floor was built in most of the tombs. All the tombs had been affected by several natural disasters. Lake Van Basin, where the district is located, has a risky potential in terms of seismicity. In the basin, there have been devastating earthquakes with $M > 6$ in Ahlat (1881), Malazgirt (1903), Erçiş (1941), Çaldıran (1976), and Van (2011). These earthquakes had affected all the examined structures. Although they were exposed to these devastating earthquakes, they were not greatly damaged. This shows how advanced the construction technologies of these structures were. The existence of vegetative formations appears clearly in the main part of the investigated buildings, in addition to different parts of the structure, however it did not create a very big damage. Repairs and renovations had been conducted in the past in all the structures that were examined, which is an important step in maintaining the authenticity of the structures and extending their life. The maintenance and restoration of these structures is not random. These processes are designed and decided by relevant institutions to be held at appropriate times. One of the damages caused by the people included writing their names around the tombs irresponsibly. Additionally, the use of drilling materials like nails to install doors and windows caused different damages. All tombs were built in the masonry building style. The structures were built on a square or a rectangular base usually consisting one compartment and were symmetrically constructed. No damage in the structural system elements constituting the structure was found. No deformation was observed in the horizontal or the vertical direction. In addition to the dome-shaped shelters, only a very small portion had flat roofs. For example, in the Dede Maksut Tomb, to make the roof of the building invisible from outside, a device consisting the local stones called a raft was placed around the roof covering. Additionally, in the section described as the roof, water troughs called *çoratan* in Turkish were placed around the floor. The purpose of using *çoratan*s is to provide drainage for the precipitation water from the roof. One of the reasons for destruction is treasure hunting and theft of building stones. The stones used in these structures are generally used in garden masonry works and transportation of the smuggled historical artifacts. The observations form for the damages occurred in all the tombs considered, are shown in Table 2. The ID numbers given in the previous section were used. The images of different types of damages and destructions in the tombs are shown in Figure 4.

Parameter/Tomb ID	1	2	3	4	5	6	7	8	9	10	11	12	13	14	15
Distortion with time effect	X	X	X	X	X	X	X	X	X	X	X	X	X	X	X
Impact of natural conditions	X	X	X	X	X	X	X	X	X	X	X	X	X	X	X
Destruction by people	X	X	X	X	X	X	X	X	X	X		X	X		X
Active use of structure	X	X	X	X	X	X	X	X	X	X	X	X	X	X	X
Neglect									X						
Is it originally preserved?	X	X	X	X	X	X	X	X	X	X	X	X	X	X	X
Dislocation of the building stones										X					
Breaking and splitting			X	X		X		X	X	X	X	X	X		X
Calcification of surfaces			X	X	X	X	X	X	X	X	X	X	X		X
Wear of wall joints					X		X		X		X		X		X
Seaweeds and vegetative formations	X	X	X	X	X	X	X	X	X	X	X	X	X	X	X
Repair or not	X	X	X	X	X	X	X		X	X	X	X	X	X	X
The presence of germinated soil layer										X					
Cracks	X	X	X	X	X		X	X	X	X	X	X	X		X
Blackening and decay on surfaces	X	X	X	X	X	X	X	X	X	X	X	X	X	X	X
Mass loss									X						
Sealing of joints												X			
Cracking due to rootstocks of plants							X					X

Existence of water entering the structure						X				X			X		
Freezing– thawing effect	X	X	X	X	X	X	X	X	X	X	X	X	X		X
Effect of the surrounding building	X	X	X	X	X	X	X	X	X	X	X	X	X		X
Color cast and color change	X	X	X	X	X	X	X	X	X	X	X	X	X	X	X

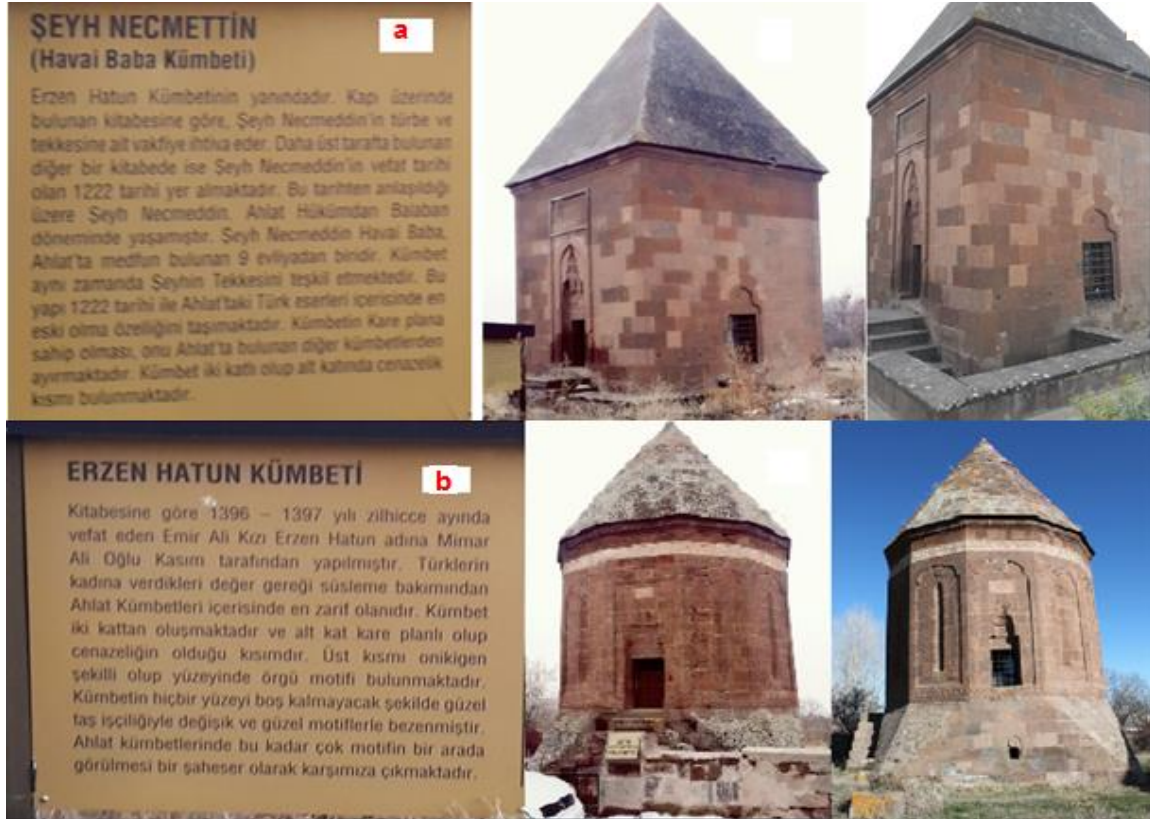
Figure 5 Images and inscription of the tombs of the study (a) Sheikh Necmeddin (b) Erzen Hatun

After observation-based structural analysis for all the tombs, detailed structural analyses were conducted for two tombs with different architectural styles that could represent the others. The tombs considered in this study belong to Sheikh Necmettin and Erzen Hatun. The Sheikh Necmettin Tomb was built on a 5.10×5.10 m square plan with a total height of 10.53 m. The Erzen Hatun Tomb was built on a 6.60×6.60 m square plan with a height of 13.02 m. The visuals of and the inscriptions on the tombs are shown in Figure 5.

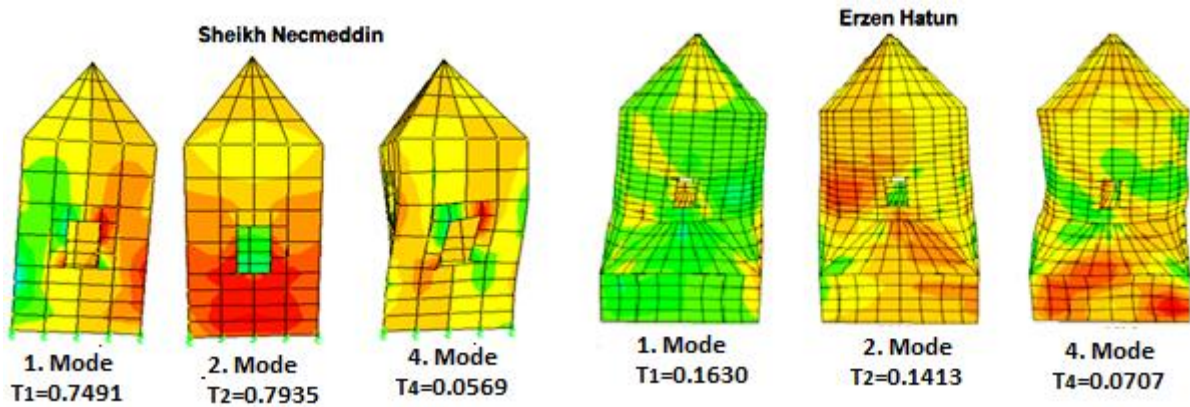
Figure 9 Modes and period values obtained for the tomb models

The prepared finite element models consisted of 261 nodes and 238 shell elements for the Sheikh Necmeddin Tomb, and 896 nodes and 815 shell elements for the Erzen Hatun Tomb. The dynamic properties of the tombs were determined by modal analysis. While the modal analysis was being performed, the first 18 modes were considered for these tombs. In the model, the modes higher than 80% of the mass participation rates in the X and Y directions were taken into consideration. Therefore, it was observed that taking more modes did not have much effect. According to the results of the model modal analysis of the effective modes of natural vibration periods, the mass participation rates are shown in Table 4, and the mode shapes are shown in Figure 9.

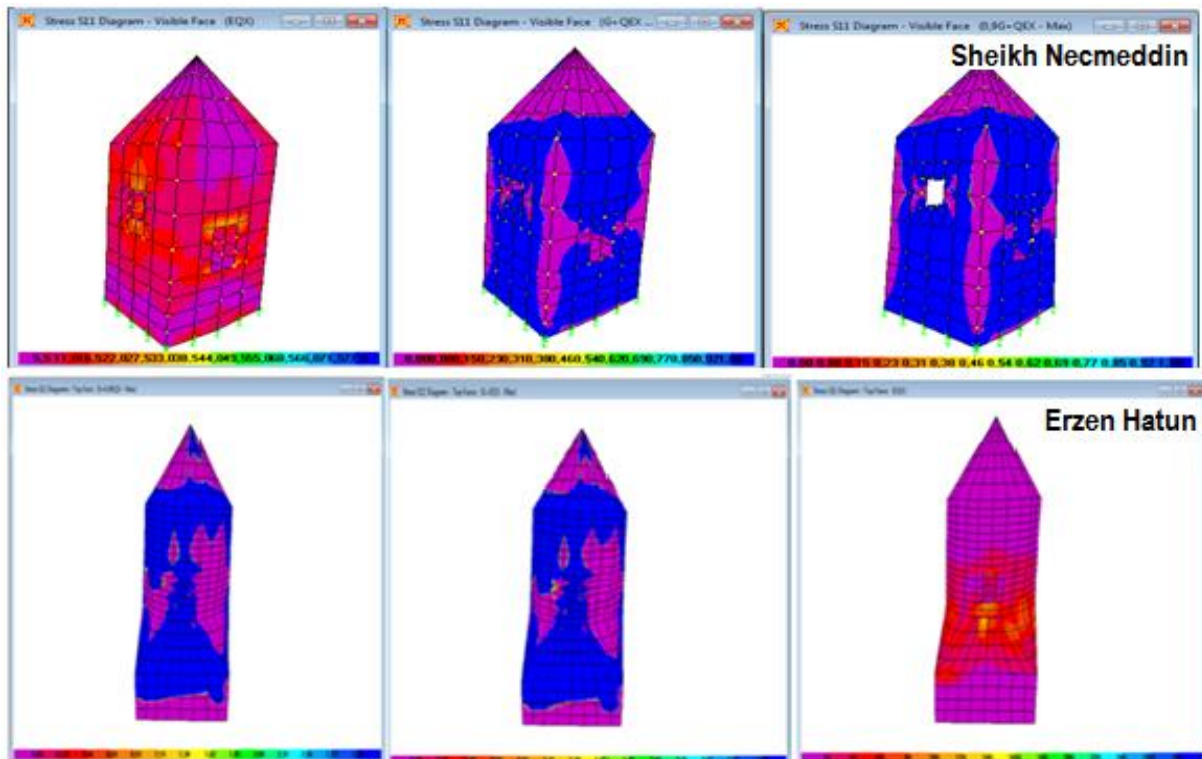
Figure 10 S11 stress values for different loading conditions

Static, dynamic, and earthquake loads were considered for tensile calculations. Static load calculation was performed by the software based on the material properties. The defined spectrum was utilized for the earthquake loads. For earthquake loads, two different directions of loads were defined as EQx and EQy. Using these values, calculations were made for different load combinations. The stress diagrams that were obtained based on the different loading conditions for S11, which were the vertical stress values in the X direction in the software, are shown in Figure 10.
