IBPC2018

Rain-tightness of door sill sealing

Lars Gullbrekken^{1,*}, Steinar Grynning¹

¹ Department of Materials and Structures, SINTEF Building and Infrastructure, Trondheim, Norway

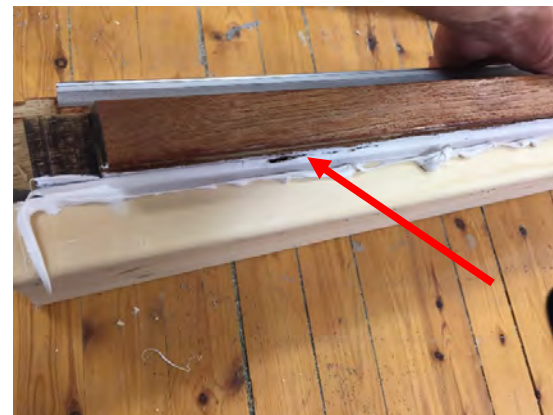
Figure 8. Small defects in the silicon compound was found by closer inspection.

Challenges related to the workmanship of the application of the silicon compound was encountered even in a controlled laboratory environment and when carried out by qualified craftsmen. When applying the sealing compound as carefully as possible (see Figure 7), small faults were found by close inspection, as seen in Figure 8.

The workmanship of the sealing of the joint was challenging due to the geometry of the detail. Even if the silicon sealant was carefully applied, voids between the silicon sealant and the door sill were found when inspecting closely. When improving the faults, the test showed that the joints were surprisingly tight. Most of the tests showed no water leakages at 600 Pa pressure difference. According to the SINTEF Building Research design guidelines this is *high performance*. However, leakages were observed at lower pressure difference for the sills with no silicon sealing and at faults in the silicon sealing. This indicates that the detail is vulnerable and that great care should be taken when applying the silicon sealant. The performance of the sealed joint is depending on the workmanship of the craftsmen. In order to further improve the robustness of the detail there is a need to introduce sealing methods which ensure high performance more independently of workmanship.
