7th International Building Physics Conference

IBPC2018

Campus as a Lab for Computer Vision-based Heat Mapping Drones: A Case Study for Multiple Building Envelope Inspection using Unmanned Aerial Systems (UAS)

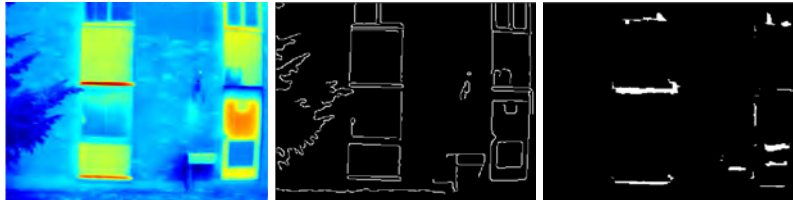
a) Successful infiltration detection.

b) Successful thermal bridge detection.

Figure 4. Experimental results from various sides of the inspected buildings. In each triplet, the left are IR scenes, middle are edge detection, and right are the segmented leakage regions.

We tested the developed algorithm on 149 thermal images that contain a total of 1018 heat leakage regions. From these leakage regions, the algorithm successfully detects 751 of them, and missed 267 actual thermal anomaly regions. The workflow also reported 237 regions that are considered false positives. This resulted in precision and recall rates of 76% and 74%, respectively. These rates will increase as the algorithm is further developed to match expert identification of anomalies. Figure 4 highlights a series of sample heat leakage images and their corresponding detection results.
