FERNANDES, A. P. B. & RODRIGUES, J. D. (2008) - Stone consolidation experiments in rock art outcrops at the Côa Valley Archaeological Park, Portugal. In *Rodrigues, J. & Mimoso, J. M., eds., Stone consolidation in cultural heritage: Research and practice*. Lisboa: LNEC, p. 111-120

# Stone consolidation experiments in rock art outcrops at the Côa Valley Archaeological Park, Portugal

*SUMMARY: The Côa Valley Archaeological Park (PAVC) is home to an impressive assembly of prehistoric open-air rock art. To evaluate the possibilities of carrying out conservation work in the rock art panels, experimental interventions in non-engraved schist outcrops were commissioned in 2003 to three different Portuguese stone conservation companies. Together with another experimental intervention done in 1995 when a dam was being built in the Côa River, we propose to assess the stone consolidation materials and techniques that were used on both occasions as well as their adaptation and evolution in the overall environment where they were applied.*

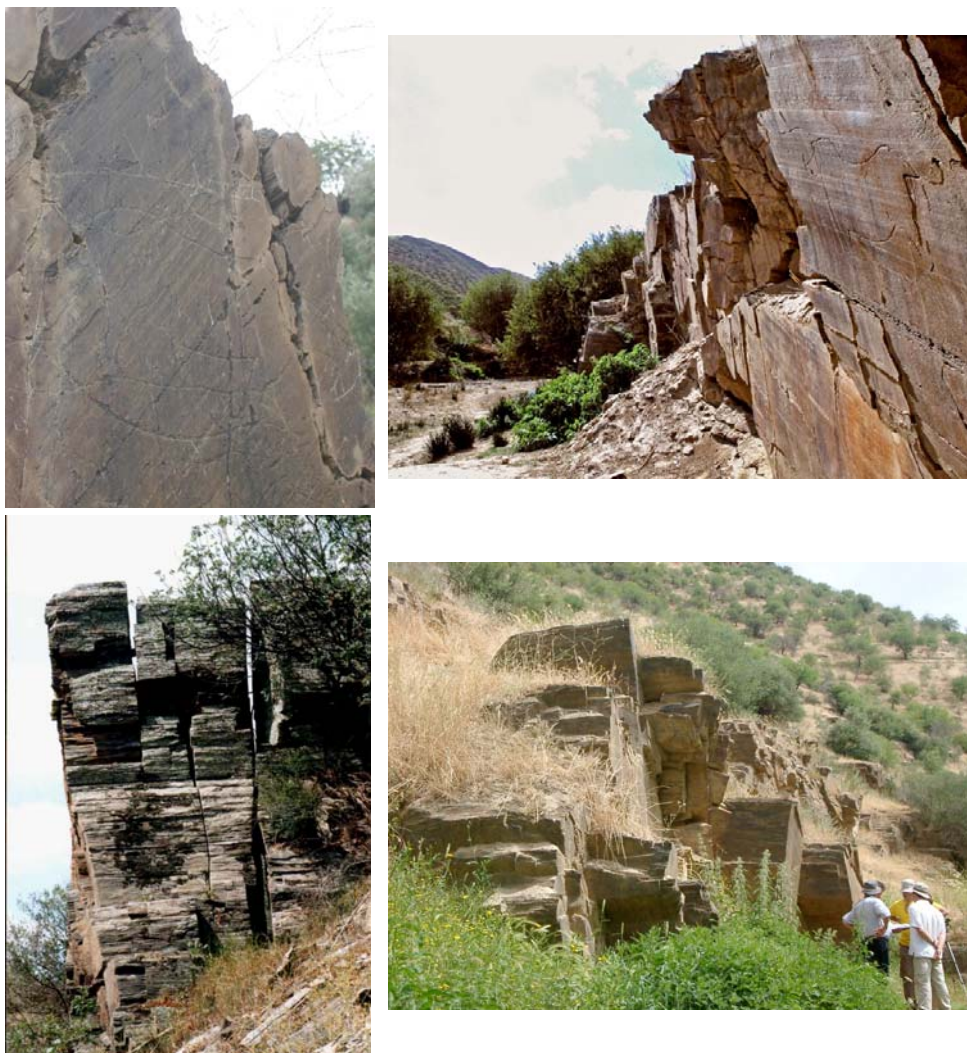
Figure 1 - Aspects of the rock art panels and their geomorphologic setting. Engraved surfaces (above) are well developed and very smooth, constituting perfect panels. Most panels are engraved in surfaces from a same and very penetrative joint family (below) that runs for long distances in sub-parallel orientation. Notice the sharp edges and the dismantling process progressing from the borders inwards directly affecting the engravings

The engravings were inscribed onto moderately metamorphic schist outcrops of very regular surfaces resulting from well-developed tectonic joints (Fig.1). The rock high resistance to weathering allowed for the conservation of such delicate engraved motifs for a very long period; in fact, some of the most ancient ones were dated back to some 25000 years BP<sup>3</sup>.

Schists are the main lithotype present in the Côa Valley region. They are fine-grained and very compact, sometimes presenting intercalated thin layers of slightly coarser varieties of greywacke-type. In the vast majority of cases, the engravings were incised upon the surfaces of very smooth tectonic joints (Fig. 1). These all belong to the same tectonic family with large continuity running in sub-parallel surfaces for very long distances.

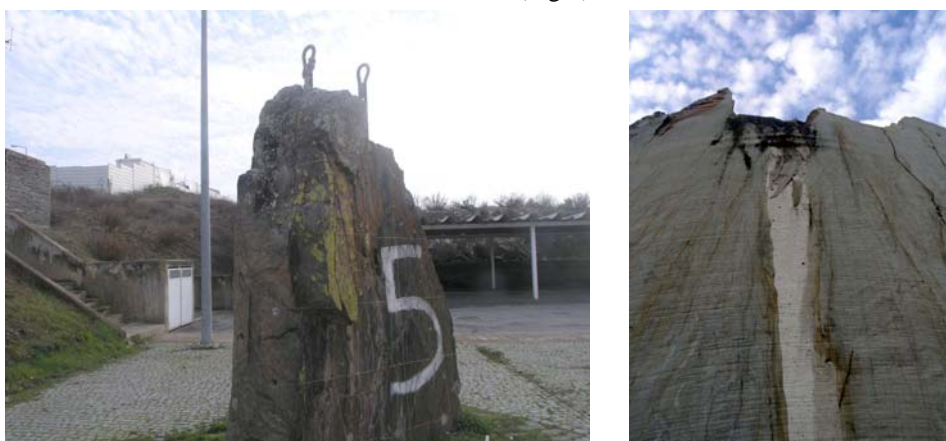
Figure 2 - Aspects of the translocated block. Notice on the right the saw cut surface and the mortar filling of the rock joint

A detailed analysis of the dislocated block reveals that it is in a good conservation condition. There are no apparent losses of fragments, the materials used to consolidate the weaker parts of the block are still in place and no harmful effects were identified in the adjacent rock. As far as we can evaluate, the intervention carried out more than a decade ago as definitely contributed to the stability of the block.

A close examination revealed that the epoxy material has turned yellowish and opaque, constituting an aggressive aesthetical change. The used mortars show no major alteration, both in colour and texture. On the other hand, mortar and resin still form separate but coherent solid unities, with no visible loss of fragments. Their strengths seem to have not significantly changed, as well.

The displacement action was executed by SWECO, a Swedish company that has in its curriculum the relocation of the Temple of Ramses in Abu Simbel threatened by the construction, in the 1950's, of the Assuam dam. After studying the general conservation condition of the un-engraved block to be moved as well as its geomorphologic features (mainly the orientation and width of fractures), epoxy resin and what was described as "special cement"<sup>10</sup> – probably, by looking at it now, a reinforced Portland based mortar – was injected in the existing fractures. In a second step diamond drill bits were used to perforate several openings that ran across the total width of the block. Steel extendable bars were then introduced throughout these openings and sealed with epoxy resin and Portland cement. Two big hook-like bars were also fitted on the top of the block allowing a crane to move it once it had been cut away from its core. Finally, a diamond saw cutter separated the (6 tons, 2,5 m high, 1,5 m long and 60 cm width) block from the original bedrock, allowing it to be moved to the location where it now rests (Fig.2).

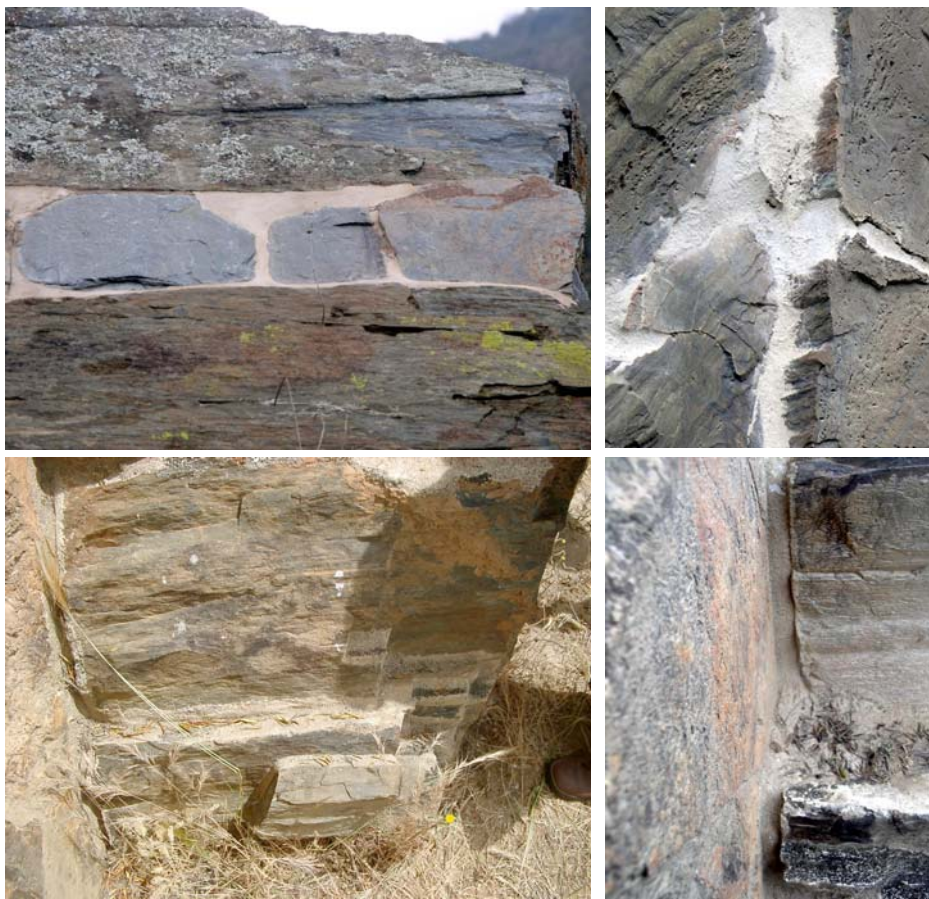
Figure 3 - Aspects of solutions proposed by the contractors. Bridging a large gap to avoid excessive water infiltration (upper left); details of the mortar filling of wide fracture gaps (upper right and lower left) and detail of the filled gap after a flooding episode (lower right).

Contractors were asked to accurately identify and map the degradation forms and to carry out a simple cleaning operation for better identification of the relevant problems to address. The differences between the sites and the composition of the teams lead companies to follow distinct action paths, an approach that revealed an interesting cause-effect relation. A few examples of the solutions developed by the contractors are shown in Fig. 3.

The other two interventions followed a more incisive approach, by directly addressing the treatment of fractures present on the surface of the outcrops. One of the mortars used in Canada do Inferno reveals some kind of biological colonization with areas progressively acquiring a green colour. In the Ribeira de Piscos site, the intervened outcrop was covered, at the very end of the intervention, with loose small schist fragments, grinded from slabs that were laying on the ground. The objective was to give a more natural finishing touch to the outcrop. Although they were slightly bonded with rock, most of these fragments have already disappeared.

One of the objectives of the Ribeira de Piscos intervention was also that occasional flooding would help to give a more natural appearance to the treated outcrop. Floods deposit sediments that in turn became the needed soil for smaller, in a first phase, and then higher plants to root. Since the trial interventions were executed at least one major flood has occurred. However, this flood has not lasted for too long, and, consequently, the amount of sediment deposited was minimal. Therefore, the Ribeira de Piscos outcrop still possesses a somewhat unnatural looking. However, assessing the behaviour of the applied materials and of the treated outcrops when exposed to such a stressful event was also one of the objectives of the interventions. Of the three interventions only the Canada do Inferno outcrop was not located in an inundation area. After the end of the flood and consequential lowering of water levels, an analysis of the other two sites revealed that both treated outcrops behaved well and that no loss of materials, both in the rock and applied materials.
