**DIFFERENT BEHAVIOUR AND  
MANAGEMENT OF TWO LITTORAL  
DUNES IN SOUTHERN SPAIN**

***P. Lopez-Garcia, M. Navarro, J. Roman- Sierra,  
G. Gomez-Pina, A. Contreras, R. Martell  
and J. J. Muñoz-Perez***

Coastal Engineering Research Group, Universidad de Cadiz,  
Puerto Real, Cadiz, Spain

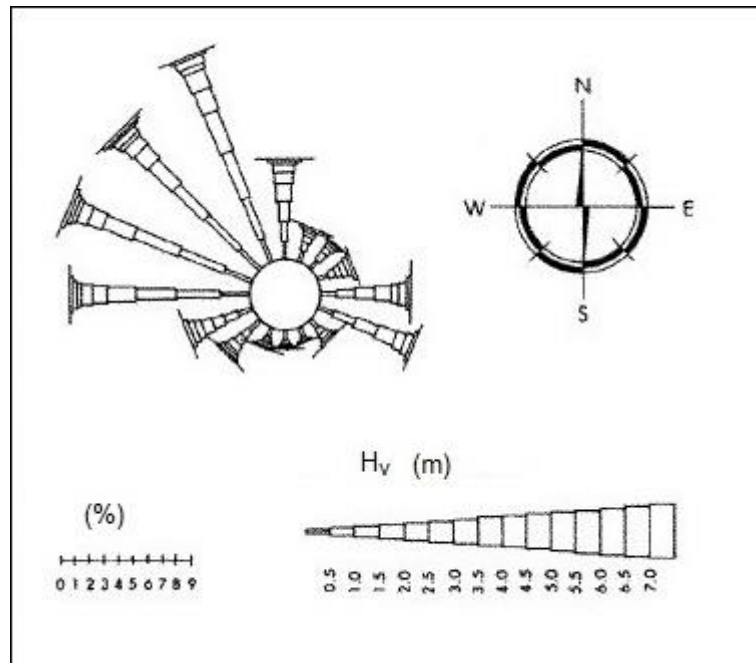
Figure 2. Wave direction rose diagram for the study area. Where  $H_v$  is the significant wave height.

The littoral zone is mainly affected by winds and waves (both “sea” and “swell” wave conditions) approaching from the SW to WNW (Figure 2). Atlantic winds blowing from the W and WSW are responsible for most of the important winter storms in the area.

Waves approach the coast mainly from the west (45% of the annual frequency), with an average height of less than 1 m and a significant wave height associated with storms of 3 m ([www.puertos.es](http://www.puertos.es)).

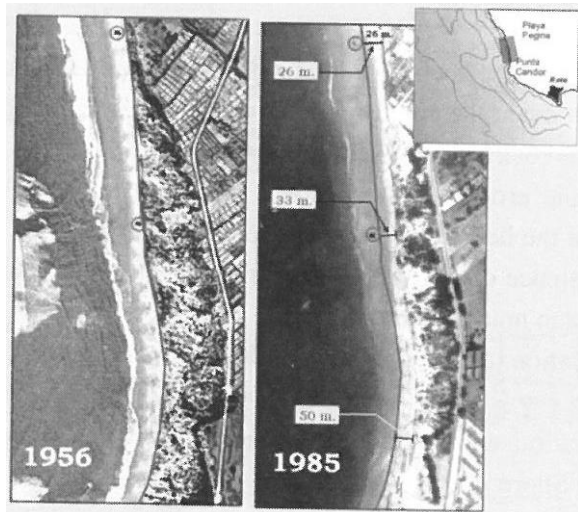
Figure 3. Coastline retreat within a 30-year period.

As a result, the study area and the dune system located at its northern end present very high erosion rates, with a retreat of 40 m in the last 30 years (Muñoz-Perez & Enriquez, 1998).

- The presence of reef areas that affect the beach morphodynamics as they prevent the connection between the beach and the sediment below the rocky platform.
- High dune erosion rates (0.5 – 1 m retreat per year) due to the nature of the beach and cliff sediment (Figure 3).
- The existence of environmentally rich rocky areas to be preserved from beach nourishment projects.
- The location of still-preserved dunes under natural geological erosion.
- Urbanization and dune occupation prior to the approval of the Spanish Shore Act in 1988.
- The high degree of tourism development on an eroded coastline.

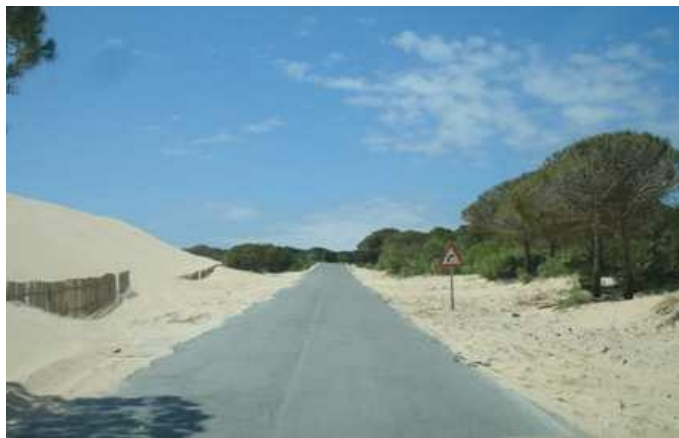
Figure 5. Encroachment of the Punta Paloma road by the Valdevaqueros mobile dune.

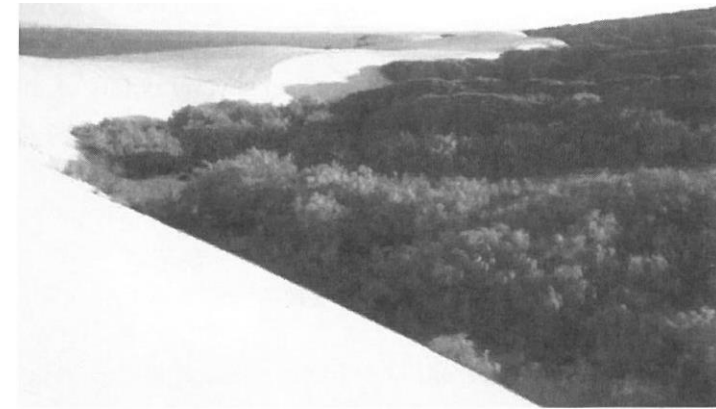
Figure 6. View of the dunes invading the pine grove.

Although several restoration works have been carried out by the Coastal Department in recent years, the special wind conditions that affect the dunes do not facilitate control of their mobility. Dune restoration works started with the reshaping of the dune profile in order to obtain a better aerodynamic stability complimented by the experimental use of wooden fences to decrease erosive surface patterns. Also, experimental transplanted vegetation techniques (*Ammophila arenaria* sowing) were used in certain potentially stable areas. These experimental dune activities have been carried out several times in order to lessen the frequency of the occupation of the local Punta Paloma road by the mobile dunes, still an unsolved problem.

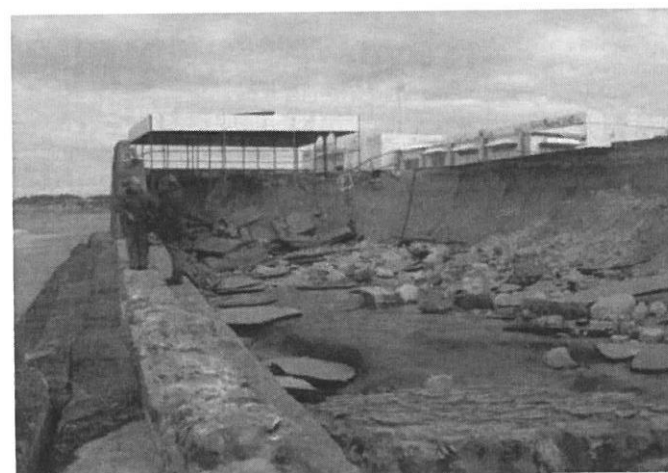
Figure 7. Destruction of Punta Candor protruding paved area after the storm of December 2004.

Several projects on this coastline have been successfully performed. One of the most important restoration works was applied in Punta Candor where erosion destroyed a protruding paved area in 2004 (Figure 7).

Wave processes have been analysed in order to understand local negative effects. The location of these concrete structures at the shoreface of the beach created a wave reflection from the wall, generating constructive interference of the reflected wave with the incident wave. The new wave produced by this interference, a standing wave, turned out to be more erosive than the original incident wave. When the incident wave was oblique to the wall, it produced lateral erosion. Storm waves can cause the eroded material to be swept out to sea by rip currents or to be transported down the coast by the oblique reflection of swell waves from these structures (Silvester & Hsu, 1997).

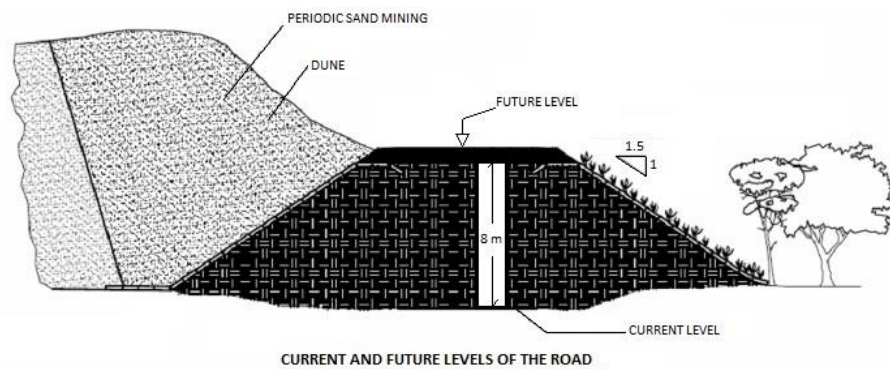
Figure 8. Alternative I. Elevation of the existing road.

The Coastal Department, after having analysed the problem that the continuous dune advance represents for the Mas Palomas inhabitants, has proposed three alternatives. Alternative I consists of changing the level of the affected zone of the existing road (Figure 8). The work would be performed along a road length of approximately 500 m and the road would be elevated by about 8 m. This would decrease the dune advancement, and sand extractions would be easier to carry out in the future.

Alternative I (elevation of the road) would assure road communication and would facilitate sand extraction and by-passing from the new road. On the other hand, dune advancement would not be completely stopped. As a result, this option would not allow the environment to reach an equilibrium situation. The cost of execution is estimated to be 4.6 million Euros.

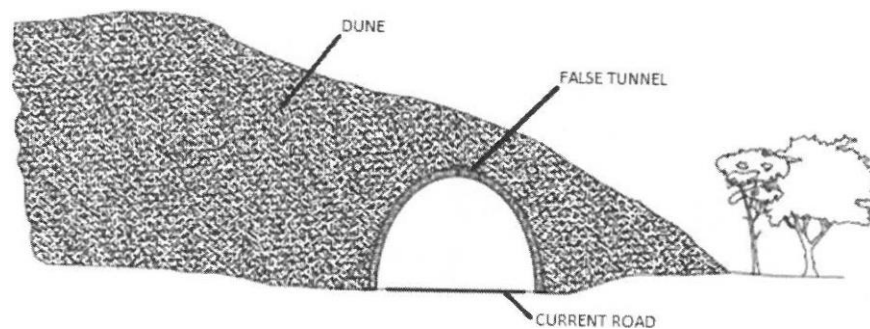
Figure 9. Alternative II. Creation of a false tunnel.

Alternative II is based on the protection of the road by the creation of a false tunnel (Figure 9). The aim is to allow the high dune advancement rate to continue without the necessity of sand extractions. As a result, dune natural development would not be interrupted.

Alternative II (creation of a false tunnel) would permit natural dune development without any technical interference over a long time period. However, the cost for this work is considered to be too high (5.2 million Euros) for a road with such a low traffic density.

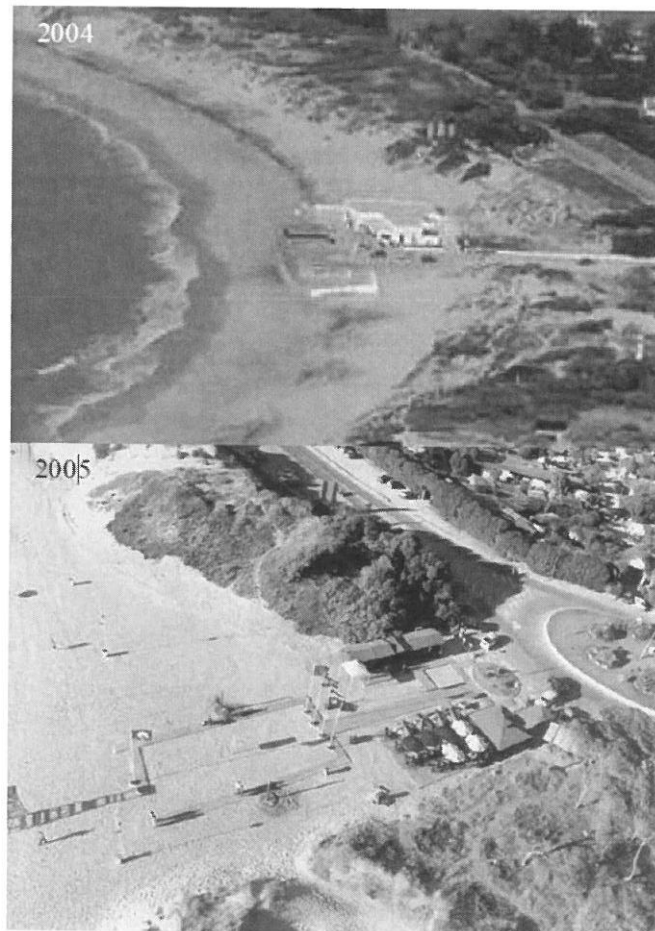
Figure 10. Comparison between pre- (2004) and post-restoration works (2005) at Punta Candor.

The first phase of the Punta Candor restoration was quickly completed over a 6-month period, as there were political interests due to the closeness of the local Town Hall elections (Figure 10). The new Punta Candor beach facilities finally achieved an EU blue flag thanks to this restoration project.

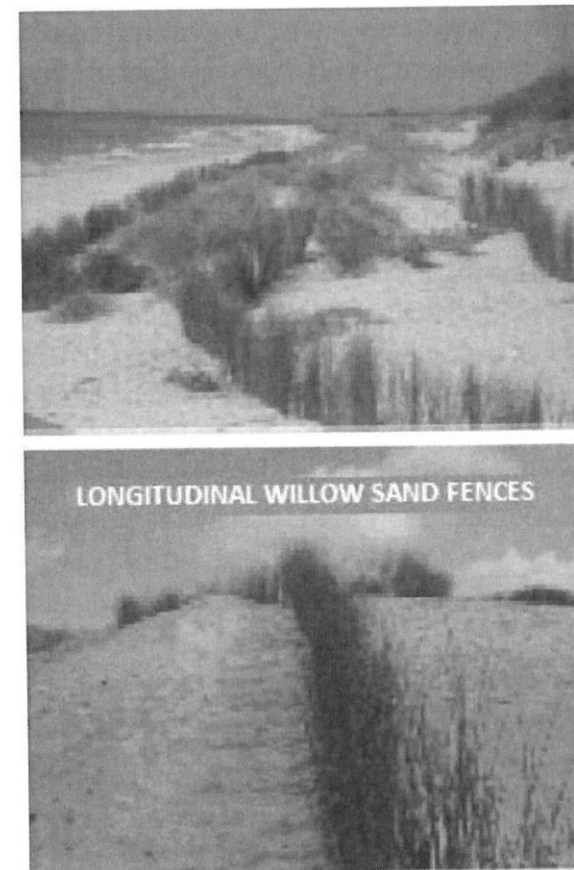
Figure 11 . Dune restoration works in Punta Candor.

Dune restoration work began in the spring of 2007 with dune replenishment from a sandpit and the installation of longitudinal willow fencing, and cross-walks (Figure 11). The new sand had a different colour from the natural Punta Candor dune sand, but this feature changed after 3

months, recovering its natural colour. To prevent ecological problems linked to the existence of chameleon nests, the installation of the willow sand fences was carried out by hand. All of these actuaciones allowed better access from the newly created parking area to the beach and provided for dune protection and stabilization as well as the sustainable use of the ecosystem.
