# Monitoring and Automatic Change Detection of Cultural Heritage Sites using Sentinels and Copernicus Contributing Missions

ESA Living Planet Symposium, 13.–17.05.2019, Milan

# Study site Palmyra

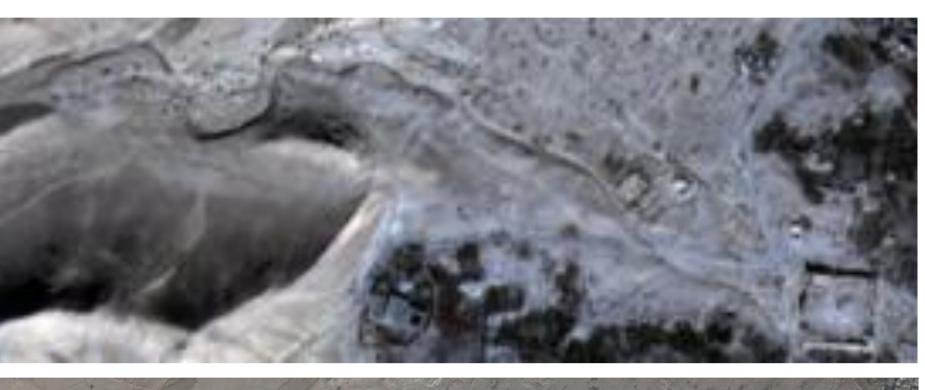
Sentinel-2, GSD 10 m, free, every 5 days

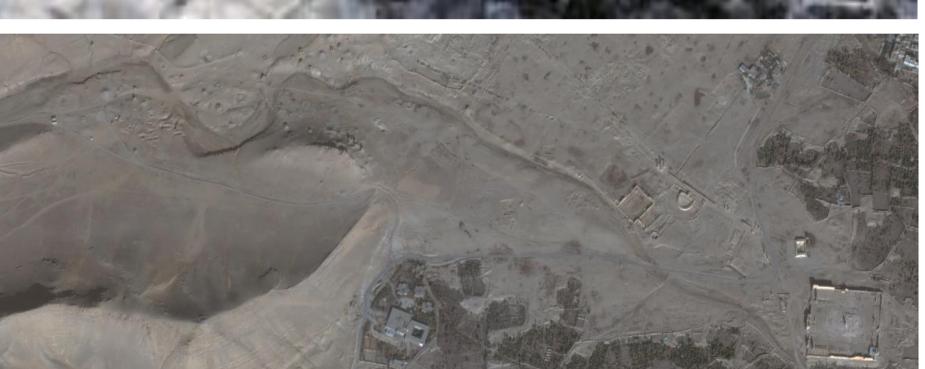
WorldView-2, GSD 0.5 m, 100 €/km<sup>2</sup>, min 100 km<sup>2</sup> tasked acquisition

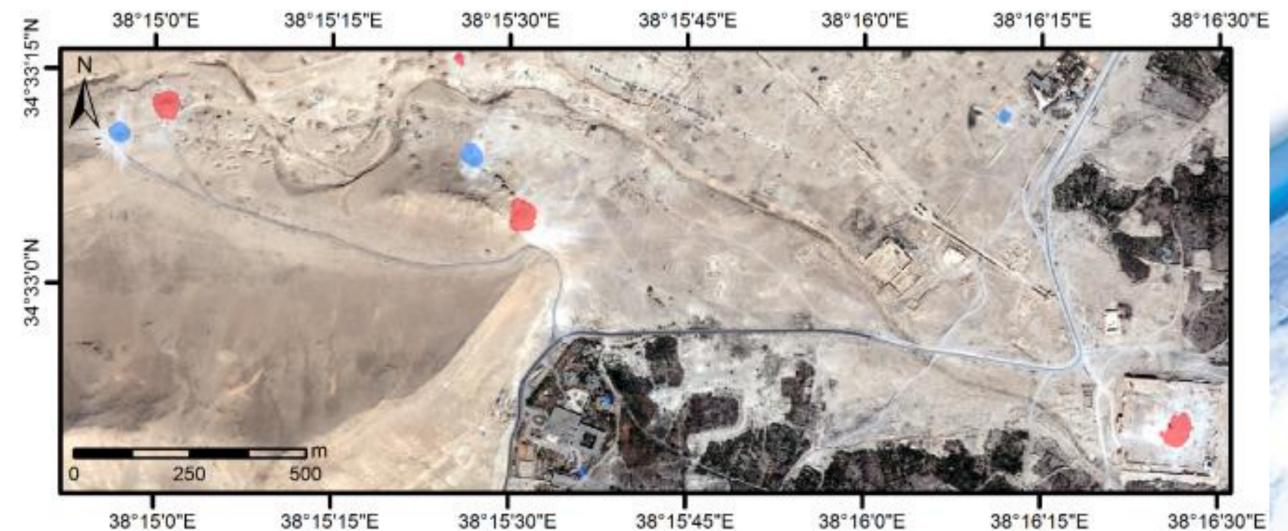
38°15'45"E **Automatically detected changed objects**

Automatic detection of differences in texture reveal consecutive damages, carried out until the 27th of August and the 2nd of September 2015 (highlighted in blue and red respectively). The texture of a target is defined by distribution of pixel values in its surroundings, which changes abruptly from smooth to rough whenever a structure is damaged or collapses, and when the shadows projected by a building disappear. Textural differences are robust to local variations in brightness values, and also to co-registration errors between the images due by misalignments and distortions.

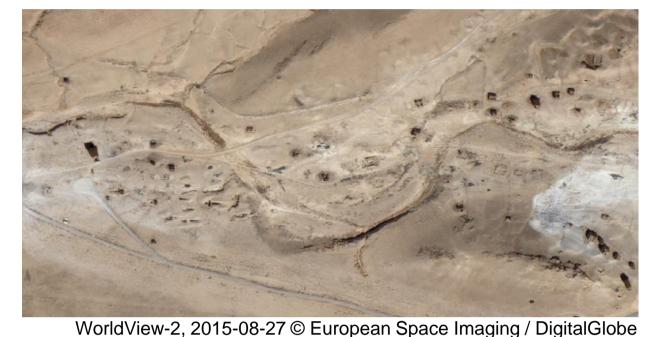
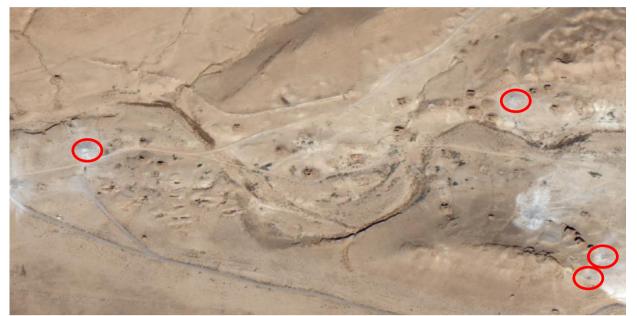
Palmyra, Tower Tombs of Elahbel

The damages are related to the temple of Bel, the temple of Balshamin and several 2000 years old tower tombs scattered in the ancient necropolis.

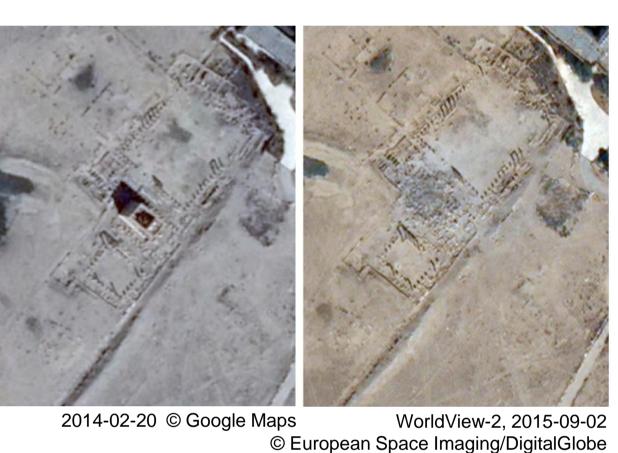
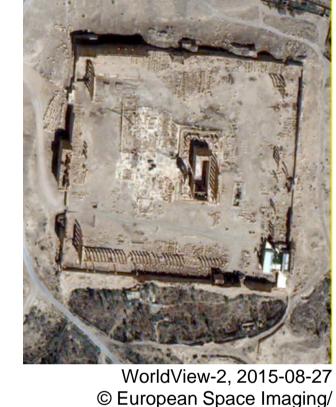
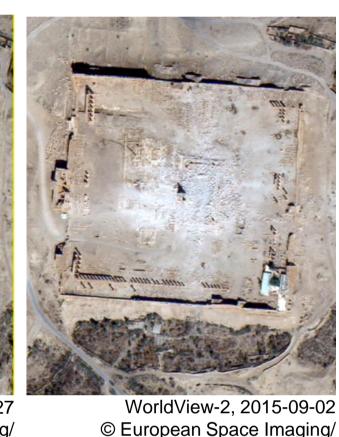
Palmyra, Baalshamin Temple destroyed by IS (24.08.2015)

Palmyra, Temple of Bel destroyed by IS (~30.08.2015)

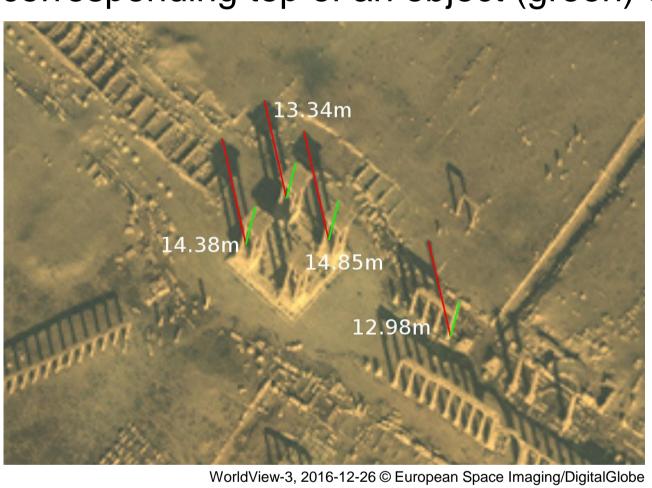
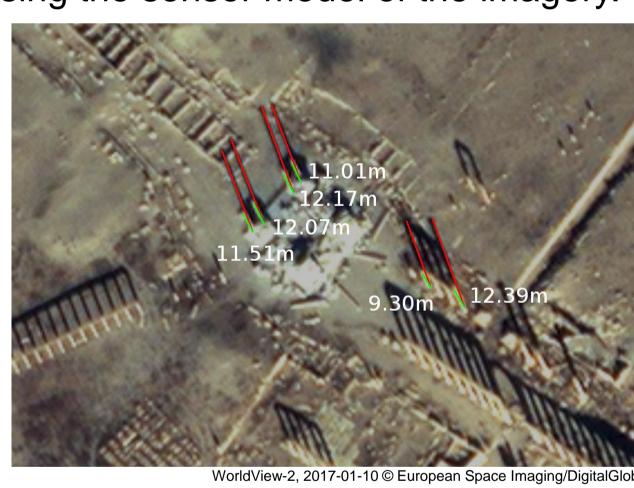
The Tetrapylon was destroyed later between 2016-12-26 and 2017-01-10 as shown in the images below. From the satellite imagery the height can be automatically derived just by marking the end of the shadow (red) and the corresponding top of an object (green) using the sensor model of the imagery.

Palmyra, Tetrapylon destroyed between 26.12.2016 and 10.01.2017
