Master Thesis - June 2018

Recycling fishing nets into concrete

Abstract

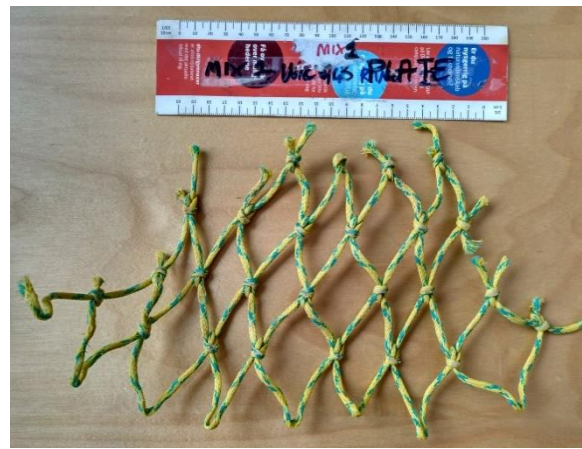
Figure 4.1. Pieces of discarded PE fishing nets.

(b) Piece of discarded 'yellow' PE fishing nets.

On figure 4.1., it is shown the two different fishing nets used for the test, differentiating between 'green' PE and 'yellow' PE fishing nets.

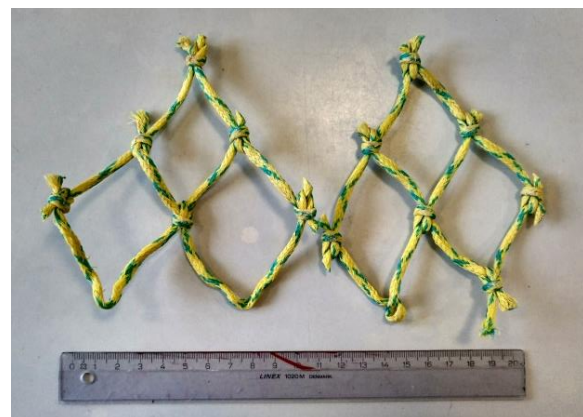
Figure 4.2. Small scale PE fishing nets.

(b) Small scale 'yellow' PE fishing nets.

The fishing nets were cut and measured for the small-scale experimentation as it is shown on figure 4.2. The small scale 'green' PE fishing nets were compound by six net meshes with an inside dimension of 30 mm and the small scale 'yellow' PE fishing nets were compound by three net meshes with an inside dimension of 75 mm.

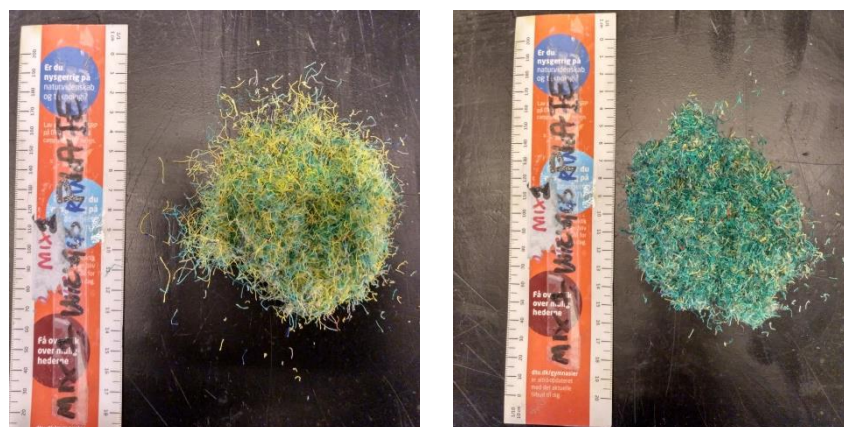
Cut fibers from used fishing nets made of PE and collected by the Danish company Plastix were also measured and used in the experimentation, differentiating between 'green' and 'yellow' PE fibers. Before starting the experiment these fibers were cleaned and sieved to ensure that only the longer fibers were added to the samples to make easy to evaluate the microplastics release results at the end. More information about the fibers is provided in section 9.1.

(a) PE 'yellow' fibers from discarded nets.

(b) PE 'green' fibers from discarded nets.

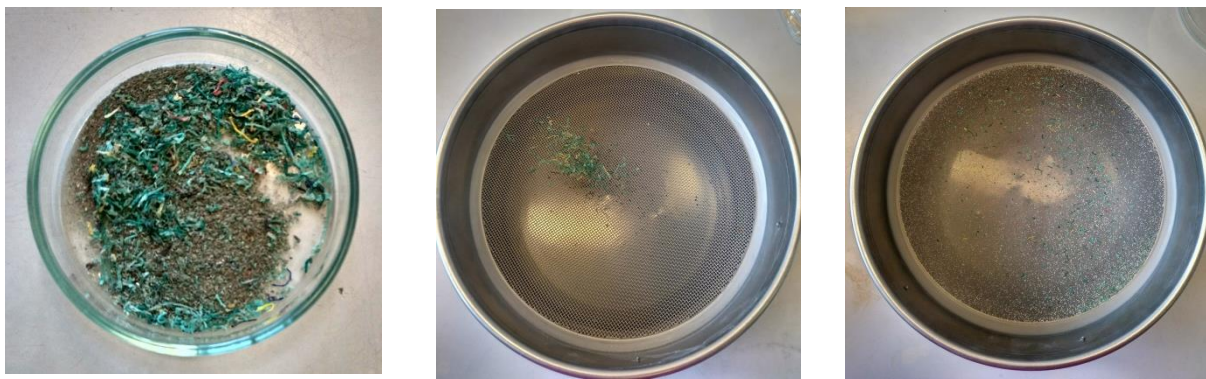
In order to analyze and characterize the materials coming together with the fibers, the impurities were classified in three categories depending on the size: particles and fibers bigger than 1 mm, particles and microplastics smaller than 1 mm but bigger than 250 μm and particles and microplastics smaller than 250 μm . The separation was done mechanically, using sieves of 1 mm and 250 μm holes' length.

(a) Sample of 60 gr of 'green' PE fibers and impurities.

(b) Sieve of 1 mm hole size.

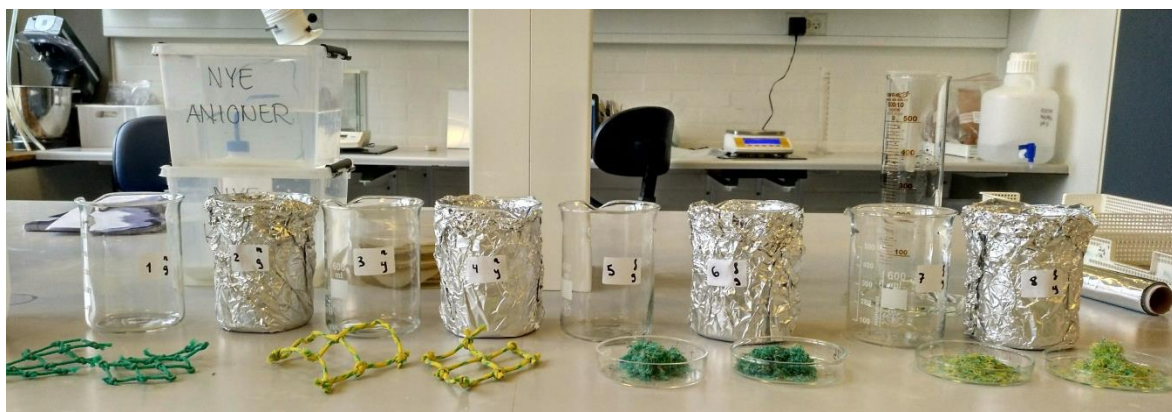
Figure 5.2. Preparation of the set-up for the microplastic release experimentation.

For each test, a 600 ml glass was used. To avoid sunlight exposition, aluminum paper was used to cover the samples considered under water surface, as it is shown on figure 5.2.

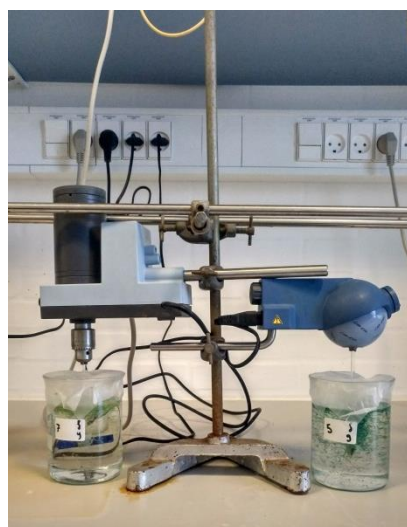
Figure 5.3. Set-up for the microplastic release experimentation.

The fibers and nets were deposited freely within the glasses and covered with film to avoid water evaporation. Mixers were added to specimen's number 1, 3, 5 and 7, in which surface nets were simulated with sunlight exposure and wave agitation. On figure 5.3. it is shown the set-up for the experimentation. Specimen's number 2, 4, 6 and 8 were left totally covered during the whole period as it is shown on figure 5.4.

(b) Small-scale fibers experimentation set-up.
Number 5 and 7.

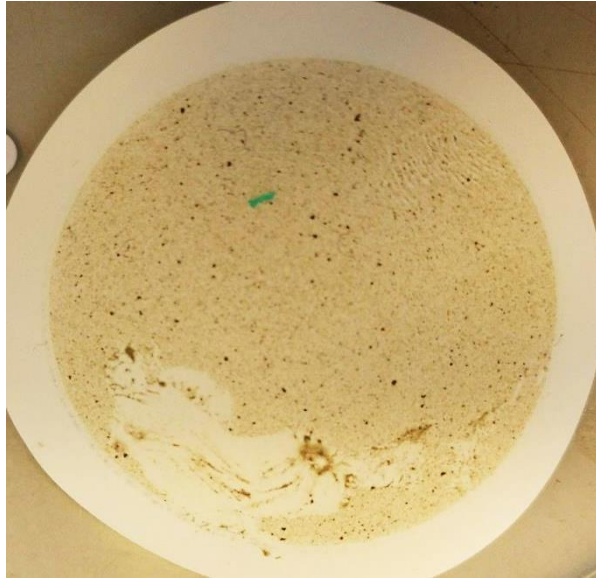
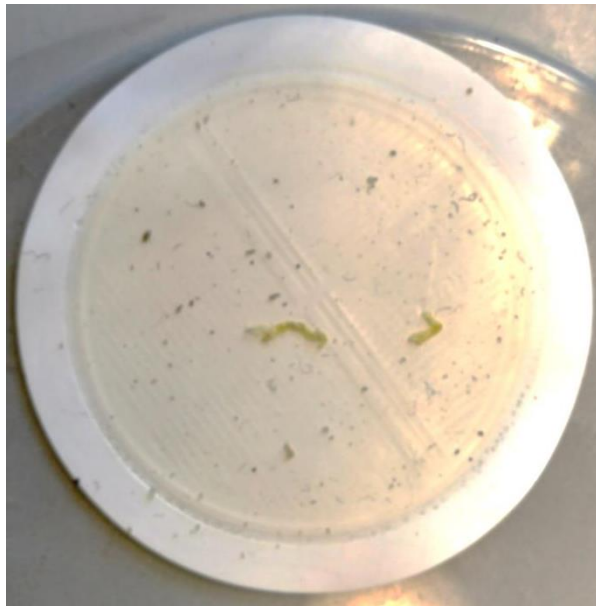
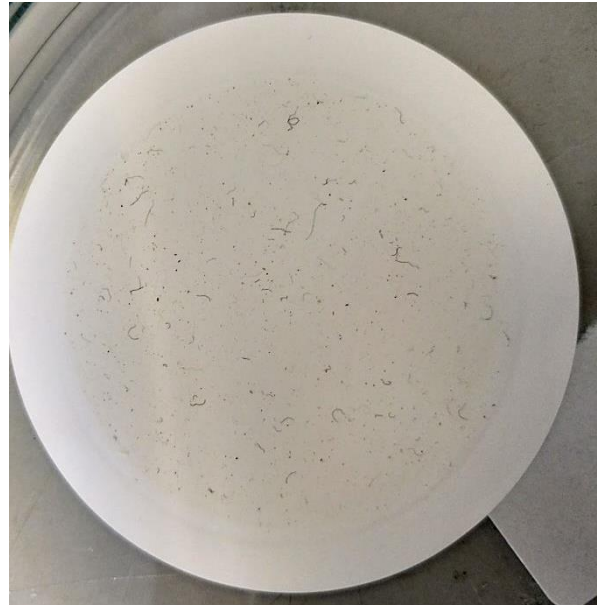
Figure 6.5. Filter surfaces of samples N° 1,2,3 and 4, corresponding to the small scale fishing nets tests.

The differences among the nets that were exposed to the ocean conditions on the surface (Figure 6.5 (a) and (c)) and the nets that were not exposed to these conditions (Figure 6.5 (b) and (d)) can be appreciated simply taking a look to the figures. Moreover, it can be

observed easily the difference in the impurities attached to the filter between 'yellow' and 'green' PE nets exposed to waves' friction and UV light. The 'green' PE net (Figure 6.5. (a)) released a higher quantity of clay and sand particles than the yellow one (Figure 6.5. (c)).

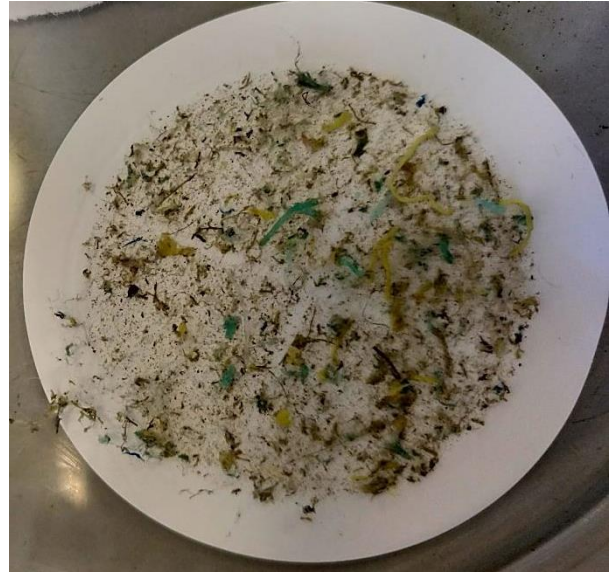
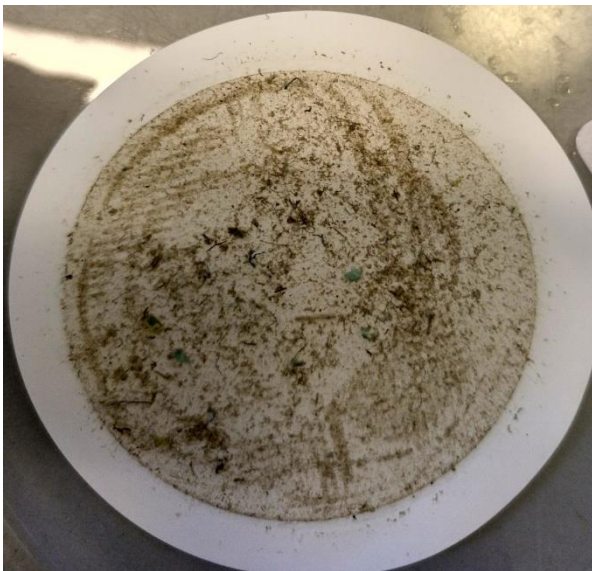
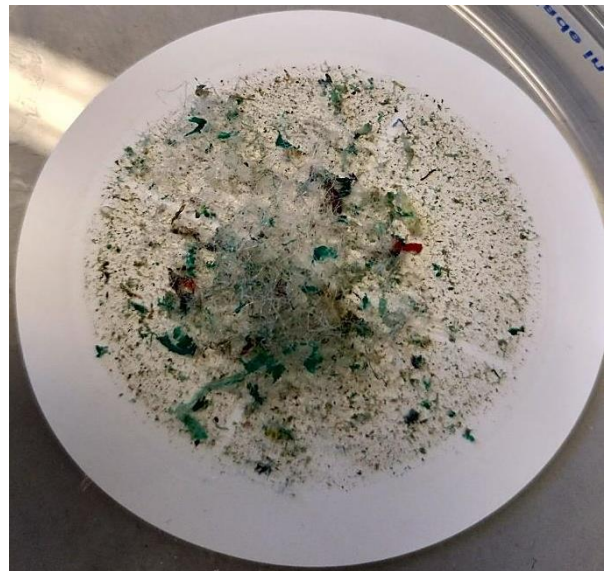
Figure 6.6. Filter surfaces of samples N° 5,6,7 and 8, corresponding to the fibers' tests.

The same differences regarding the quantity of impurities found in each sample, comparing the 'green' and 'yellow' PE waste fibers (Figure 6.6 (a) and (c), Figure 6.6. (b) and (d), respectively) is recognized visually in test in which fibers were used. Although, several microplastics, not released during the two months experiment, were found in the samples nº 7 and nº8 (Figure 6.6 (c) and (d). Finally, it can be observed in sample nº 8 (Figure 6.6 (d), a ball of white plastic filaments, catching different microplastics inside.

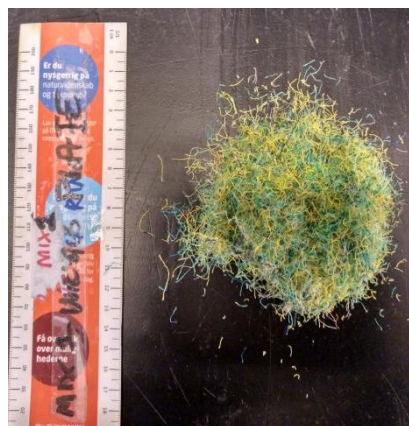
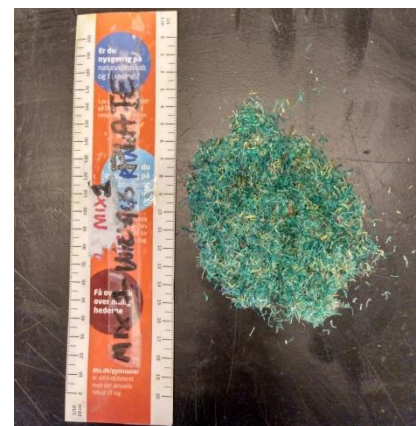
Figure 9.1. Different types of fibers used in the specimens.

(b) PE 'yellow' fibers from discarded nets.

(c) PE 'green' fibers from discarded nets.

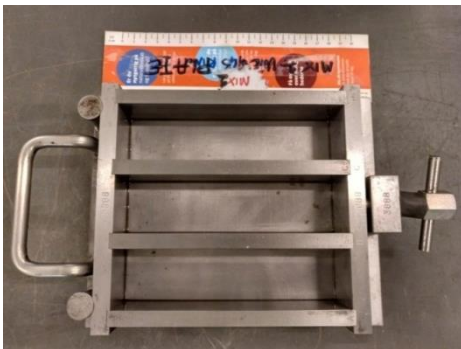
Figure 9.2. Prism mold and specimen with dimensions 160 x 40 x 40 mm.

On figure 9.2., it is illustrated the mold used for prism samples and one prism specimen after the demolding process.

(a) Prism mold used in the casting.

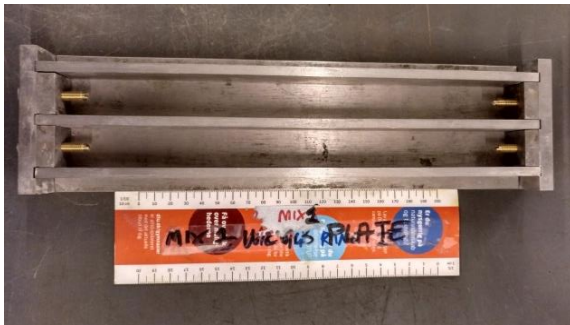
Figure 9.3. Bar mold and specimen with dimensions 285 x 25 x 25 mm.

On figure 9.3. is illustrated the mold used for bar samples and one bar specimen after the demolding.

(a) Bar mold used in the casting.

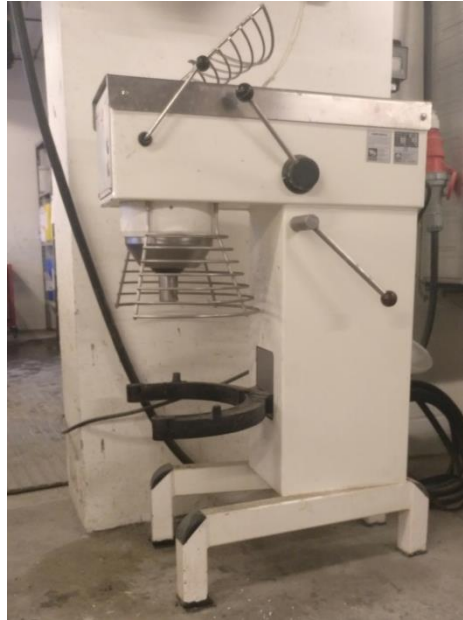
Figure 9.4. Hobart Mixer for high volume mixtures used for the experimentation.

The mixing of the mortar mixture was performed on a Hobart Mixer, which has a volume capacity of 5 liters and a speed range from 0 to 3, being the fastest.

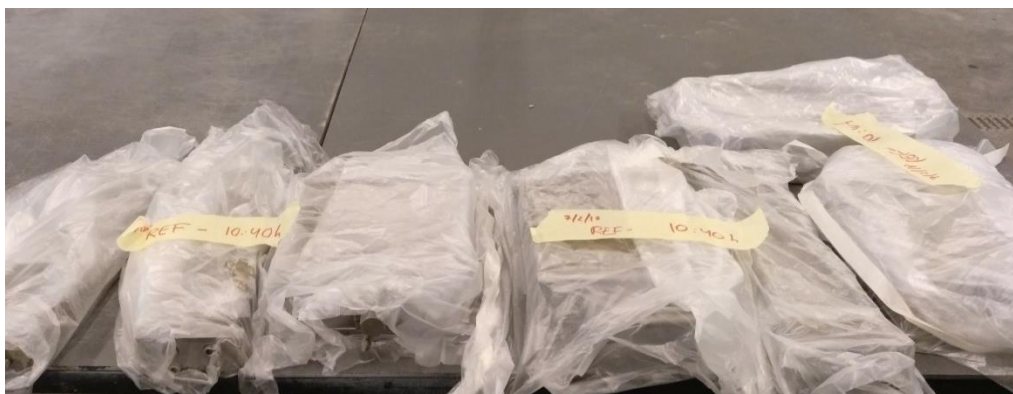
Figure 9.6. Specimens after casting covered with plastic during 24 h.

The samples cured in the molds for 24 hours covered with a plastic to avoid the evaporation of water and maintain a moisture environment (Figure 9.6.). After 24 hours the samples were unmolded. The prism specimens were left to cure completely covered in water and the beams specimens were painted and left to dry free in the environment chamber.

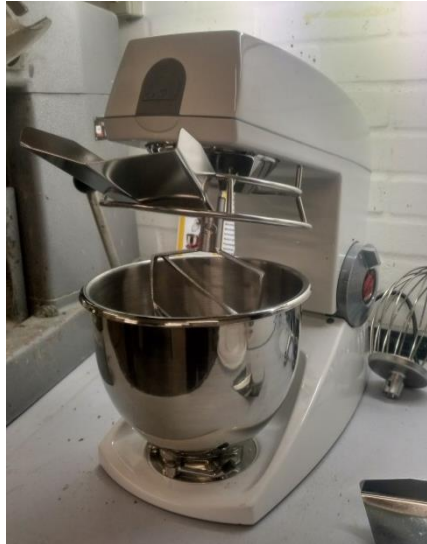
Figure 9.7. Hobart Mixer for low volume mixtures used for the experimentation.

Due to the low volume needed for the second casting, the Hobart mix, up to 2 liters, on figure 9.7. was used.

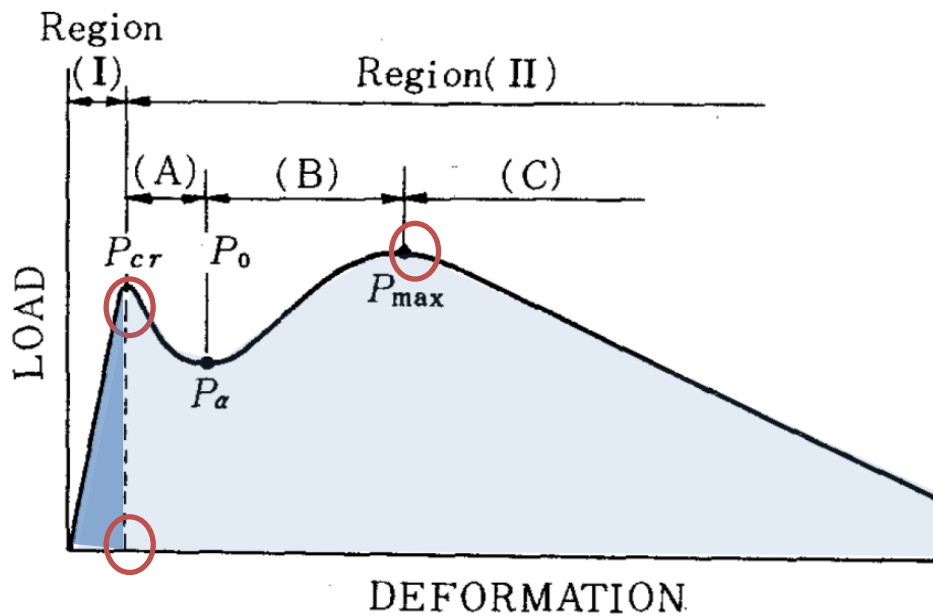
Figure 10.2. Schematic working curve for plain concrete and FRM. K. Kobayashi and R.Cho (1981)

As it is shown in the figure xxx, if the mortar was not reinforced with fibers, the load bearing capacity would reach zero after the initial crack (point A), meaning the samples would break in two. However, the fiber reinforced mortar (FRM) samples would have a significantly load bearing capacity after the initial crack with a maximum load (point B) and maximum post-break load (point C). The area under the graph in figure 10.2. is defined as the flexural toughness (blue area), and as it is shown the FRM will have a significantly higher toughness (light blue) that of the reference samples without fibers (dark blue).

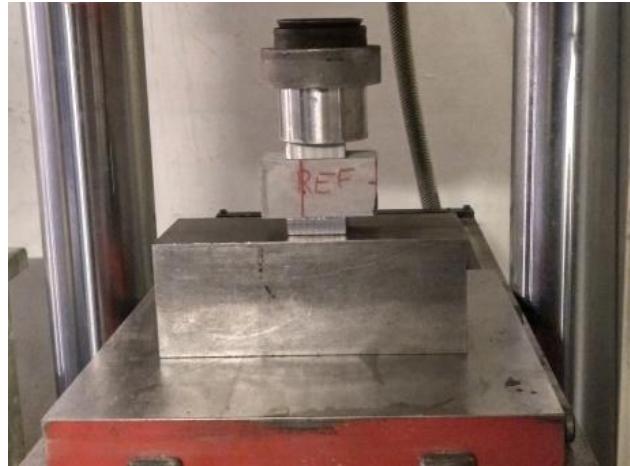
Figure 10.3. Compression of mortar sample.

The load is applied on a 40 x 40 mm surface of the prism until fracture. The sketch set-up is illustrated on figure 10.3.

(b) Set-up in pressure machine Tony 300.

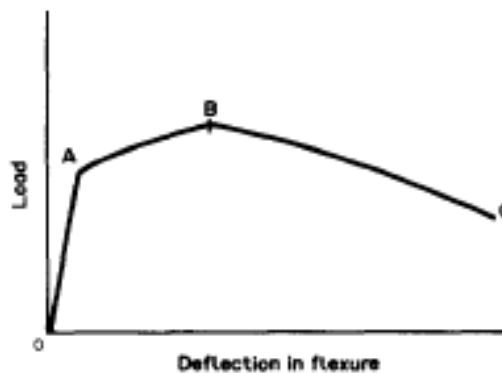
Figure 10.5. Typical load-deflection curve for fiber-reinforced concrete. Source: V. S. Parameswaran, 1991

A typical load-deflection curve for fiber-reinforced concrete in flexure is shown on figure 10.5. The segment AB represents the region where there is continuous cracking of the matrix and some debonding and pulling-out of the fibers. It should be noted that during this part of the debonding and pulling out process, the fiber stress is generally substantially less than the yield stress of the fibers, so yielding of the fibers does not occur. In the declining portion of the curve, BC, matrix cracking and fiber pull-out continue. If the fibers are long enough to maintain their bond, they may eventually fail by yielding or fracture in this region of the curve. (V. S. Parameswaran, 1991)

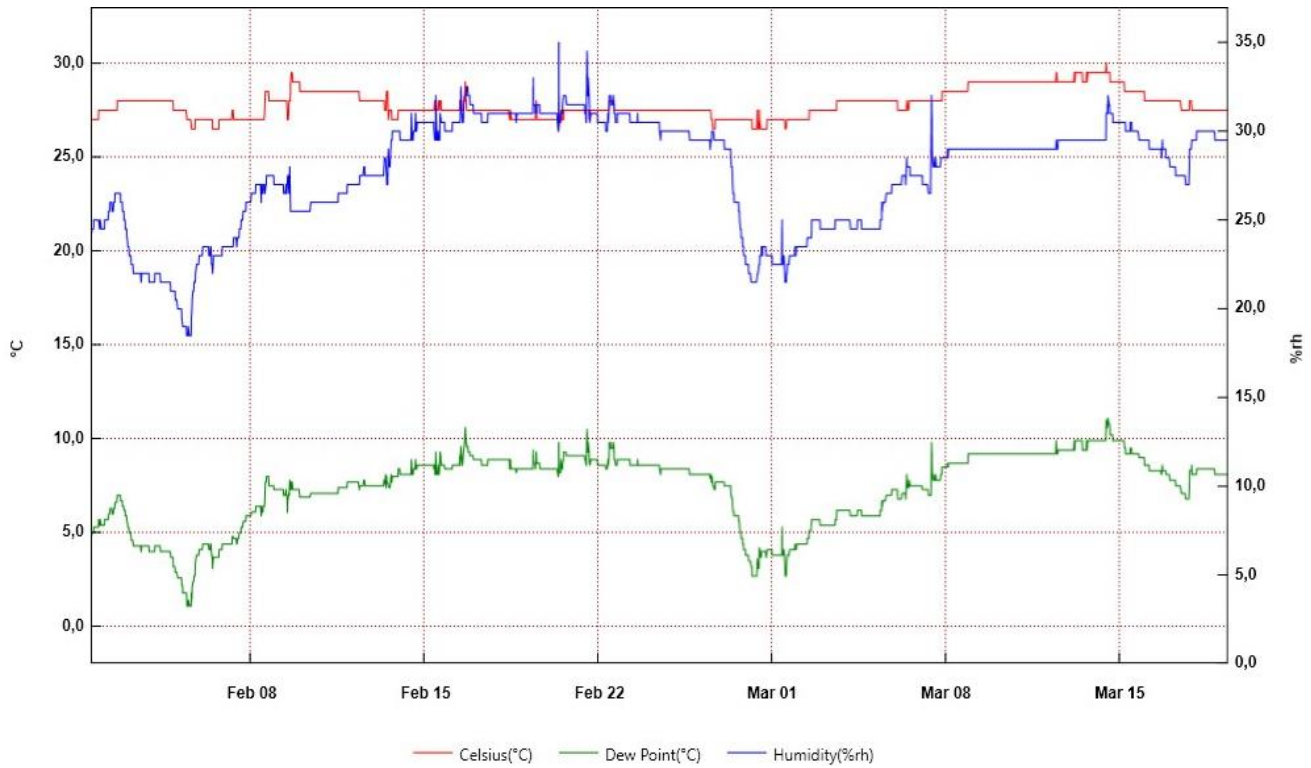
Figure 10.6 Temperature and humidity evolution during the experimentation period.

On figure 10.6. below, the evolution of the temperature and the rate of humidity during the 28 days experiments' period are shown.

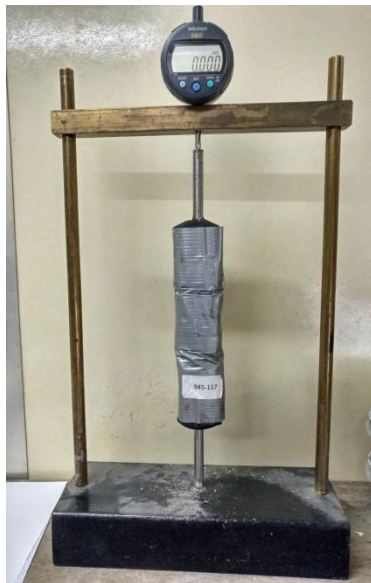
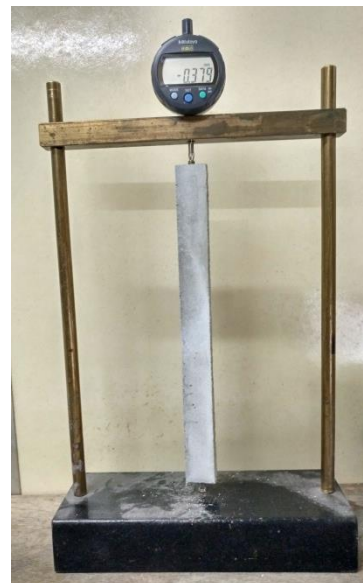
Figure 10.7. Micrometer used for LVDT test.

The test was carried out in a micrometer placed in the environmental chamber. The zero of the micrometer is set with a reference bar whose length is 297, 5 mm. For each measurement, the micrometer gives the difference between the reference and the tested bar in mm.

(a) Micrometer with reference bar.

(b) Micrometer with bar specimen.

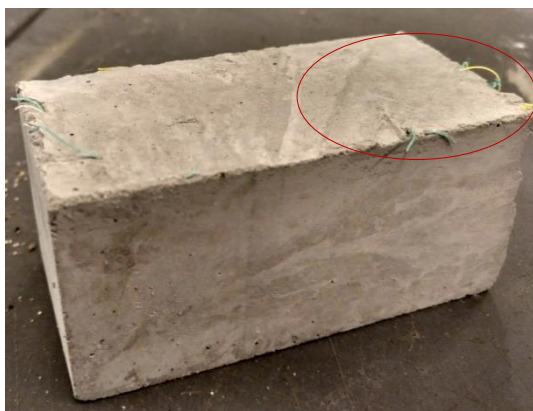
(a) PE fibers protruding from the edges.

A characteristic aspect of the FRM samples is the predisposition of the fibers to protrude from the different samples, especially on the edges as can be seen on figure 11.2., which is associated with the procedure of the filling of the molds. This problem can cause difficulties to get an even surface on the samples.

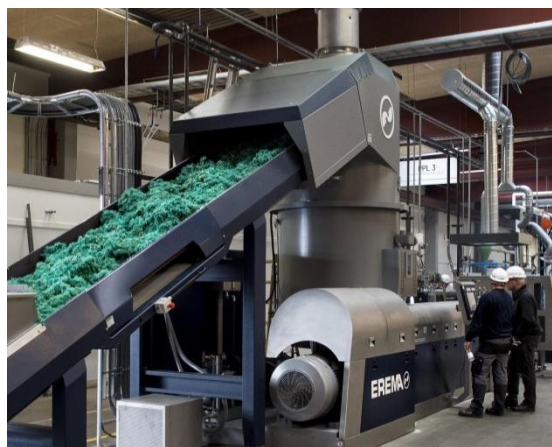
Figure 13.2. Processing and cutting of discarded fishing nets in Plastix installation.

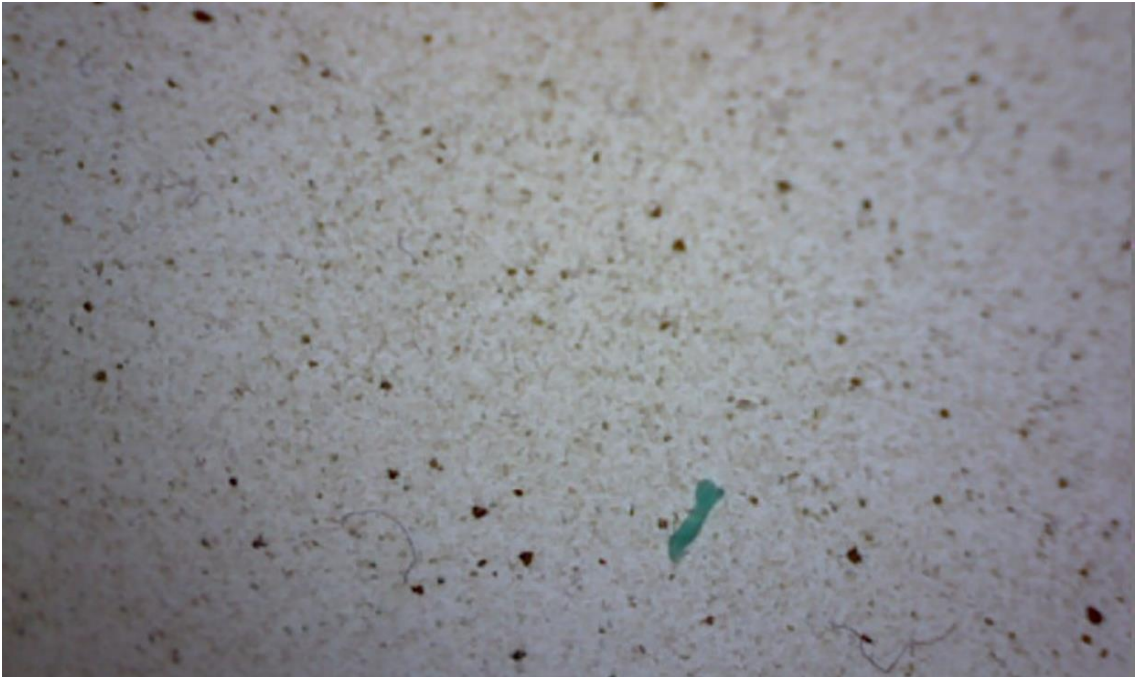
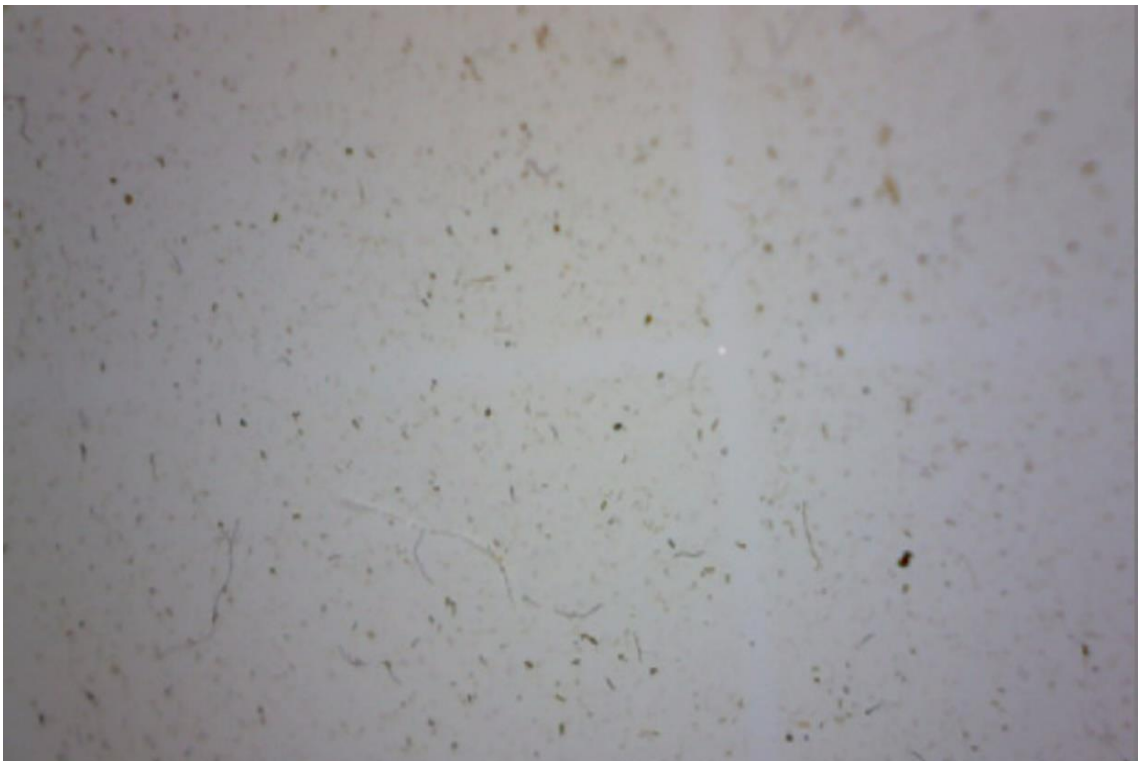
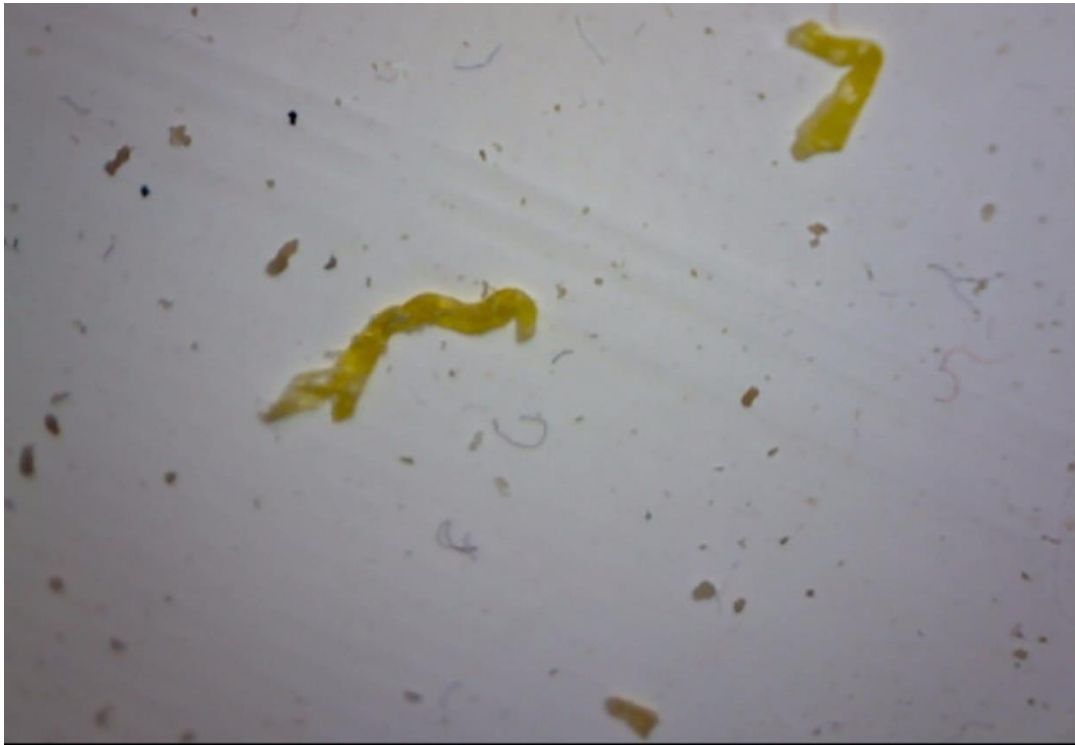
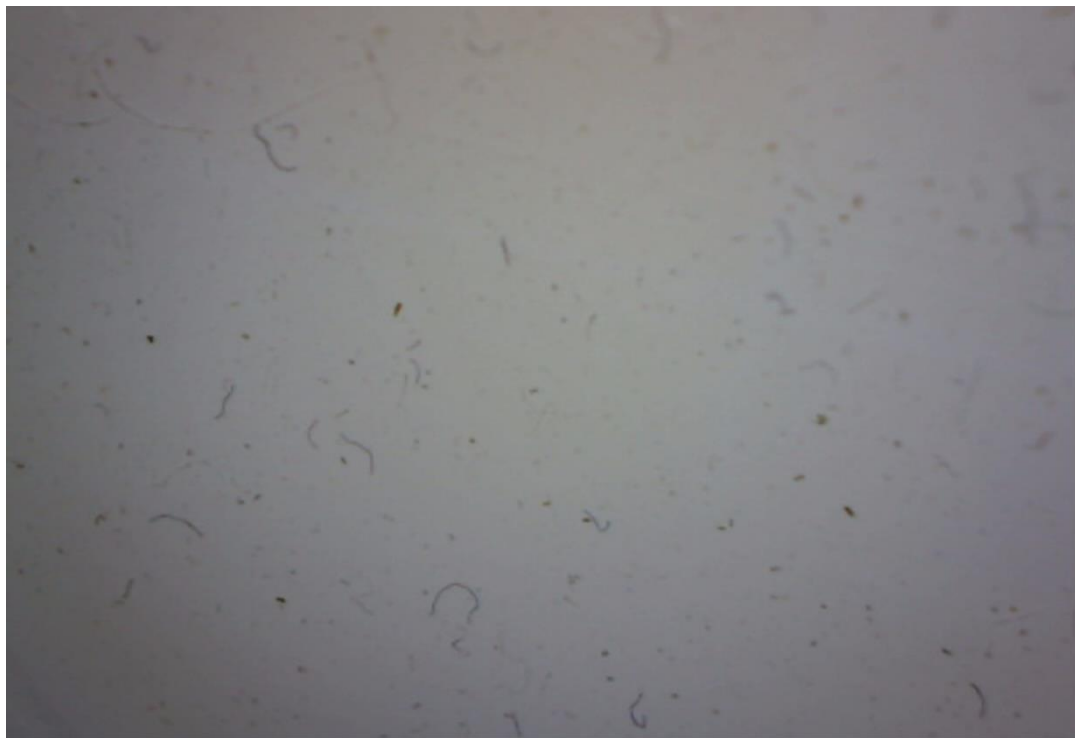
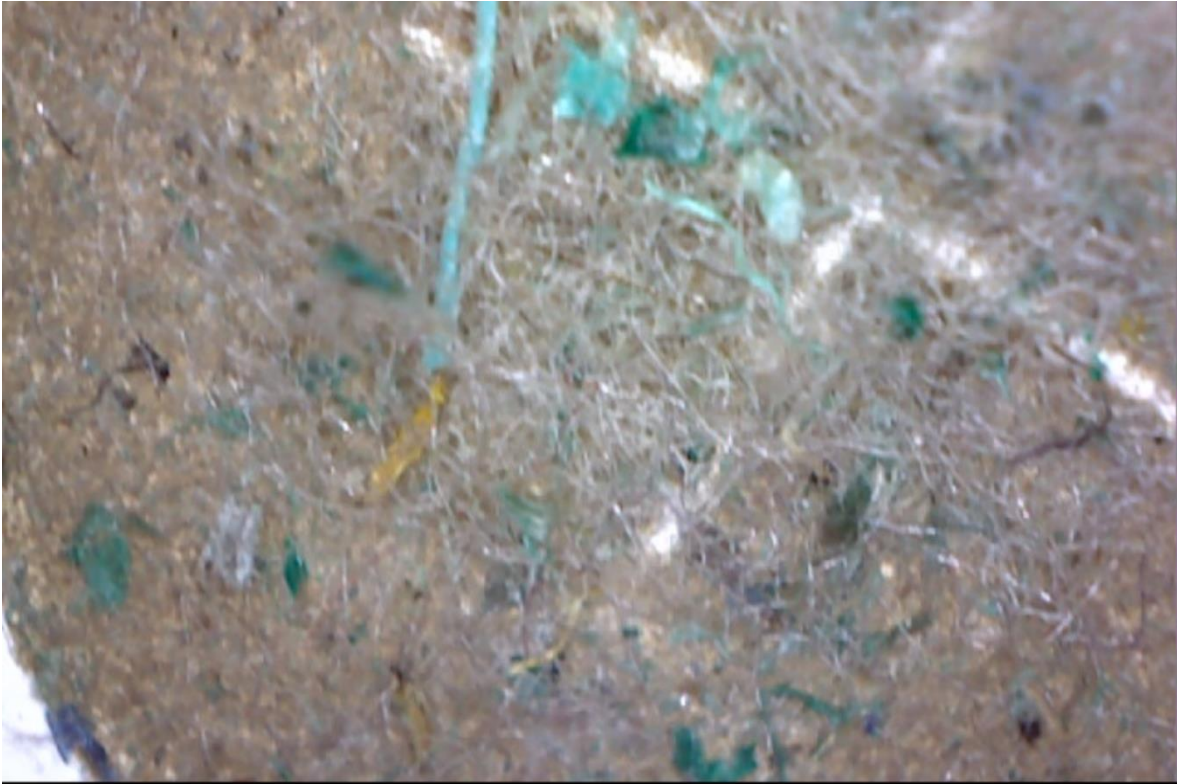
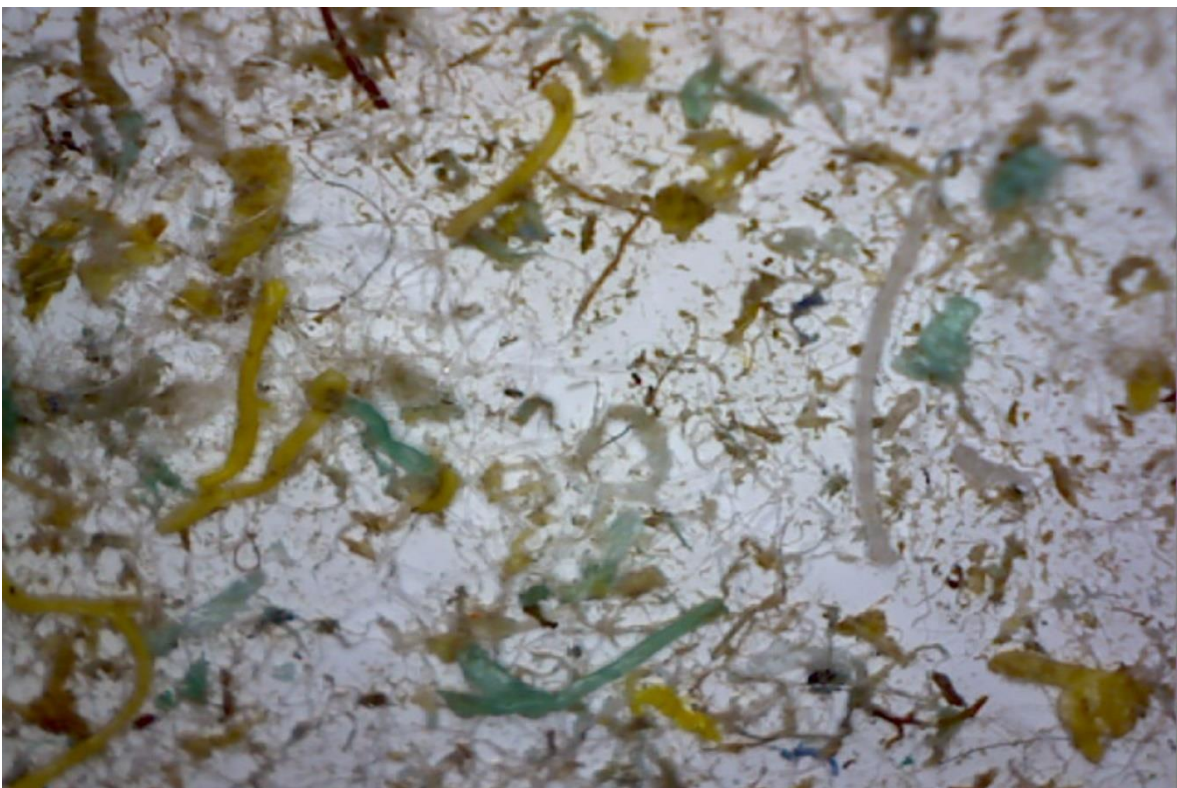
From figure 16.1 to figure 16.8. some previous pictures taken to the filter’ surfaces, used in the experiment in section 5.2.,with the microscope portable are shown. For the analysis

of the filters' surface finally the fix electronic microscope pictures were used because of the better quality.
