Article

Investigation on Farmland Abandonment of Terraced Slopes Using Multitemporal Data Sources Comparison and Its Implication on Hydro-Geomorphological Processes

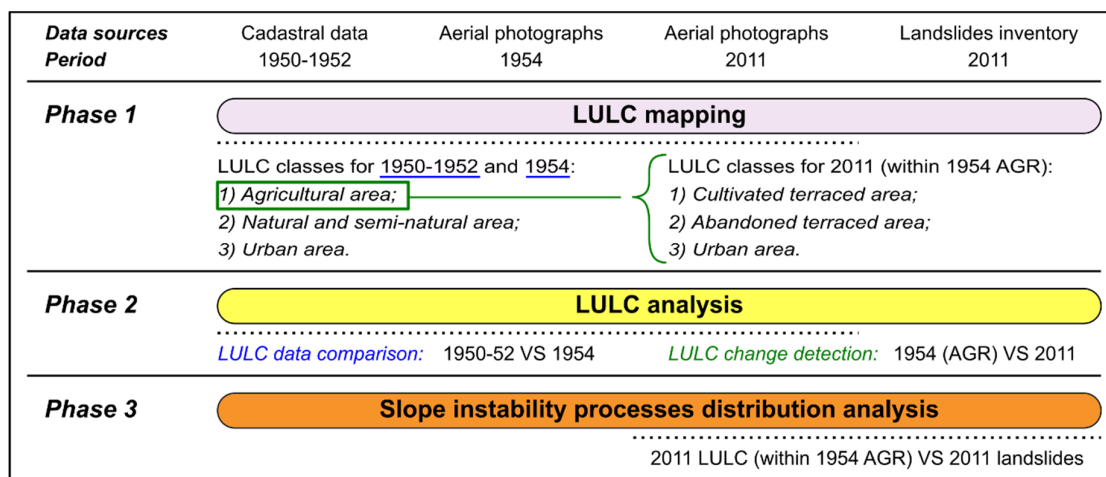
Figure 2. Workflow sketch summarizing the considered data sources and the sequence of performed methodological phases. The dotted lines refer to the data sources and indicate which of them are involved in each phase. Blue- and green-highlighted elements in Phase 1 refer to the Phase 2 components; LULC, land use and land cover; AGR, agricultural area.

This research consists of a quantitative multi-temporal analysis performed in a GIS environment. This work has been carried out in three steps (Figure 2). In the first step, historical and recent aerial photos have been used as mapping basis to obtain LULC data of the study area in 1954 and 2011, respectively.

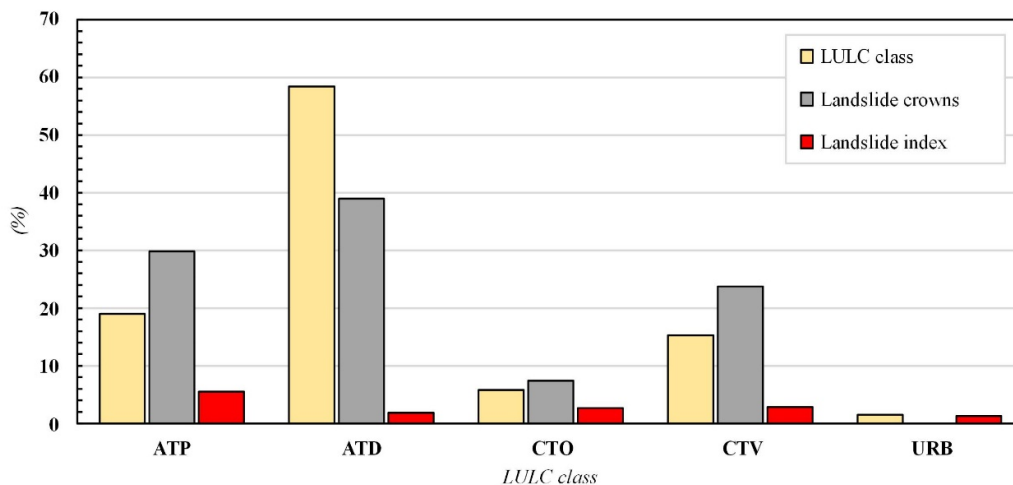
Figure 6. Histograms showing the relationships between the percentage of landslide crowns and of the Landslide Index with respect to land use/land cover of 2011 (LULC 2011); ATP, abandoned terraced slopes with poor cover; ATD, abandoned terraced slopes with dense cover; CTO cultivated olive groves; CTV, cultivated vineyards; URB, urban areas.

After the disastrous rainstorm occurred on 25 October 2011, 364 shallow landslides were mapped by Cevasco et al. [78] through visual analysis of aerial orthophotographs and geomorphological surveys. Overall, GIS analysis revealed that 295 of these rainfall-induced landslides have been triggered over agricultural terraced areas dated 1954 while nine landslides run-out through them from neighboring zones. The smallest slope failure covered a surface of a few square meters, the largest one covered 5376 m² while the average landslide size was estimated to be 216 m². The corresponding total area affected by landslides is 6.48×10^{-2} km², representing 2.75% and 1.12% of AGR 1954 and of the entire Vernazza catchment, respectively. Considering that the extent of 1954 cultivated slopes was about 2.35 km², the average landslide density in this land use class is 125 landslides/km². Generally, in 2011 the highest amount of rainfall-induced instability phenomena (68.8%) occurred on abandoned agricultural lands, which are the most represented land cover class (77.4%), while 31.2% of slope instabilities affected still cultivated terraced slopes (21.1%). In particular, as can be seen in Figure 6, most of the landslide crowns (39%) affected ATD while a lower

percentage (29.8%) of the landslides has been triggered on ATP, representing 58.4% and 19.0% of 1954 agricultural areas, respectively. An important amount of landslide crowns was also detected in CTV (23.7%), while considerably lower landslide scars affected CTO (7.5%), which represent 15.3% and 5.8% of the areas that were cultivated in 1954, respectively. Furthermore, it was observed that landslides triggered on cultivated areas are generally lower in magnitude than those occurred on abandoned ones. In detail, the average extent of landslides that occurred on CT (70 m²) is about half of those that occurred on ATP (140 m²) and ATD (145 m²). The most important observations come from the analysis of the landslide index, which represents the landslide area in each land use class in relation to the area of the considered land use class. The highest LI value was obtained for ATP (5.5%). Significant LI values were also associated to CTV (2.85%) and CTO (2.67%) whereas it was significantly lower for ATD (1.85%).

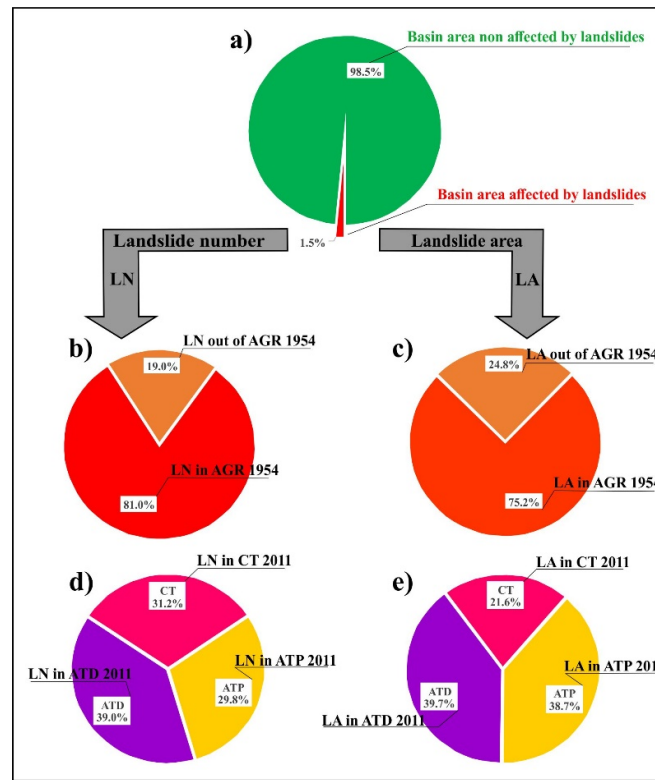
Figure 7. (a) Percentage of basin area affected by shallow landslides; (b) Percentage of landslides triggered in and out of AGR 1954; (c) Percentage of landslide area in and out of AGR 1954; (d) Percentage of landslides triggered in CT, ATP and ATD in 2011; (e) Percentage of landslide area in CT, ATP and ATD in 2011; LN, landslide number; LA, landslide area; AGR 1954, agricultural area of 1954; CT, cultivated terraced slopes; ATP, abandoned terraced slopes with poor cover; ATD, abandoned terraced slopes with dense cover.

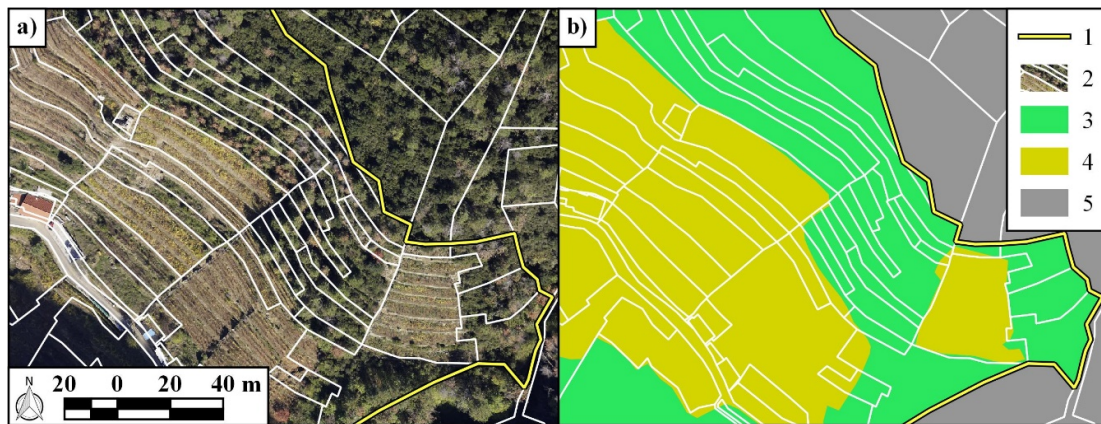
Figure 8. Comparison between the cadastral map and the 2011 orthophoto (a) and the 2011 LULC map (b). It can be noted the high fragmentation of land ownerships as well as the spatial accuracy of old cadastral data. 1, Boundary between the agricultural areas and the natural areas dated 1954; 2, parcel border; 3, abandoned terraced slope with dense cover (ATD); 4, cultivated vineyard (CTV); 5, natural and semi-natural area (NAT).

the high fragmentation of land ownerships can make difficult the maintenance of dry-stone walls. In this regard, cultivated areas can be often placed near or surrounded by abandoned properties, making the maintenance works on border dry-stone walls not possible to be carried out (Figure 8).
