Data-Driven Development of a Roadside Safety Marketing Campaign for Tree Removal – Phase I

TECHNICAL REPORT DOCUMENTATION PAGE

1. Report No. TRP-03-375-18	2.	3. Recipient's Accession No.	
4. Title and Subtitle Data-Driven Development of a Roadside Safety Marketing Campaign for Tree Removal – Phase I		5. Report Date July 17, 2018	6.

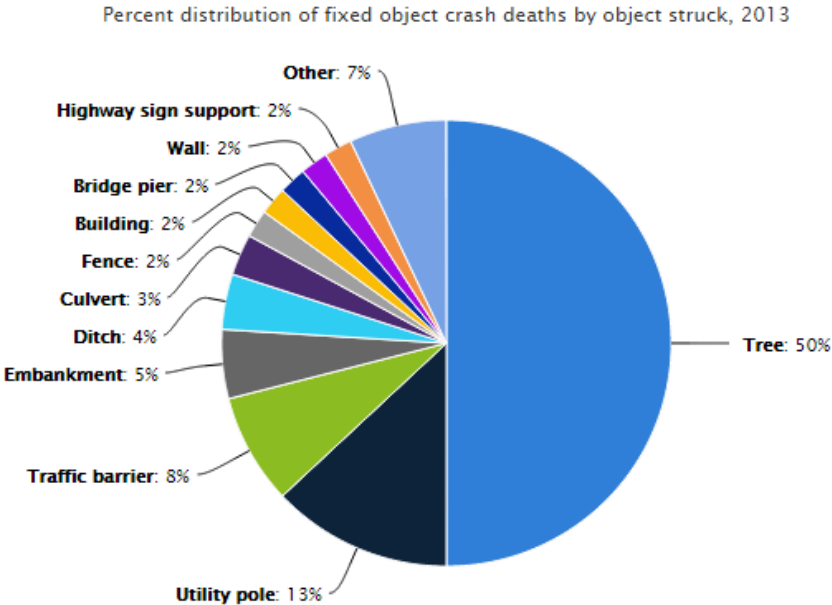
Vehicle/tree collisions make up between 25% and 28% of all fixed object ROR crashes, but are responsible for about 50% of all fixed-object roadway fatalities [6, 8-10].

Figure 1. Percent Distribution of Fixed Object Crash Deaths by Object Struck [3]

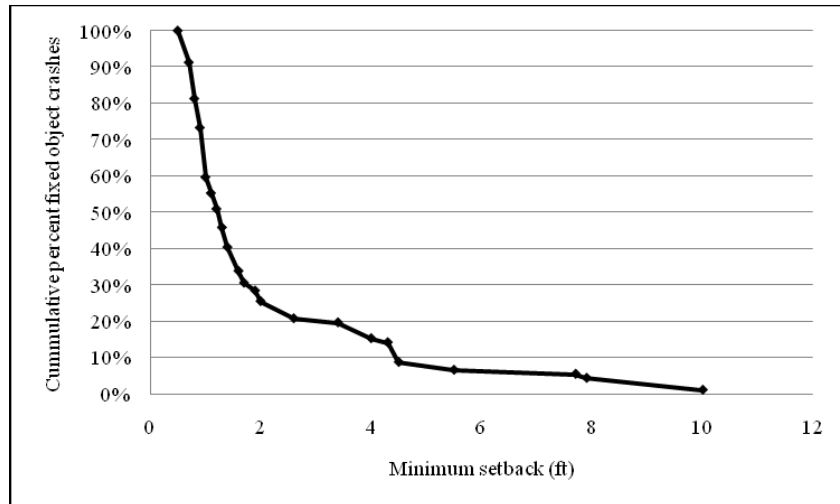
Iowa State University published a 2009 report that summarized the effects of clear-zones on safety performance in Iowa. This report stated that 90% of fixed object ROR crashes in the studied areas occurred on road segments where the clear zone distance was less than 5 feet. This relationship can be seen graphically in Figure 3. Additionally, the authors discovered that 90% of all fixed object crash costs originated from highways with clear zones less than 4 feet wide [25].

Figure 3. Cumulative Percent Fixed Object Crashes vs. Minimum Setback [25]

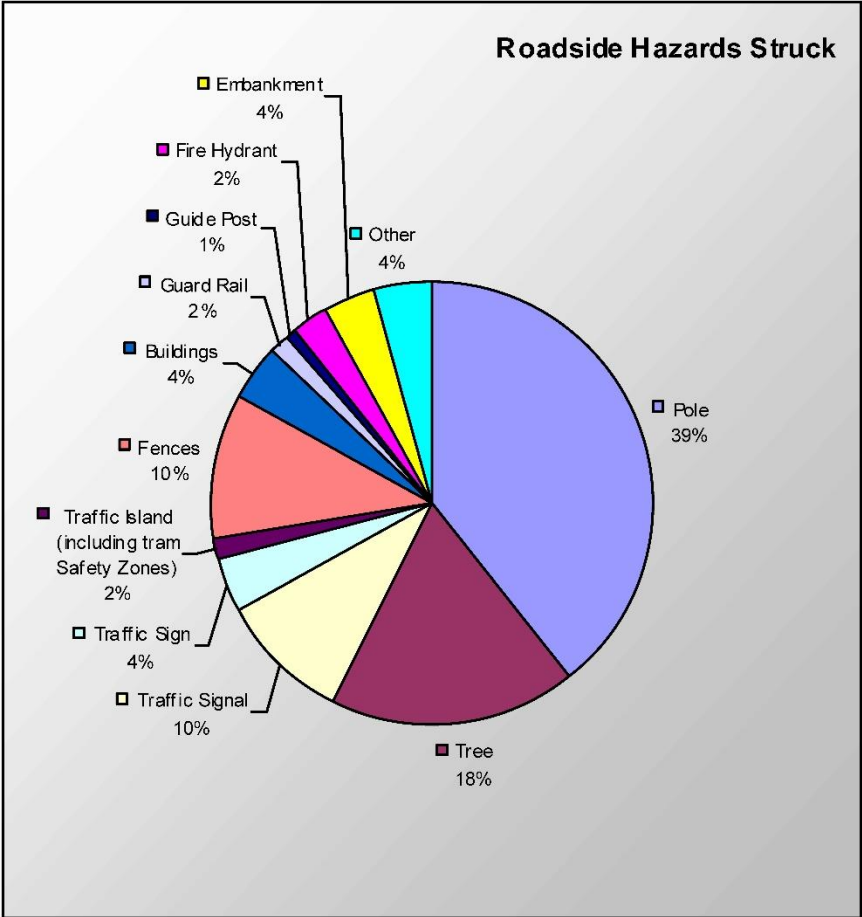
Australians have experienced preventable roadside destruction in the form of vehicular impacts with trees and tree derivatives. For example, 39% of all fixed object impacts in Australia are due to utility poles and 18% are due to trees, which can be seen in Figure 4. These rates can be compared with those seen in urban areas, where 48% of fixed object impacts are due to utility poles and 12% are due to trees [29].

Figure 4. Percentage of Roadside Fixed Struck Hazards in Australia from 2001-2005 [29]

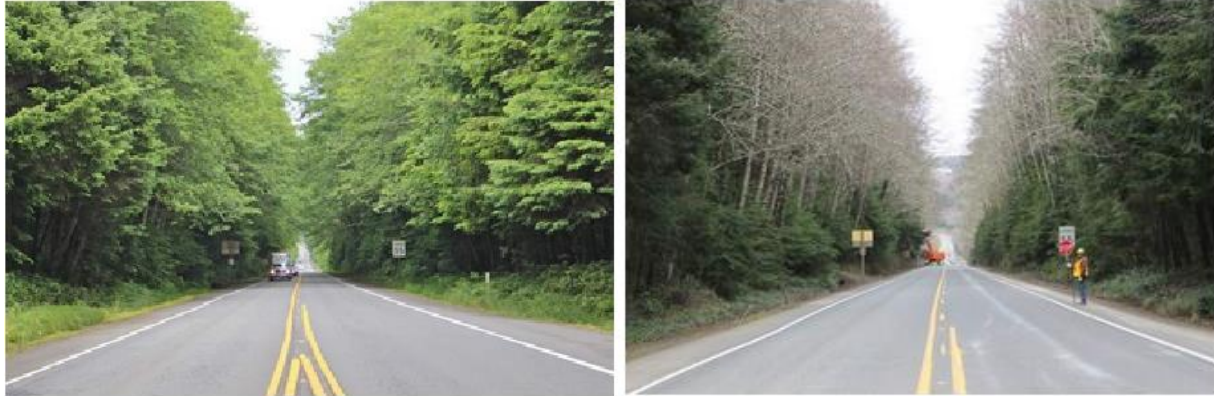
Figure 8. Highway 101 in Oregon Demonstrating Tree Aging and Formation of Hazard Trees [63-65]

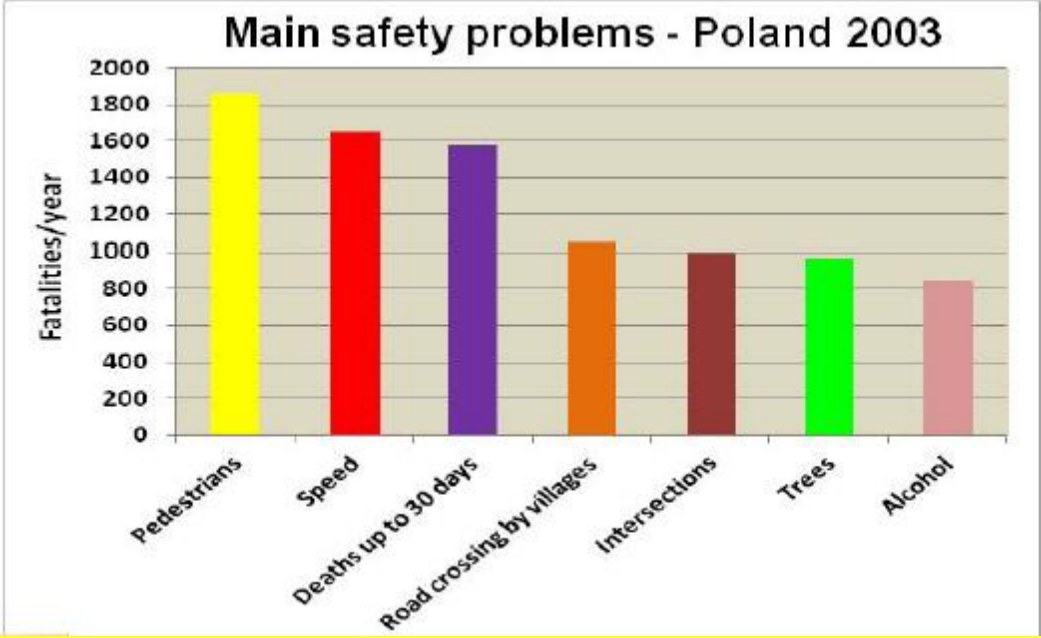
In Poland, tree crashes resulted in higher fatalities than alcohol-related road incidents, with tree crashes comprising 11% of all crashes in 2003, as shown in Figure 10 [37]. To reduce ROR fatalities, Poland developed an integrated program of road safety improvement called “GAMBIT” in 2007. GAMBIT was credited with saving 2,250 lives over nine years, as shown in Figure 11. The Polish government established new speed limits and improved visibility by cutting trees at intersections, improving road infrastructure, and implementing the AASHTO “forgiving roads” concept into designs [37, 76]. Some agencies relied on different methods to mitigate roadside safety and tree issues rather than cutting down trees, such as implementing national road improvement programs and installing crash cushions or guardrails.

Figure 10. Main safety problems – Poland 2003 [37]

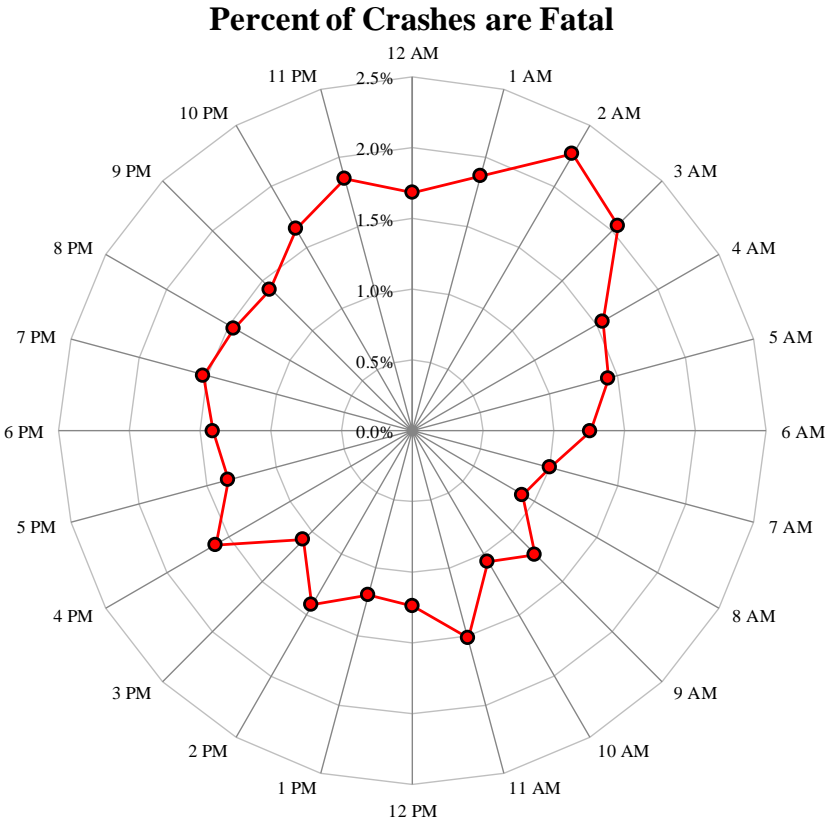
Results suggest that between 1 a.m. and 3 a.m., approximately 1 in 50 crashes involving a tree or utility pole results in death.

Figure 17. Fatal Crash Percentage as a Function of Time

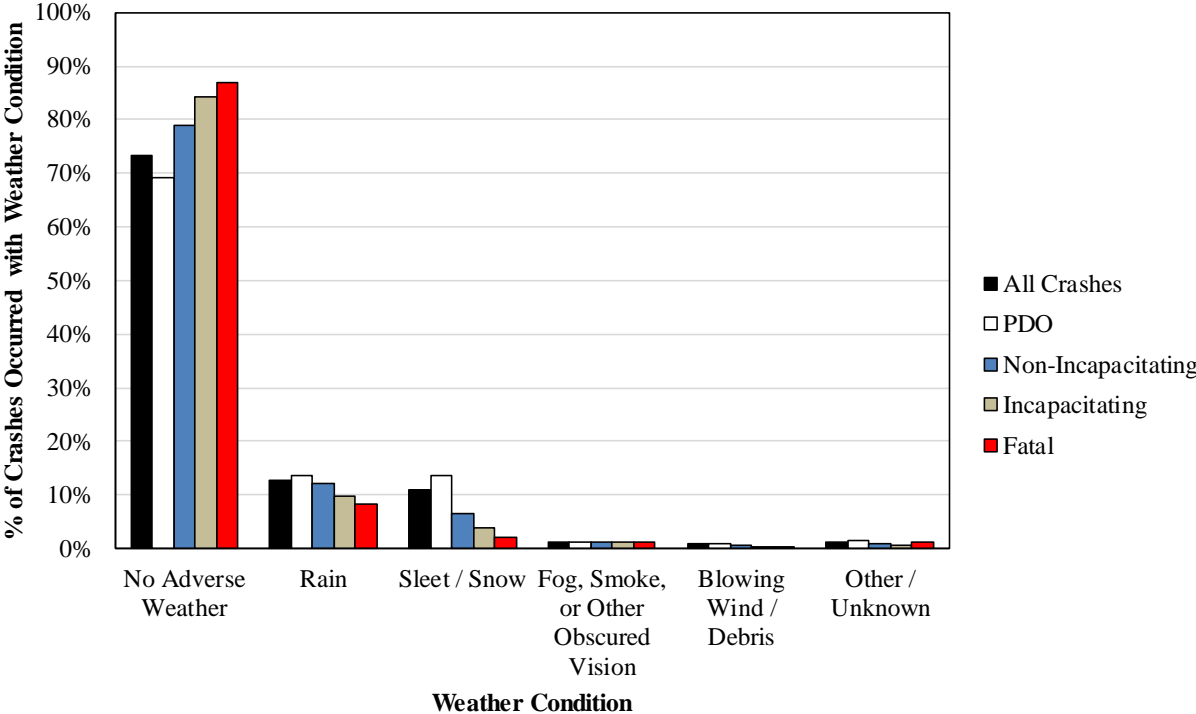
Figure 21. Distribution of Injuries by Prevailing Weather Conditions at Time of Crash

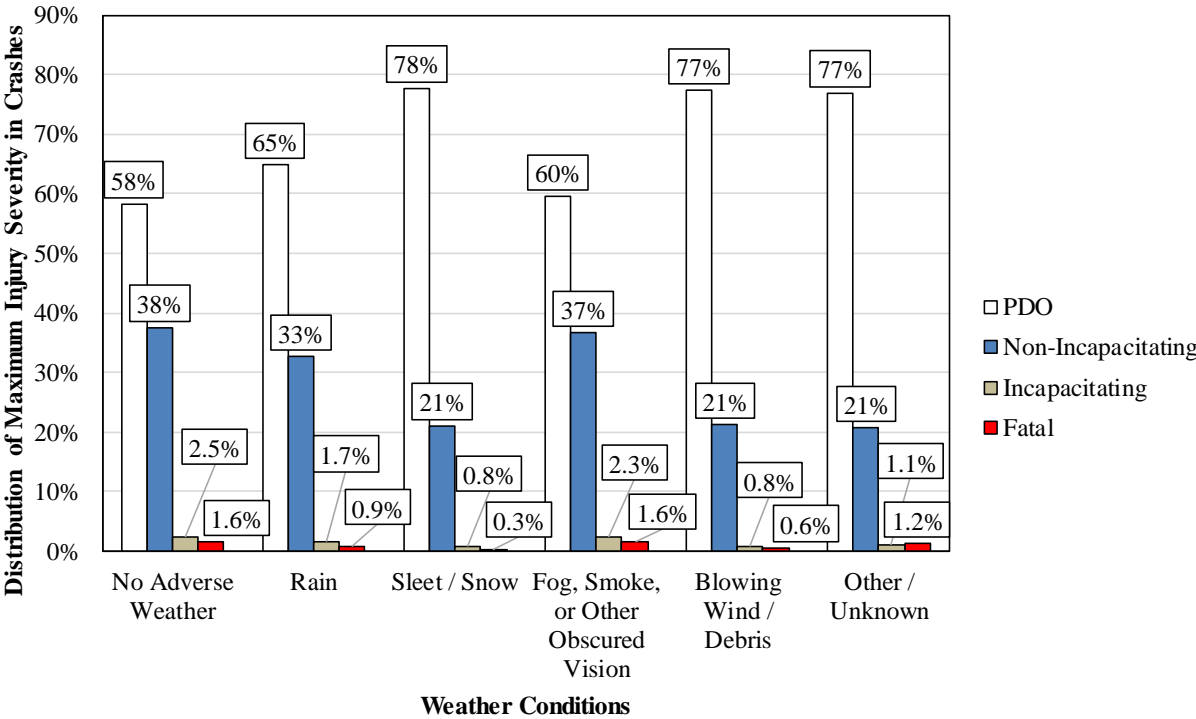
Figure 22. Distribution of Injuries by Weather Condition

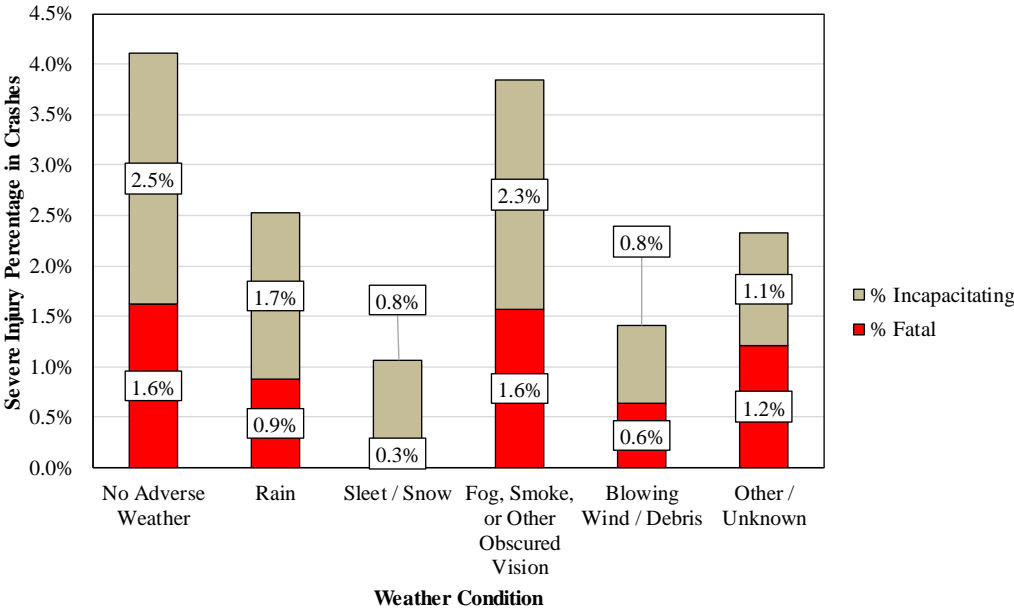
Figure 23. Severe Injury Percentages by Weather Condition

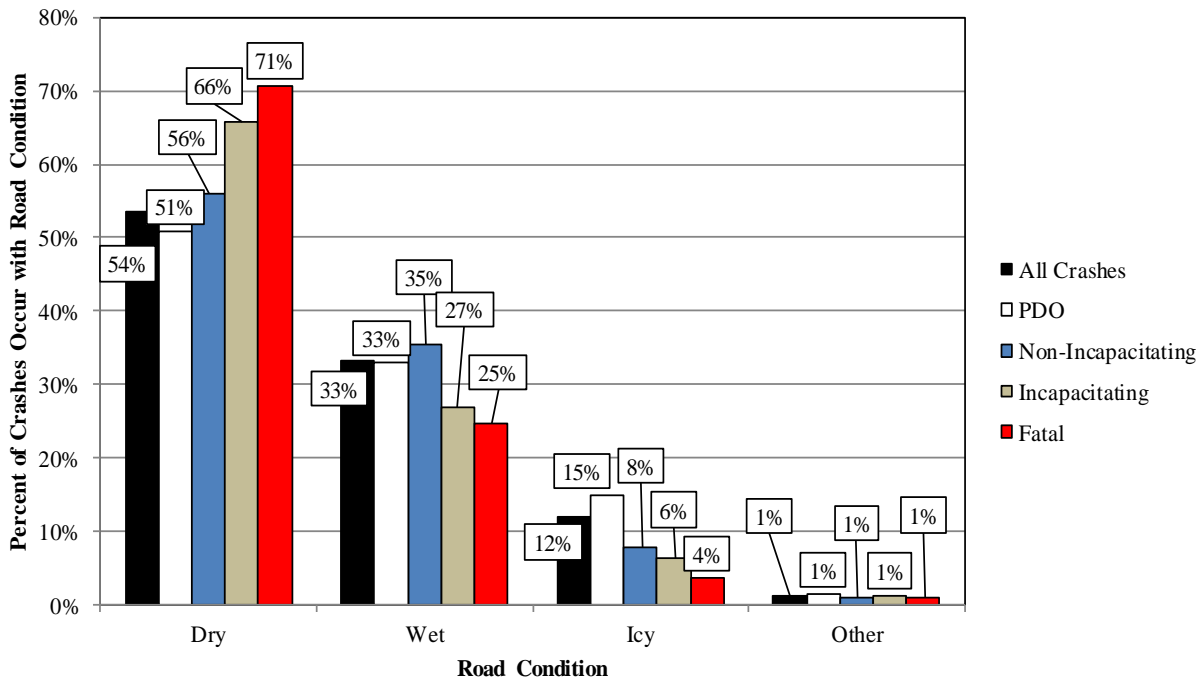
Figure 24. Distribution of Injuries by Road Conditions at Time of Crash

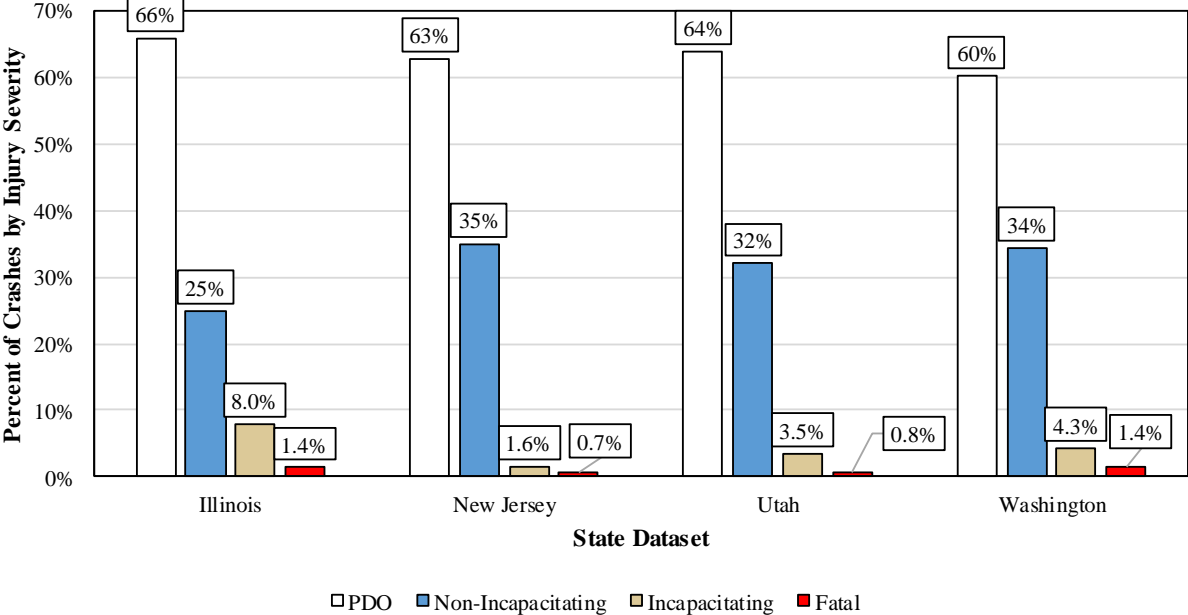
Figure 28. Distribution of Injuries for Occupants of Light Trucks by State

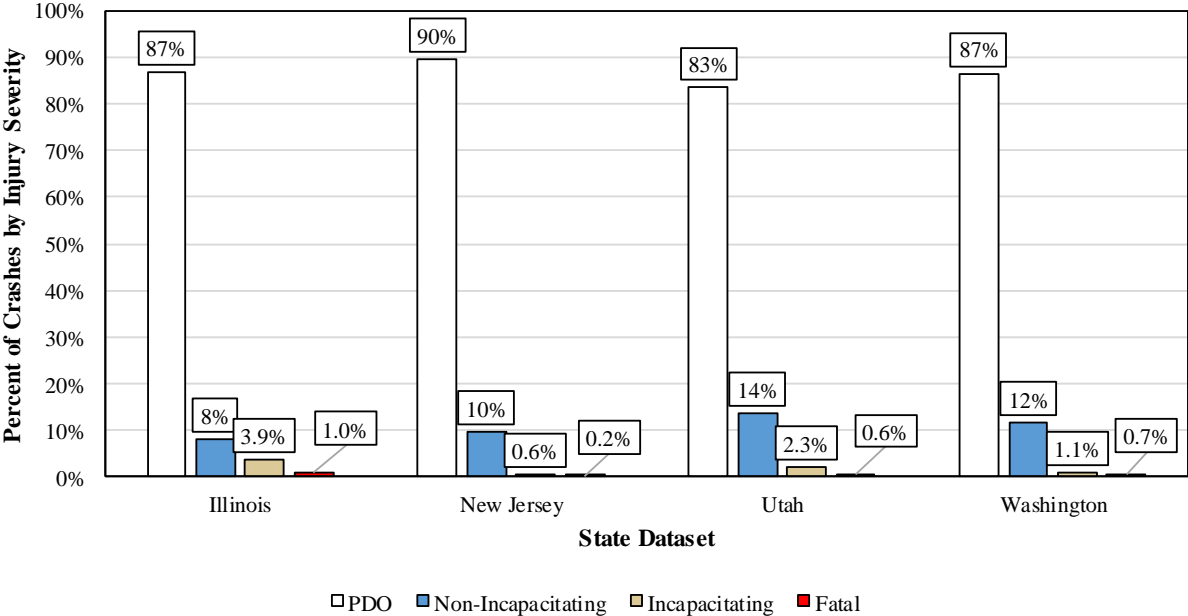
Figure 29. Distribution of Injuries for Occupants of Heavy Trucks by State

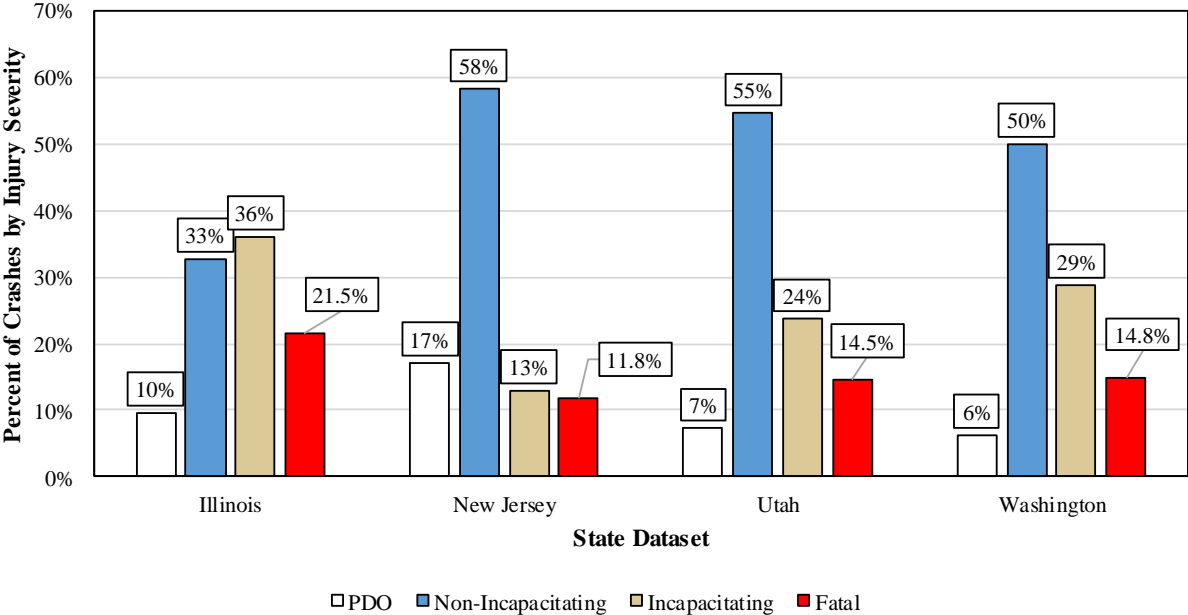
Figure 30. Distribution of Injuries for Motorcyclists by State

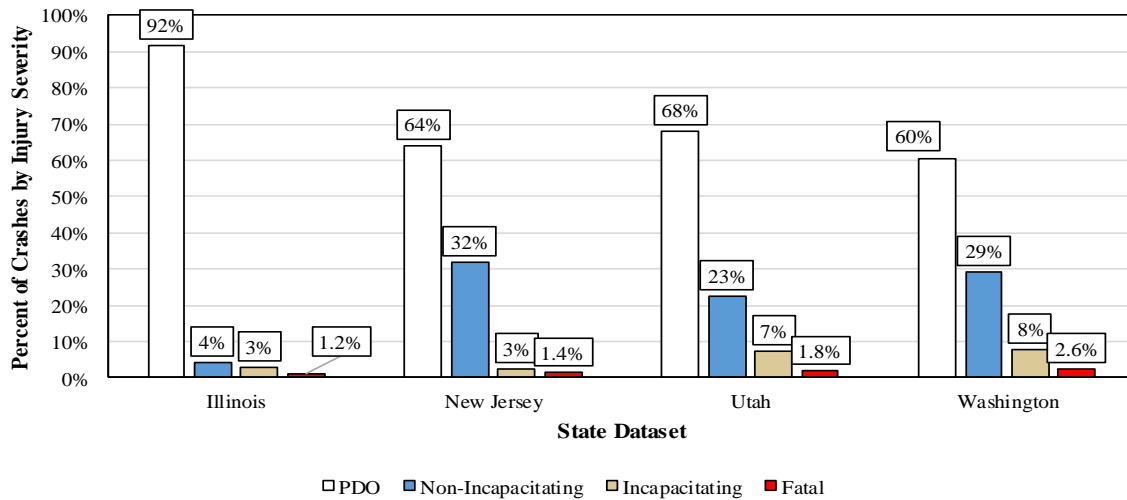
Figure 31. Distribution of Injuries for Occupants of Other or Unknown Vehicle Types by State

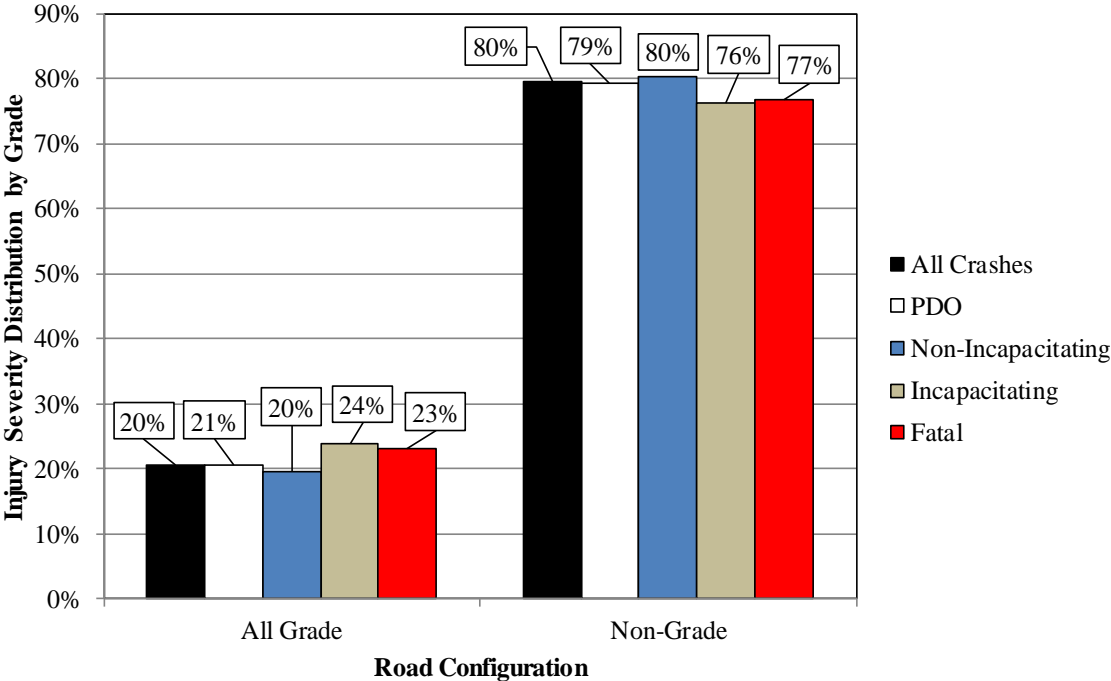
Figure 42. Percent of Injury Crash Types Associated with Grade and Non-Grade Roads
