# Testing UAVs to perform aerial photographic survey of harp and hooded seals in the West Ice area

SURVEY REPORT – KV “SVALBARD” 16-26 MARCH 2014

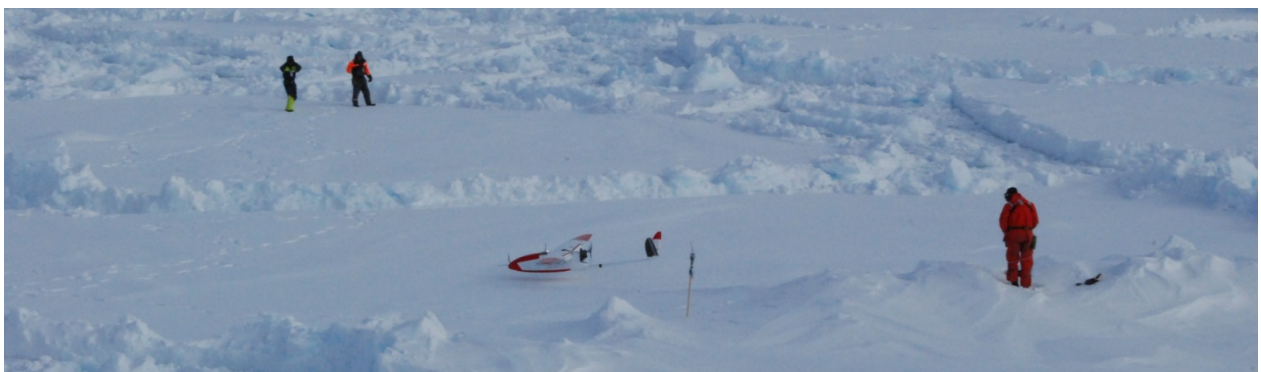
**Figure 2.** Kjell-Sture Johansen is landing CW1 on a small ice floe. Photo: S. Solbø, Norut

The CW1 airframe is produced by ET-Air S.R.O in Slovakia. Final assembly was done by Norut. The main airframe structure is fiberglass composite made using CNC (Computer Numerical Control) routed molds. The propulsion is a Zenoah G62, a 62cc two-stroke petrol engine, running on 95 octane petrol with a 2% oil mixture. The plane is equipped with Iridium modem and beyond radio line of sight range is only limited by fuel amount and battery capacity for powering avionics and payload. Up to 3 hours operation is possible in good weather. High wind and cold weather will reduce range. The aircraft is launched by pneumatic launcher from the ship deck, and needs adequate ice surface to land on.

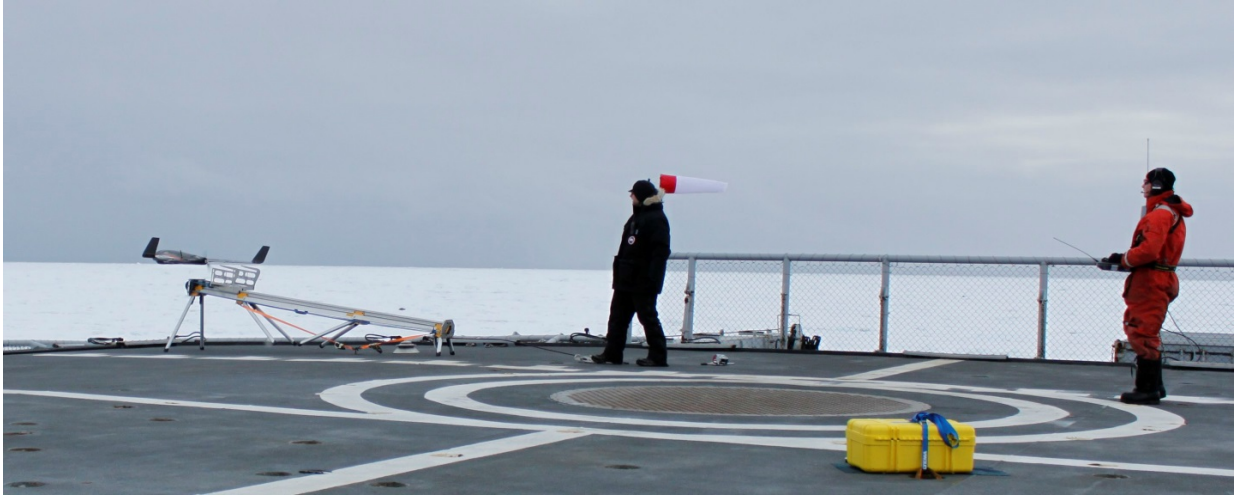
**Figure 3.** Take-off CWM from the KV “Svalbard” Helicopter deck, 19. March 2014. Foto: D. Stødle, Norut

only be used for within a 10–20 km radius (range depend on antennas used for tracking and radionoise in the area). The aircraft is launched from the ship deck with a bungee catapult launcher. If the deck is large enough (like on the helicopter deck of KV Svalbard), it is possible to land the aircraft on the deck, or into a net mounted on the deck.

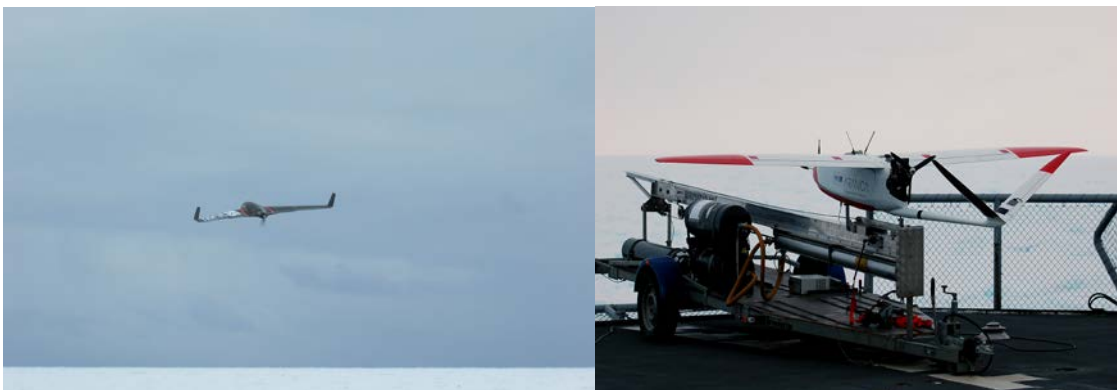
**Figure 4.** Left: CWM in flight. Right: CW1 ready for takeoff. Photos: M. Poltermann

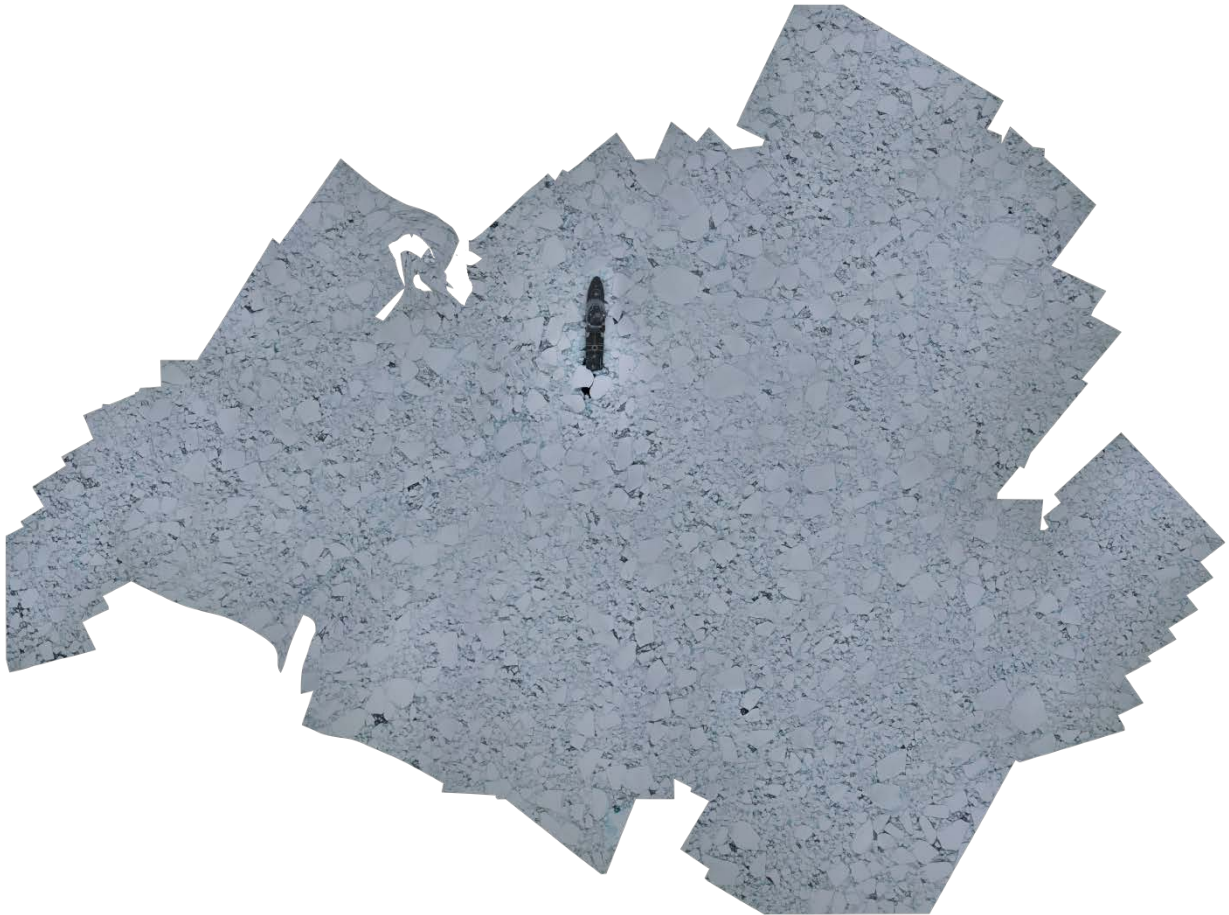
**Figure 6.** Mosaic from CWM flight on the 19 March. As the flight was mainly flown in manual mode due to airspeed sensor issues no structured grid was flown. The mosaic is based on 300 images from a 15 minutes flight.

To generate a mosaic (Figs 5 and 6) for each flight transect, the corresponding images are stitched together in a process that aligns unique key-points in overlapping images. The commercial software package Agisoft PhotoScan is utilized to perform this task. This mosaic image is geo-referenced and can be imported into GIS software (Solbø and Storvold 2013; Stødle et al. 2013).

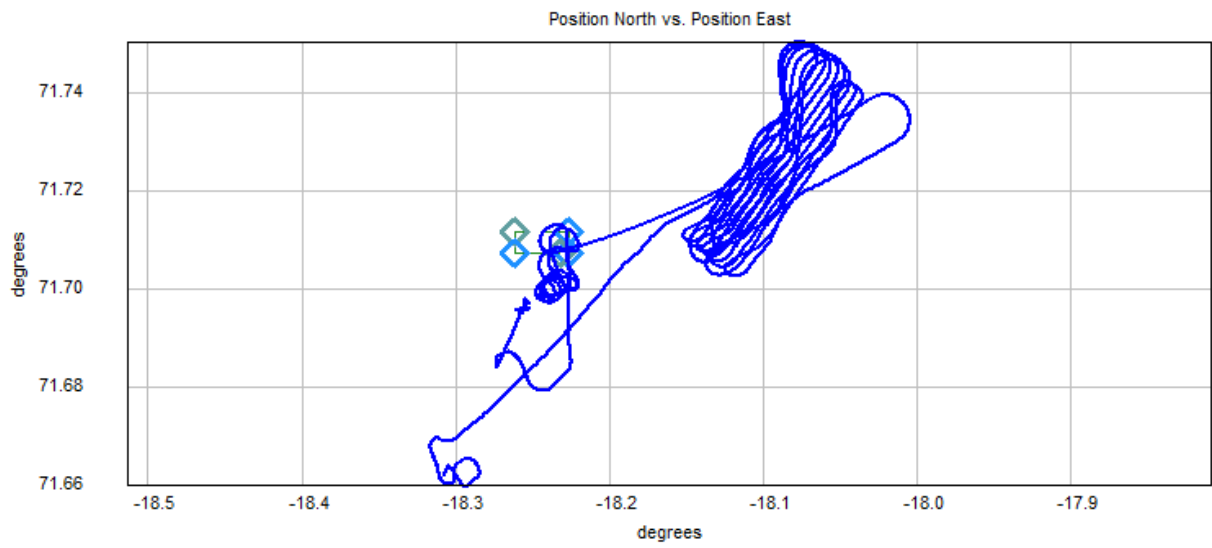
**Figure 8.** Flight track of the CW1 flight on 22 March.

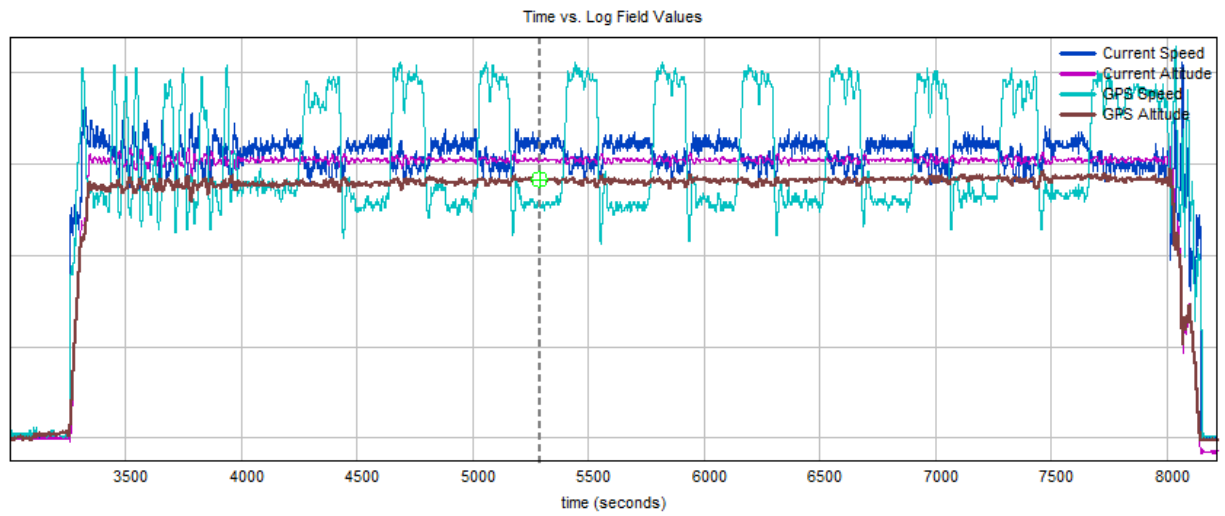
**Figure 9.** Altitude, airspeed and groundspeed from autopilot airpressure and GPS sensors. From the CW1 flight on 22 March.

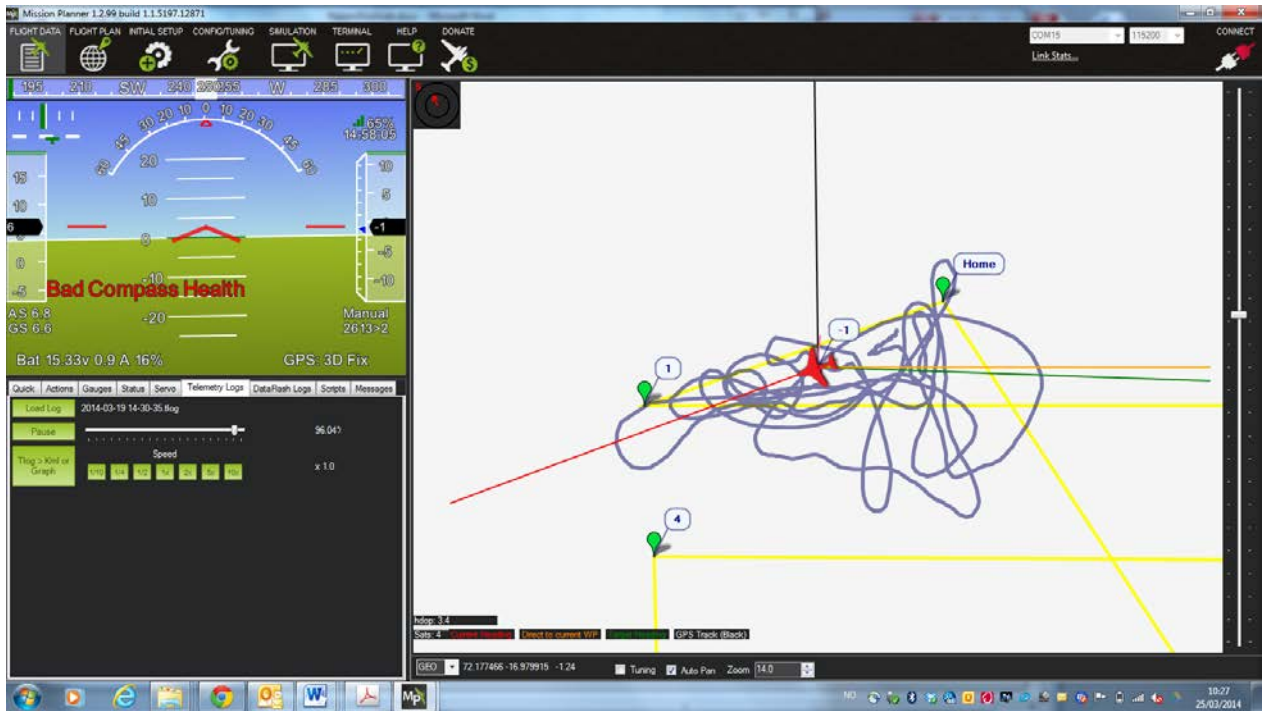
**Figure 10.** Flight track of the CWM on 19 March.

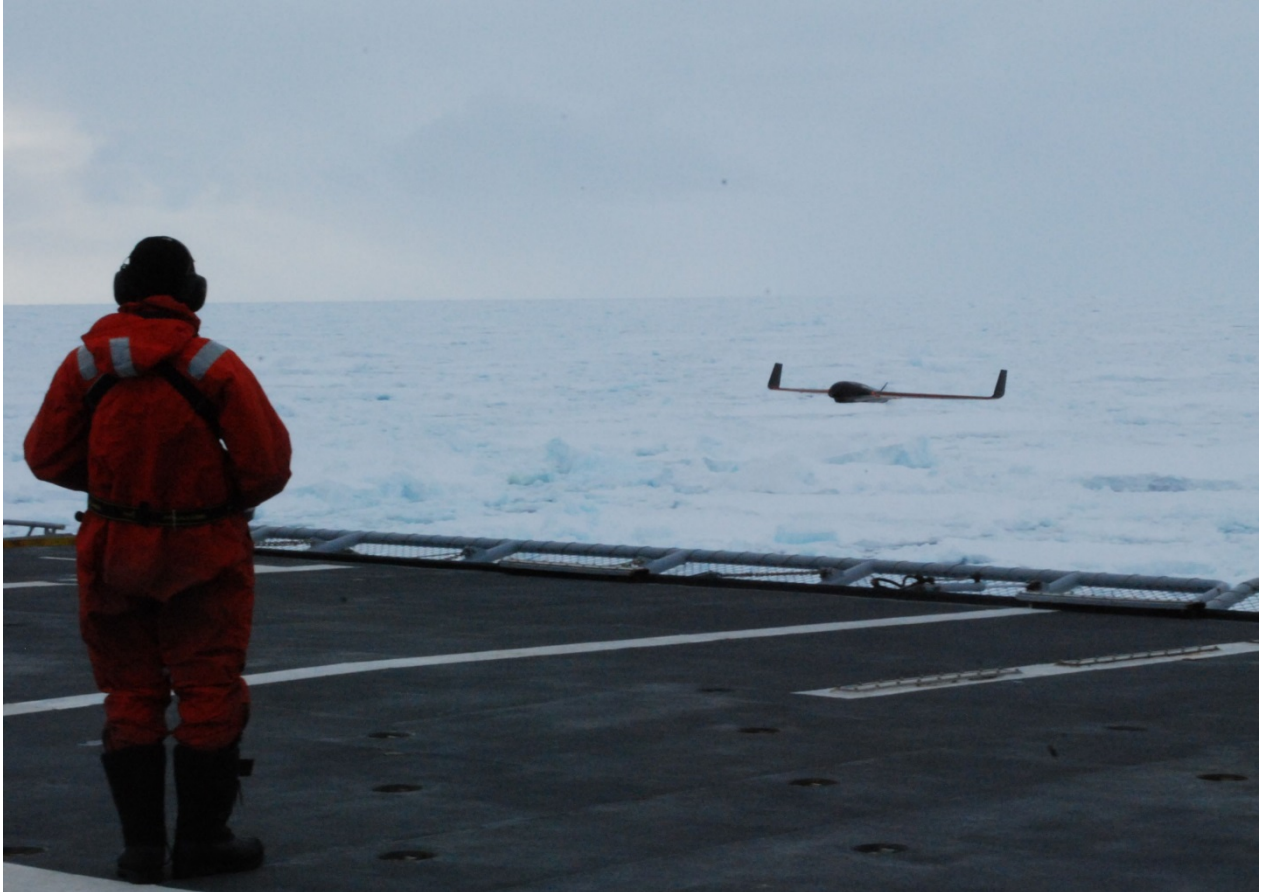
**Figure 12.** Kjell-Sture Johansen is performing a manual landing of the CWM on the KV “Svalbard” helicopter deck on 19 March. Photo: S. Solbø, Norut.

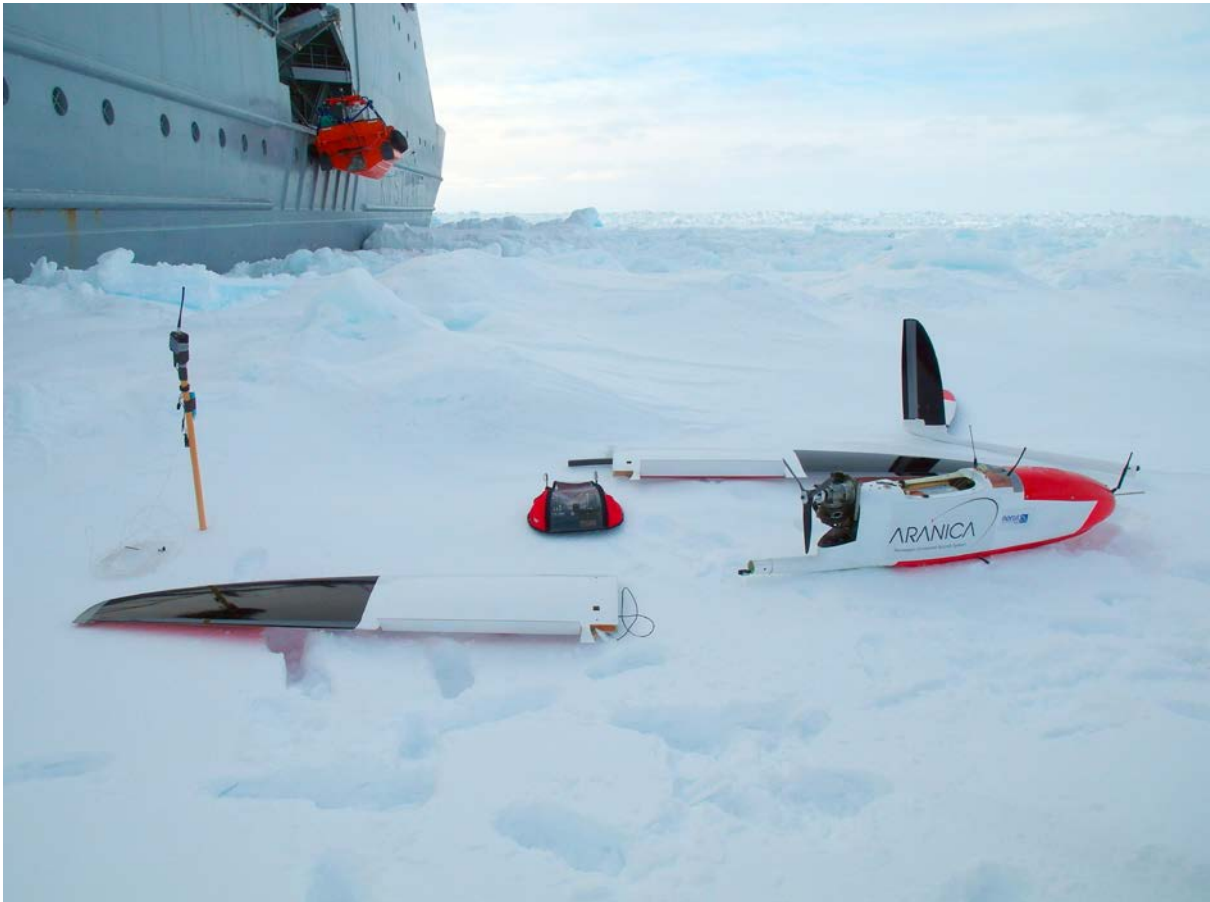
**Figure 14.** CW1 disassembled and ready to be packed in a container and picked up by the ship. Photo: M. Poltermann
