EXPERIMENTAL MANURE HANDLING SYSTEMS FOR REDUCING AIRBORNE CONTAMINATION

A Thesis Submitted to the College of
Graduate Studies and Research
in Partial Fulfillment of the Requirements
for the Degree of Master of Science
in the Department of Agricultural and Bioresource Engineering
University of Saskatchewan
Saskatoon

By
Karen Stewart

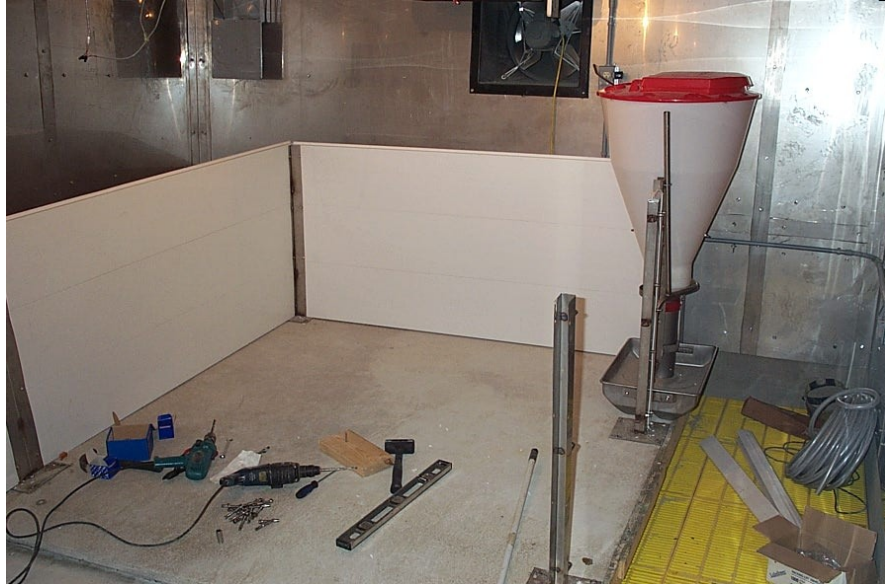
Plastic matrix flooring on fiberglass beams (Matrix Gold NR2424, Matrix Ag Inc., Calgary, Canada) that could be installed or removed in sections was used to make raised slatted floors 0.61 m above the concrete floor of the chamber (Fig. 2). Sections of this plastic flooring were removed in both chambers, allowing space for the washing gutter to be installed in one chamber and the inclined conveyor belt in the other. Plywood sheets (2 cm thick) covered by a 5 cm layer of concrete were set on supports on the slatted floors to produce sloped (8% grade) solid flooring in the areas of the pens not used for dunging. Penning was added to give each chamber the same amount of solid concrete flooring (2.13 x 2.13 m), and the same amount of dunging area (2.13 x 1.22 m) in the pens. These pens were sized for 10 grower pigs, providing each with 0.7 m² of floor space. This is more than the minimum 0.5 m² per grower pig recommended in Canadian Farm Buildings Handbook (Agriculture Canada, 1988) for solid floor pens for pigs under 45 kg.

Figure 2 Construction details in washing gutter chamber showing flooring and penning.

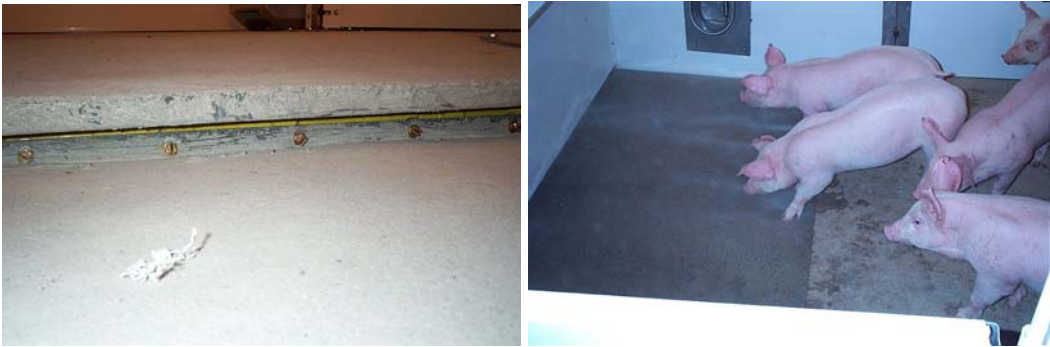
plywood holding 4 cm concrete as a table top (Figs. 3 and 4). Twelve nozzles (6 mm, brass 110° fan spray) were mounted (equally spaced) on a steel plate at the edge of the table top. These nozzles directed pressurized heated wash water parallel to the table top over the dunging area. The wash water came from the boiler supplying heated (to approximately 43°C) water to the barn, and was pressurized using a booster pump (Goulds Pumps 10GB20, ITT Industries, White Plains, NY, USA with a 2 cm Penn Flow Switch) to approximately 1.4 MPa.

a) Nozzles for the washing gutter b) Operation of the nozzles

Figure 4 Washing gutter used as a dunging area.

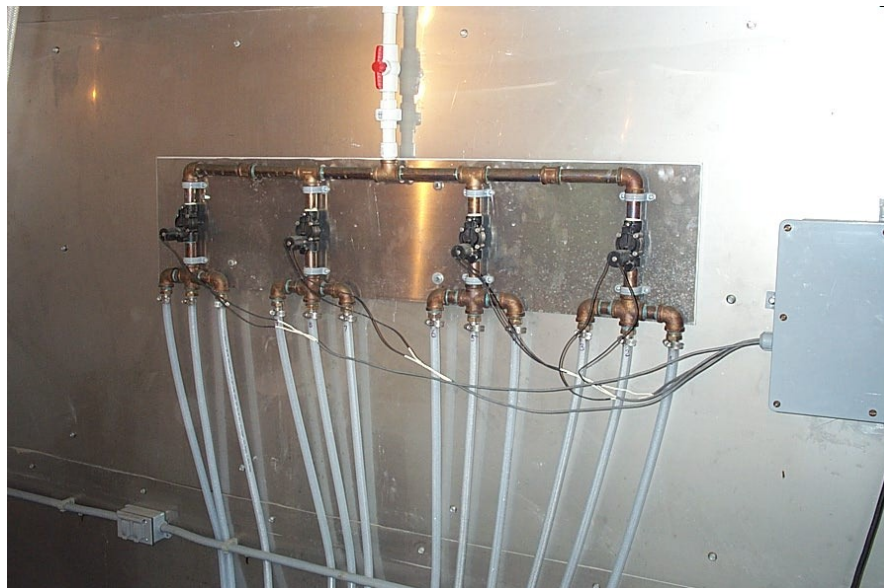
Four solenoid valves (24 VAC, 2 cm, nylon, normally closed), each controlling the water flow to three nozzles, were operated using a datalogger (Datataker DT 100, Data Electronics [Aust.] Pty. LTD., Rowville, Australia), and could be configured to deliver different amounts of water and different frequencies of flushes (Fig. 5). After some experimentation to find what worked well, the system was set up to open 6 nozzles for 30 seconds and then the remaining 6 nozzles for 30 seconds each time the dunging area was to be cleaned. The water flushed the by-products from the dunging area through a 4 cm gap under the pen wall into a 0.17 m x 0.14 m x 2.4 m long stainless steel gutter, which channeled the manure through a water trap (10 cm PVC P- trap) into the barn sewer system.

Figure 5 Solenoid valves in washing gutter chamber.

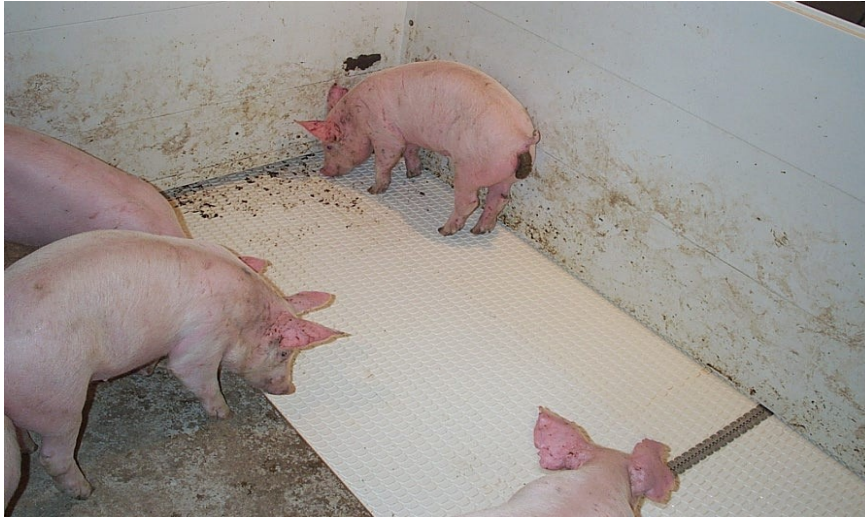
In the other experimental chamber, the 1.2 x 2.4 m custom-built conveyor belt (Univeyor Conveyors, Burnaby, BC, Canada) was used directly as the dunging area (Figs. 6 and 7). The conveyor belt could be configured to move at different timed intervals, controlled via a datalogger and the adjustable linear speed of the belt was extremely slow ($0.05 - 0.25 \text{ m s}^{-1}$). For these trials, the belt speed was set to allow

Figure 7 Pigs using the conveyor belt as a dunging area.

The conveyor belt worked well without any flooring above it. The belting chosen had a raised design to eliminate slipping, and no pigs were observed sliding on the belt. Perhaps an untextured belt with more incline to allow even better drainage would also work. This may be the first time this was tried with pigs, and their reactions are interesting. They did not avoid the belt, and did not seem to mind their dunging area moving them into a wall occasionally. They were very curious about the belt disappearing under the wall, and usually there would be pigs watching the belting vanish, although none of the pigs ever seemed to be curious about the belt appearing on the other side of the dunging area. Generally, in both rooms, the manure handling system starting up seemed to encourage the pigs to move into the dunging area, or race around the pen in play.

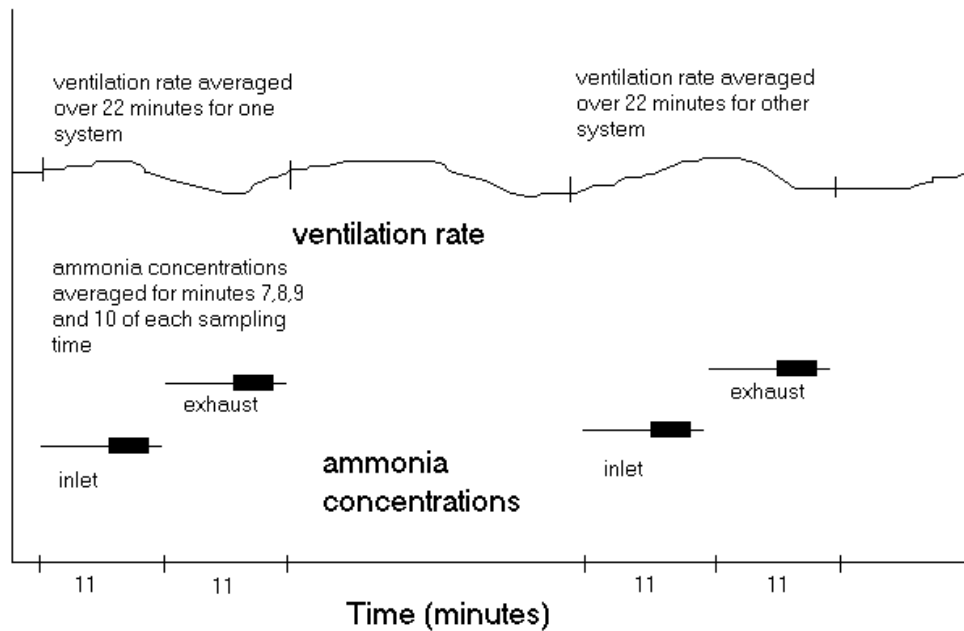
The inlet and exhaust concentrations for each chamber could not be measured simultaneously, as the same analyser was used to measure all the sampling locations. Therefore, the exhaust air was sampled immediately after the inlet of the same chamber, in order to have samples as close in time to each other as possible. The average difference between the inlet and the exhaust concentrations was considered a good representation of the ammonia added to the chamber during the total sampling time of 22 minutes (Fig. 10).

Figure 10 Ventilation and ammonia concentration sampling timeline.

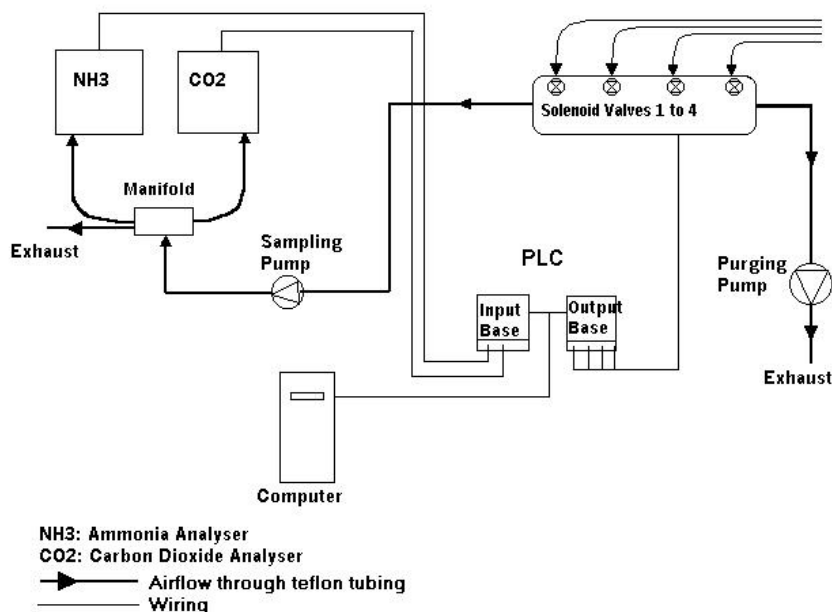
A 6.4 mm diameter Teflon tubing line was installed for each sampling location and each line was connected to a 3-way solenoid valve in the control chamber (Fig. 11). The sampling lines were contained within two 5.1-cm diameter polyvinyl chloride (PVC) pipes that linked the experimental chambers and the control chamber. A heater and a fan in the control chamber forced heated air through the PVC pipes,

keeping the temperature in the pipes above the room temperature to prevent condensation in the Teflon tubing.

Figure 11 Flow diagram showing airflow and information flow.

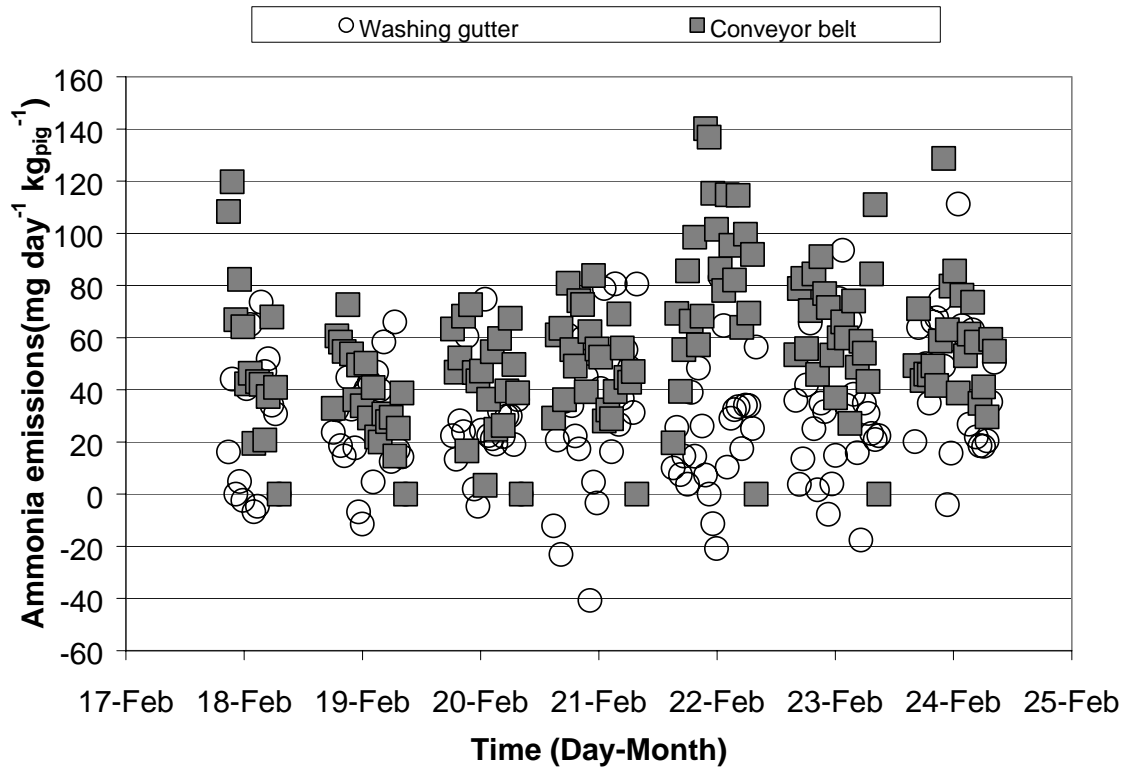
values (Fig. 15 and Fig. 16). Typically, ammonia emissions from the chamber with the washing gutter were slightly lower than for the chamber with the conveyor belt system. The ammonia emissions were also expressed as a function of the weight of pigs in the chamber in order to make comparisons with other trials and with the values found in the literature (Table 1). For all trials combined, the average ammonia emissions from the washing gutter system were $48.7 \text{ mg day}^{-1} \text{ kg}_{\text{pig}}^{-1}$ ($24.4 \text{ g day}^{-1} \text{ animal unit}^{-1}$ where an animal unit is defined as 500 kg live weight), and from the conveyor belt system were $57.0 \text{ mg day}^{-1} \text{ kg}_{\text{pig}}^{-1}$ ($28.5 \text{ g day}^{-1} \text{ animal unit}^{-1}$). Previous experiments in the same research facility with the same size of pigs reported average ammonia emissions of $46 \text{ g day}^{-1} \text{ animal unit}^{-1}$ (Payeur, 2003). On average, ammonia emissions from the rooms equipped with the washing gutter and conveyor belt systems corresponded to 53% and 62% of those baseline emissions, respectively.

Figure 15 Ammonia emissions from experimental chambers February 17 - 25, 2004. This week had the lowest average weekly emissions of all the trials for the washing gutter chamber.

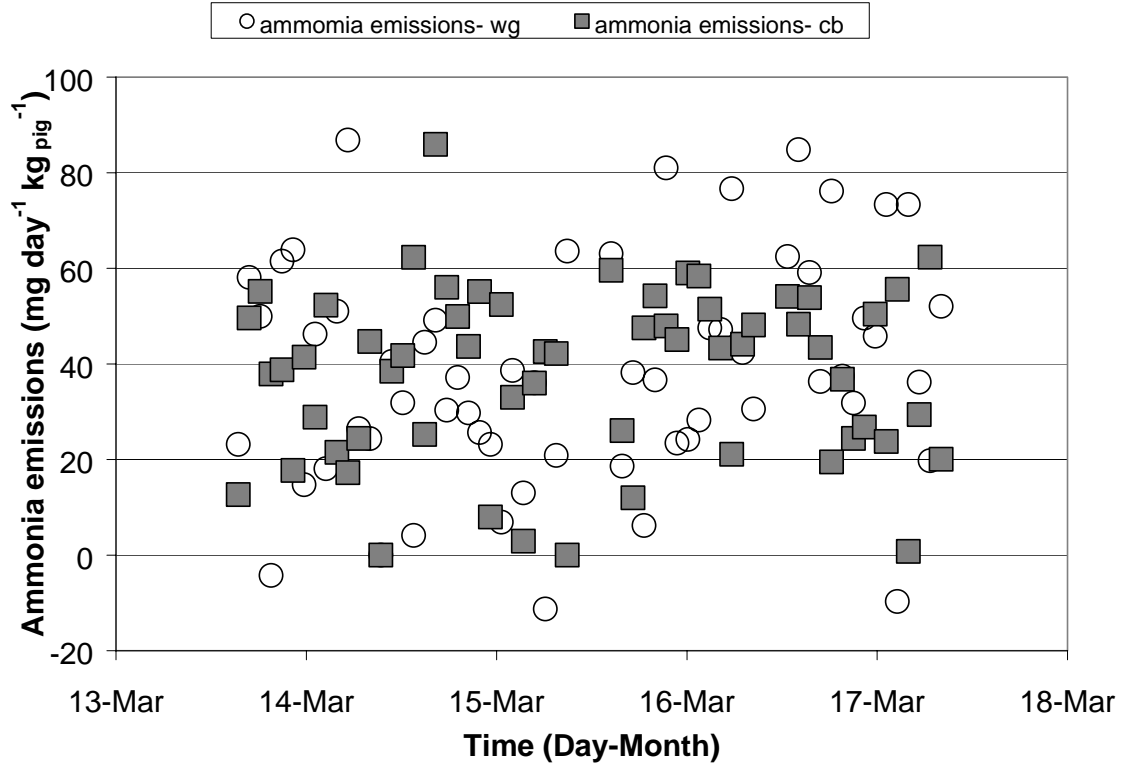
Figure 16 Ammonia emissions from experimental chambers from March 13 – 18, 2004. This week had the lowest average weekly emissions of all the trials for the conveyor belt system.

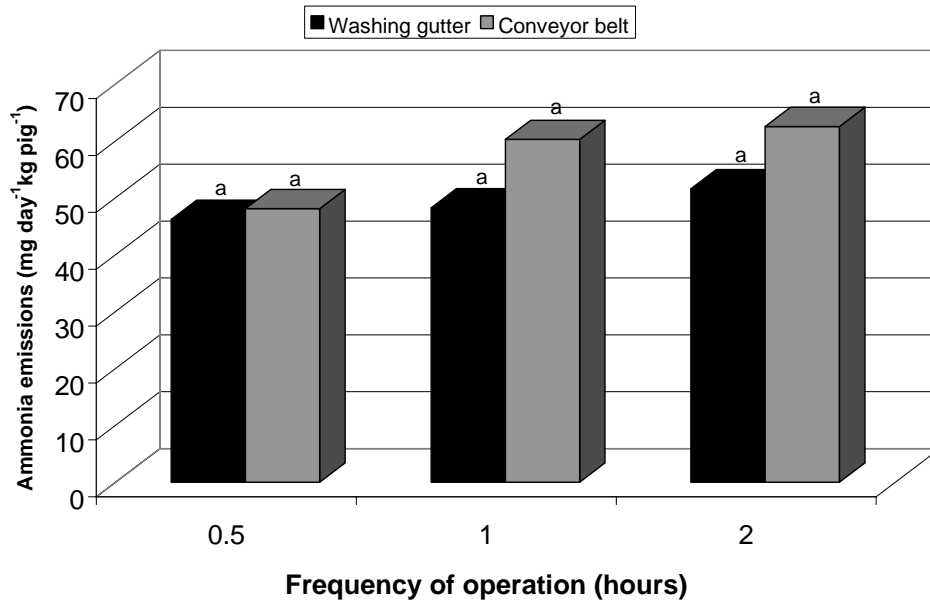
These average weekly emission values were used in the statistical analysis of the systems and the frequencies, and no significant differences were found between the systems and frequencies of operation. Based on the statistical analysis, both systems provided the same level of ammonia emissions and operating the cleaning systems more frequently did not reduce emissions (Fig.17).

Figure 17 Average ammonia emissions from the experimental chambers over all the trials. Averages followed by the same letter are not statistically different ($P>0.05$).

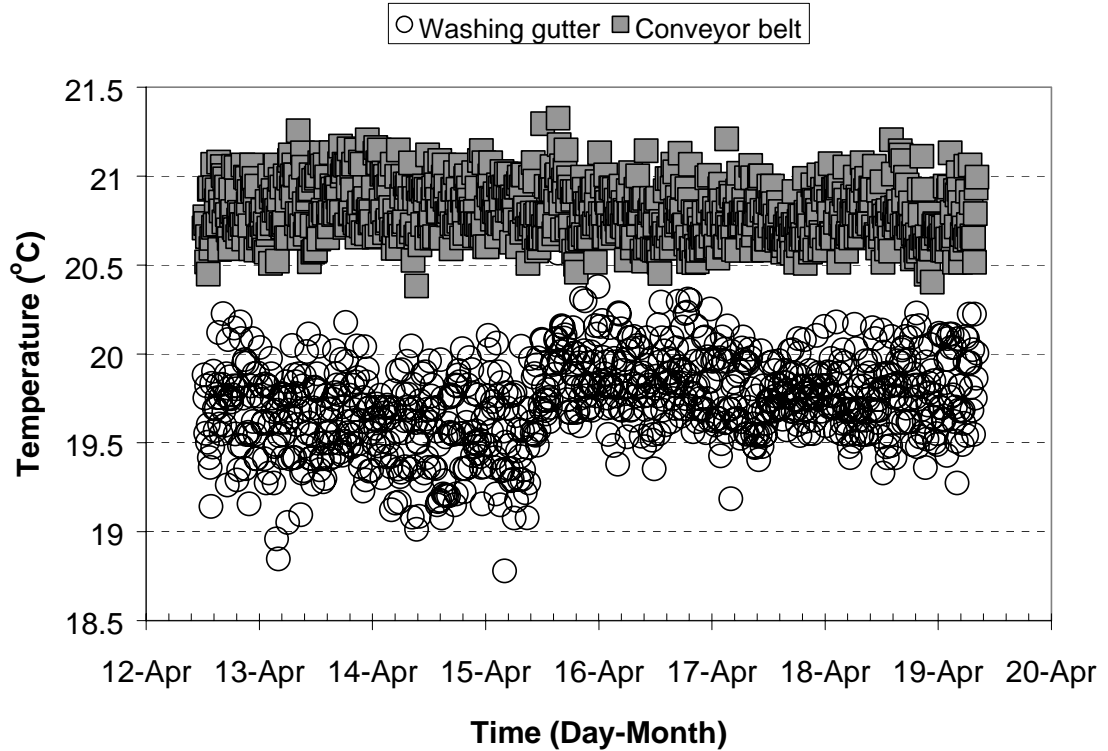
The temperature set points in the chambers varied a little depending on the average weights of the animals in the chambers, but the two chambers had the same set points at all times. Measured temperatures in the conveyor belt chamber were usually higher than in the washing gutter chamber (Fig.18), perhaps due to a controller calibration error at the beginning of the experiment.

Figure 18 Temperatures in the experimental chambers from April 12 - 19, 2004.
