**A STRUCTURAL HEALTH MONITORING SYSTEM FOR COMPOSITE  
PRESSURE VESSELS**

**A Thesis Submitted to the College of  
Graduate Studies and Research  
in Partial Fulfillment of the Requirements  
for the Degree of Masters of Science  
in the Department of Mechanical Engineering  
University of Saskatchewan  
Saskatoon**

**by  
Bryan C. Lung**

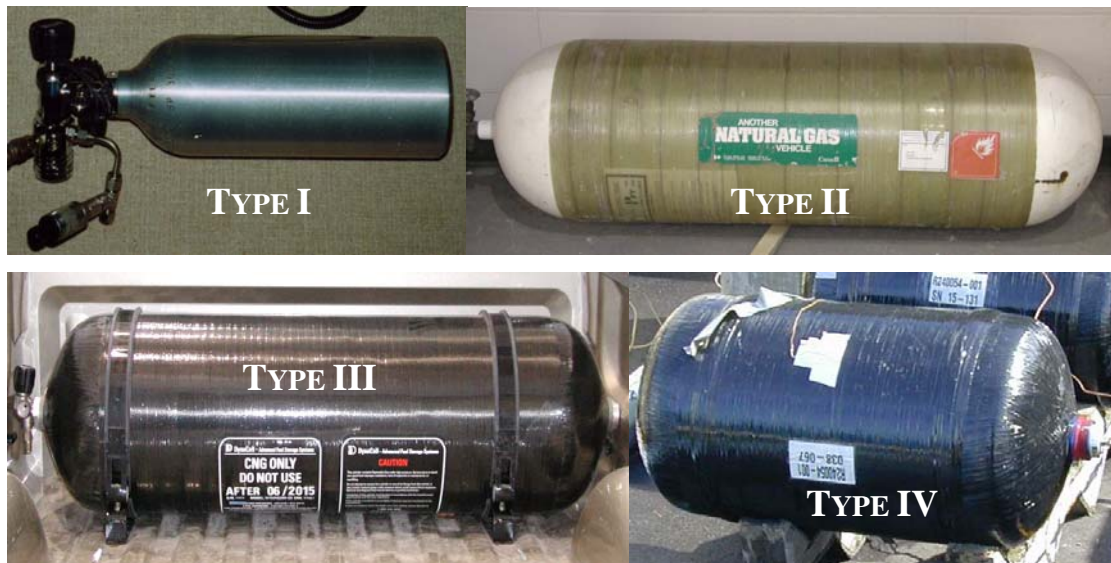
- Type I: All – metal pressure vessels, commonly called monolithic pressure vessels,
- Type II: Metal pressure vessels that are hoop-wrapped on the body with fiber reinforcement,
- Type III: Metal-lined pressure vessels completely wrapped fiber reinforcement, and
- Type IV: Plastic or non-metal lined pressure vessel with complete wrapped fiber reinforcement.

**Figure 1.1: Different Pressure Vessel Classifications**

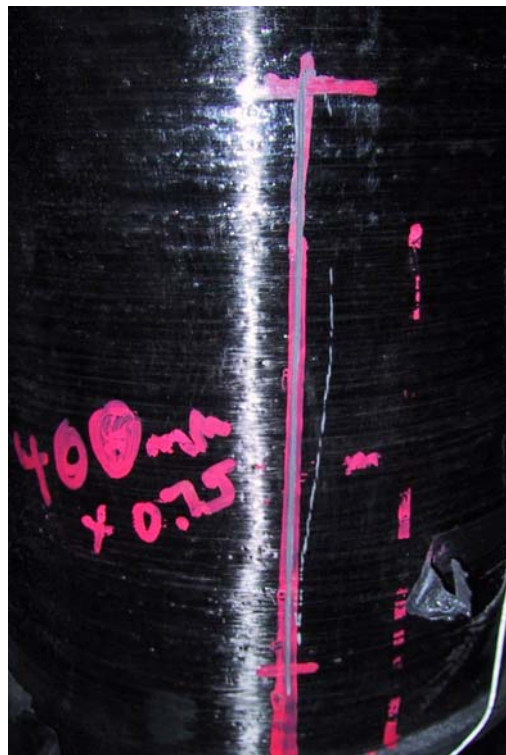
As can be seen from the above standard, the requirements for the tank to withstand cut and gouge damage are extreme and excessive. This serves as a good minimum threshold of damage for the damage detection system to pick up. Varying degrees and depths of cuts were examined for conditions under and above what the standard calls for, and used to verify and quantify the damage present in the tank. This is illustrated in Figure 2.2.

**Figure 2.2: Typical Cut and Gouge Testing**

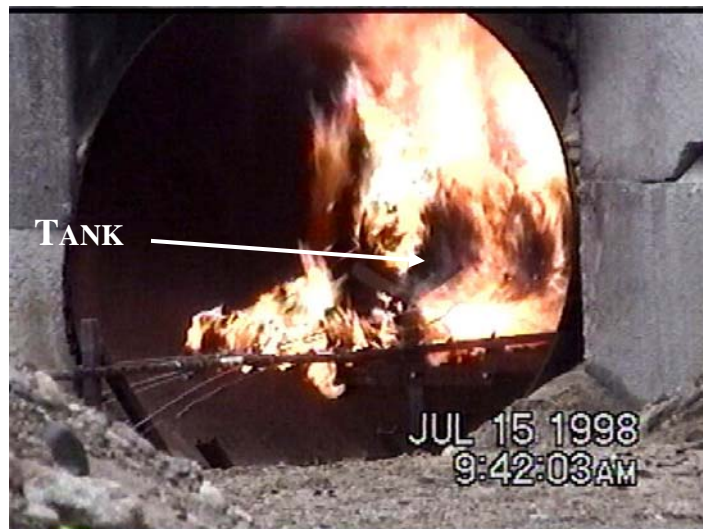
This damage type is typically identified in the codes and standards as “Bonfire Testing”, as summarized in Appendix A. It is considered a crucial component of the test matrix for the design certification of cylinders. The bonfire test objective is to determine the failure mode of the pressure vessel under heat damage. However, the damage inflicted in this test is typically too massive to get an accurate reading on threshold values. A typical bonfire test is shown in Figure 2.3. As can be seen, the tank is completely immersed in flames, and any sensors, connections or wires that are unprotected are burned off.

**Figure 2.3: Bonfire Testing**

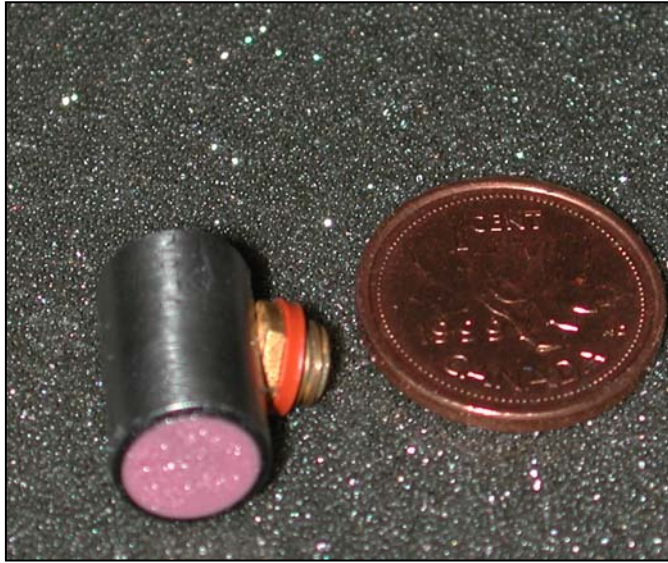
**Figure 3.1: Conventional Piezoceramic-Type Sensor**

Three different sensors were selected as potential candidates for the tank diagnostic system. These included the conventional piezoceramics, piezo-film, and flexible ceramic matrices. The first type is the conventional piezoceramic sensor, an example of which is shown in Figure 3.1. Recent developments in sensor technology (spawned initially from accelerometer developments) have reduced the size and cost of these sensors.

The piezoceramic sensors examined in this study were manufactured by Physical Acoustics Corporation (PAC) and Digital Wave Corporation. The sensors require a coupler to the structure being examined – typically vacuum grease or hot glue. Typical units have a sensitivity range up to several hundred kilohertz and are used for acoustic emission evaluation of structures. Sizes and costs have been drastically reduced, but they still remain bulky to use and in this case would need to be installed into the cylinder endboss. The typical sensor costs are around \$1000 for a single sensor.

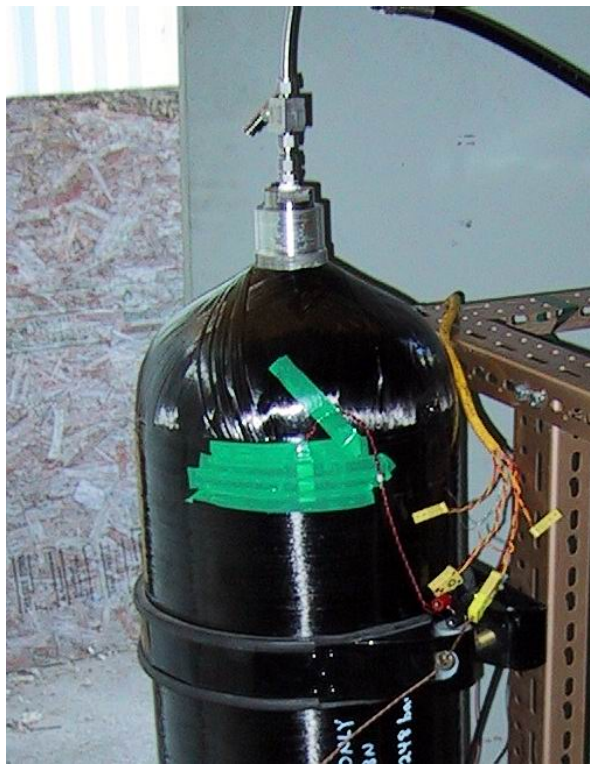
**Figure 3.13: Sensor Surface Mount Testing**

Figure 3.10 shows the apparatus for tank structure testing. Independent sensitivity studies were conducted based on sensor size, rotation, mounting mechanisms, location, and surface mounting versus integral mounting. These conditions are illustrated in Figures 3.11, showing sensitivity of sensor placement to flaw location. Figure 3.12 shows sensor size and rotational testing, and Figures 3.13 illustrates the sensor surface mounting testing. Figure 3.14 shows the final embedded sensor design and placement based on prior sensitivity testing.

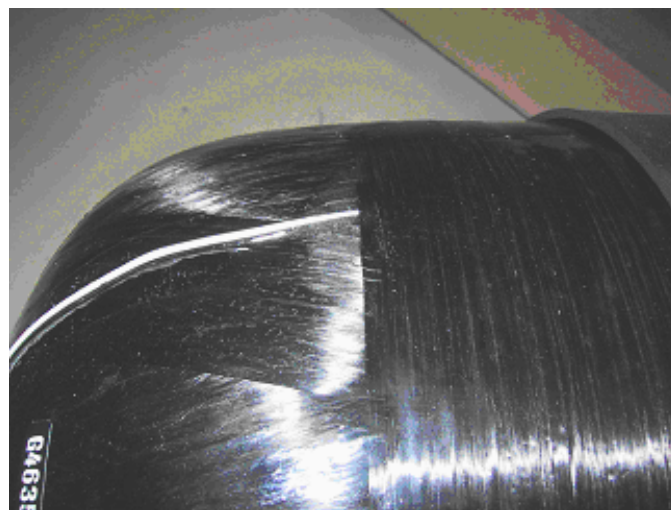
**Figure 3.17: Embedded Sensor Final Design**

The final sensor design is shown in Figure 3.17. This sensor design consists of a completely encased sensor with the final wrap of the carbon-fiber shell. There is relatively little chance of damage to the sensors or leads as they are wound predominantly into the cylinder structure. Furthermore, noise levels are reduced as the carbon fiber is an electrical semiconductor. This creates a condition very similar to a Faraday Cage, where electrical, electromagnetic, and radio-frequency noise is kept to a minimum. A summary of the manufacturing procedure can be found in Appendix B.

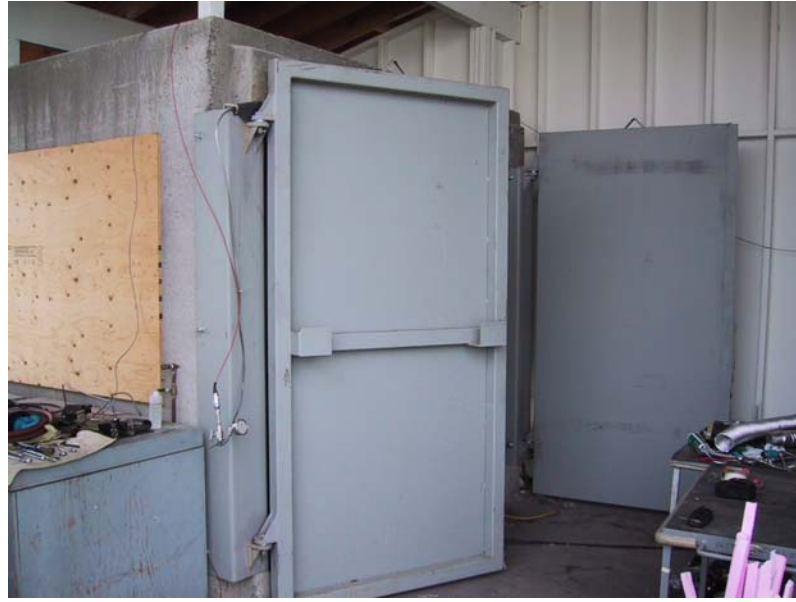
**Figure 4.3: Test Chamber with Blast Doors**

All tests were performed in the test chamber shown in Figure 4.3. There is a large amount of energy stored in a tank under high pressure, and safety precautions were made accordingly.

Pressure transducers were located outside the cylinder and test chamber and routed through high-pressure hosing and tubing, so that destructive tank testing could be conducted without any risk to personal safety.

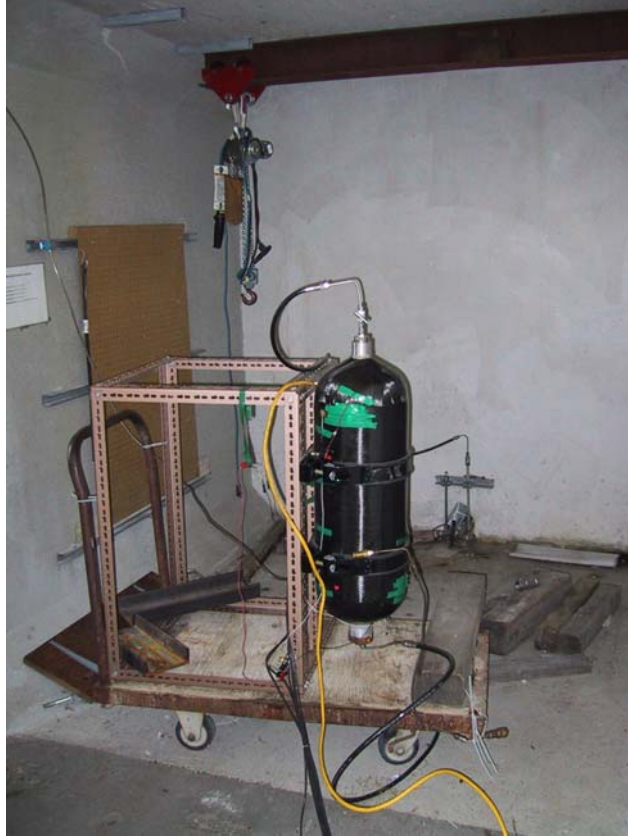
**Figure 4.4: Support System**

The structure, as shown in Figure 4.4 was utilized to support the tank during testing. Provisions were made to facilitate testing of different mounting mechanisms (neck mounting and tank strap mounting). Furthermore, testing with different media was examined, including water and gaseous media.

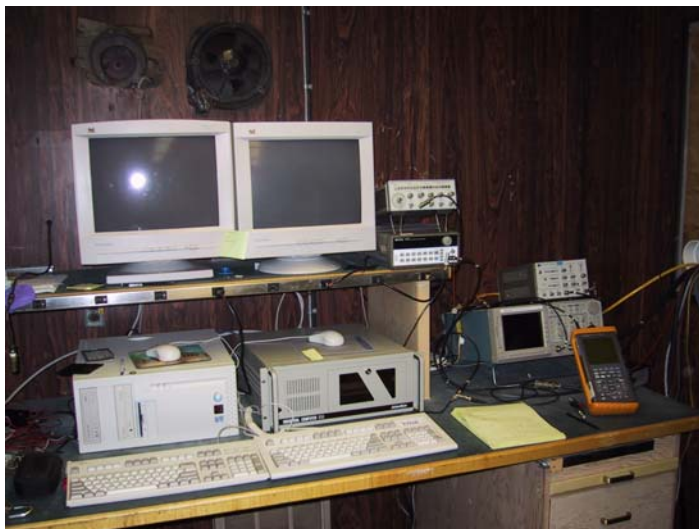
The tank damage monitoring system is shown in Figure 4.5. This system utilized two personal computers interfaced together in Matlab®. One computer was used for monitoring environmental variables and tank impedance, while the other was used to monitor the health of the pressure vessel. Signal generators were required, and all systems were interfaced to work in unison.

**Figure 4.5: Tank Damage Detection and Analysis System**

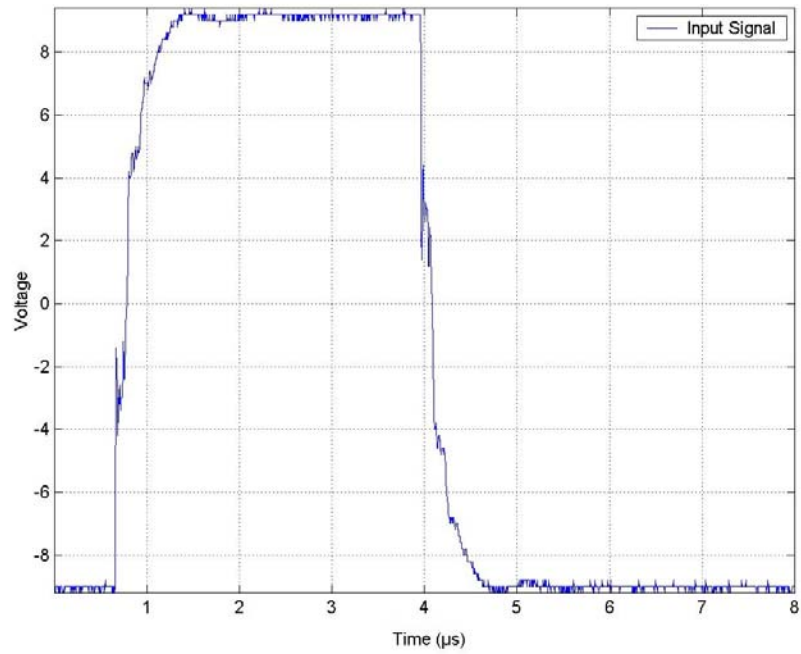
Typical input signals to the piezo-film transducers are shown in Figure 5.1. Typical output or received signals are shown in Figure 5.2.

**Figure 5.1: Input Signal**

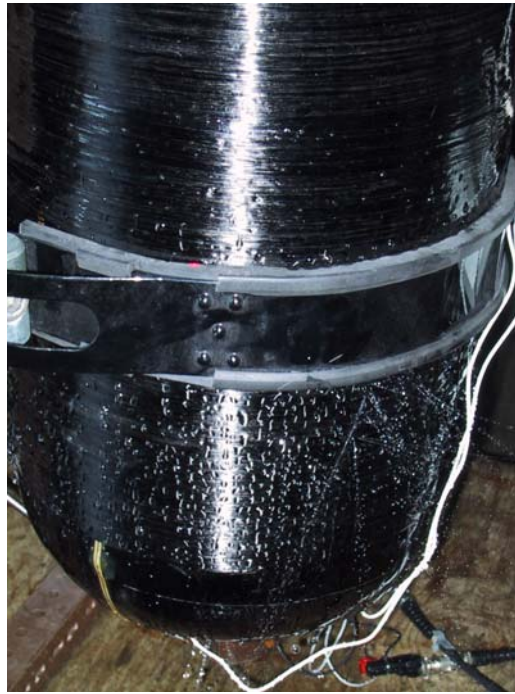
characteristics for the tank make the exact loading on the aluminum liner unknown. This autofrettage procedure stresses the tank to put the aluminum liner under compression when the tank is empty (much like preloading a bolt before loading it), and this results in placing the stresses on the composite in one direction (tension) only.

**Figure 6.2: Tank Fatigue Failure**

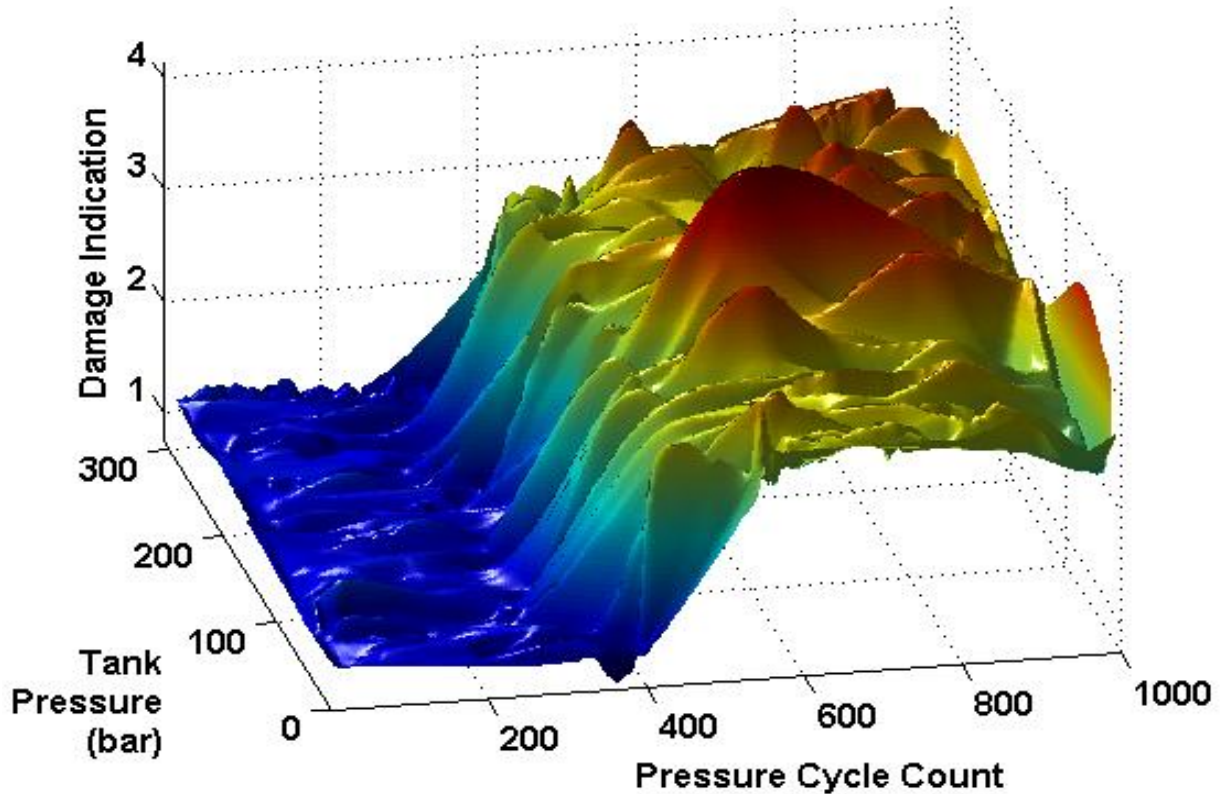
Figure 6.3 shows the results of the cut and gouge damage inflicted on Tank G4642. The system was operated for the first 500 cycles to generate a normal operational profile. As can be seen for the first part of the tank life, the system operates with a nominal damage indicator coefficient value of 1.0. After the damage was inflicted, however, there is a noticeable change in the damage indicator with a jump in reading past 2.5. The tank damage consisted of two longitudinal cuts: 400 mm by 0.75 mm and 25 mm by 1.75 mm, as specified in the NGV2-2000 standard.

**Figure 6.3: Cut and Gouge Damage Results**

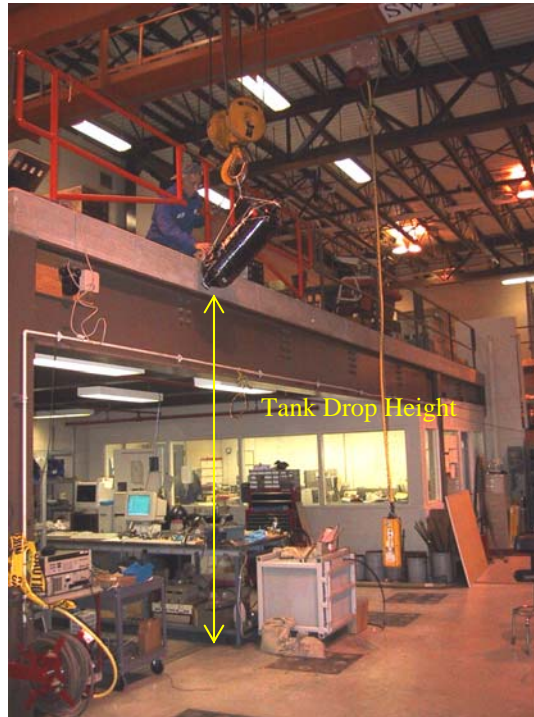
Figures 6.6 and Figures 6.7 show respective damage on the tank and the damage mechanism that has been used to inflict the damage on the tank. As has been previously indicated, the damage is not visible to the naked eye. However, the damage on the tank has been substantial enough to produce a pronounced change observable to the tank damage detection sensing system.

**Figure 6.7: Tank Drop Height of 3.05m (10 ft)**

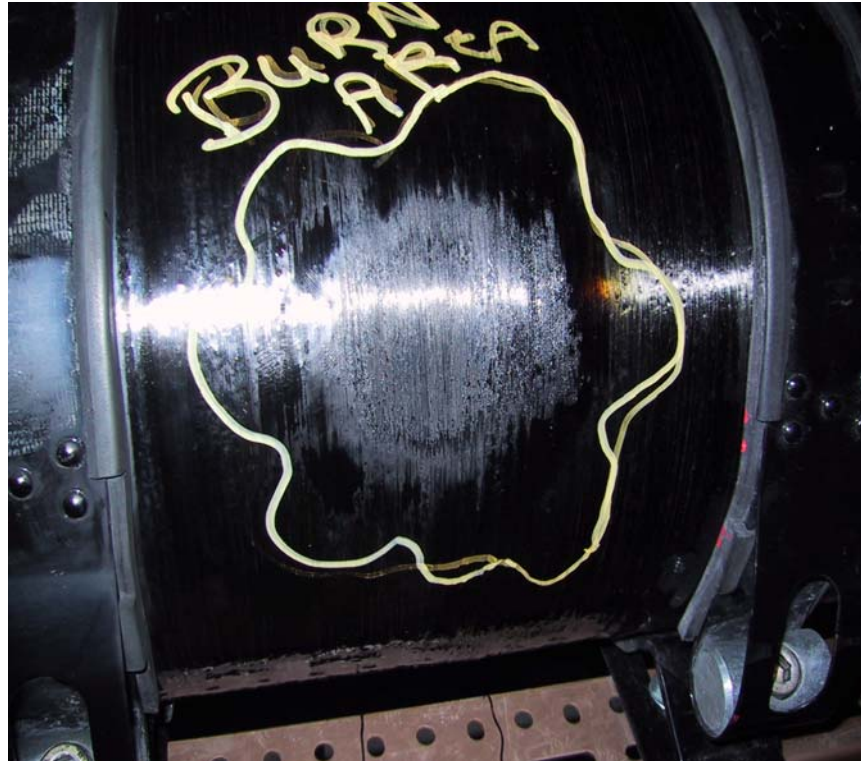
The heat damage on the tank is shown in Figure 6.9 as a change in color on the surface of the tank. This is actually indicative of the loss of the epoxy matrix that holds the CFRP overwrap together.

**Figure 6.9: Heat Damage on Tank Sidewall**

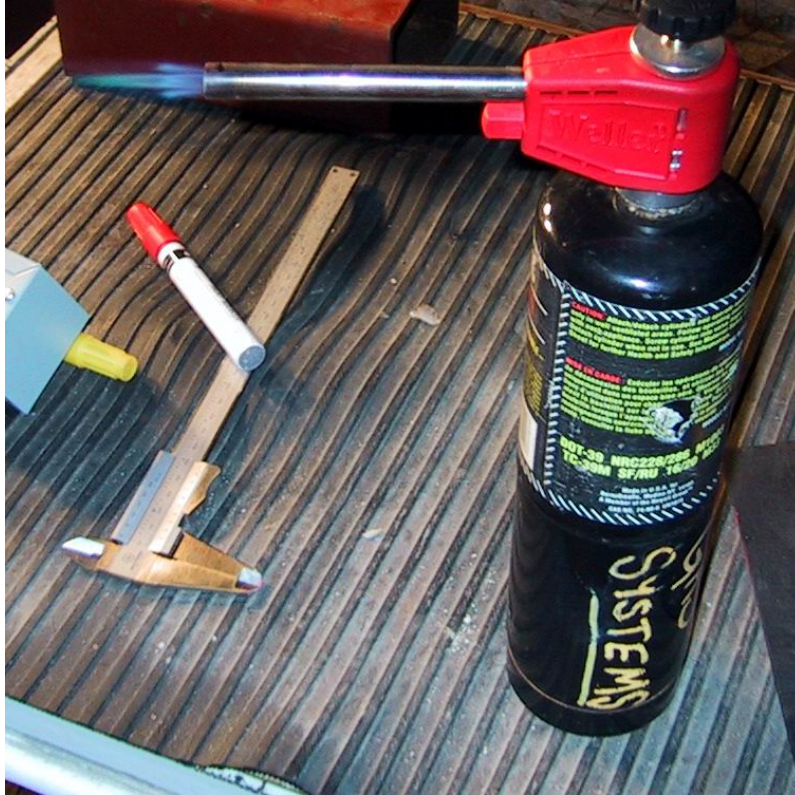
The small propane heat source is shown in Figure 6.10. This small torch was applied to the surface of the tank and was held for approximately 30 seconds. A localized area of heat damage was created from the torch, simulating the application of heat on a tank side wall from such operations as cutting a strap or a bolt off the mounting mechanism. Although the damage is visible to the eye, there is the risk that the tank will be subsequently installed with the damage hidden from view. As such, it is important to detect and manage this damage mechanism.

**Figure 6.10: Propane Torch Used to Create Heat Damage**

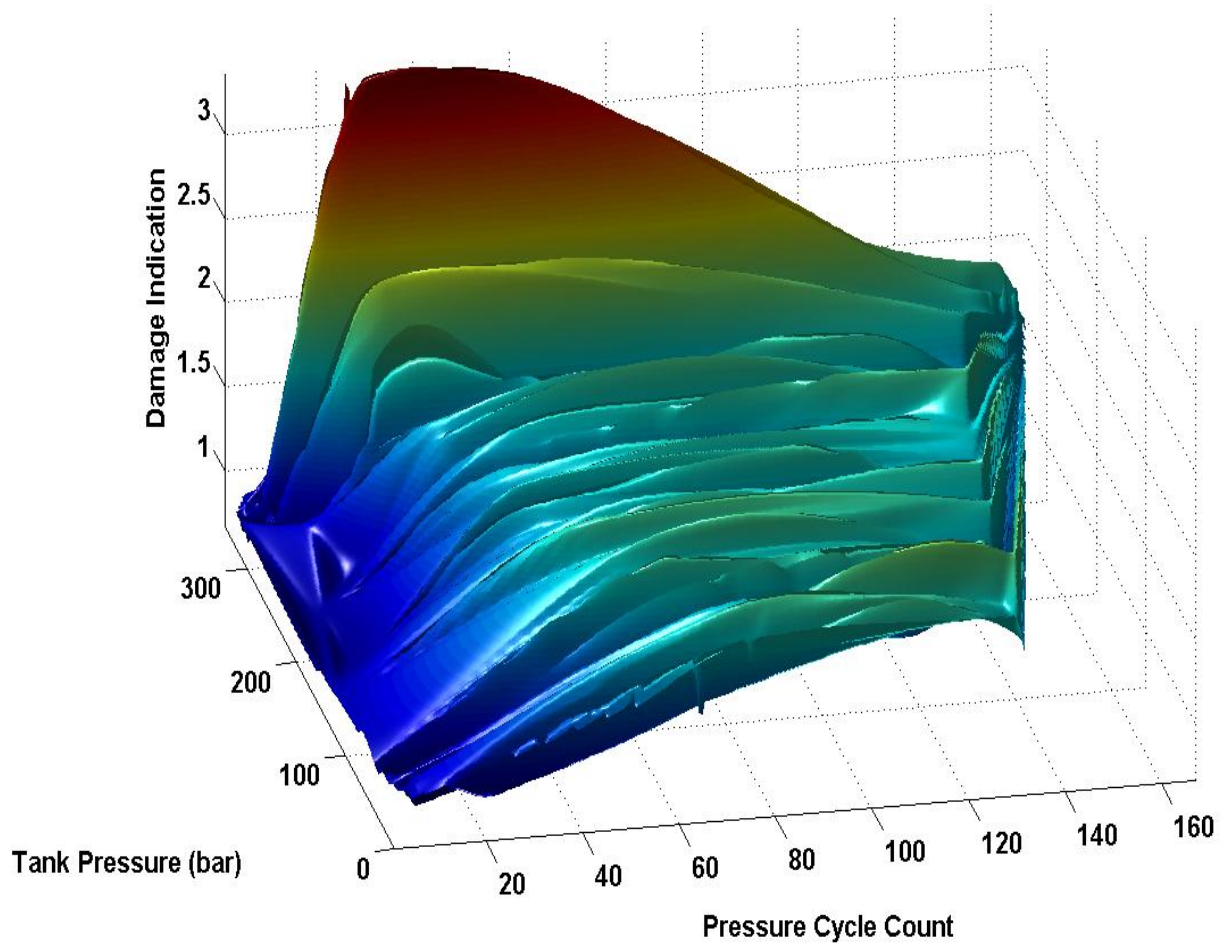
Figure 6.11 indicates the test results from the simulated stress rupture testing. The tank was subjected to an elevated pressure three times its service pressure up to 630 bar (9100 psi) and let set for eight hours. This is further illustrated in Figure 6.12; however, the stress rupture damage is shown at 30 pressure cycles with an elevation in damage from 1 to 1.5. Note that the damage detection system was not activated during the over-stressing at three times its service pressure. The results shown in Figure 6.11 indicate damage indicator levels before the over-stressing and after the over-stressing.

**Figure 6.11: Stress Rupture Damage Plot**

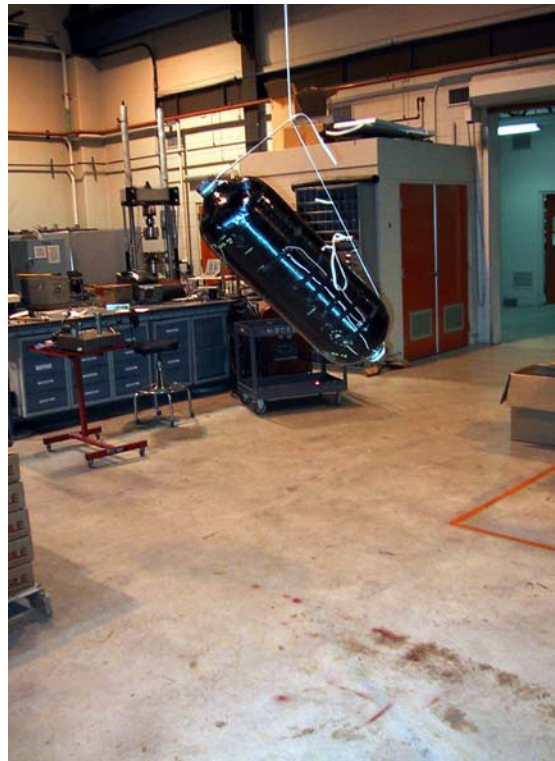
Figures 6.15 and 6.16 show the drop site where the 1.8 m (6 ft) drop was conducted, and the subsequent damage to the tank. Note that this damage is considered minimal for the design with little or no reduction in burst strength of the tank.

**Figure 6.15: Drop Impact from 1.8 m (6 ft) onto Smooth Concrete**

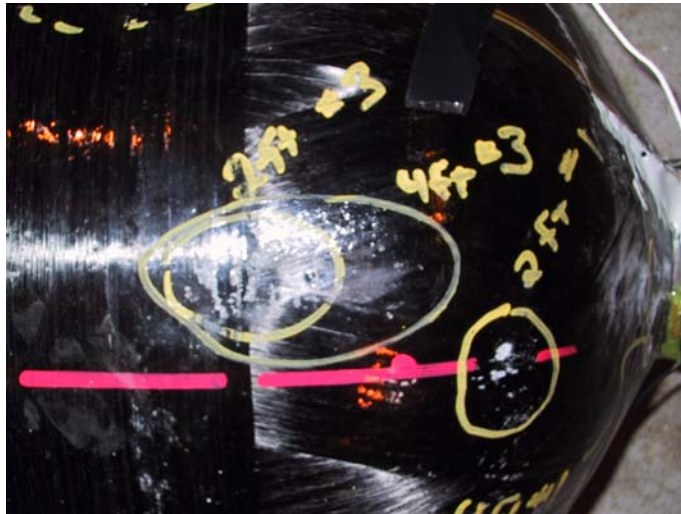
**Figure 6.16: Delamination Damage from 1.8 m (6 ft) Drop**

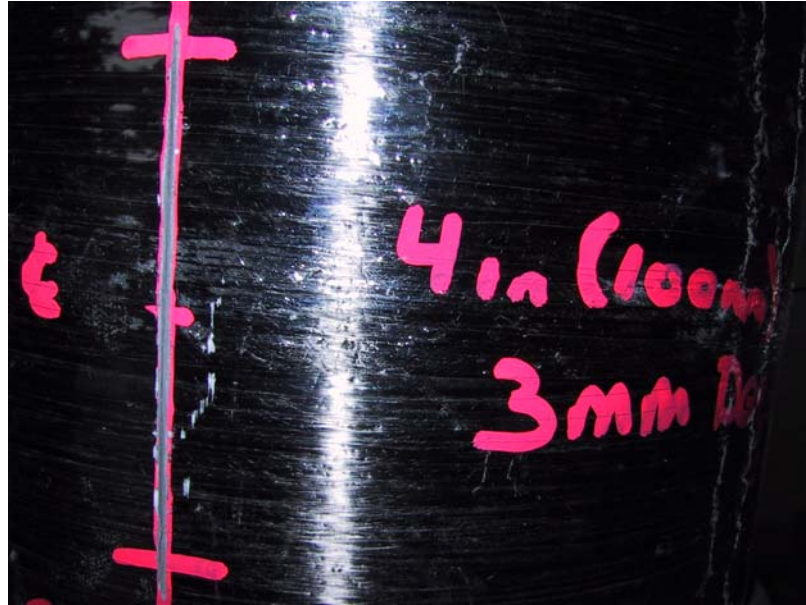
Figures 6.17 and 6.18 show the two cuts applied to the tank. The first cut, 100 mm (4 in.) long and 3 mm (0.11 in.) deep was applied to the tank at 3000 pressure cycles, producing a damage indication level of 3.5. Note that the damage indicator rises sharply and settles at the new level, giving indication of the damage inflicted on the structure, and not of a transient response that becomes immeasurable. The second cut, 100 mm (4 in.) long and 4.5 mm (0.18 in.) deep was inflicted at 7000 pressure cycles. Note that this was accomplished by cutting the tank at the same point as Cut #1, just making the cut deeper. This was done to show incremental damage levels on the tank. This produces a stable damage indication reading of 4.8.

**Figure 6.17: Cut #1 – 100 mm (4 in.) Long by 3 mm (0.11 in.) Deep**

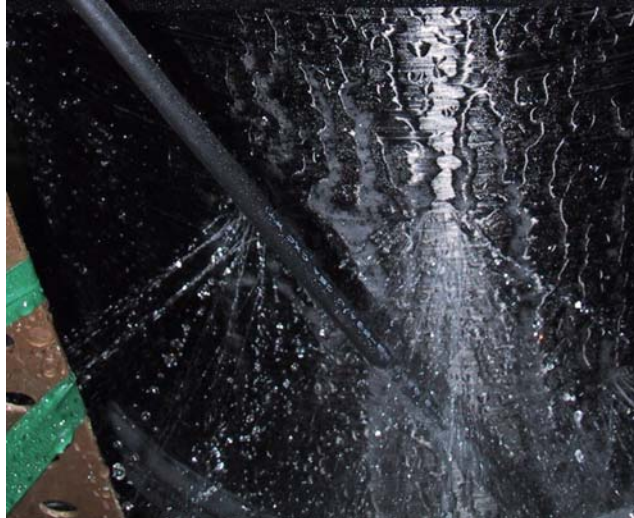
**Figure 6.19: Fatigue Failure of Tank after 17,500 Pressure Cycles**

Figure 6.19 shows the eventual fatigue failure of the tank after 17,500 pressure cycles, the equivalent of 48 years of operation at one fill per day. The tank fails under liner fatigue directly opposite the cut line.

At 17,500 pressure cycles, the tank begins to leak, but not before the damage indication levels rise. When the tank starts to leak, the hydraulic system is not able to produce 310 bar (4,500 psi) in the test tank, and the system shuts down. The observations of the system at high pressure, and at a high damage indication (6.0) show that the system was able to pick up an elevated damage signal before the tank fatigued. This is important because the system has the potential to produce an early damage indication before eventual failure occurs. In field implementation, a single pressure cycle is typically observed in a day for most gaseous-fuelled vehicles, giving ample opportunity for the system to detect damage.

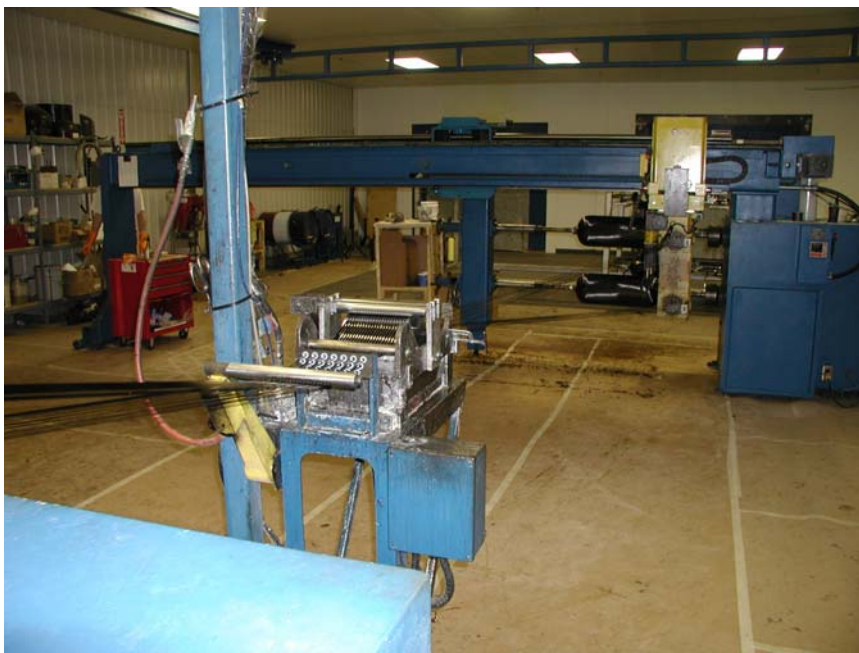
**Figure C.2: Computerized Winding Machine**

Figure C.2 shows the computer controlled winding machine used in the winding process. The machine requires a pre-programmed winding scheme based on a particular cylinder

design. Further to this, this winding machine has been specifically designed and manufactured to this application.

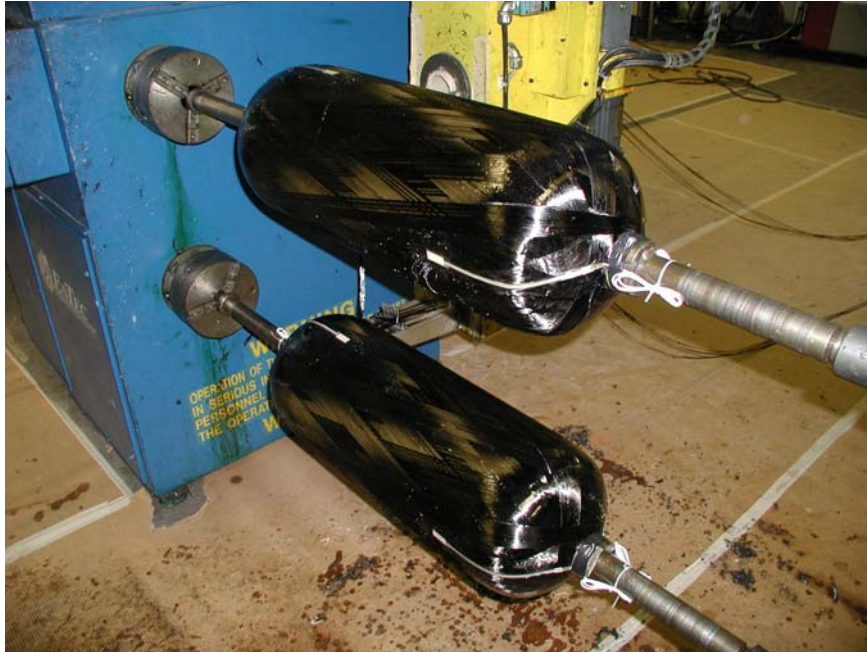
**Figure C.4: Helical Wrapping and Sensor Placement**

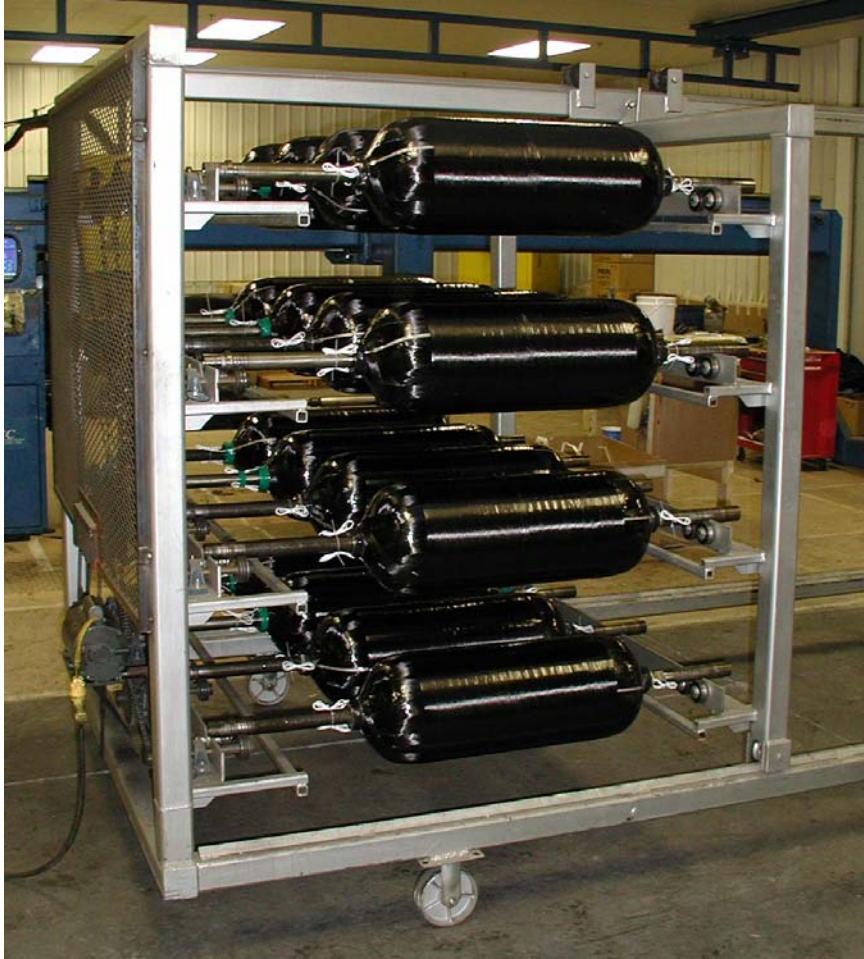
Figure C.5 shows the assembly used for curing the resin on the cylinders after winding has been completed. The cylinders are placed on a rack that has a mechanism for rotating the cylinders while being placed in an oven at elevated temperatures. The purpose of rotating the cylinders is to prevent drips and large pockets of resin from forming on the surface, which will tend to crack once the cylinder is put into service. Any drips or surface epoxy will crack due to the large deflections that the cylinders undergo when pressurized (between 1 and 3% strain longitudinally, and up to 5% strain in the hoop direction).

**Figure C.5: Curing Assembly**
