**THE INFLUENCE OF THERMAL EFFECTS ON
STRUCTURAL HEALTH MONITORING OF ATTRIDGE
DRIVE OVERPASS**

A Thesis

in the Department of Civil Engineering

University of Saskatchewan

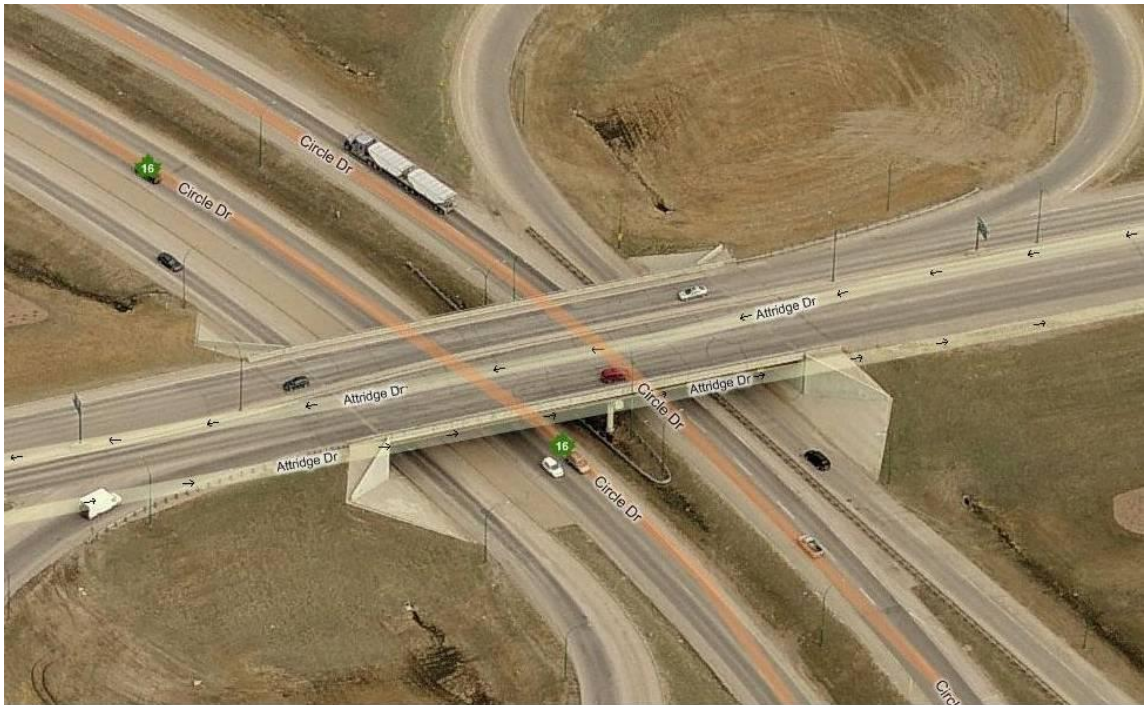
Figure 3.1. Aerial view of the Attridge Drive Overpass (Source: Microsoft Bing Maps).

The Attridge Drive Overpass (Figure 3.1 and Figure 3.2) is located at the intersection of Attridge Drive and Circle Drive in the City of Saskatoon, Saskatchewan, Canada. Built in 2001, the structure is a two-span integral abutment bridge with an alignment that is skewed by $16^{\circ}5'16''$ and span lengths of 38.7 m and 30.6 m. The overpass is a composite steel girder-concrete deck structure with a 300 mm thick reinforced concrete deck and a 90 mm polymer modified asphalt wearing surface. Supported by nine built up steel girders, the bridge deck is 27 m wide and is sloped at 2% towards the outside shoulders. As can be seen in Figure 3.3, the bridge features four eastbound lanes

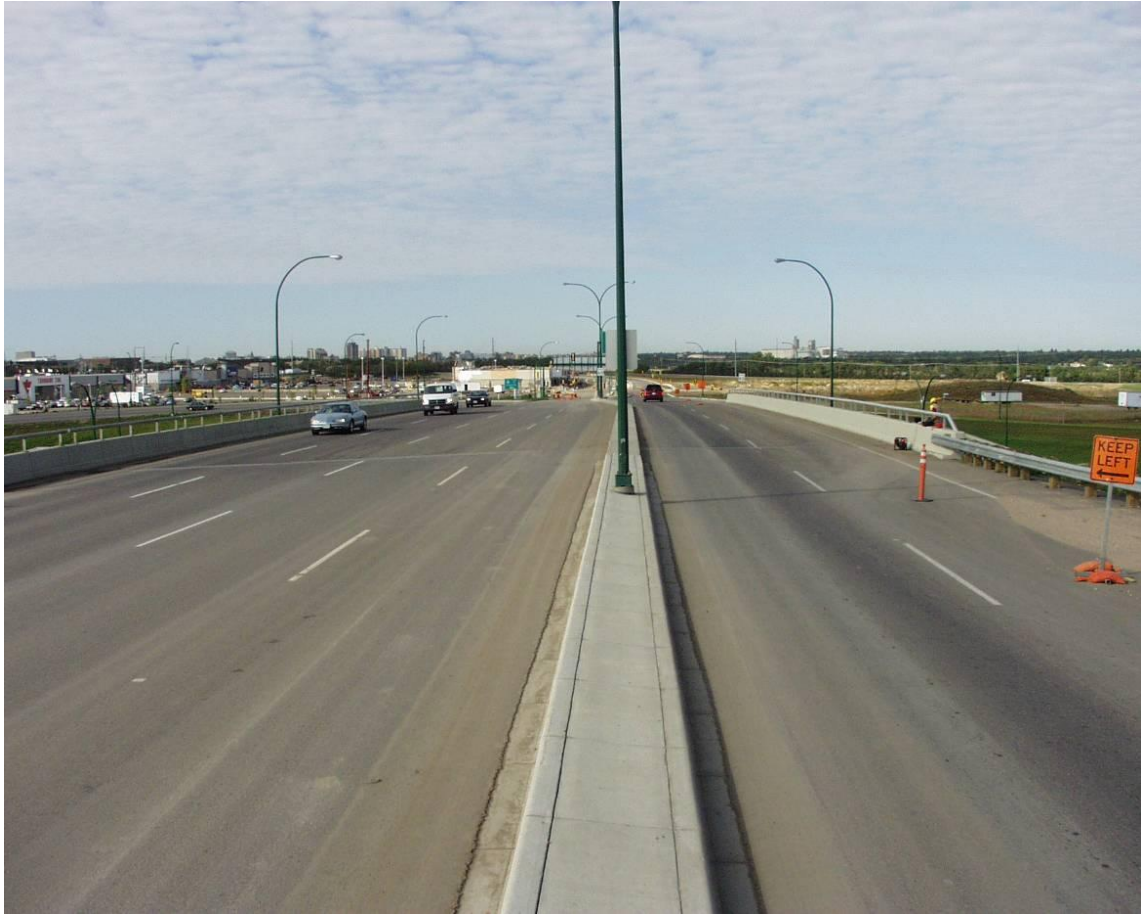
Figure 3.3. Driving lanes, viewed from the East.

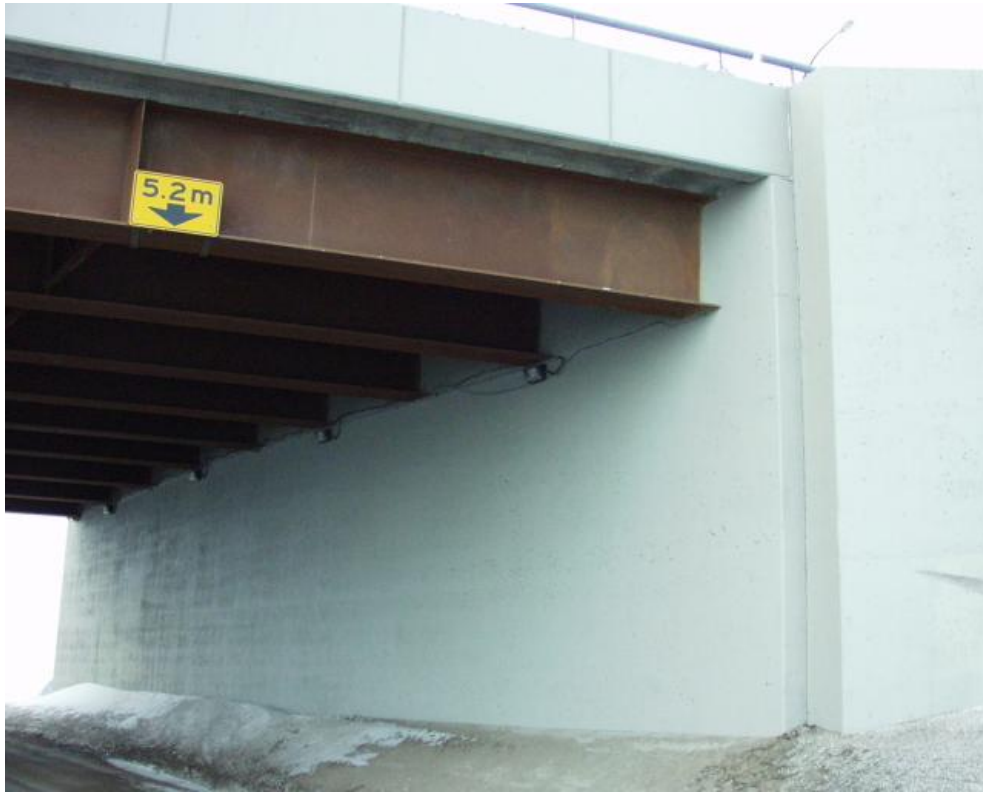
Figure 3.4. Deck slab and girders cast integrally with the abutment.

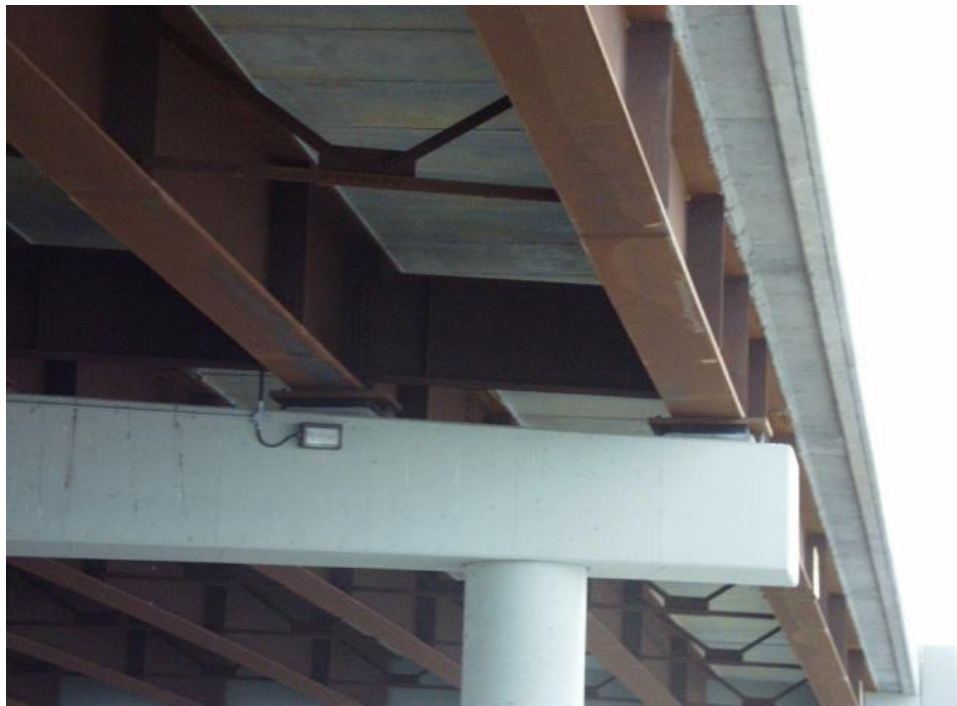
Figure 3.5. Connection between girders and pier.

Approach slabs 6000 mm long and 300 mm thick are anchored into the abutment back-wall so that they move in concert with the bridge. At the pier, the girders are welded to the sole plates, which rest on neoprene pads and are anchored to the pier cap in a direction parallel to the skew alignment. This configuration is intended to create the equivalent of roller supports at the pier to allow the bridge to move freely in the longitudinal direction. The connection between the pier and girders is illustrated in Figure 3.5.

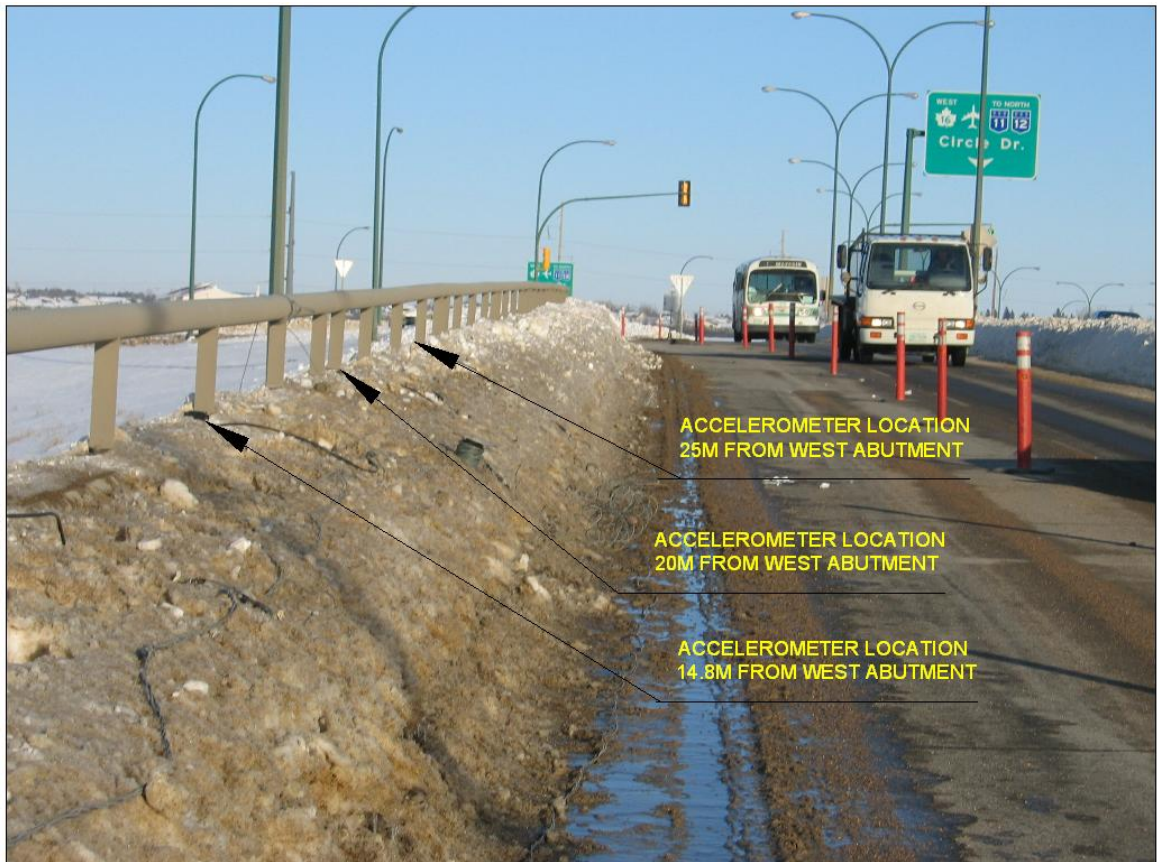
Figure 3.6. Closed lane during testing.

Test schedules were established in consultation with the City of Saskatoon for the performance of the ambient vibration tests. The city provided traffic control during the testing so that the bridge could be safely instrumented. The lanes adjacent to the instrumented barrier wall were temporarily closed during measurement and subsequently re-opened to traffic (Figure 3.6). The ambient air temperature was also recorded intermittently during each seven hour test period (approximately 9:00 a.m. to 4:00 p.m.) in order to establish the relationship between the temperature change and measured dynamic response. Temperature was measured by a thermometer placed in a shaded area on the bridge deck near the barrier wall.

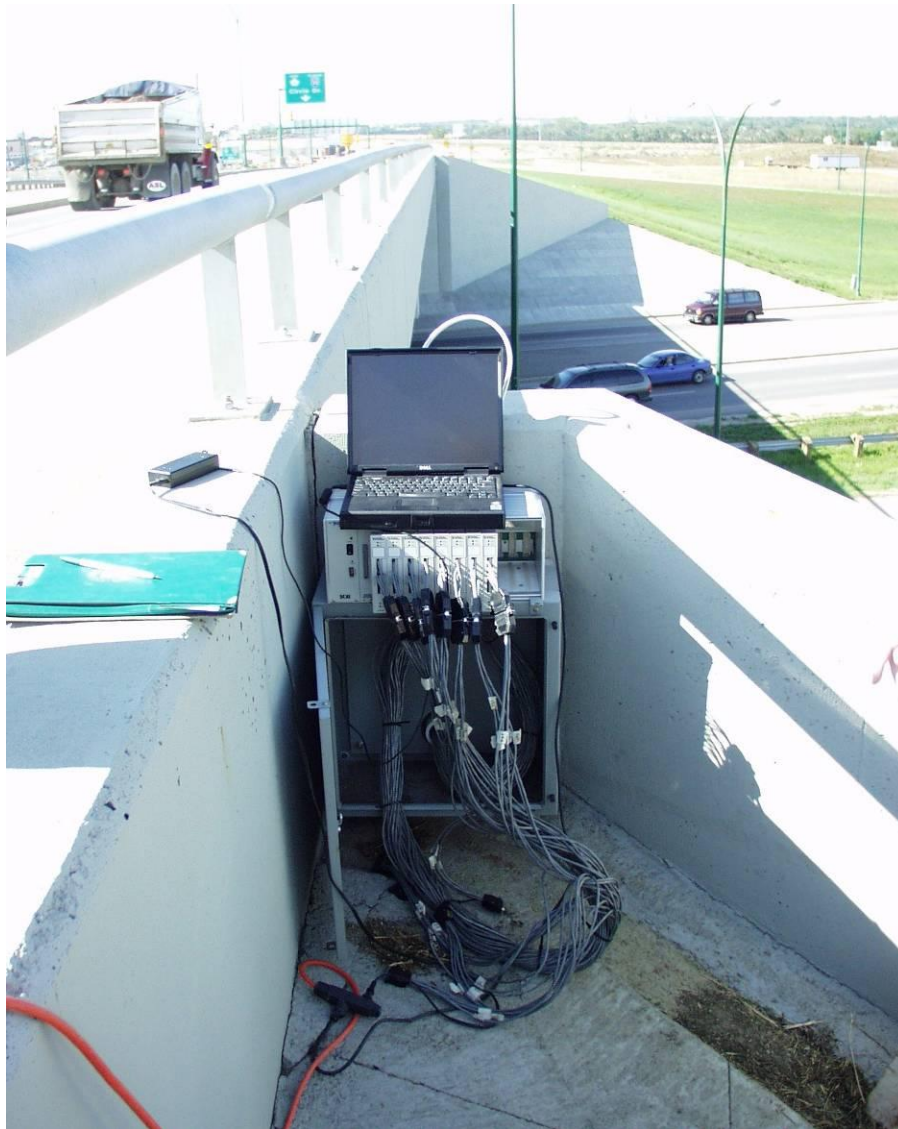
Figure 3.8. Data acquisition system.

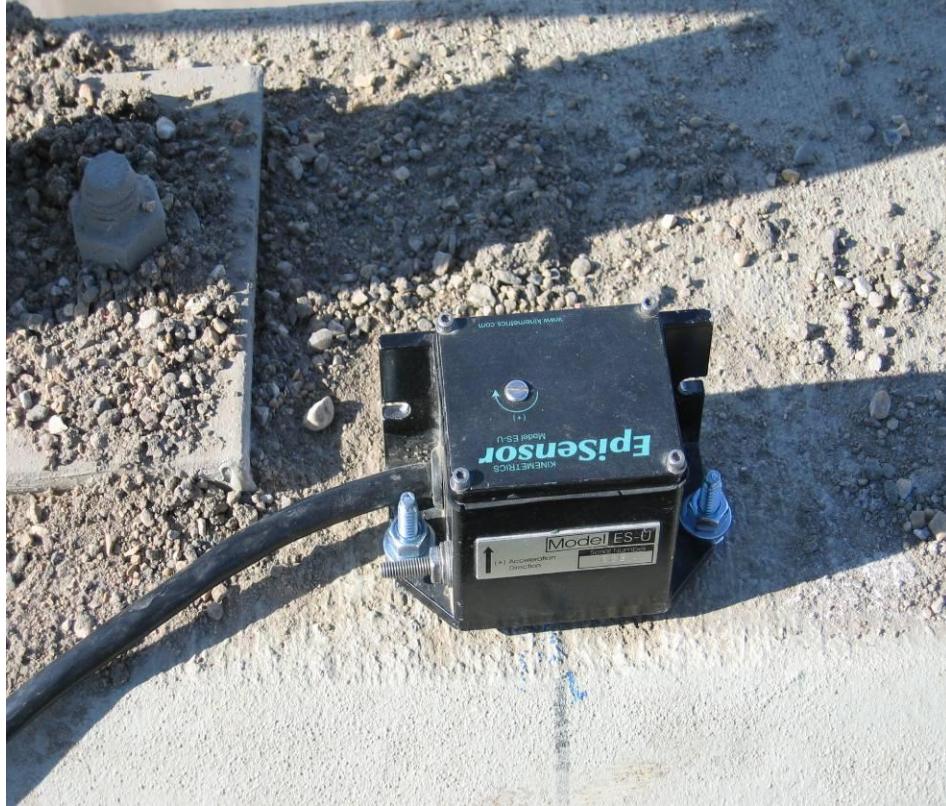
Figure 3.9. Accelerometer used during measurement.

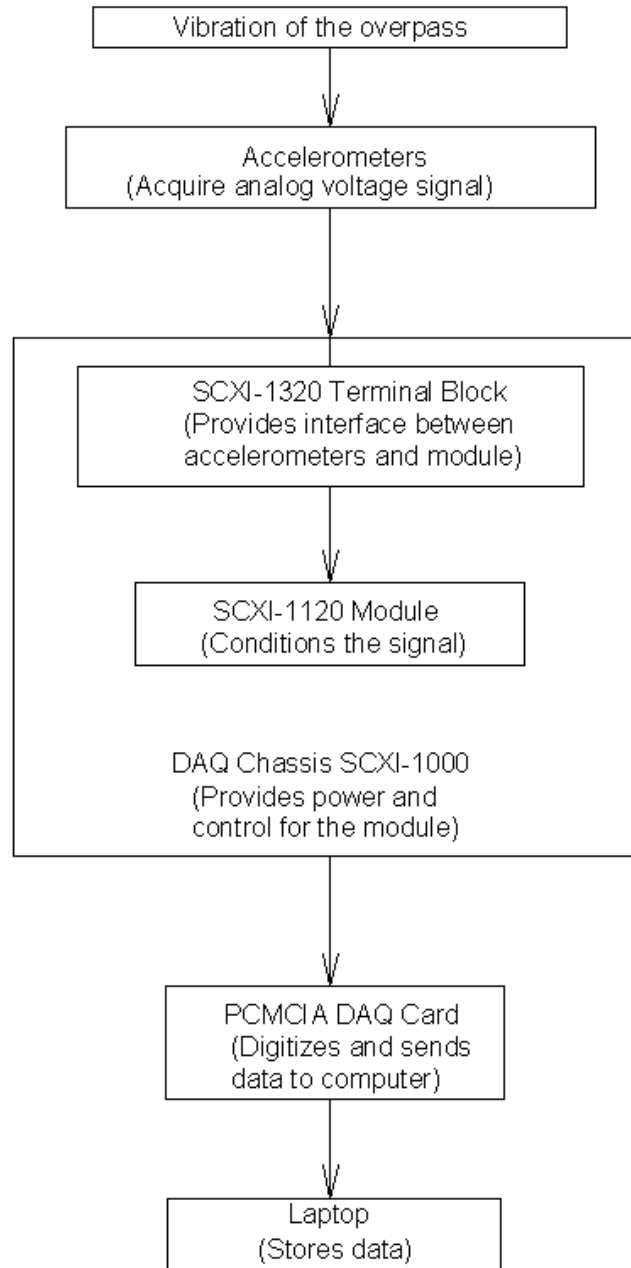
Figure 3.10. The flow chart of data acquisition system components.

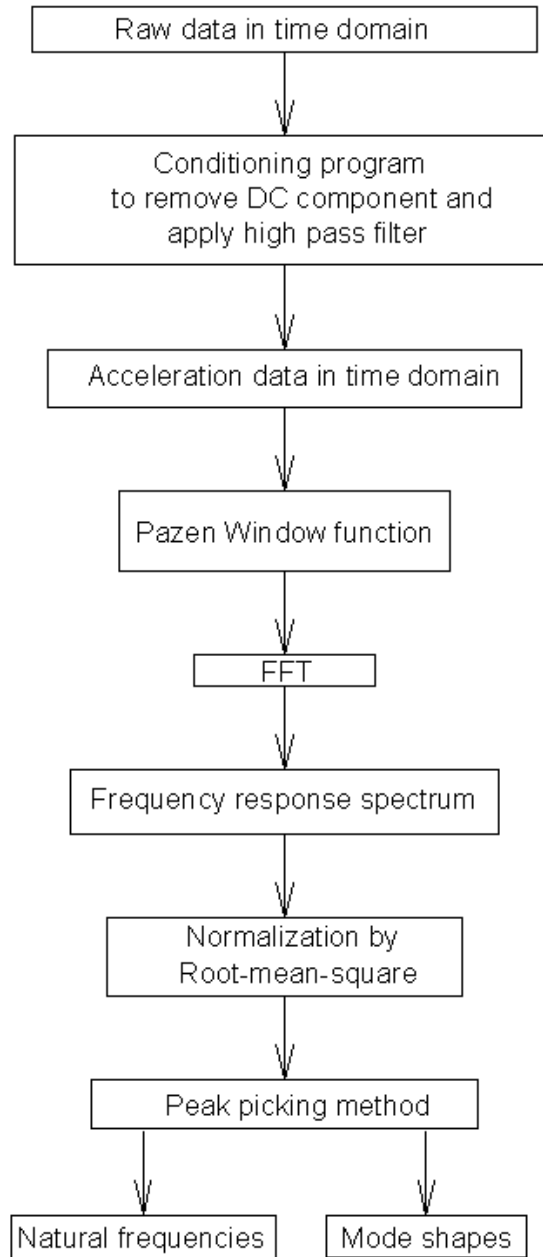
Figure 3.11. The flow chart for data processing.

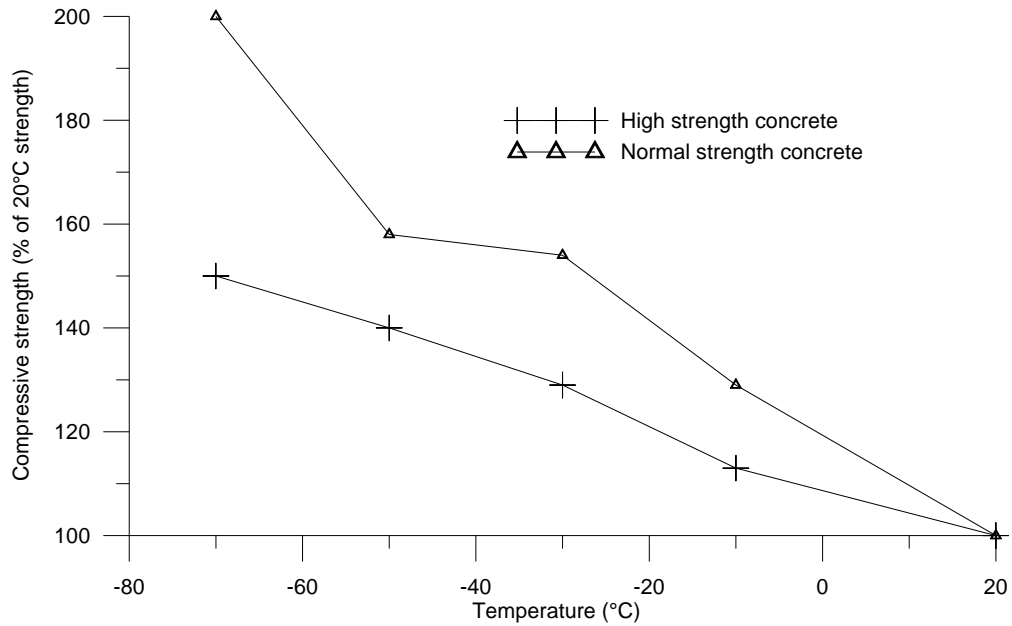
Figure 4.2. Variation of compressive strength for normal and high-strength concrete with temperature (Shah and Ahmad (1994)).

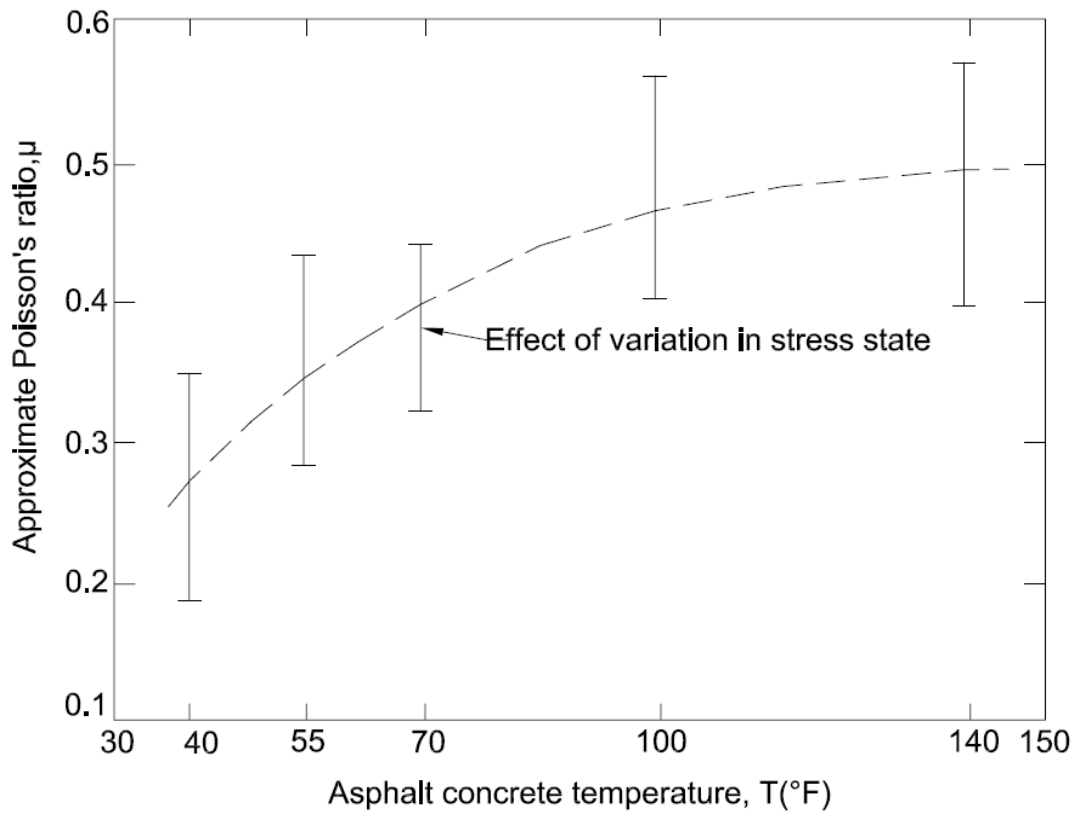
Figure 4.4. Variations of Poisson's ratio of asphalt concrete with temperature (after Yoder and Witczak 1975).

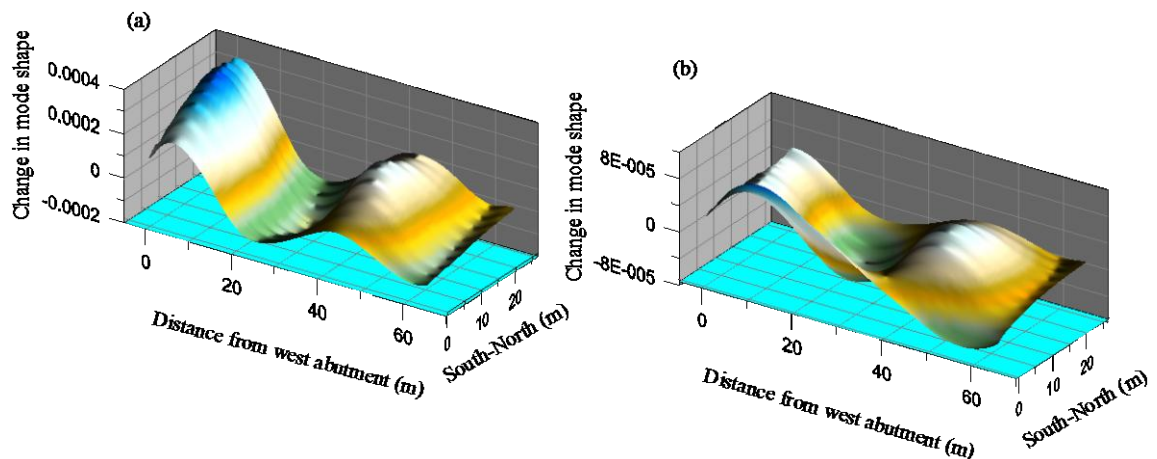
Figure 6.4. Distributions of the change in mode shape over the surface of the deck caused by an increase in temperature from 20°C to 35°C using: (a) line-by-line normalization; and (b) surface normalization.

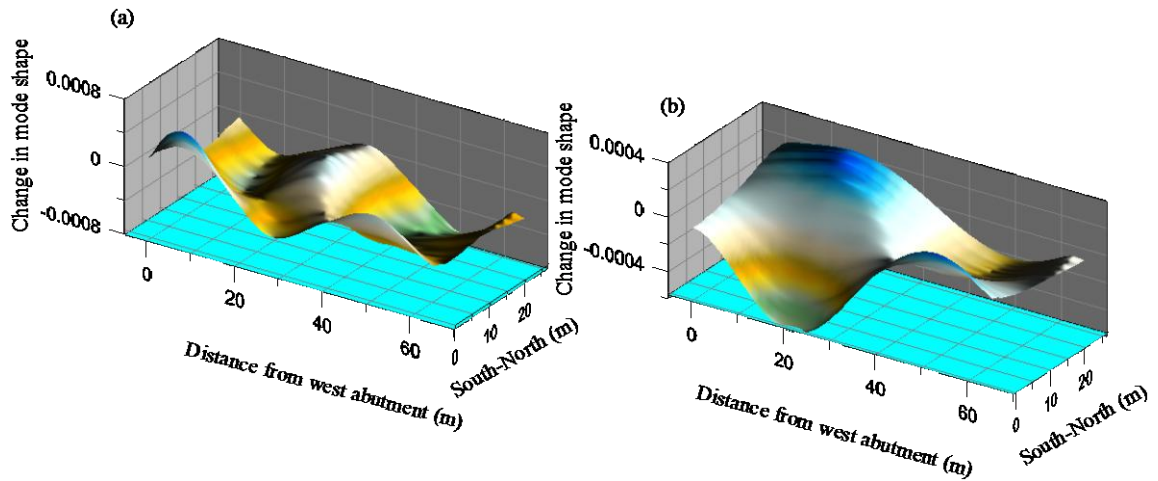
Figure 6.5. Distributions of the change in mode shape over the surface of the deck caused by a decrease in temperature from 20°C to -25°C: (a) using line-by-line normalization; and (b) using surface normalization.

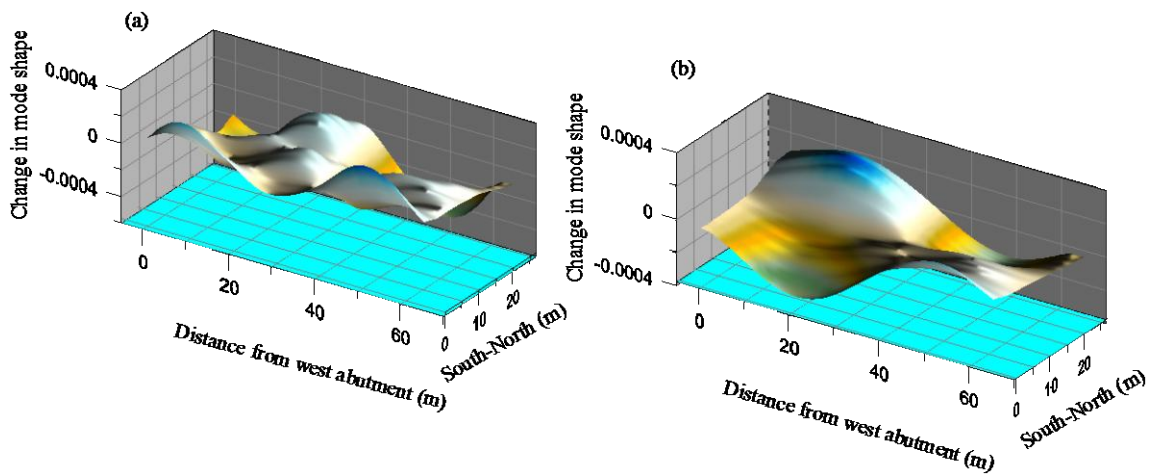
Figure 6.6. Distributions of the change in mode shape over the surface of the deck caused by a decrease in temperature from 20°C to -10°C: (a) using line-by-line normalization; and (b) using surface normalization.

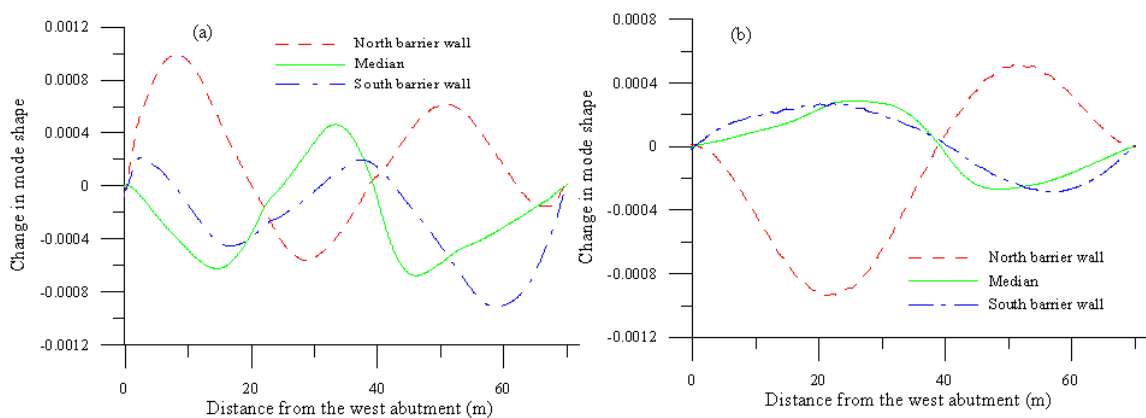
Figure 6.7. Distributions of changes in mode shape along three longitudinal lines, corresponding to a decrease in temperature from 20°C to -25°C: (a) using line-by-line normalization; and (b) surface normalization.

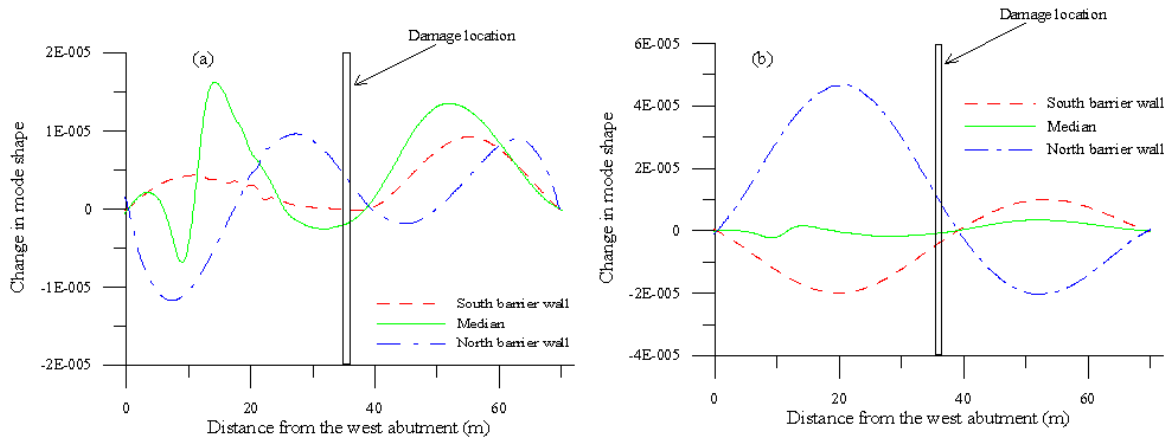
Figure 6.12. Distributions of changes in mode shape caused by damage state 8 at an ambient temperature of 20°C along selected longitudinal lines: (a) calculated using line-by-line normalization; and (b) surface normalization.

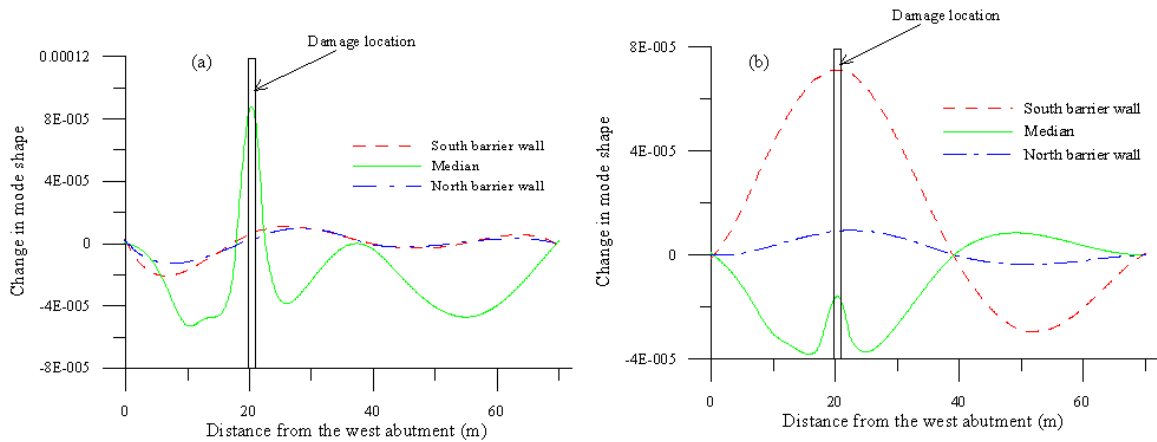
Figure 6.14. Distributions of changes in mode shape caused by damage state 6 at an ambient temperature of 20°C along selected longitudinal lines: (a) calculated using line-by-line normalization; and (b) surface normalization.

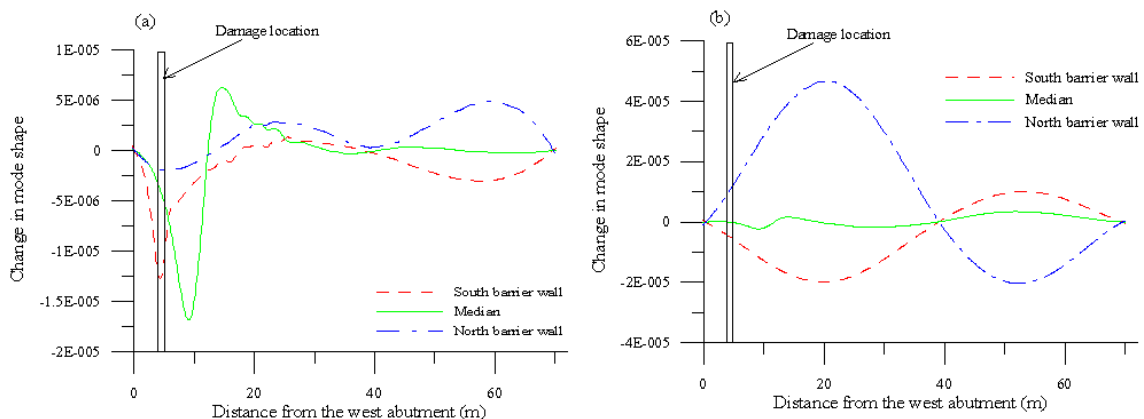
Figure 6.16. Distributions of changes in mode shape caused by damage state 1 at an ambient temperature of 20°C along selected longitudinal lines: (a) calculated using line-by-line normalization; and (b) surface normalization.
