Hindawi Publishing Corporation
BioMed Research International
Volume 2013, Article ID 157247, 8 pages
<http://dx.doi.org/10.1155/2013/157247>

Review Article

Fracture of Ceramic Bearing Surfaces following Total Hip Replacement: A Systematic Review

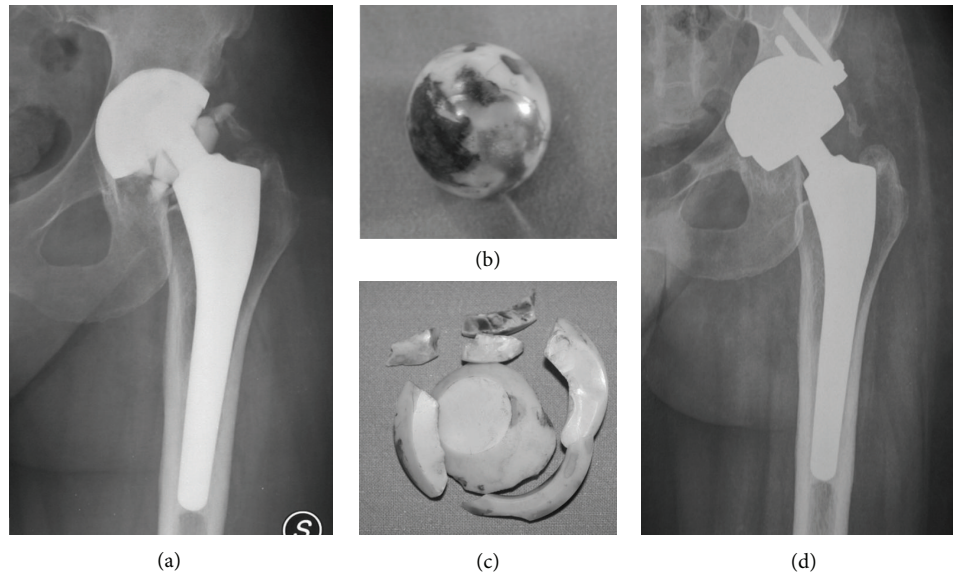
FIGURE 1: (a) Preoperative radiograph showing catastrophic failure of a ceramic liner. (b) The retrieved ceramic head grossly damaged because of contact with metal back. (c) The retrieved ceramic liner. (d) Postoperative radiograph after cup revision and bearing surfaces exchange to metal on metal coupling.

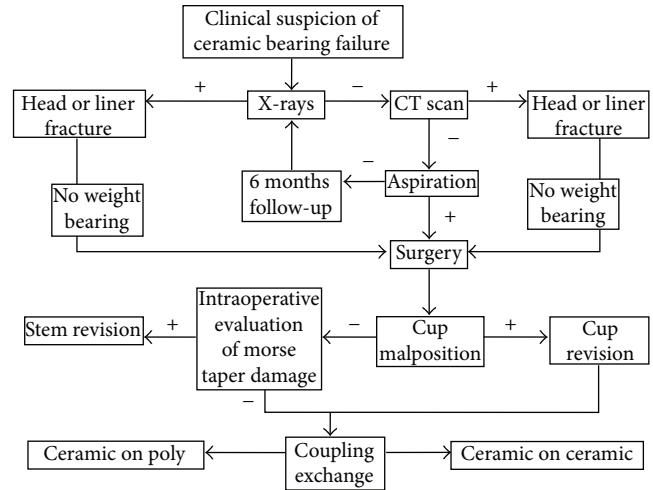
FIGURE 3: Algorithm with guidelines for the diagnosis and treatment of fractured ceramic bearings following THR.

When addressing the suspicion of a rupture of ceramic components of hip arthroplasty (Figure 3), the first diagnostic step is as usual the performance of standard X-rays; in most cases an adjunctive CT scan is required to refine the diagnosis and better characterize the mutual relationship between the cup and the stem. Current knowledge consider the use of short neck 28 mm heads as the only factor that significantly affects the risk of ceramic head fracture, and malposition of the cup on the axial plane and misalignment of the liner during insertion as the only two relevant factors affecting the risk of liner fractures. Synovial fluid microanalysis seems to be a valuable tool for early diagnosis of ceramic liner fracture and the presence of a noisy hip following THR should raise the suspicion of liner fractures; however, data

on synovial fluid aspiration reliability should be confirmed on larger cohorts of patients. Once the diagnosis of ceramic component fracture is done, revision surgery is required. It is not possible to draw definitive conclusions about the best treatment strategy, however during revision surgery an extensive synovectomy and thorough irrigation of the articular space are mandatory, while COC or COP couplings are both considered as viable options to reduce the risk of third body wear of revised implants.
