# OBSERVATIONS AND RESTRICTIONS FOR TRACKING INDICES MEASUREMENT IN MATERIALS TESTING

A. Fuchs and H. Zangl

Graz University of Technology

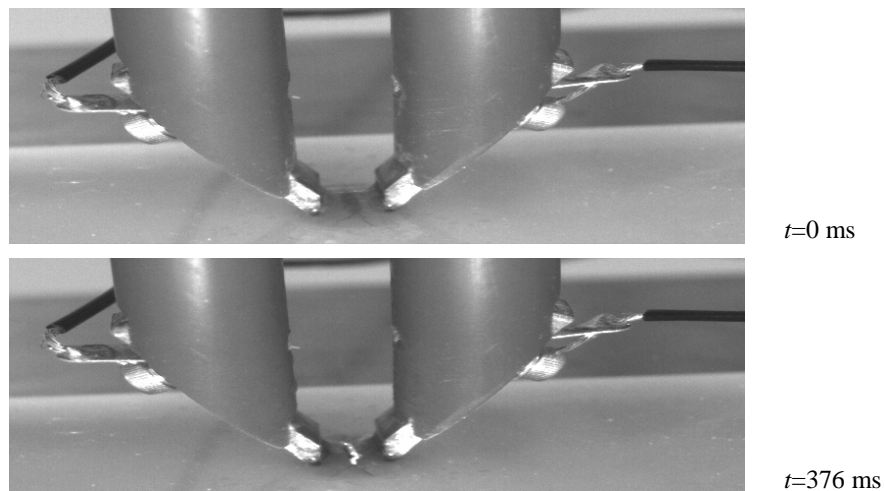
Figure 2. Photo of the relevant insulator surface when the droplet hits the material ( $t=0$  ms) and when the first sparks can be observed in the images ( $t=376$  ms).

The first observed phenomenon during testing of rubber-like materials was the burn-in of certain patterns in the middle of the two electrodes. For test voltages below 300 V the current density is not sufficient to cause a burn-in pattern in the insulator surface, for test voltages of 400 V and higher, burn-in patterns are manifest. Deep and significant patterns occur after 20 to 30 droplets latest and represent a change in the surface structure of the material under test. Figure 2 shows a sequence of high-speed camera images for the measurement setup in Figure 1. At the time step  $t=0$  ms a droplet has hit the insulator surface and the electrolytic fluid connects the two electrodes. The current between the electrodes heats up the fluid and causes evaporation. At the time step  $t=376$  ms the first sparks in the middle of the electrodes can be observed in the digital images. It is important to note that in all experiments sparks always occurred in parallel to the electrodes' surfaces and not from one electrode to the other. Depending on the test voltage the sparks remain for more than a second and are of high intensity.

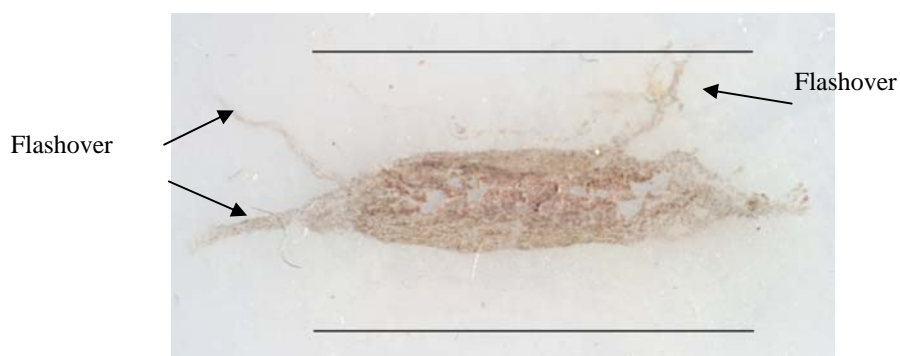
Figure 3. Photo of a burn-in pattern as a result of PTI testing at a voltage of 400 V using the setup in Figure 1; Distance between the electrodes (black lines) is 4 mm.

The burn-in pattern is significant and well-developed. Figure 3 shows a photo of this pattern. The black vertical lines in the figure mark the contact lines of the electrodes with the elastic test specimen. It can be seen in both the camera images and the burn-in pattern that the sparks occur locally in the middle of the electrodes also causing flashovers beyond the length of the electrodes.

On closer examination, the weights with which the electrodes are pressed against the test specimen seemed to be the reason for this local pattern. Due to the mechanical stress caused by the chisel-shaped electrodes, the elastic material is deformed so that the contact lines under the electrodes show the highest and the section in the middle of the electrodes exhibit the lowest

deformation. Consequently, when a thin film of conducting fluid is placed on this surface by means of a droplet, current maxima and hence a thermal hot spot will be found in this center section.

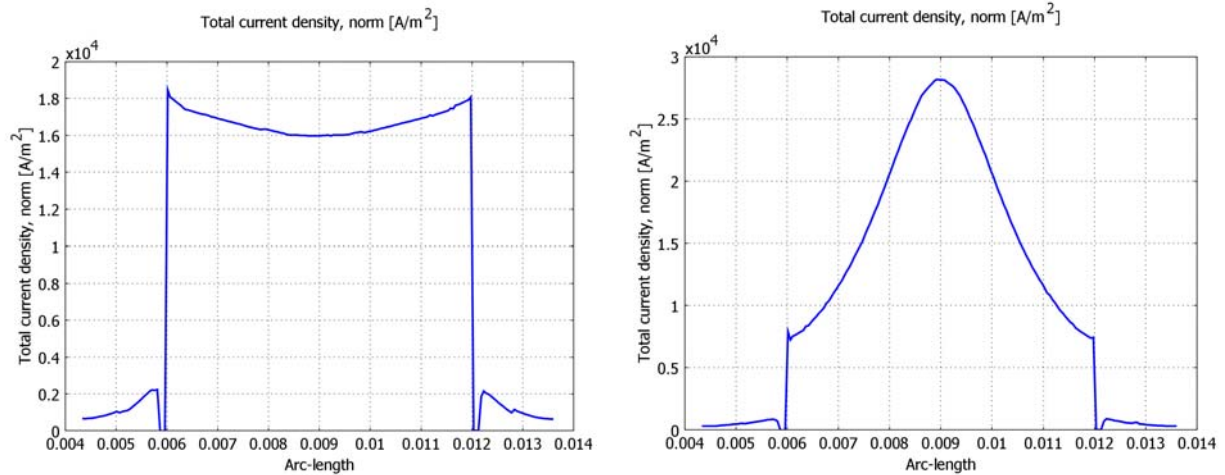
Figure 5. Simulation results for the current density between the electrodes for (left): Non-deformed geometry and (right): Deformed geometry with “hot-spot” in the middle [2].

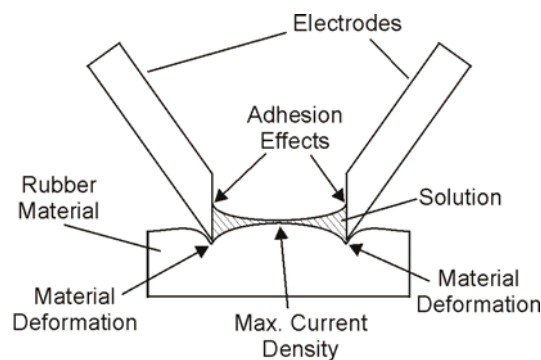
Figure 6. Adhesion and material deformation for chisel-shaped electrodes causing a current density maximum in the middle of the electrodes.

Figure 6 illustrates the effects of deformation and adhesion for the chisel-shaped electrodes that cause a narrow, significant burn-in pattern.

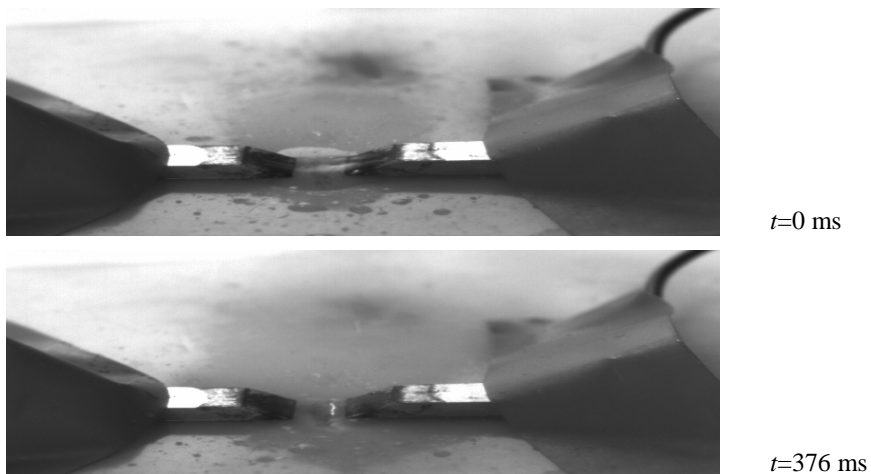
Figure 7. Photo of the relevant insulator surface for horizontal chisel-shaped electrodes when the droplet hits the material ( $t=0$  ms) and when the first sparks can be observed ( $t=376$  ms).

Figure 7 shows high-speed camera images for the moment a droplet hits the surface and connects the two electrodes via a fluid film ( $t=0$  ms) and the first occurrence of sparks ( $t=376$  ms). In the camera images adhesion effects can be observed again, although the effects seem to be less significant due to the sloped front face of the electrodes. Also for this arrangement the sparks develop at the liquid layer or the boundary layer of the fluid, where the highest current density can be found due to the adhesion of the electrolyte. The sparks show less intensity and no flashovers beyond the length of electrodes could be observed. The burn-in pattern on the insulator surface is shown in Figure 8 – the electrode edges are marked with black lines in this figure.

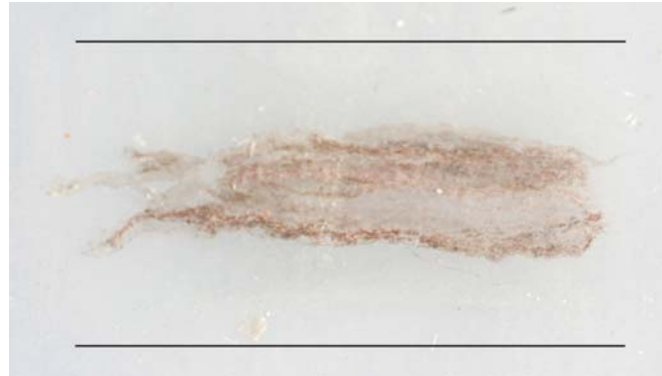
Figure 8. Photo of the burn-in pattern as a result of PTI testing at a voltage of 400 V using horizontal chisel-shaped electrodes; Distance between the electrodes (black lines) is 4 mm.

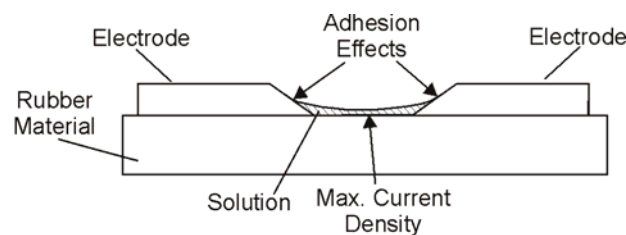
Figure 9. Adhesion effects for horizontal chisel-shaped electrodes causing a current density maximum in the middle of the electrodes.

Figure 9 illustrates the effects of adhesion for the chisel-shaped electrodes causing a narrow burn-in pattern that is less significant compared to patterns presented in Section III. Deformation of the material can be neglected since no weights on the electrodes are used in these experiments and the contact surface on the elastic insulator is much higher.

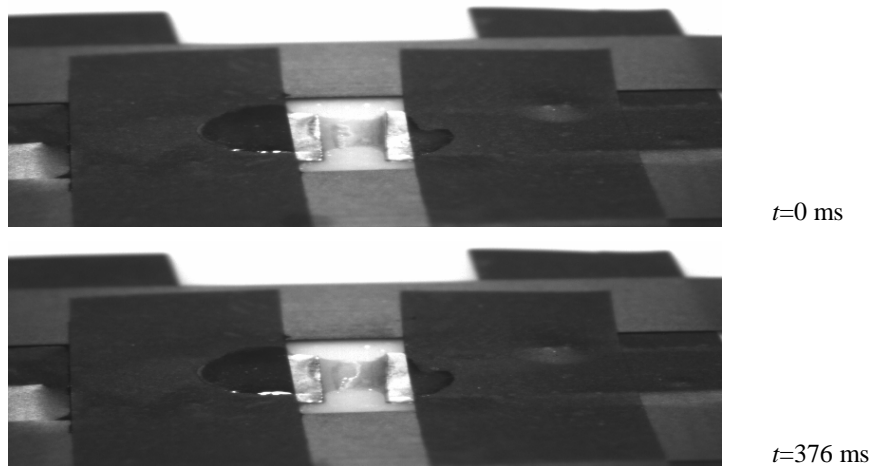
Figure 10. Photo of the relevant insulator surface for horizontal flat electrodes when the droplet hits the material ( $t=0$  ms) and when the first spark can be observed in the images ( $t=376$  ms).

excited with a 400 V 50 Hz AC signal while the potential of the second electrode was kept on ground. With this setup both deformation of the material and fluid adhesion on the surface of the electrodes can be mostly neglected. Camera images reveal that a droplet, which hits the surface of the insulator, forms a fluid layer of nearly constant thickness. When the electrolyte starts to evaporate as a result of the electric current, the fluid boundary layer is randomly distributed between the electrodes, also causing randomly distributed sparks, which are roughly in parallel to the electrode edges. The burn-in patterns are hence distributed over the entire gap between the electrodes. A band of weak sparks can be observed in camera images, such as shown in Figure 10, which slowly moves from one electrode to the other while the fluid is evaporating. Figure 11 shows a photo of the resulting burn-in pattern, which differs from the previous ones since it is less intensive and spreads from the edge of one electrode to the other.

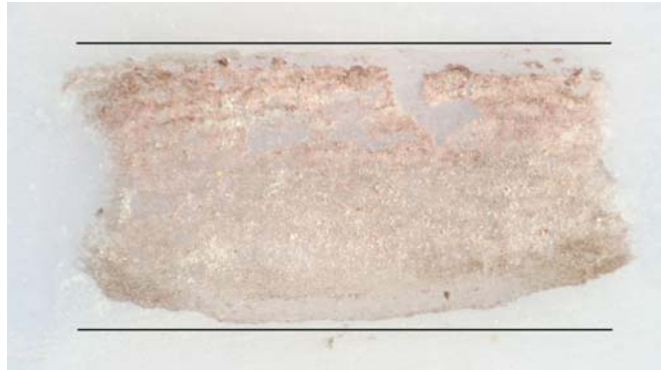
Figure 11. Photo of the burn-in pattern as a result of PTI testing at a voltage of 400 V using thin horizontal electrodes; Distance between the electrodes (black lines) is 4 mm.

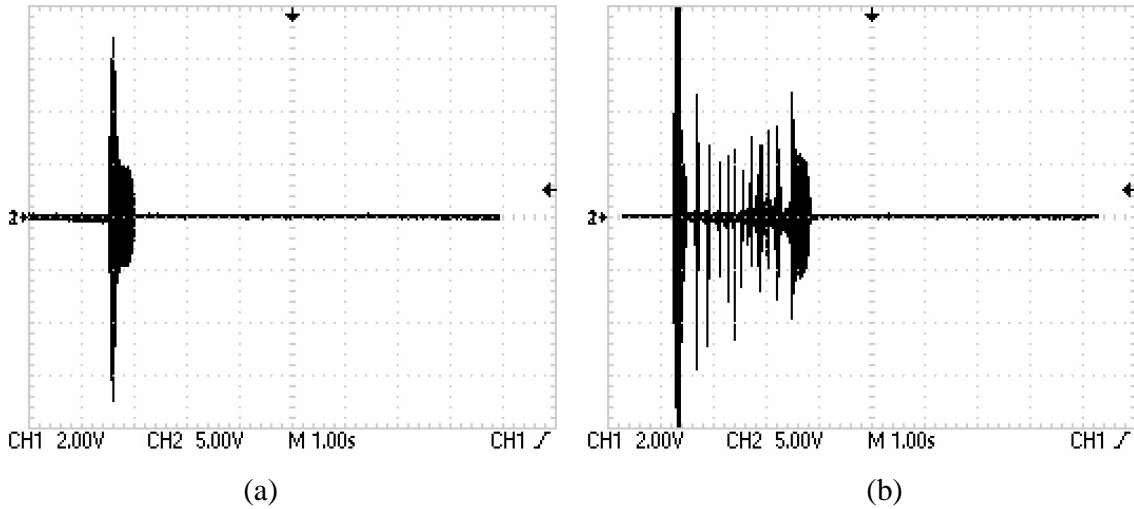
Figure 13. Voltage drop on a  $50 \Omega$  resistor for (a): Smooth evaporation and (b): Eruptive evaporation of a droplet on the surface of the insulator material.

For all realized electrode structures two types of droplet evaporation could be observed after the electrolyte has hit the surface. In both cases the conductive fluid droplet connects the two electrodes and the resulting current immediately heats up the fluid in-between and causes boiling. For the first type of evaporation, the droplet forms a consistent fluid layer between the electrodes and sparks occur where this layer is thinnest until the film is disconnected. The current signal is measured as the voltage drop on a 50  $\Omega$  resistor and is shown in Figure 13a for this smooth type of evaporation. The maximum peak to peak current is about 280 mA in this figure.

In a second type of droplet evaporation, which could also be observed in experiments with all electrode structures, boiling of the fluid causes parts of the droplet to splash onto farther sections of the insulator material. The fluid film is then nearly disconnected and a stepwise delayed firing occurs as a consequence of the eruptive boiling. The voltage drop on a 50  $\Omega$  resistor of such an

eruptive evaporation with multiple firing is given in Figure 13b. The maximum peak to peak current is about 360 mA in this figure.

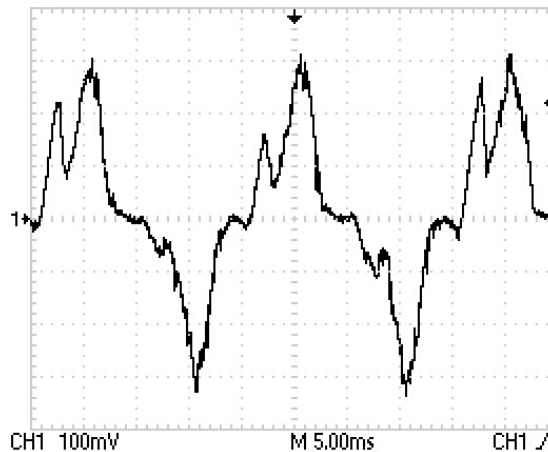
Figure 14. Detail plot of the current proportional voltage drop on a  $50 \Omega$  resistor.

The detail plot of the current signal on a  $50 \Omega$  resistor in Figure 14 shows the non-linear, time variant characteristic of the resistance that is formed by the fluid layer in-between the electrodes.

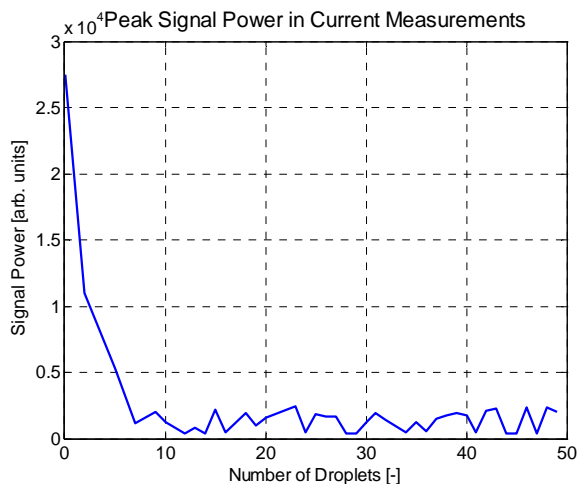
Figure 15. Signal power of the current measurement results vs. number of droplets [2].

The second observed phenomenon while testing the insulator material on tracking behavior is the decrease of current peak amplitude with increasing number of added droplets. The electric current between the electrodes evaporates the distilled water in the solution film and causes reduced resistivity when drying. As a consequence, the peak signal amplitudes fade away with time, as can also be seen in Figure 13. Figure 15 shows a diagram representing the signal power trend in recorded current signals for an increasing number of droplets. It can be observed that especially for the first couple of droplets the amplitude levels decrease too, although more ions should become available on the surface.
