# A tribological study in the perspective of vibro-electric analysis

**S.S. Erol<sup>a</sup>, C. Meran<sup>b,\*</sup>**

S.S. Erol, C. Meran, A tribological study in the perspective of vibro-electric analysis, Archives of Materials Science and Engineering 78/2 (2016) 87-92.

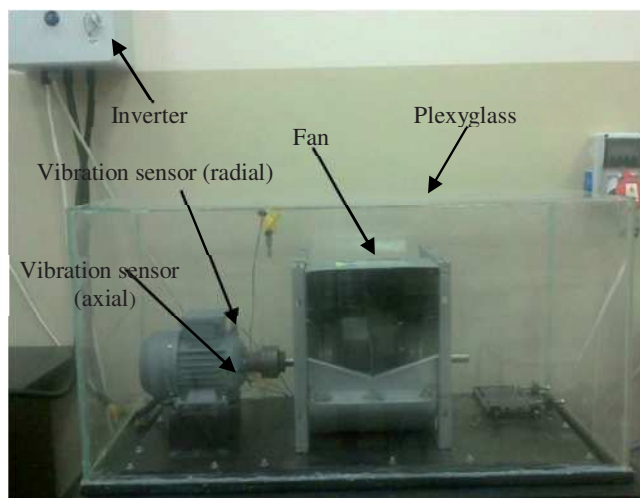
Fig. 1. A view from the test setup

The test setup built as consists of double inlet fan, AC induction motor, five feet of flexible coupling and

frequency inverter. The test setup construction is built on a steel plate and a steel tripod. The test setup is placed on a double-decker rubber sheet that was located between the test setup and the tripod; also, a vacuum rubber below feet of the tripod has been placed on the floor. This structure with a data acquisition card and an electrical motor is associated to monitoring system with a computer. Testing structure in Figure 1 presents an real view.

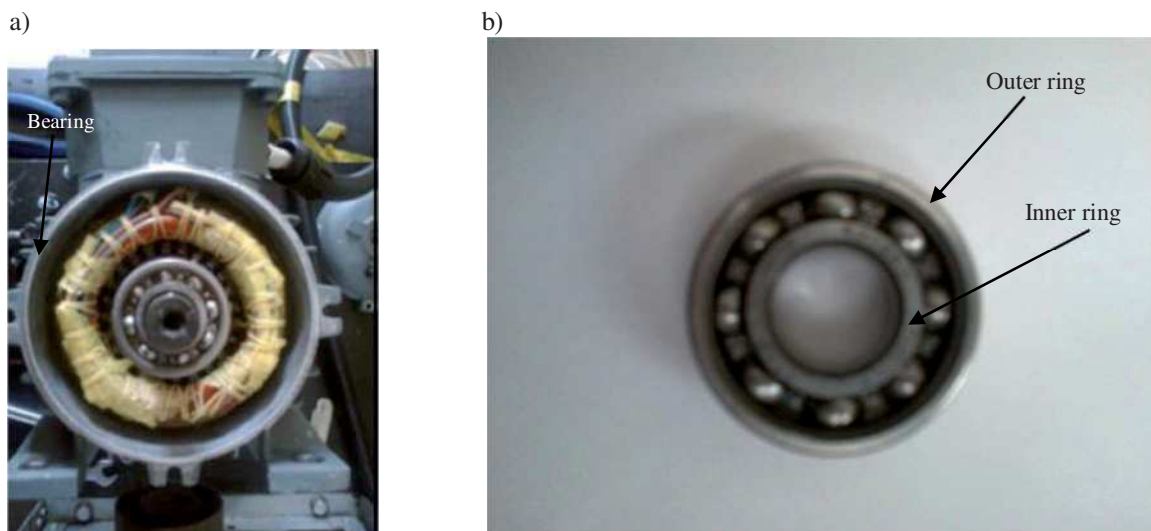
Fig. 2. a) Tested bearing, b) non-lubricated bearing

In order to create condition of oil starving failure, oil is fully cleaned from the tested bearing; insufficient quantity of 0.55 g oil was used for bearing in order to supply speedy deterioration. Tested bearing is represented in Figure 2.

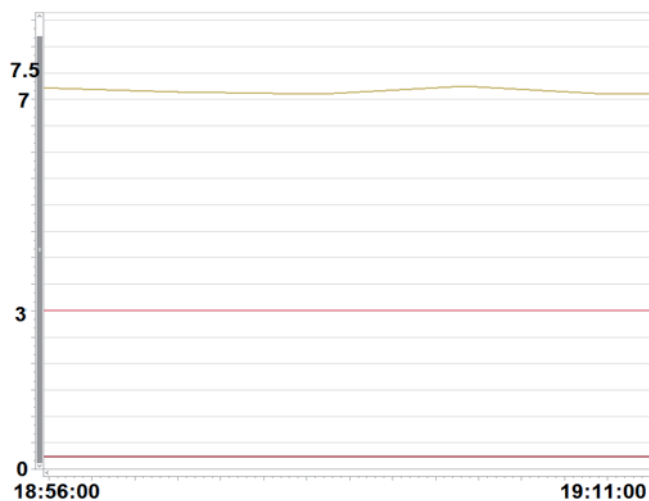
Fig. 3. Electrical consumption trend analysis (std. deviation – time)

Trend values are given through three different parameters as bearing parameter, mechanical looseness and unbalance. In both parameters of bearing (standart deviation: 3) and unbalance (0.2), no change is detected under the condition of oil starvation. Trend values of mechanical looseness condition had change even slightly between standart deviation of 7.3 and 7.5 almost in the middle of the test time.

Respect to the electrical consumption analysis, data interpretation is based on trend values in Figure 3 and power spectrum density values in Figure 4.

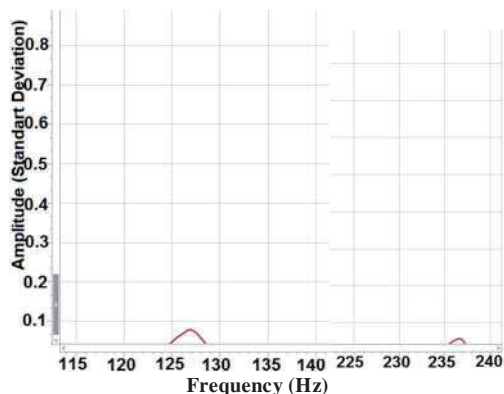
Fig. 4. Electrical consumption psd analysis (std. deviation – frequency)

As trend values are not sufficient enough informative about the condition of oil starvation, examination of PSD values is studied. According to algorithm of the electrical consumption analysis device, some specific failures are categorized on frequency intervals which are called bands. Respect to bands, PSD signal around 127 Hz is categorized

in band of bearing factor 2 and signal around 237 Hz is categorized in band of bearing factor 4. As the bearing is healthy and does not have any damage on its elements, these signals at 127 Hz and 237 Hz signs the effect of oil starving condition. Furthermore, increase of rotor indicator in trend analysis and increase of the psd signal about 63.8 Hz is detected which may lead to symptom of resonance condition.

According to analysis results of electrical consumption measurement on effect of oil starving failure; bearing signals and resonance signals are found in the psd data.

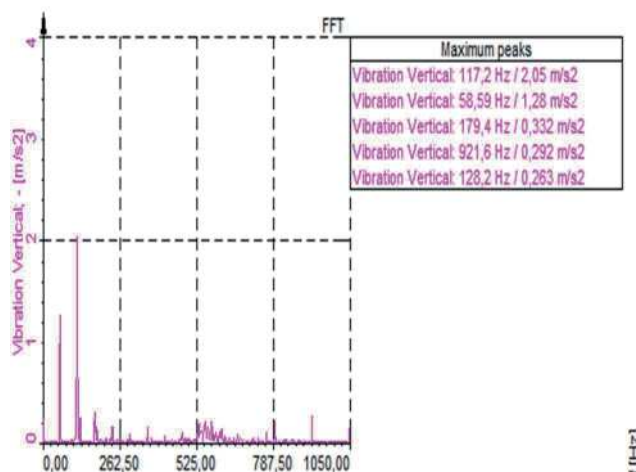
Fig. 5. Spectrum in vibration FFT data of radial direction

Harmonic of 2x has been detected as the first dominant signal in radial direction with amplitude of 2.05 m/s<sup>2</sup>. Second dominant vibration signal is detected at harmonic of 1x on 58.59 Hz. In radial direction, signal at 175.77 Hz that is the upper harmonic of fundamental frequency (3x) excited a signal at the frequency 179.4 Hz which is a natural frequency and consequently superharmonic resonance has been observed with the signal amplitude as 0.332 m/s<sup>2</sup>. Resonance effects has been detected at fourth and fifth dominant signals as well. Fourth signal at 921.06 Hz has been excited by 921.12 Hz (38xω<sub>c</sub>) and fifth signal at 128.2 Hz has been excited by 125.26 Hz (1xω<sub>bst</sub>) in the frequency-domain.

Respect to the Figure 5 and Table 3, oil starvation increased the vibration magnitude of signals at the element passing zone. Respect to the findings, 38<sup>th</sup> order of cage frequency and 1st order of the ball spinning frequency appeared eminently among five dominant signals. The effect of oil starvation on frictional forces through steel material of the bearing has brought out these signals and excited natural frequencies.

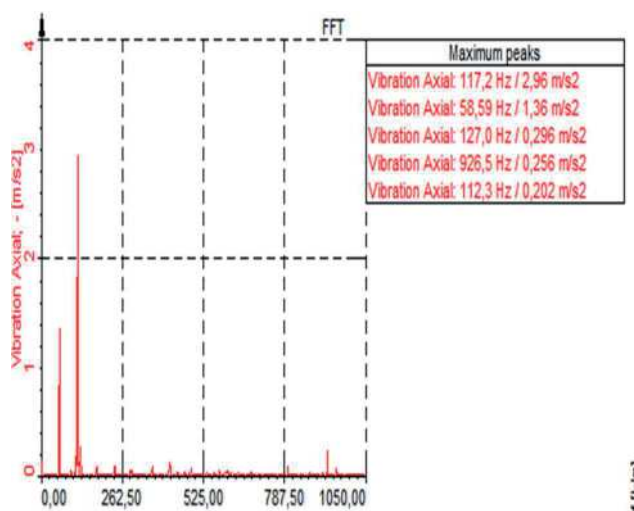
Figure 6. Spectrum in vibration data of axial direction

In axial direction, signals at harmonic of 2x is detected as the first dominant and 1x is detected as the second dominant harmonic same as in the radial direction frequency spectrum. First dominant signal's value as 2.96 m/s<sup>2</sup> in axial direction is higher than the first dominant signal's value as 2.05 m/s<sup>2</sup> in radial direction. Third dominant signal at frequency of 127 Hz has been excited by the 1x $\omega_{bsf}$  and subharmonic resonance occurred. Fourth dominant signal is similarly as radial direction excited by the signal at 38x $\omega_c$  and subharmonic resonance occurred. Fifth dominant signal is excited by the signal at 3x and subharmonic resonance occurred as well.

Respect to the Figure 6 and Table 4; first two dominant signals are same in the axial and radial direction and other three dominant signals are the natural frequencies which are excited by the same frequencies.

According to the findings in Table 4; signal at harmonic 2x has been detected with the highest amplitude and 1x has been detected as the second dominant signal which is a characteristic feature of unbalance effect. Bearing frequencies as ball spinning frequency and cage frequency are appeared on the third and fourth dominant signal that is an indicator of oil starvation and they stimulated natural frequencies. Bearing frequencies are eminently detected in axial measurement as well. Fifth dominant signal appeared on a natural frequency stimulated by harmonic 3x.
