MONITORING SAFETY CRITICAL INFRASTRUCTURE WITH MOBILE ROBOTS

**Monitoring Safety Critical
Infrastructure with Mobile
Robots
Opportunities and Challenges**

Tariq Sattar

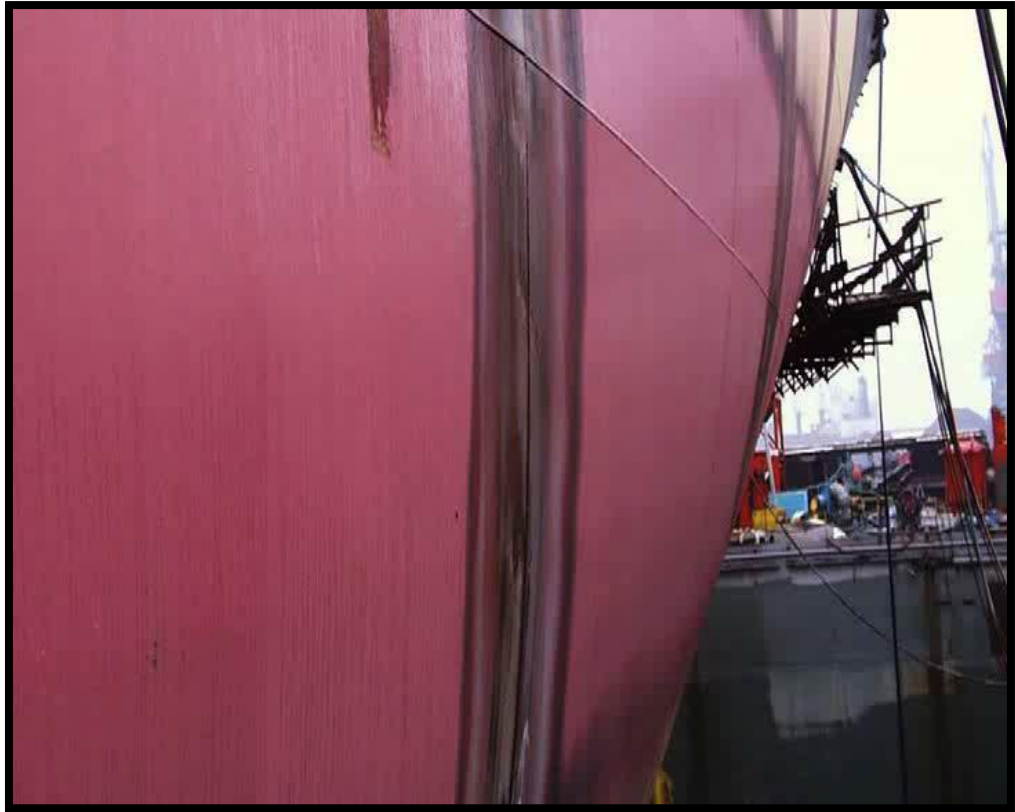
Ultrasound NDT
of horizontal and
vertical welds on a
new build cargo
container ship –
Odense Shipyard

Dimensions:

30m height

30m width

300m length

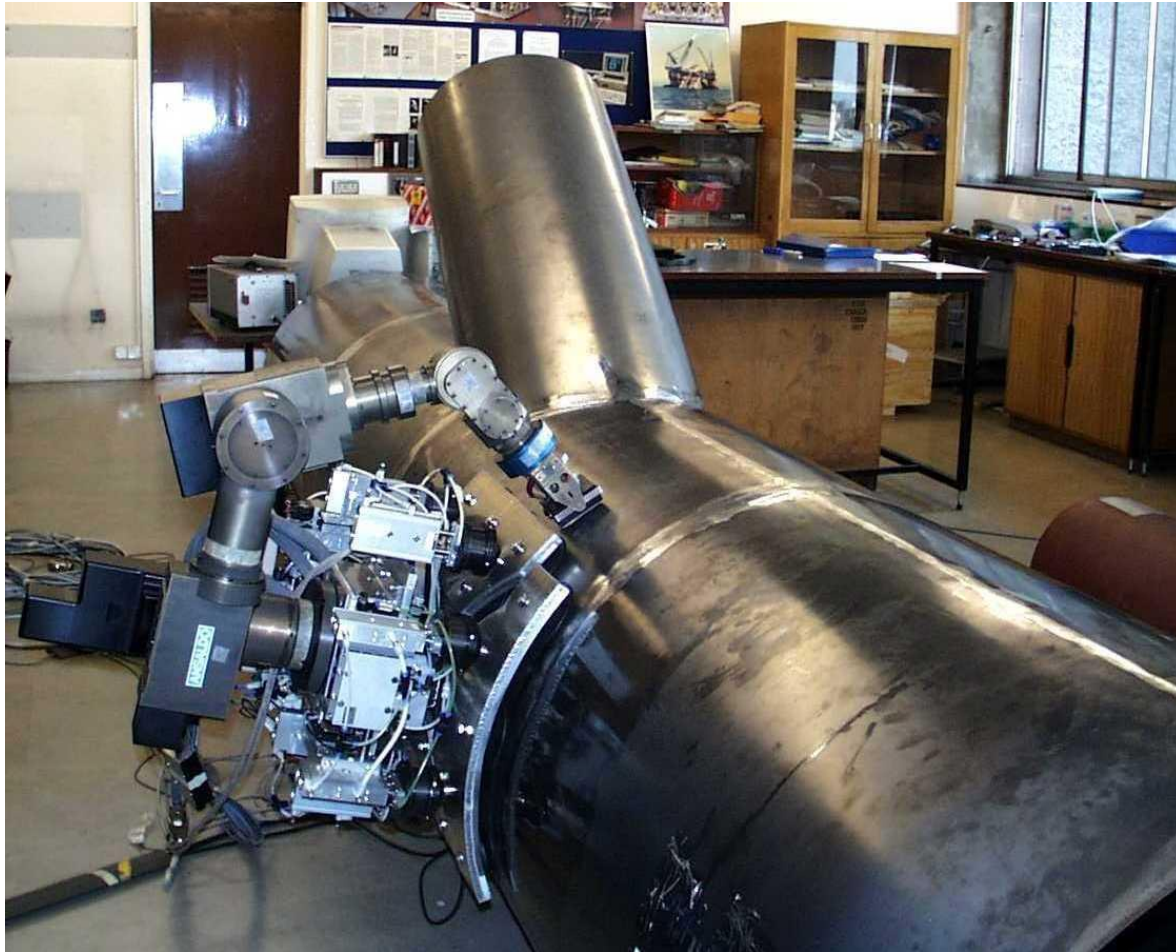
Ultrasound NDT of nozzle welds in primary circuit of nuclear power plant

Pipe diameter 860 mm, vehicle mass = 30kg, 500x500 mm, max P= 37 kg, arm mass = 22 kg, 7 DOF, arm payload = 5 kg, repeatability ± 1 mm, couplant retrieval system, force controller

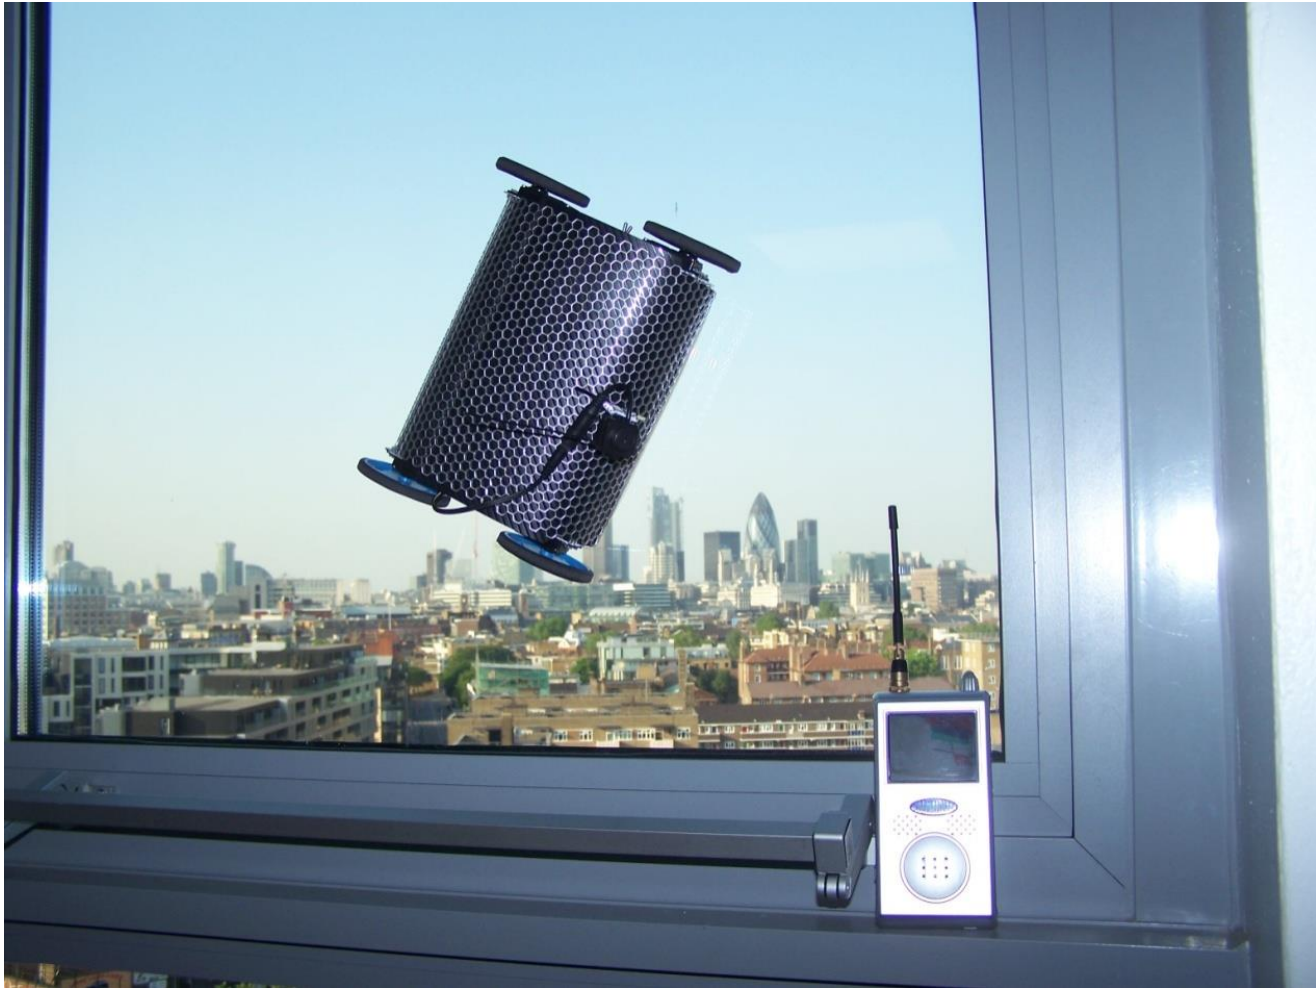
WALLEXPLOR

Wall climbing robots for NDT, inspection and surveillance on non-ferrous surfaces

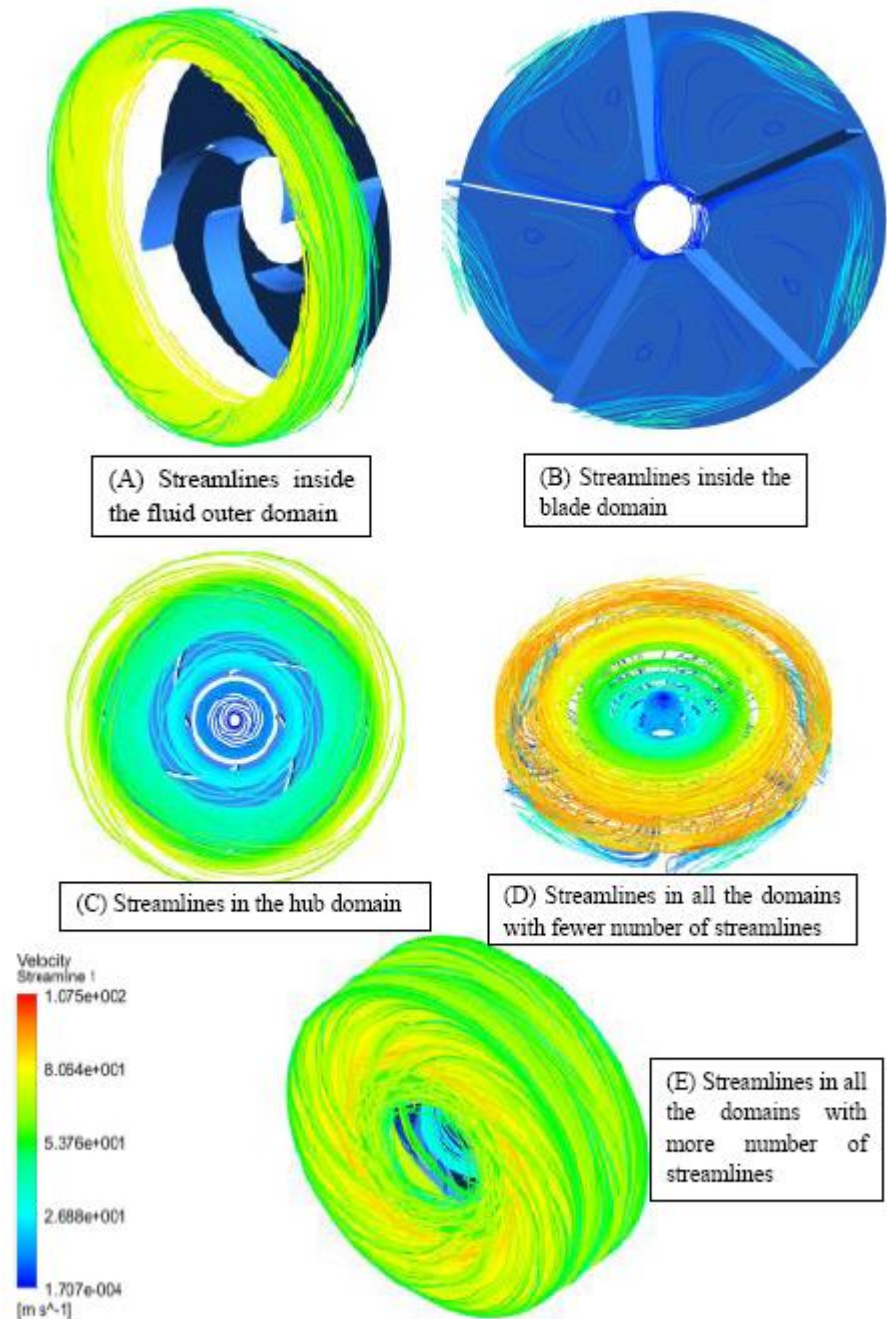
Figure 3-10 isometric view to show the streamlines inside the vortex chamber in the blades

ANSYS
analysis of
streamlines and
pressures
created by
VORTEX
machines
Aim: Increase
Payload
capability of
climbing robot

Achieved: 4 kg
with an A4
sized robot.

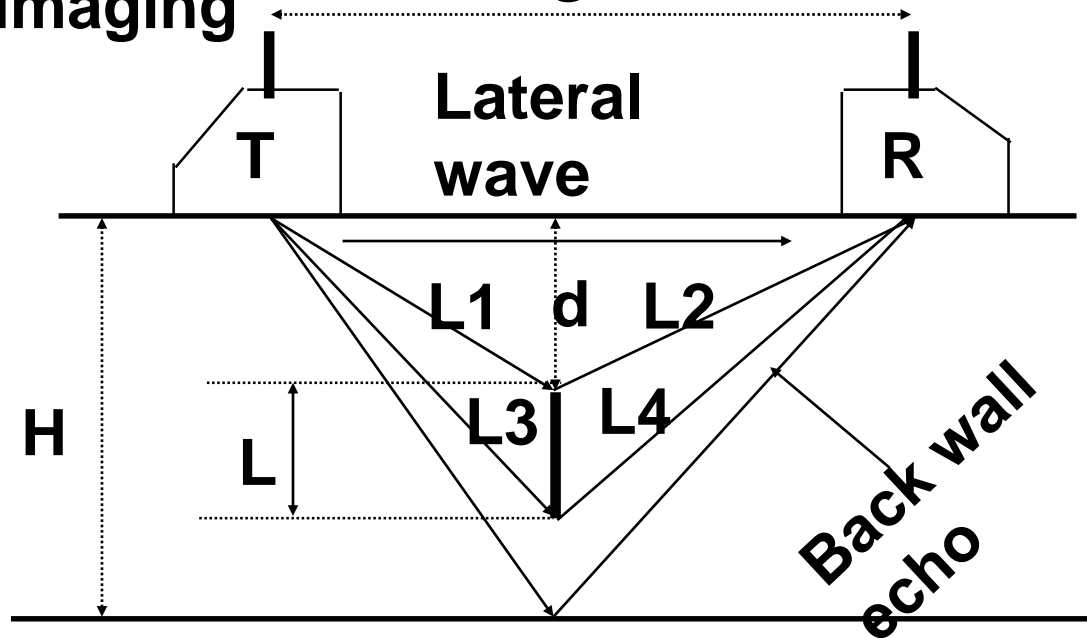
Time Of Flight Diffraction (TOFD) method B-Scan imaging

T – Transmitter
 R – Receiver
 H - Plate thickness
 L - Size of the defect

t_L - Time for the lateral wave
 t_1 - Time for the top tip diffraction along the path ($L1+L2$)

t_2 - Time for the bottom tip diffraction along the path ($L3+L4$)

t_{bw} - Time for the back wall echo

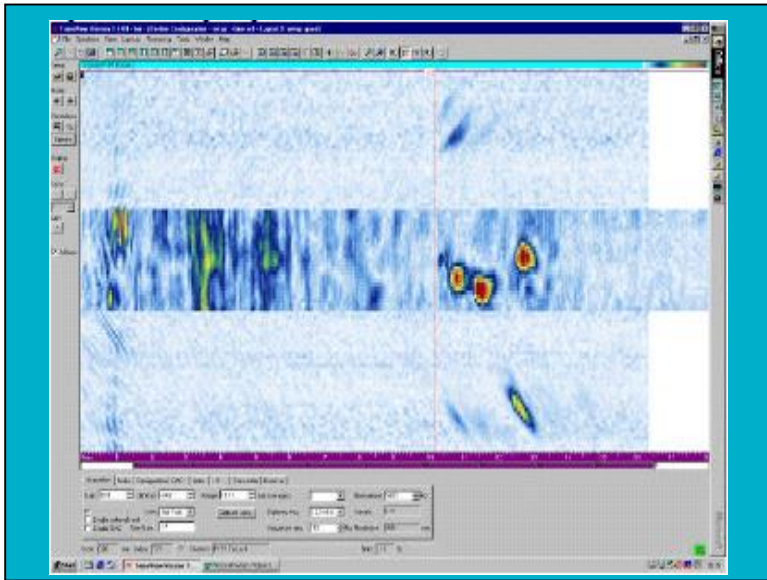
ULTRASONIC PHASED ARRAY
to inspect rivets on aircraft,
ROBAIR project

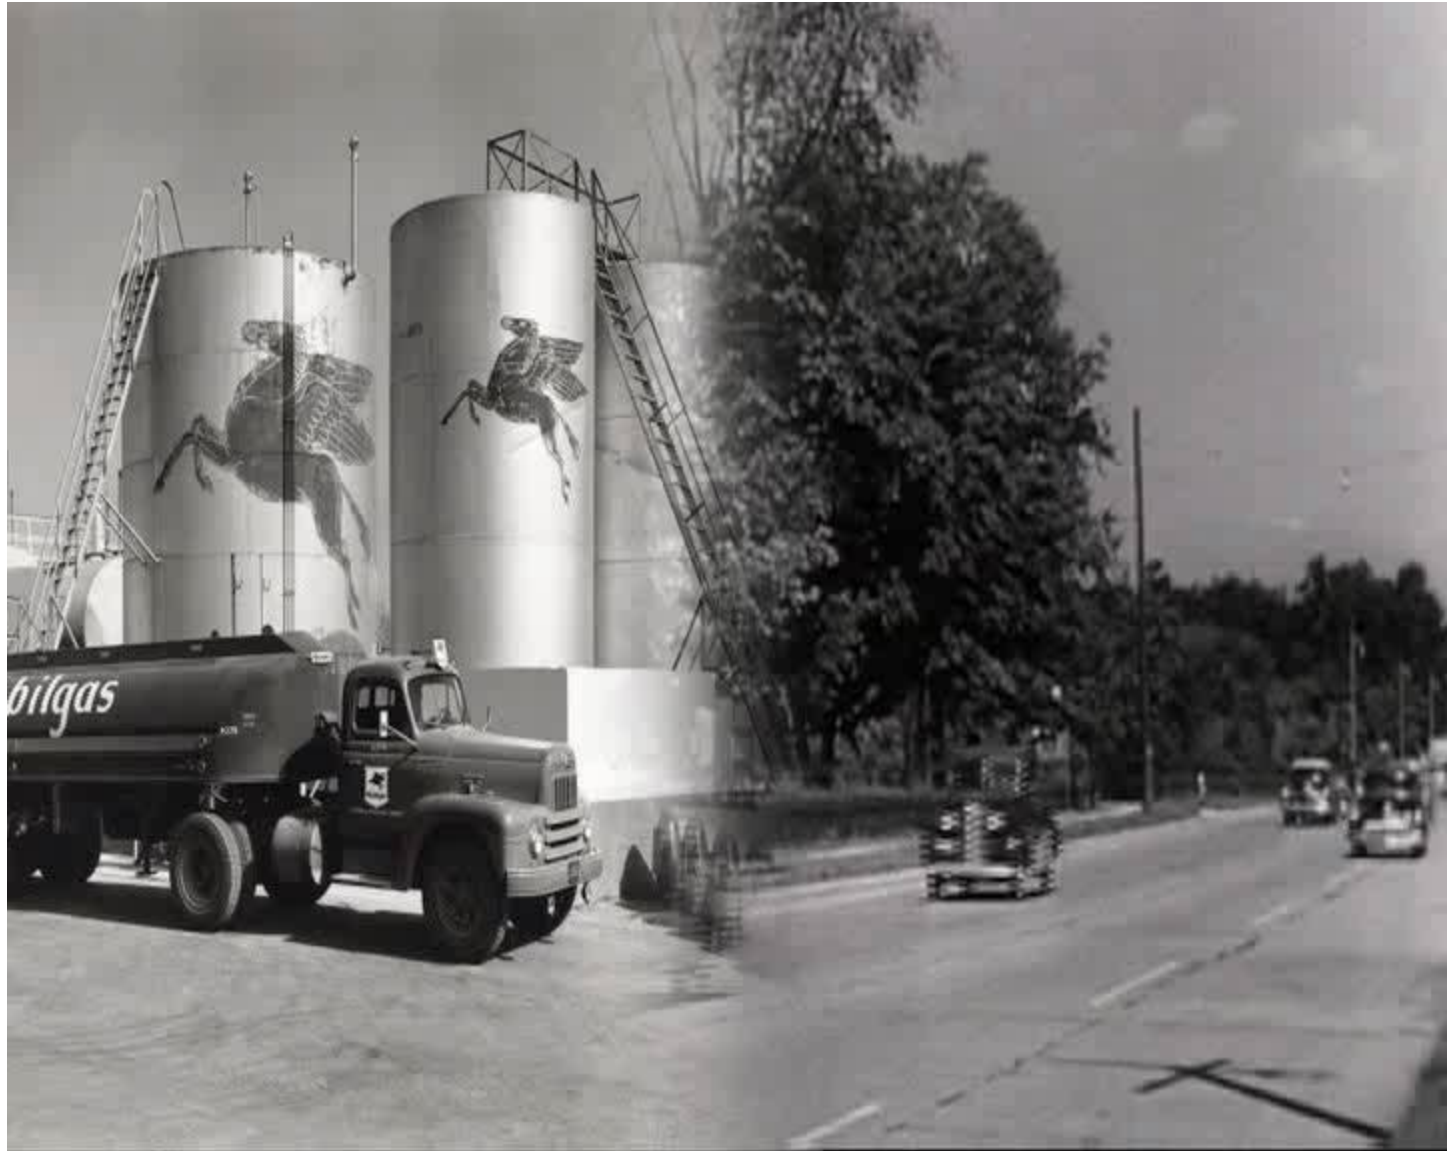
In-service inspection of petro-chemical storage tanks with mobile robots – RobTank project

Worldwide, over 218,000 petrochemical storage tanks and 53,000 large storage tanks with diameter > 50m are mostly inspected with outages. A large 100m diameter crude oil tank can be out of service for up to 9 months

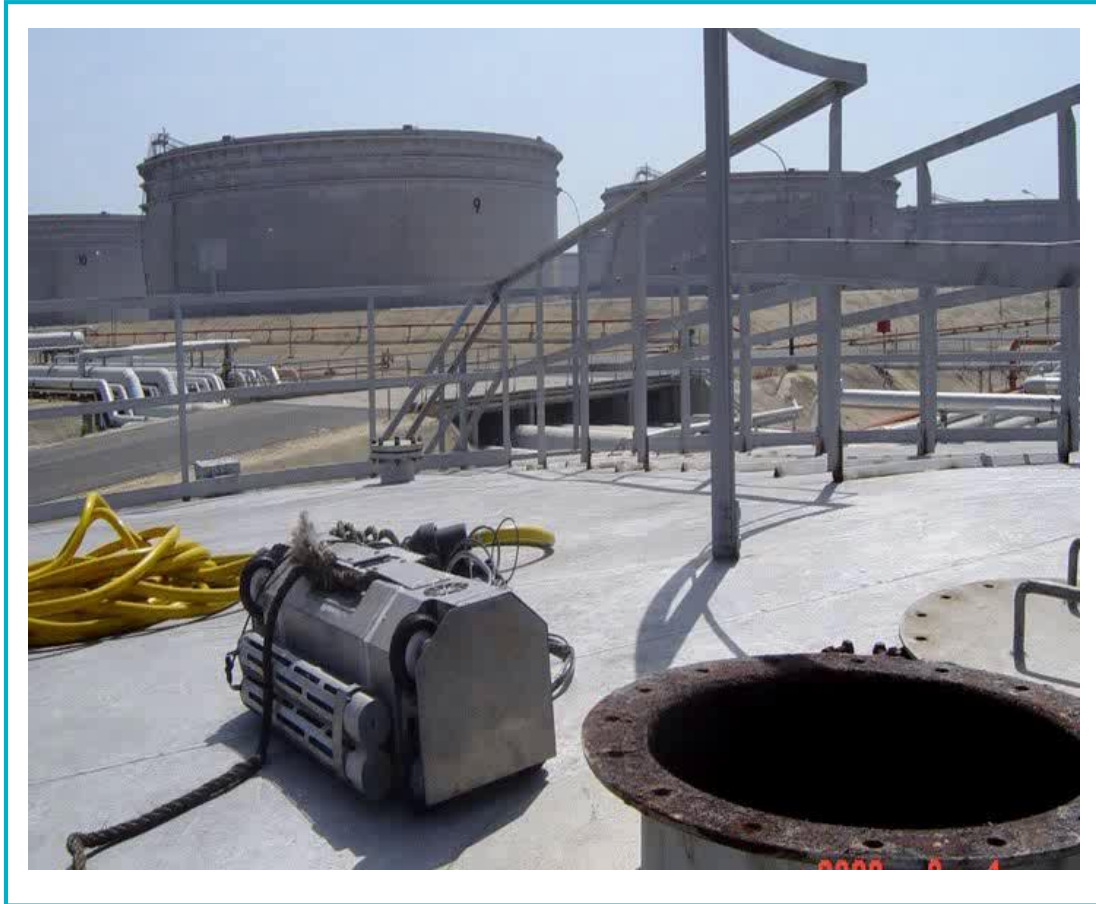
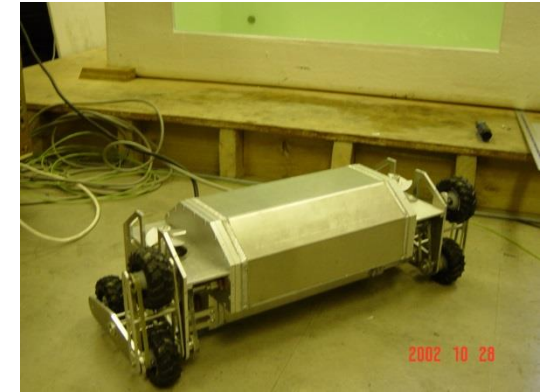
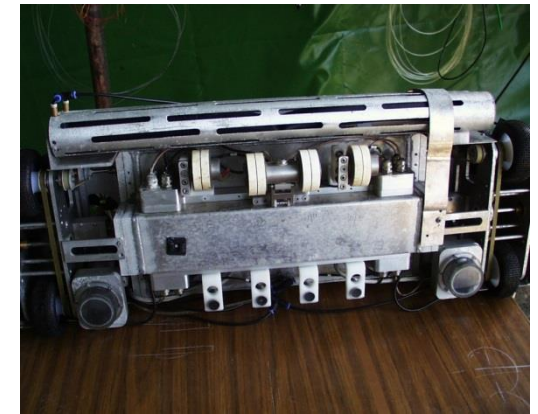
EU FP5 ROBTANK: Mobile wall climbing robot enters through manholes on the floating or fixed roof of a tank to inspect tank floor and internal walls

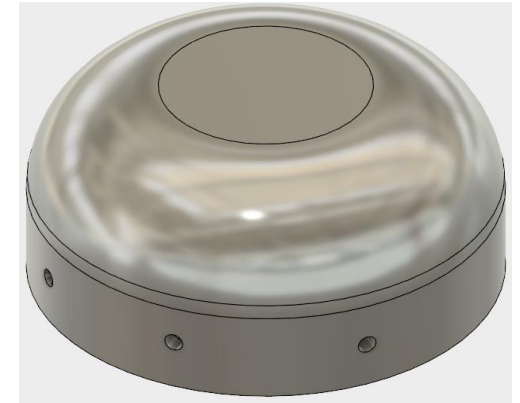
New InnovateUK funded project NAUTILUS: Bathyscaphic Robotic Floor Thickness Monitoring of Hazardous Liquid Storage Tanks

1. Active buoyancy control
2. Ultrasound NDT
3. Under liquid data communications
4. Zone 0 certification

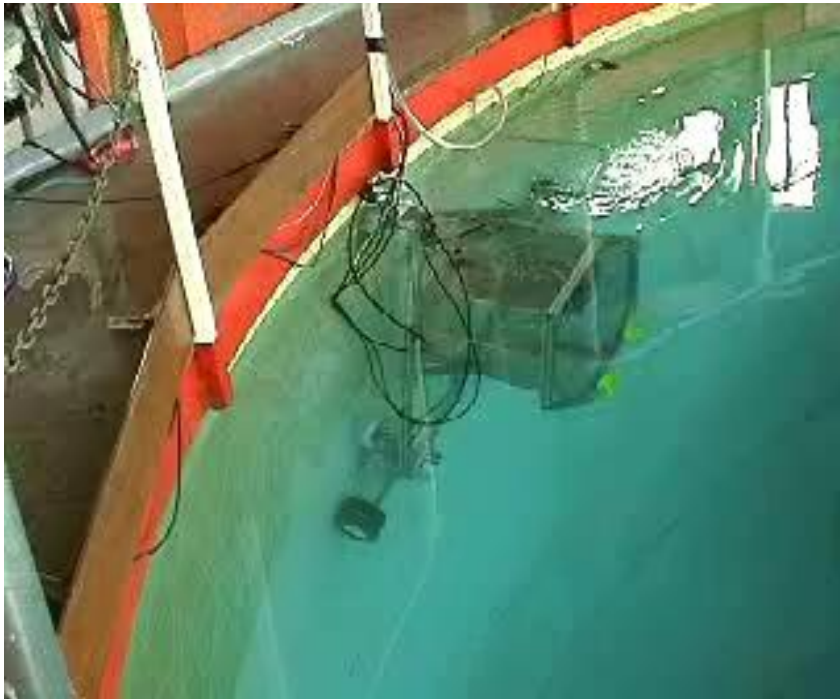
FP6-SME: RIMINI Development of new and novel low cost robot inspection methods for in-service inspection of nuclear installation

- Wall climber with nozzle crawler and scanning arm
- Neutrally buoyant climber+ nozzle crawler
- Positively buoyant climber, parked with suction cups

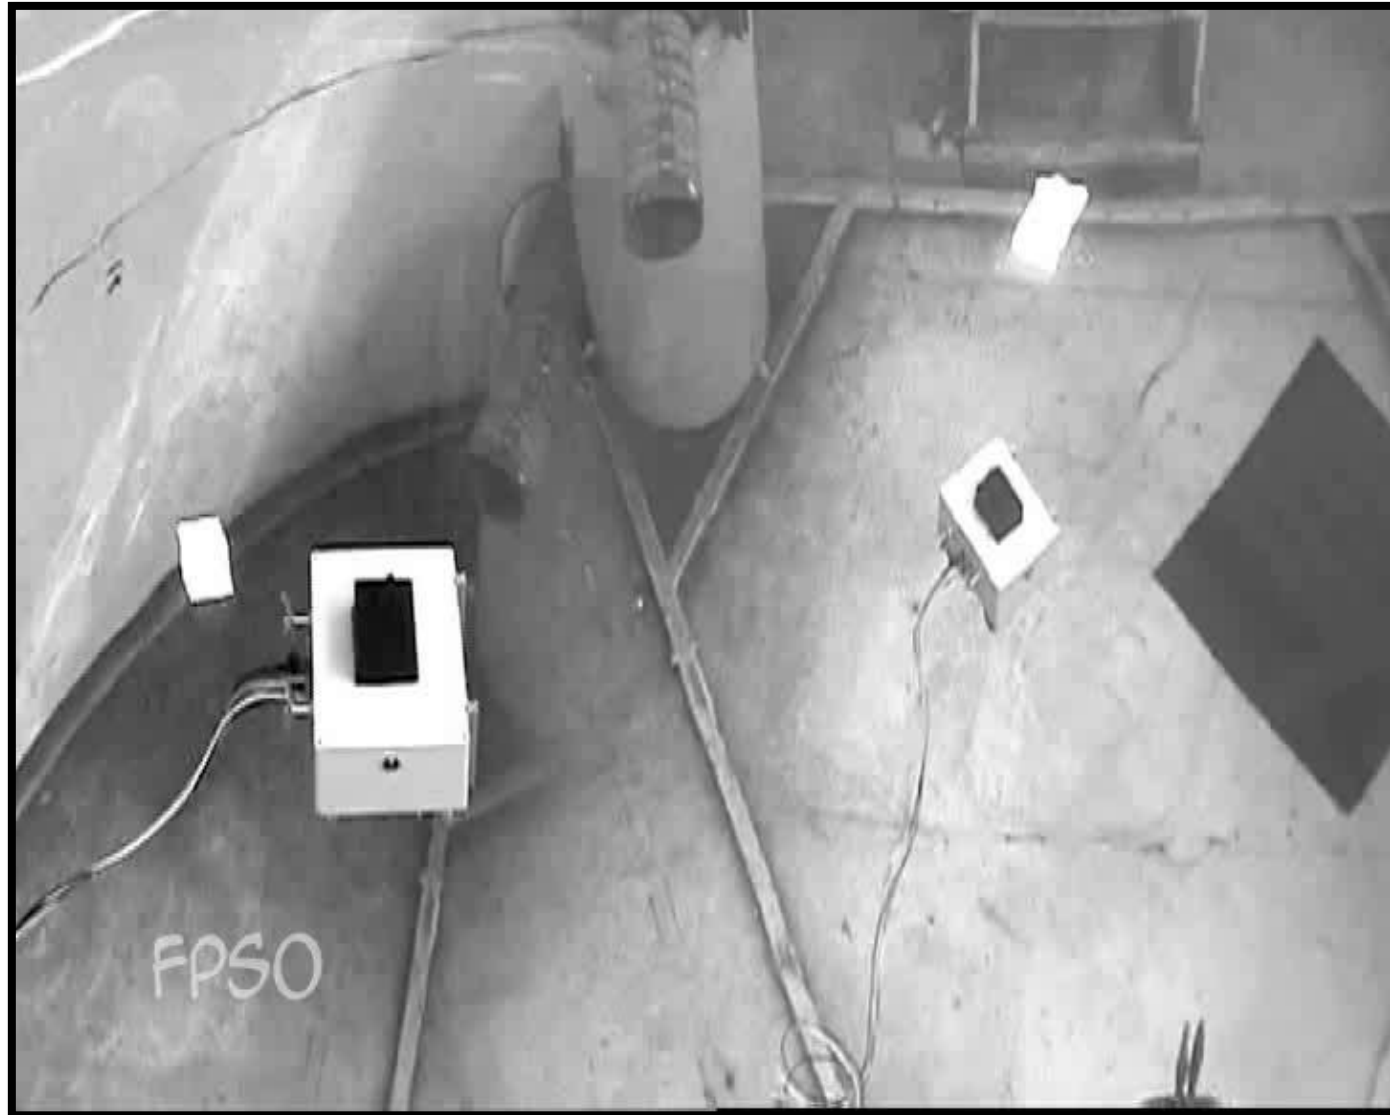
FPSO swimming and floor inspection robot to inspect tank floors and welds on strengthening plates
