Journal of Materials and Engineering Structures

Research Paper

Numerical Analysis of the Tetracylon Roman's Triumphal Arch of Tebessa: A Case Study.

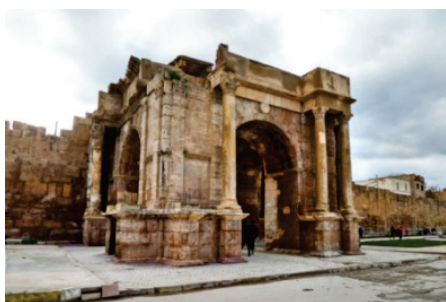
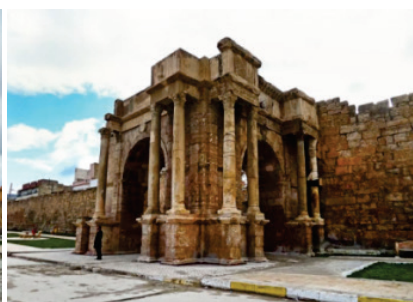
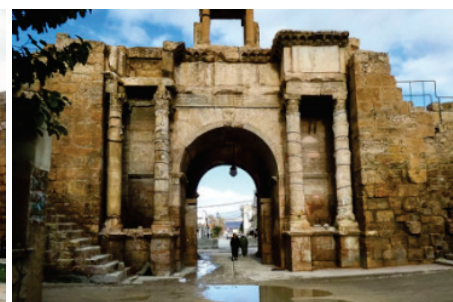
Fig. 1 - Caracalla Roman's Triumphal Arch of Tebessa

a- North and West spans

b- North and East spans

c- South span

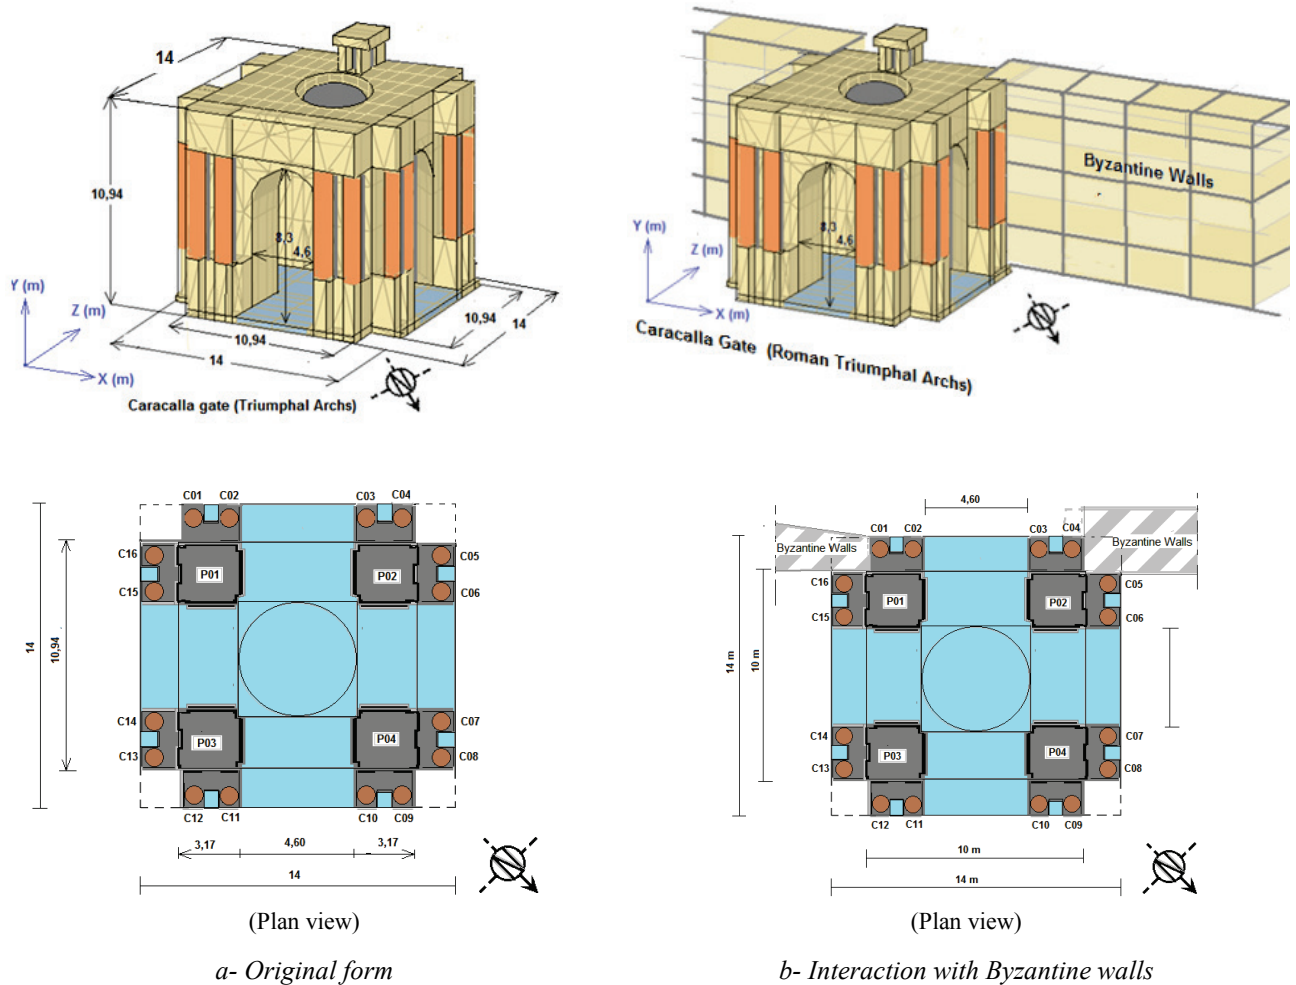
of 16 columns of about 6m length and a diameter varying between 0.6 and 0.7m, the columns are detached from the wall and with pilasters (total of 4 pilasters of 3.7 x 3.7 m) behind, supported by a podium from which their pedestals extend. The main entablature is above the pairs of columns and continues in the recess above the spans. On the attic on three sides dedications are inscribed. At the centre on all sides, the entablature supported an aedicule which historians reported that it was been holding a statue. At the very top of the arch (roof), it is thought by some scholars that there would probably have been a low dome which collapsed over time. Idealized presentation of the monument and its interaction with the Byzantine walls are presented in Figure 2 (a and b), for each state a plan view is presented. In its actual state, the dome and 3 columns (C12, C13 and C14) are missing.

Fig. 2 -Original state of the Gate.

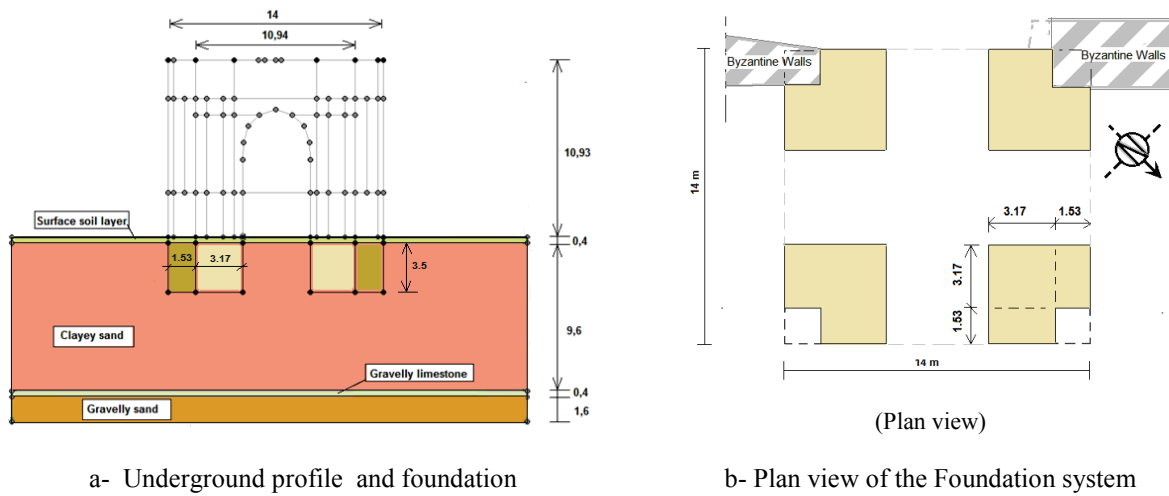
Site investigation by Touahmia et al. [8], reported the following geotechnical profile of the underground. The upper soil layer or surface soil is 0.4m, the following layer is clayey sand that extend to 10m beneath the surface, below there is a gravelly limestone of 0.4m and a stiff layer of gravelly sand that extend over 12m from the ground surface.

In general manner the monument's underground was found to be in a very stiff and compact state, which indicates that both primary and secondary consolidation is finished. The geotechnical profile and the probable configuration of the foundations system are shown in Figure 3.

Fig. 3 -Geotechnical profile and foundation's system.

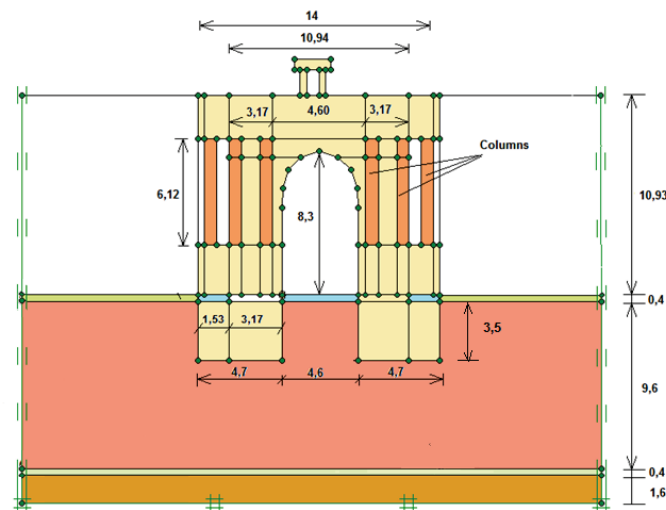
The adopted numerical model is 34m wide (about 10m wall extension from each side of the Gate), it extends 20m in the z-direction and is 23.5m high. (11.5m for the height of the Gate + 12 m to model the geotechnical profile layered-underground). The model is sufficiently large to account for the implantation of the monument (14x14 m) and the width of Byzantine walls, within the surrounding boundaries of the numerical model, and to provide enough distances to avoid any influence from the model boundaries. The Geometry and configuration of the model are presented in Figure 4.

Fig.4- Geometry and configuration of the model.

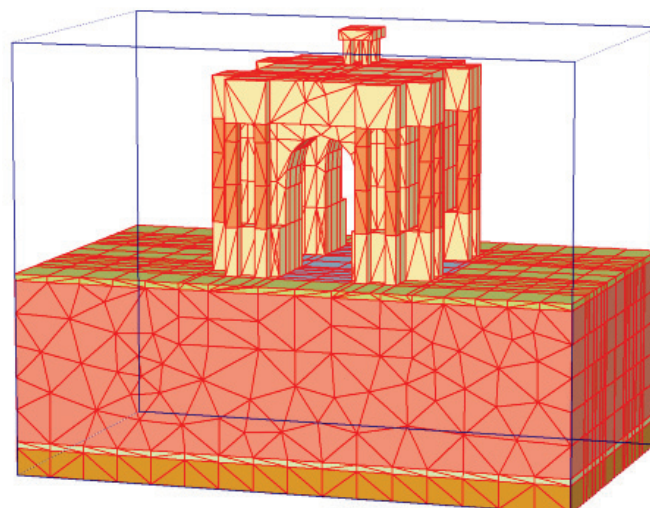
The modelling mesh data adopted in the finite element computation are based on a fine coarseness mesh, 15 nodes wedge elements leading to 8880 elements, 25068 nodes and 53280 stress points. In the z-direction the monument was modeled with 16 parallel planes, and 15 slices, each slice corresponding to a particular change in the configuration (geometry) of the model in z-direction. At the Input phase -construction of the geometry model- all the architectural details, materials and boundary conditions are defined by means of points, lines and colored clusters. Lines and clusters are activated or deactivated according to the architectural specifications of each slice, to obtain the desired 3D finite element model, representing as closely as possible, and the monument. A typical 3D generated finite element models is presented in Figure 5.

Fig. 5 - Typical 3D F.E model of the Gate.

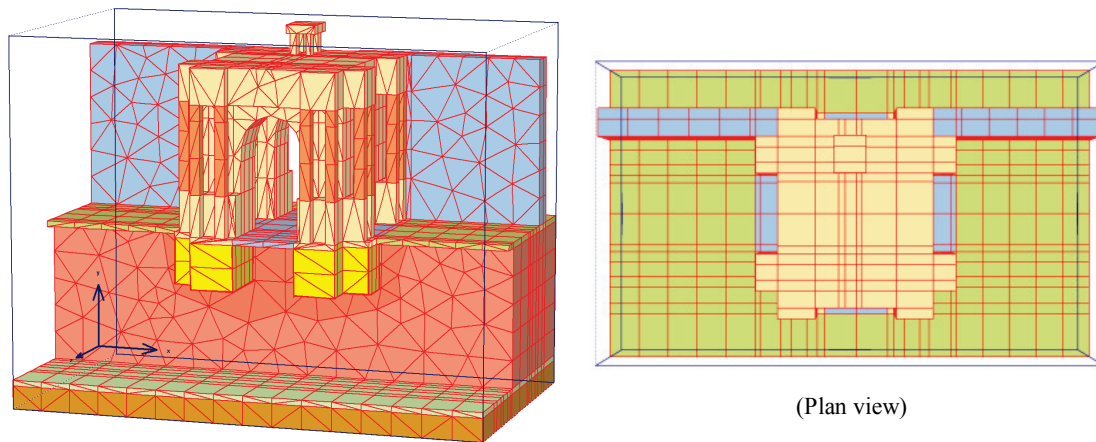
In Figure 6, part of the soil clusters are deactivated, in a partial geometry model, to highlight the configuration of the foundation system, a plan view of the model is also shown in this figure.

Fig. 6 - Partial geometry F.E. model (Gate + Byzantine walls).

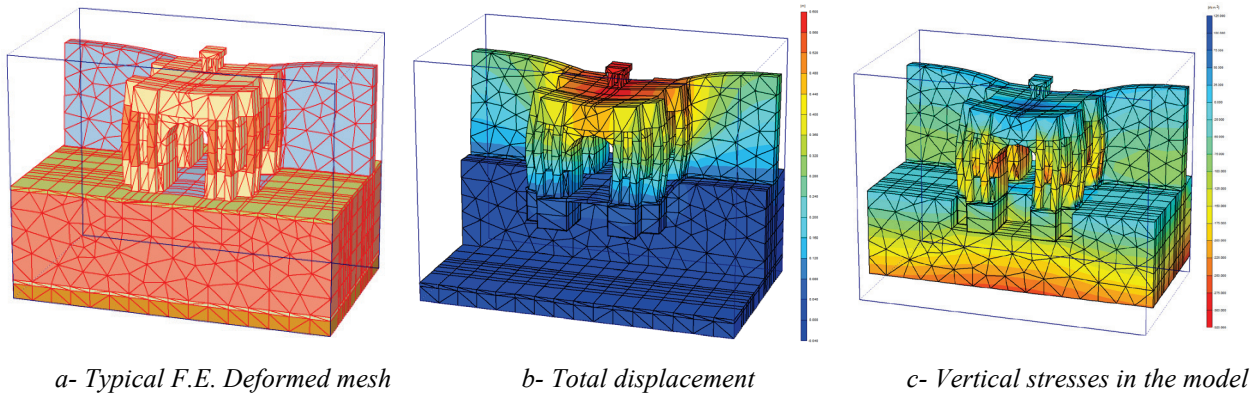
After each phase computation, a corresponding deformed mesh of the model is generated, with the extreme total displacements, a typical deformed mesh model, corresponding to the second phase (phase 2: after the Building of the Byzantine walls) is presented in Figure 7(a), the displacements were scaled up 3 times to highlight the deformation pattern in the model. In Figure 7 (b and c), the total displacements, and the vertical stresses in the model are respectively shown, in partial geometry models.

Fig. 7 -Deformed mesh model.

The main deformations in the monument corresponding to each computation phase, are summarized in Table 4, the deformation of the collapsed column (C12) is investigated, large vertical displacement of the column is computed in the second phase (due to tilting of the Gate), combined with the horizontal displacement and some probable building imperfection, this could be the cause of the collapse of the column (C12). In its actual state (phase 3) the computed displacements are comparable to previous site measurements [8], where, the horizontal displacement of the column (C09) was found equal to 4.9 cm. As far as the vertical deformations are concerned, the maximum vertical displacement (V_{max}) computed, is concentrated in the roofing of the monument which could explain the collapse of the dome. In phase 4, it could be seen that the eventual restoration of the columns and the roofing would have little effect on the deformation of the gate.

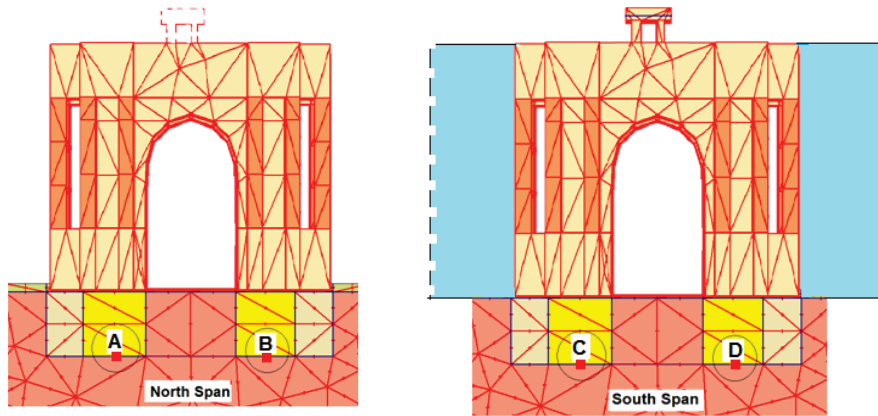
The settlement of the monument, was computed as the vertical displacements of some selected reference's nodes (A, B, C, D) corresponding to the bottom interface of the foundation with supporting soil, as shown in Figure 8.

Fig.8 - Selected nodes

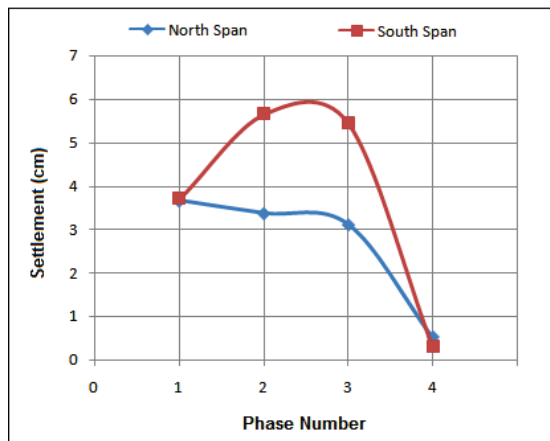
Fig. 10 - Tilting of the monument

In Figure 10, the maximum settlement of the North and South spans are plotted against the phase's numbers. It could be seen, again, that most of the tilting was due to the settlement of the Byzantine walls. In the phase number 4, the displacements of both spans are equal because in this phase the displacements were set to zero before phase computation to estimate the effect of the restoration upon the actual state of the Gate.

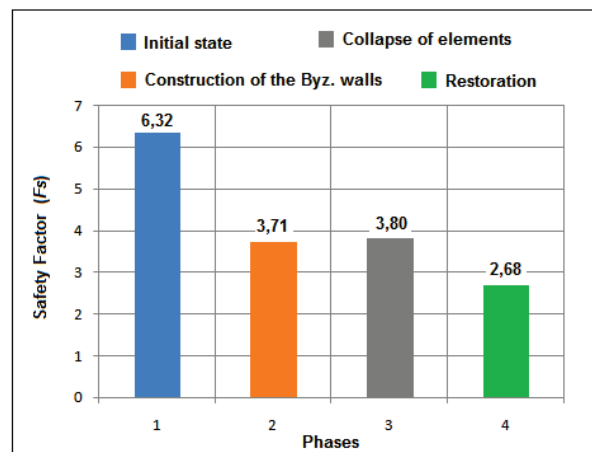
In the stability analysis, prescribed ultimate state was fully reached in all phases, which means that no collapse occurred; corresponding global safety factor is then computed. The results are plotted in Figure 11. As far as the restoration phase is concerned, it could be stated that the restoration of the missing elements would slightly affect the stability of the monument, but not its firmness, neither its equilibrium.

Fig. 11 - Global stability of the monument
