Condition and Change Analysis of Tidal Wetlands on the Squamscott River, Great Bay Estuary, New Hampshire Using Remote Sensing

TECHNICAL REPORT

Title: Condition and Change Analysis of Tidal Wetlands on the Squamscott River,
Great Bay Estuary, New Hampshire Using Remote Sensing

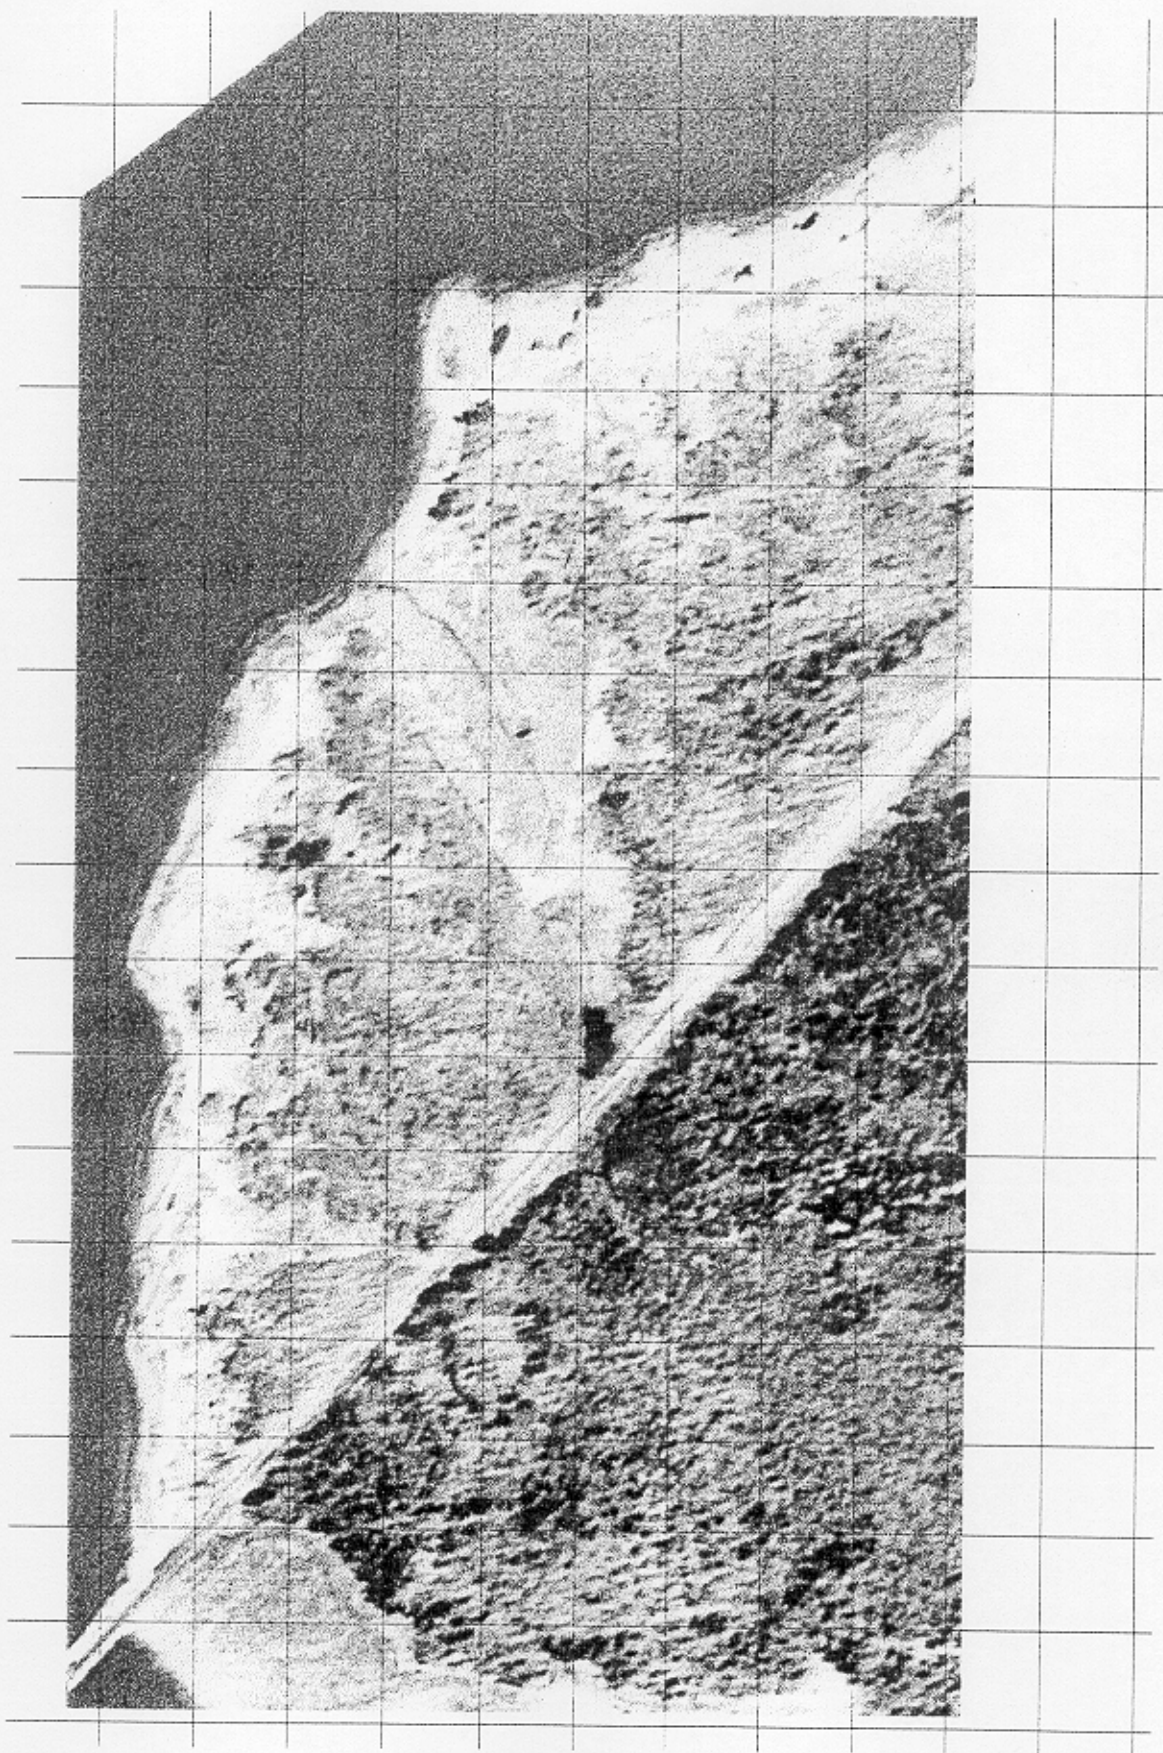
Figure 4. 1954 image of site 1 - Sandy Point.

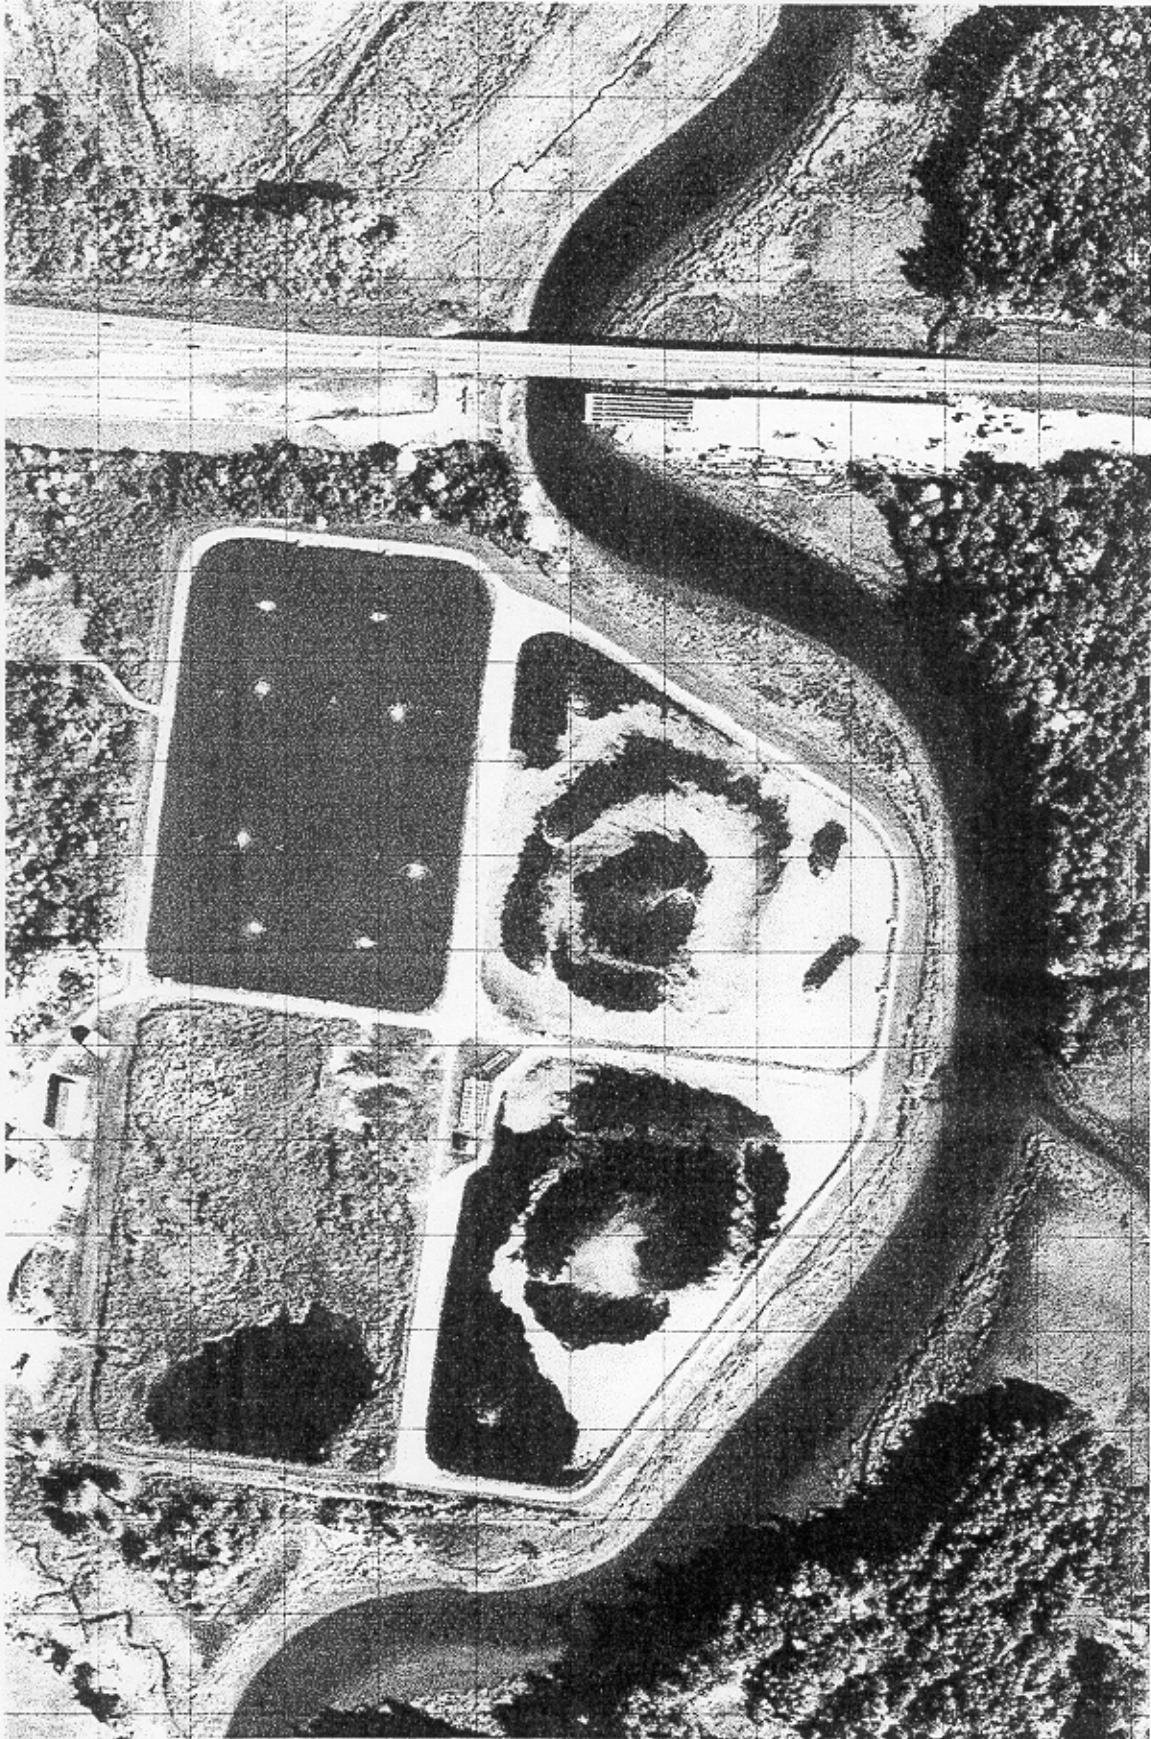
Figure 31. 1995 image of site 8 - Sewage Treatment Plant.
