## An investigation of solar panel thermal images collected from an unmanned aerial vehicle

AN INVESTIGATION OF SOLAR PANEL THERMAL IMAGES  
COLLECTED FROM AN UNMANNED AERIAL VEHICLE

An Abstract of a Thesis  
Submitted  
in Partial Fulfillment  
of the Requirements for the Degree  
Master of Arts

Ginger Ivy Jo L'Heureux  
University of Northern Iowa  
July 2019

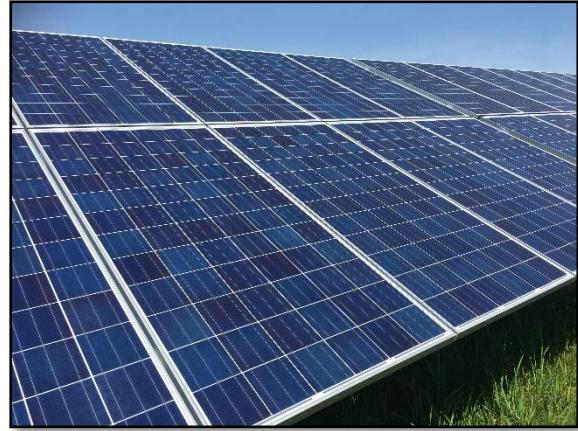
Figure 2. CFU solar panels

Solar Panel: Also known as photovoltaic (PV) or light-electricity, is a collection of solar cells spread over a large area as shown in Figure 2. When light from the sun reaches a panel, the energy from the sun is collected

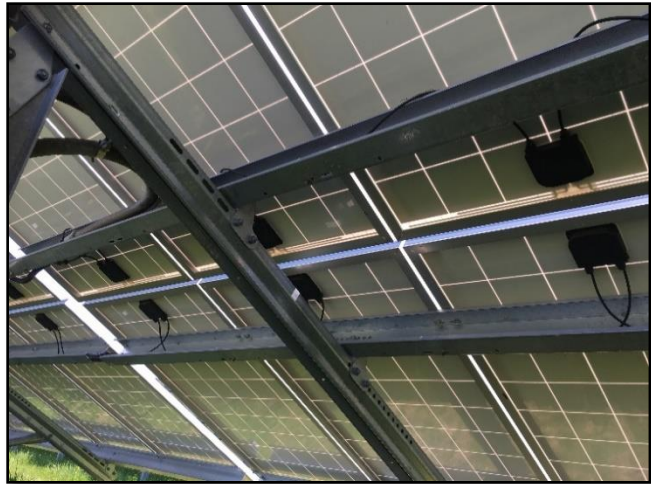
Figure 5. Support structure under solar panels

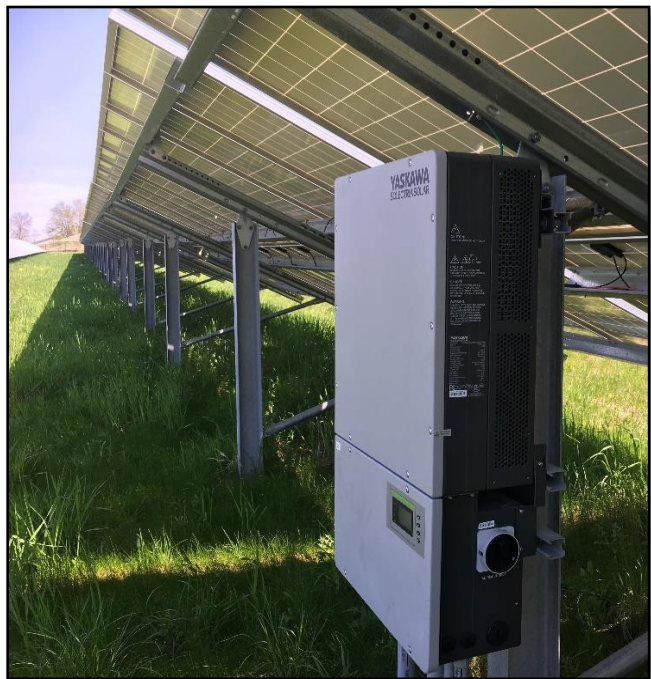
Figure 6. One CFU solar panel inverter

The inverters are mounted on the legs of the solar panel tables. The panels are grouped among the 41 inverters as shown in Figure 19 in Appendix A. Each inverter can take up to 36 kW of power. The inverters are the limiting components

of this system as more power could be created than can pass through to the system. The panels' output is in direct current (DC) but to be useable by the public, the power must be converted to alternating current (AC). This conversion is done at the 480-volt transformer where the power is then fed into the CFU electrical grid.

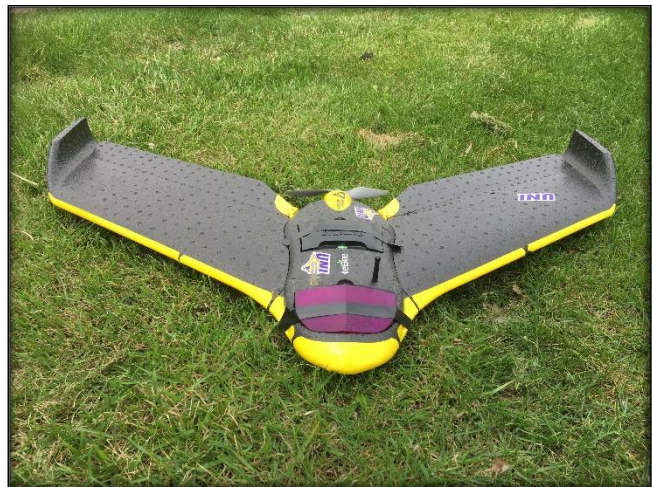
Figure 7. eBee unmanned aerial vehicle

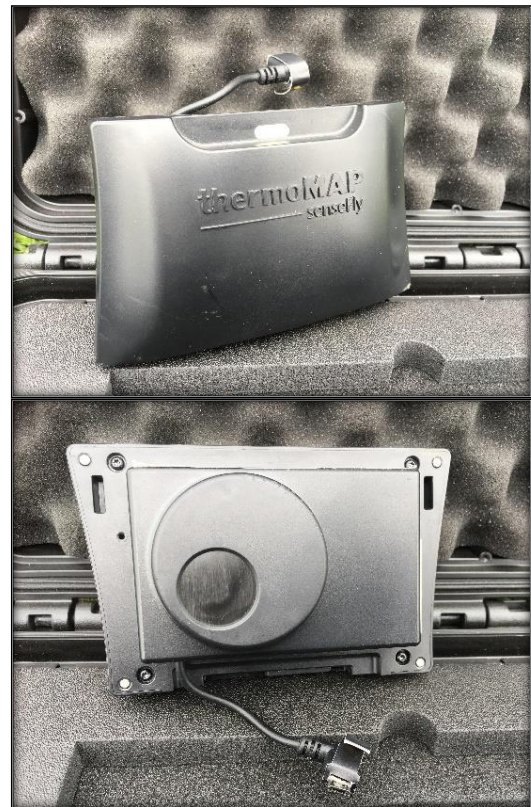
Figure 10. senseFly ThermoMAP camera

The senseFly thermoMAP camera (Figure 10) is set within the eBee UAV. This camera is a thermal infrared camera designed for the eBee flights. The camera has “radiometric calibration” which means it is created and calibrated especially for obtaining accurate and absolute temperature readings (“The professional mapping drone,” n.d.).

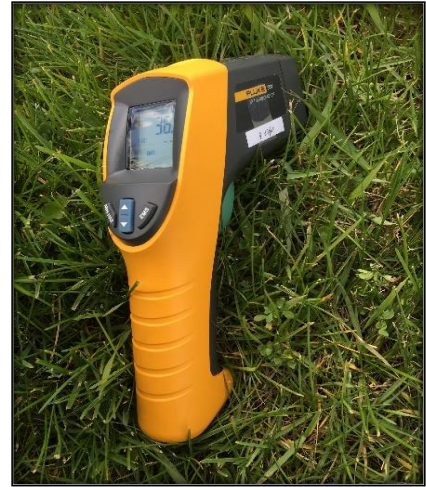
Figure 11. Fluke 561 IR thermometer

During the October, April and May flights, ground temperature readings were obtained using a handheld Fluke 561 Infrared Thermometer (Figure 11). Various points within the surveyed area were chosen to get a range of different temperatures due to varying surfaces. Temperatures were taken on asphalt, rock, grass, and prairie grass. This information will verify or show calibration errors of the temperatures obtained by the senseFly camera.

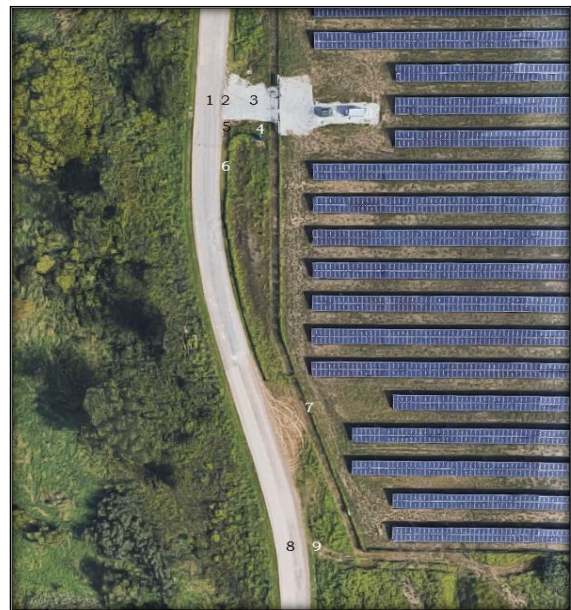
Figure 16. Approximate locations of Fluke 561 IR thermometer readings

1. Asphalt, centerline of the road and centerline of the solar garden driveway
2. Rock, edge of rock on centerline of the solar garden driveway
3. Rock, center of solar garden driveway
4. Grass, Shadow of the CFU solar garden sign
5. Grass, near corner of asphalt and south side of solar garden driveway
6. Grass (brown prairie), south solar garden driveway
7. Grass, inside the fence approximately 5<sup>th</sup> row from the south
8. Asphalt, centerline of the road, directly west of southwest chain-link fence corner of the solar garden
9. Grass, on the road shoulder, directly west of the southwest chain-link fence corner of the solar garden

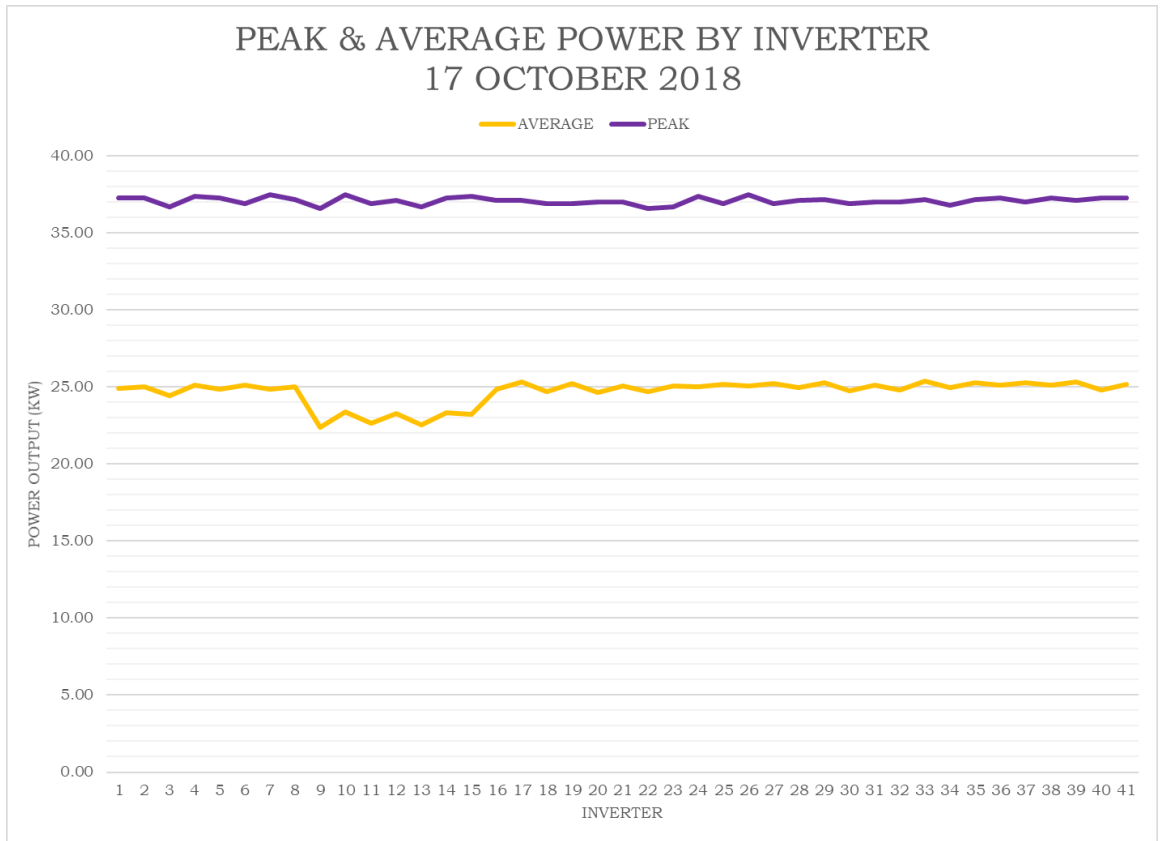
Figure 20. 2018 October 17 peak & average power

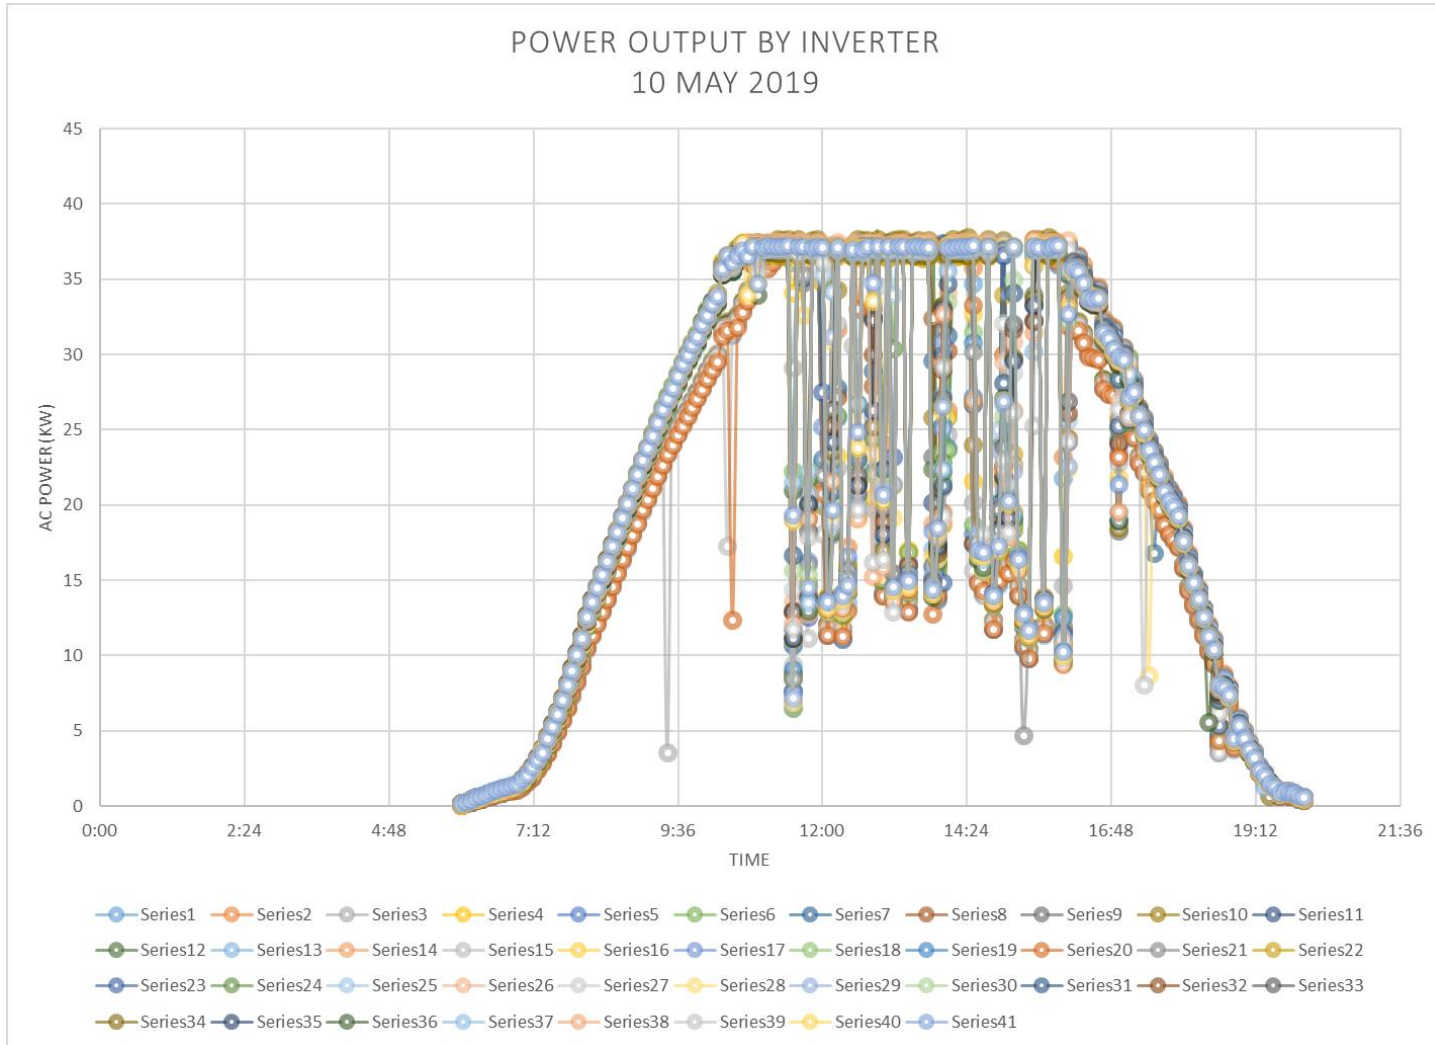
Figure 25. 2019 May 10 power by inverter – full day

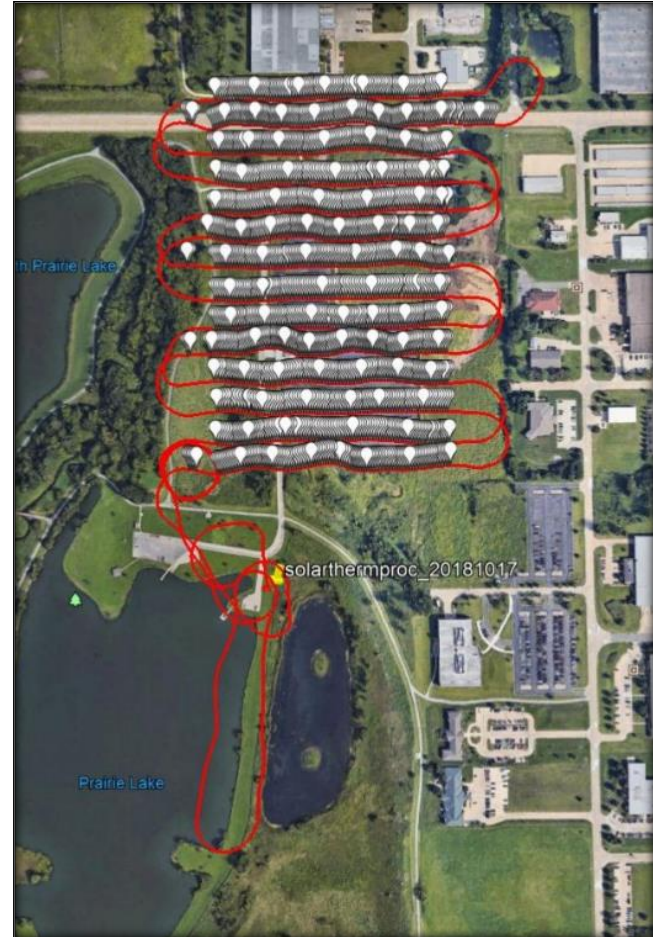
Figure 27. Flight path photo locations on 2018 October 17

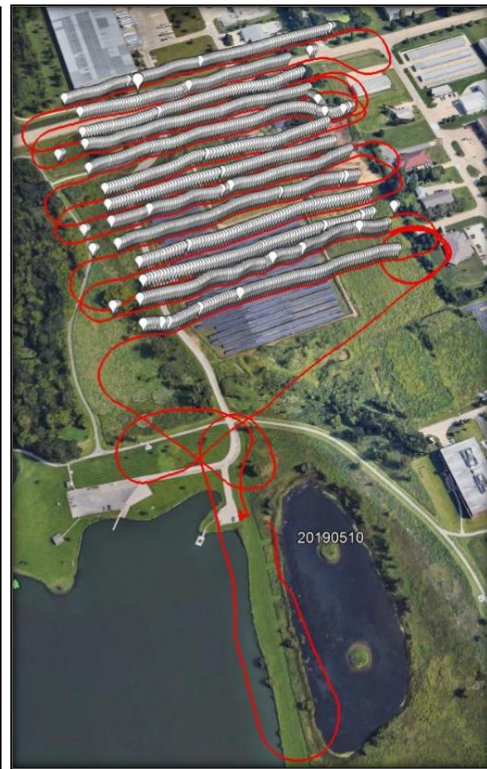
Figure 30. Flight path & photo locations for 2019 May 10

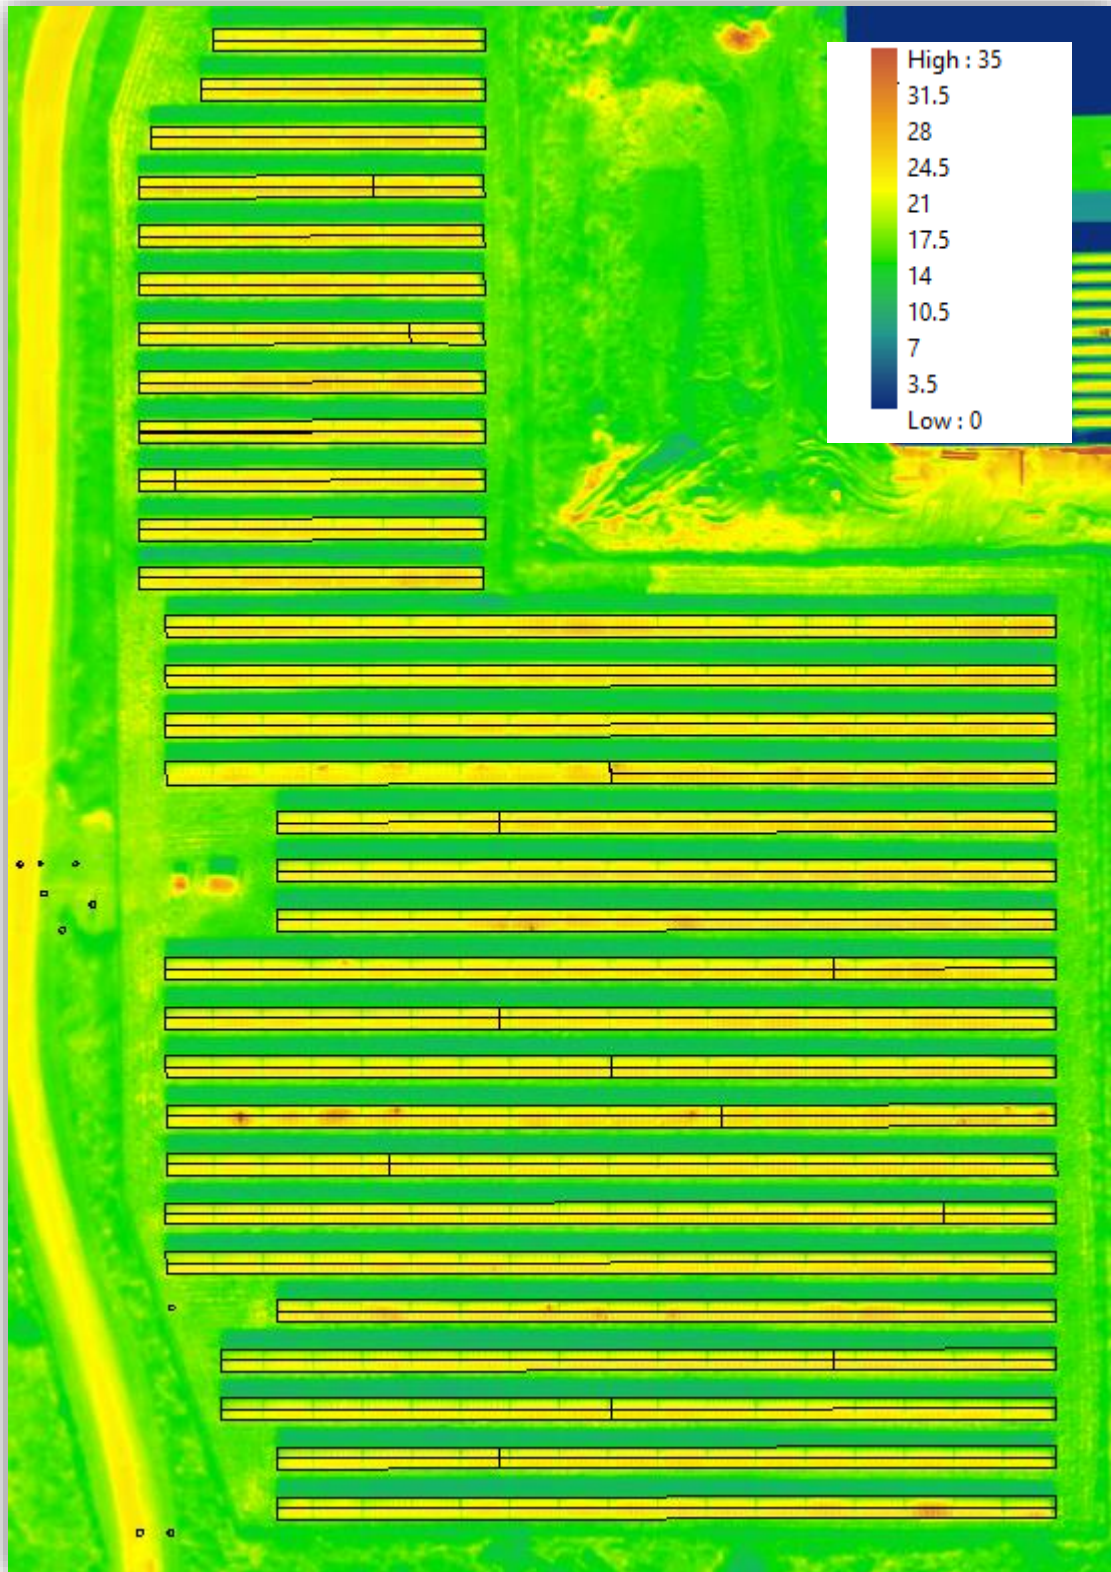
Figure 40. 2018 October 17 thermal image

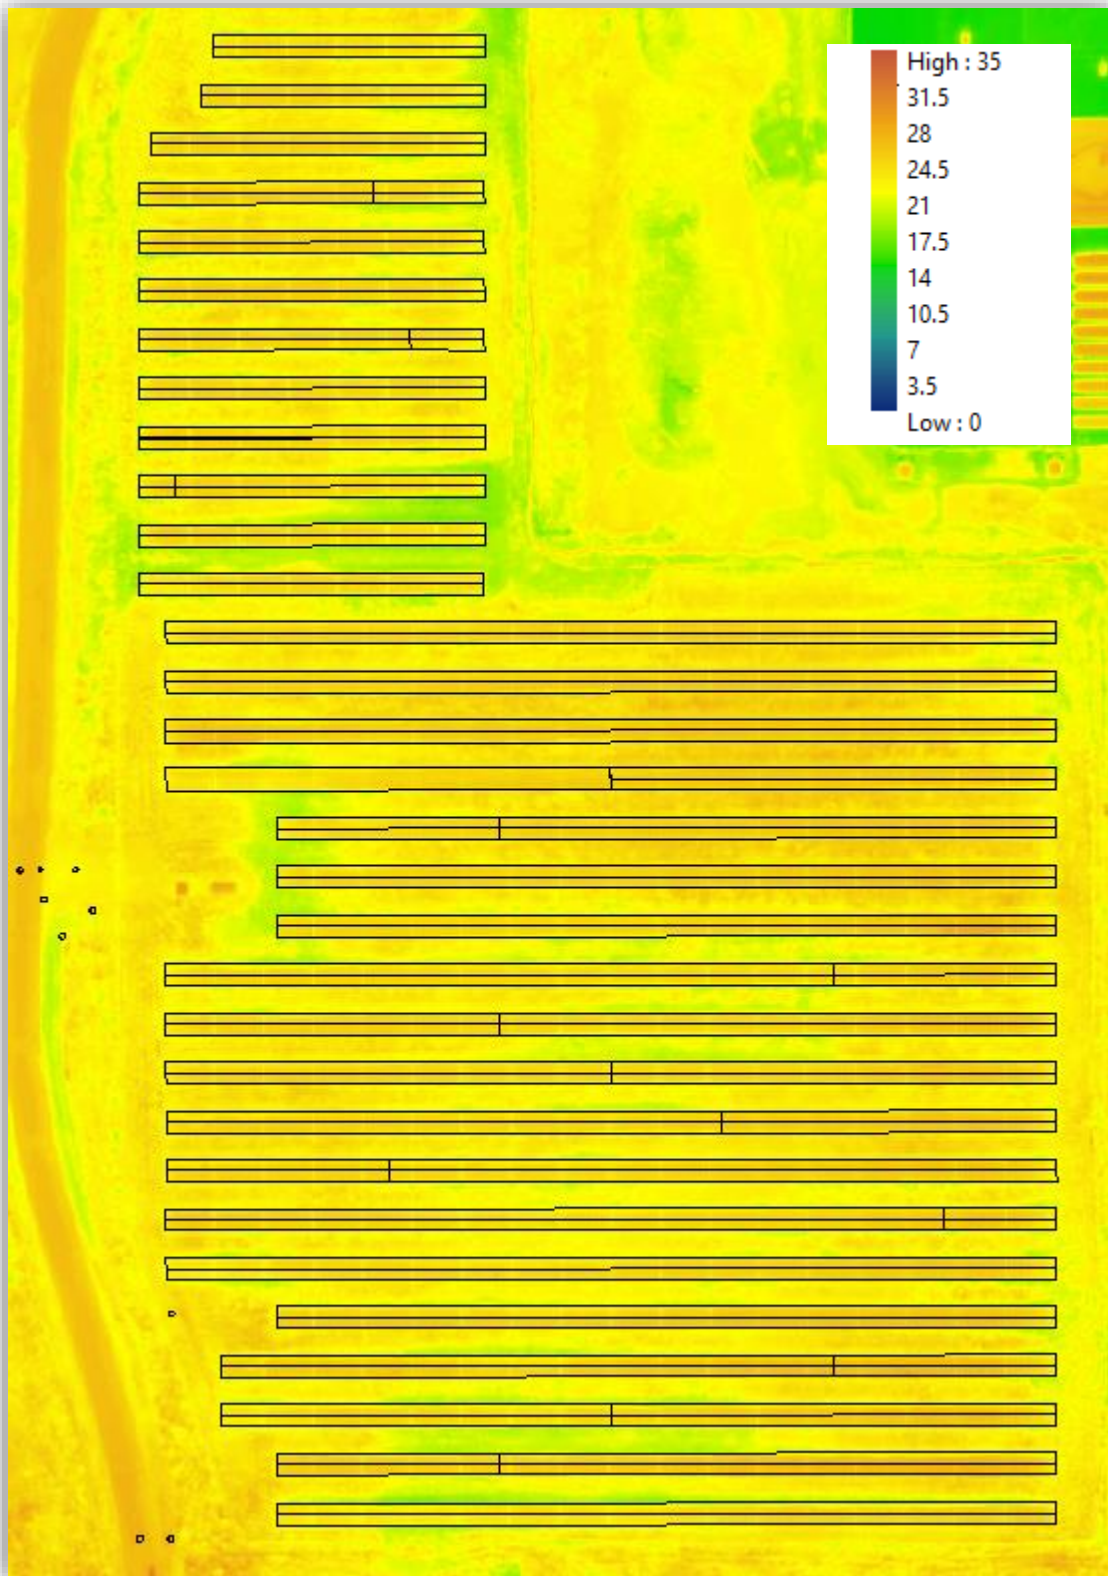
Figure 41. 2019 April 24 thermal image

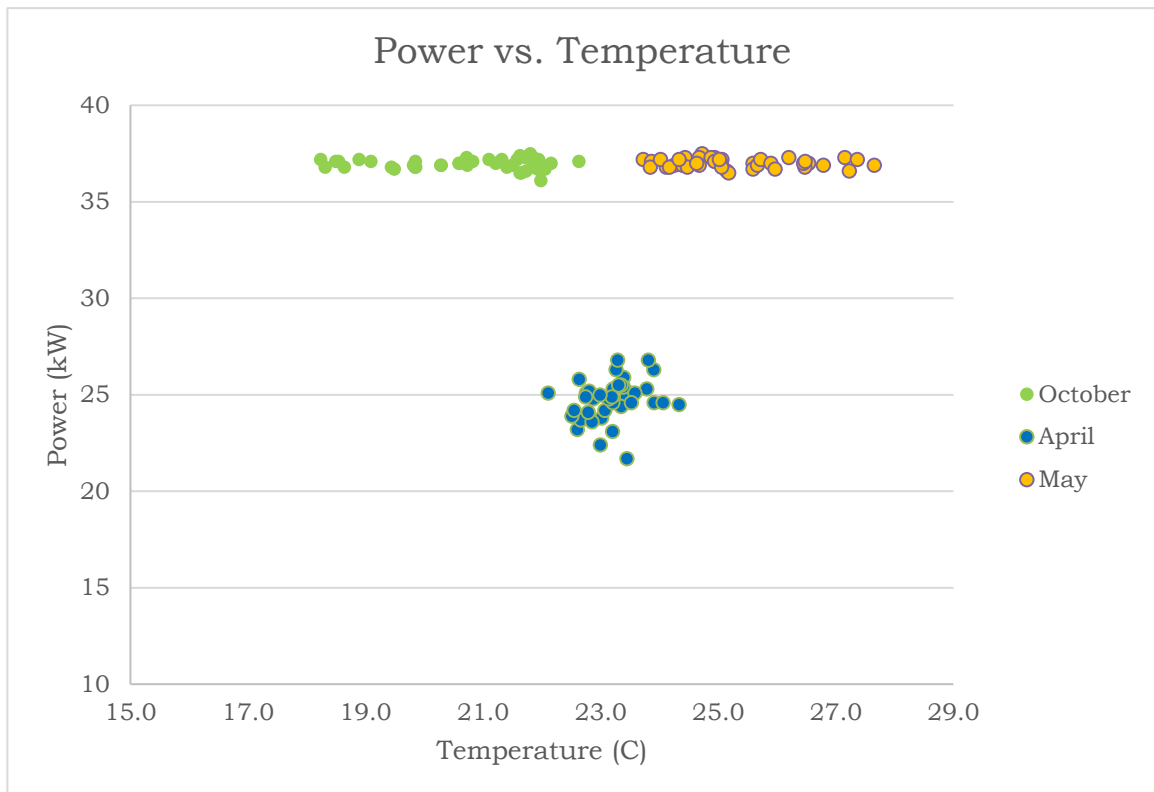
Figure 43. Power-temperature comparison

must be obtained by looking at monitoring data at each inverter, in CFU's case, on a spreadsheet. This is because the gradient of colors shown through the thermal images are temperatures relative to each other, not power. After checking the hot spots found on the thermal images taken in October against the data obtained from the inverters, it was determined the power was similar to that of the other inverters. Hot spots are shown in Figure 18. This data shows that the hot spots did not affect the overall power output for these group of panels.
