Sustainable Energy & Fuels

Virtual unrolling of spirally-wound lithium-ion cells for correlative degradation studies and predictive fault detection[†]

A spirally-wound LG 18650 MJ1 lithium-ion battery was imaged in 3D before and after 1061 cycles using X-ray computed tomography. The battery's capacity had faded to 79% of its initial value and some of that fade was attributed to delamination in the innermost region of the 'jelly-roll' structure. A method for virtually unrolling the jelly-roll and analysing it in different coordinates is presented. The method allows efficient comparison of the position and shape of the electrodes at different times and highlights imperfections present in the jelly-roll before cycling which were shown to nucleate the delamination of the electrode.

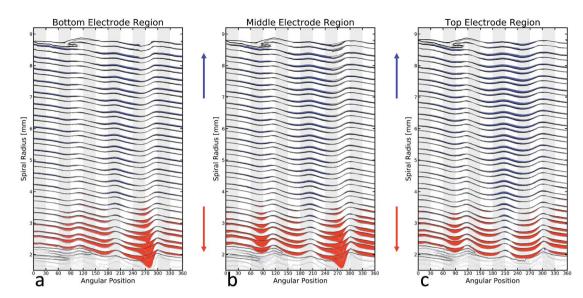
Fig. 6 Deformation patterns in three different regions of the cell after cycling. (a) The bottom electrode region, (b) the middle of the electrode and (c) the top. Blue regions indicate net outward deformation and red net inward.

Fig. 6 presents the deformation patterns in the jelly-roll for the bottom Fig. 6(a), middle Fig. 6(b) and top Fig. 6(c) of the cell. The electrode position before and after cycling are presented in black and grey, respectively. The coloured areas represent

regions of significant deformation during cycling. Red regions show inward movement, such as the 'kink' visible after cycling while blue areas indicate a net outward deformation. The shape

The major changes in the jelly-roll can be seen most clearly through the red and blue regions in Fig. 6. The jelly-roll irreversibly deforms outwardly (blue) into any space left available during the initial winding of the battery. These spaces are created by inconsistent surfaces external to the jelly-roll. The bottom of the battery imaged here is being influenced by two of these features. The first is the external current collector, visible at 270 degrees. On either side of the collector, there is significant outward deformation in the jelly-roll. The second feature is the end of the spiral electrode, which is visible between 90 and 120 degrees, near the top of the figure. Again, after cycling the electrode migrates and deforms into this space. In the top of the cell, the external current collector is no longer present but still has a significant effect. While not an inconsistency in the manner described above, the end of the current collecting tab is a very significant discontinuity in the electrode, and its abrupt termination leads to a very significant void to expand into. Wherever the electrode was unable to deform outwardly it will deform inwardly (red). This leads to the most significant inward deformation to be located in line with the anchor points described above. If sufficiently high forces are applied to inward deformation, a delamination event will occur, as is clearly evident in the cell demonstrated here. This will occur where the highest stresses are being generated which will likely be in line (radially) with the current collector.
