MODEL DEVELOPMENT AND VALIDATION OF BITUMINOUS-BASED CRACK
SEALANTS

DISSERTATION

Submitted in partial fulfillment of the requirements
for the degree of Doctor of Philosophy in Civil Engineering
in the Graduate College of the
University of Illinois at Urbana-Champaign, 2019

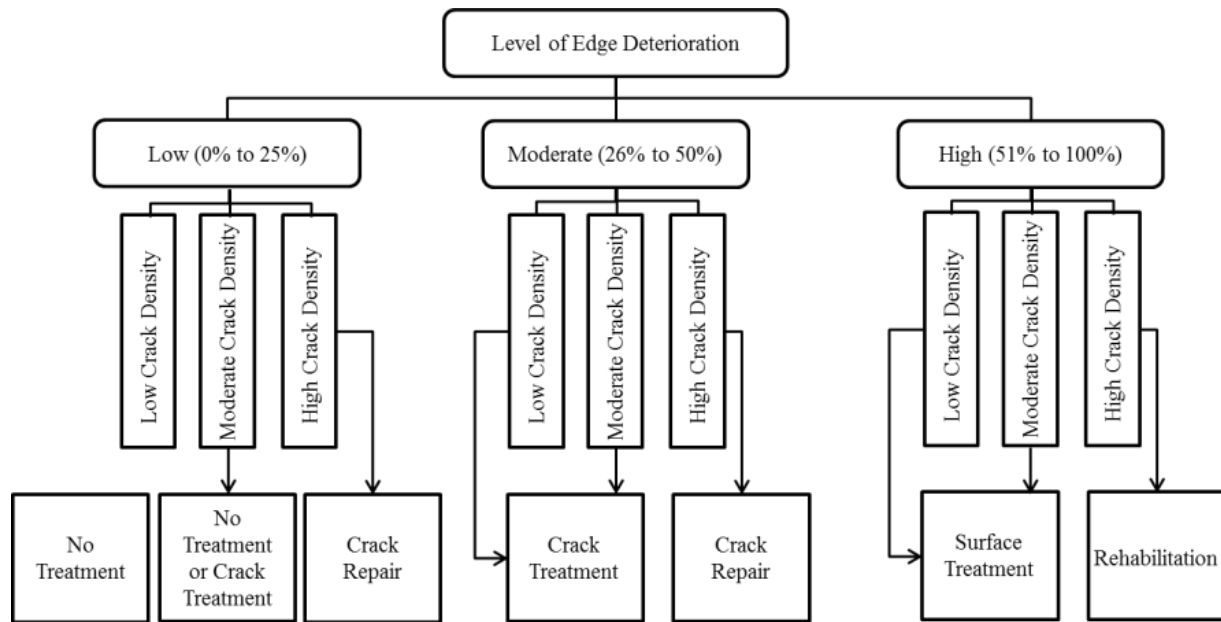
*Low Crack Density: Linear crack length per 100m pavement section to be less than 10m

*Moderate Crack Density: Linear crack length per 100m pavement section to be from 10 to 135m

*High Crack Density: Linear crack length per 100m pavement section to be more than 135m

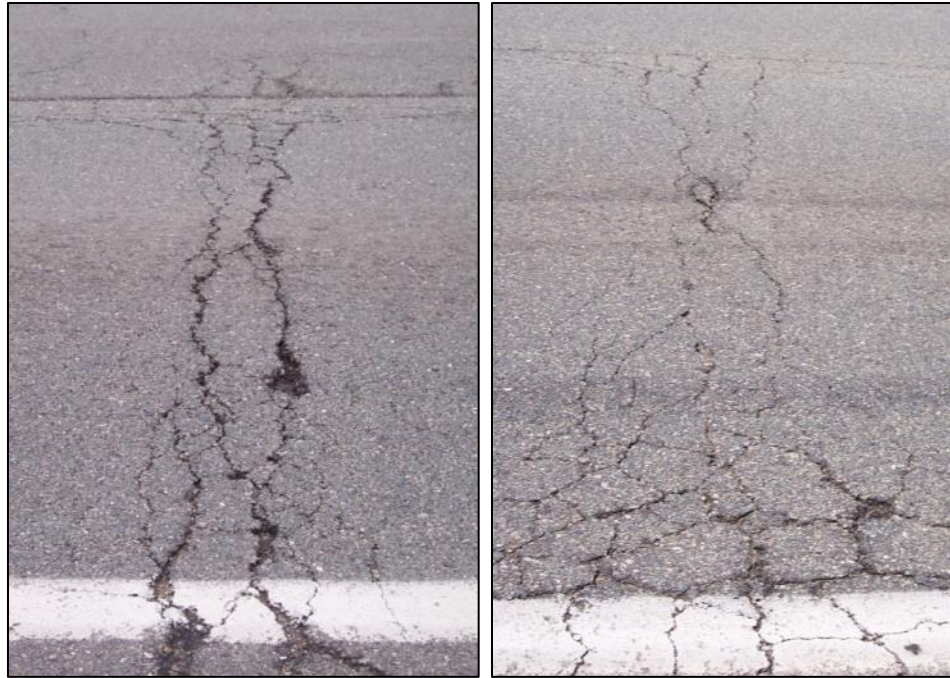
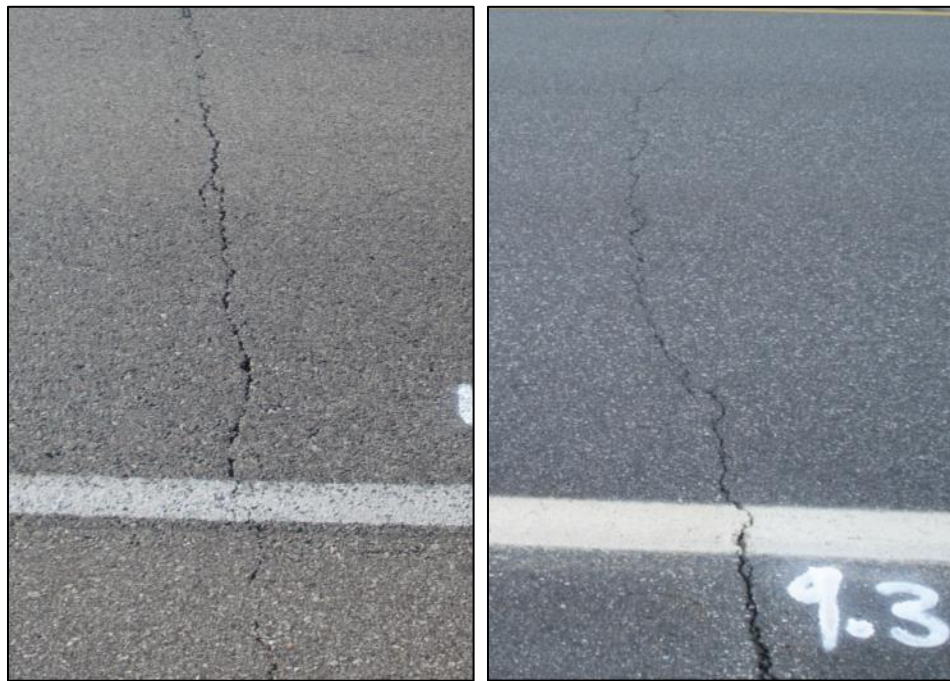
Figure 2.2. Various crack patterns usually considered in the selection of surface or crack treatments: (a) Cracks with severe branching and spalling, not recommended for crack sealing or filling; (b) Cracks with no branching and no spalling are appropriate for crack sealing or filling.

Crack sealant treatments are not recommended for cracks wider than 25mm. Figure 2.2 illustrates some examples of acceptable and unacceptable crack patterns. In addition, pavements exhibiting severe fatigue cracking are not recommended for crack sealing.

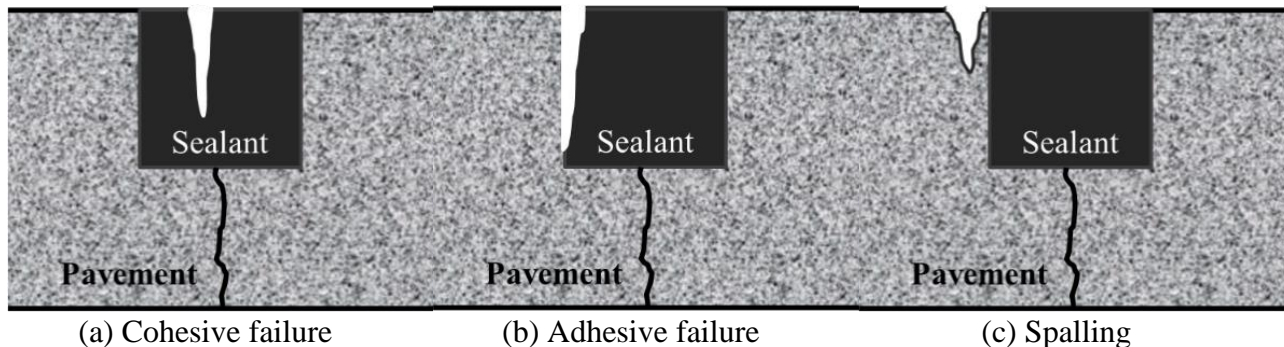
Figure 2.5. Primary modes of failure for sealants during field performance.

The primary modes of failure for sealants vary depending on application and climatic conditions (Figure 2.5). A general classification of sealant failures as related to sealants properties are described as follows:

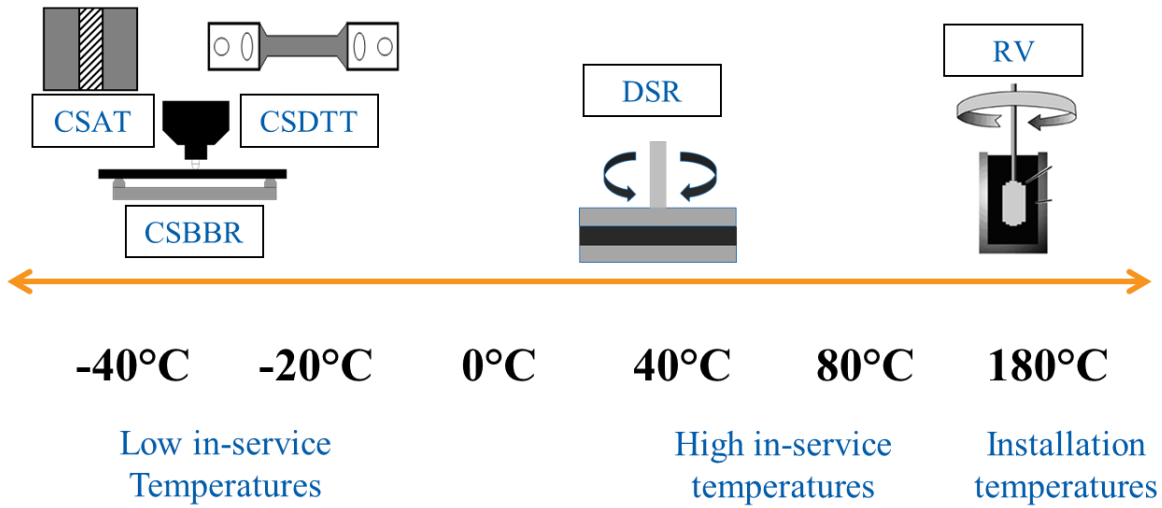
Figure 2.6. Schematics of developed AASHTO tests for crack sealant selection and spectrum of their performance temperature.

Thresholds for each test were identified to ensure desirable field performance. For example, Sealant Grade (SG) 52-34 suggests that sealant can be used at a high service temperature of 52°C and a low-service temperature of -34°C. Hence, using the developed laboratory tests, a proper crack sealant can be selected systematically based on expected service temperature. Figure 2.7 shows different zones for the pavement low temperature in North America that may be used to select the proper sealant based on its SG.

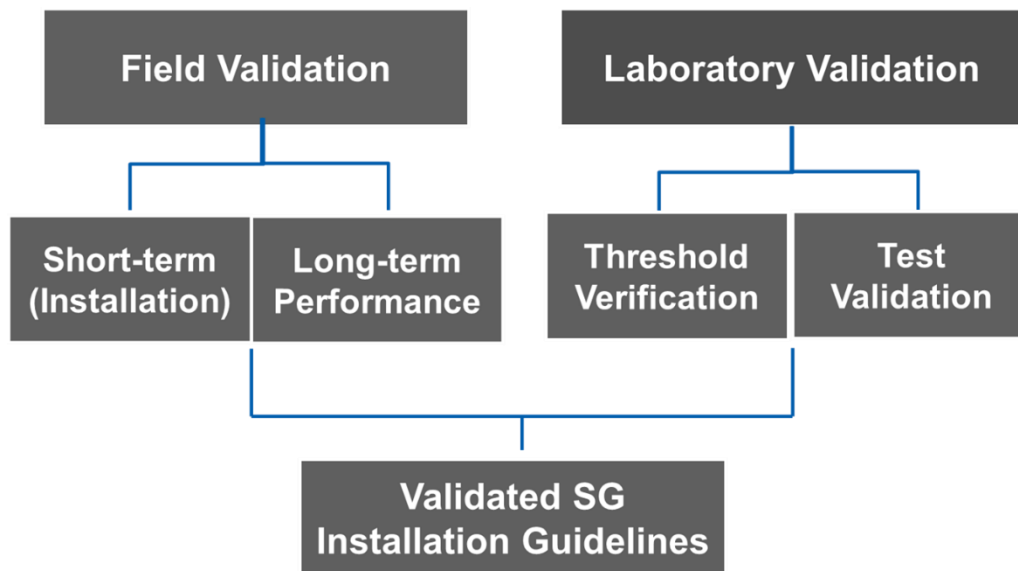
Figure 3.1. Experimental program used to validate and fine-tune provisional AASHTO test method for selection of hot-poured crack sealants.

The performance-based guidelines developed for the selection of hot-poured crack sealants were validated and fine-tuned in this study. While the between-laboratory test variations had been successfully verified, test precision was examined, in this study, so the developed laboratory tests and new guidelines could be validated for full implementation as AASHTO specifications. Field performance of crack sealants was evaluated to fine-tune the preliminary thresholds. To meet the objectives of this study, the methodology shown in Figure 3.1 was implemented.

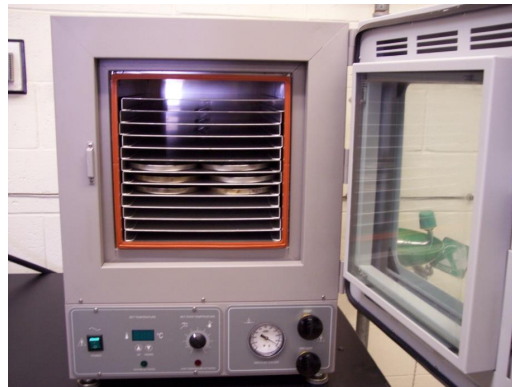
Figure 3.2. Vacuum oven used in aging of sealants.

The vacuum oven aging procedure proved to be the most appropriate method for simulating the effects of weathering on sealant properties (Figure 3.2). According to AASHTO T367, sealants are cut into slices and placed on a stainless steel pan; each pan contains 35g of sealant. The pan is transferred into a conventional temperature controlled oven which is preheated to 180°C for approximately 5min to allow the sealant to melt and form an approximately 2mm film. The sealant is then removed from the oven and cooled to room temperature. Once it cools, the sealant is placed in a vacuum oven preheated to 115°C for 16hrs. Then, the vacuum is released and the sealant is placed in an oven at 180°C for 5min or until the sealant is fluid enough to be poured.

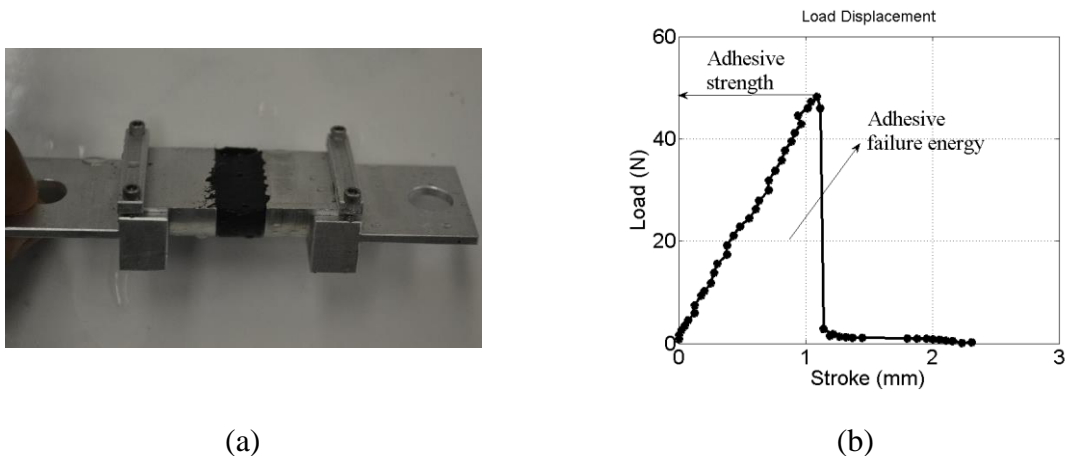
Figure 3.4. Crack sealant adhesion test (a) test specimen (b) typical maximum adhesive strength and interfacial energy results.

The direct adhesion test, AASHTO T370, was developed to determine the adhesive strength of hot-poured crack sealants, as shown in Figure 3.4. The test is conducted by applying monotonic displacement rate until the sample is separated from the substrate, thus indicating interfacial failure. A minimum of six replicates is used for each material. The specification recommends using aluminum as substrate material; however, aluminum substrate can be replaced by other materials such as rock or asphalt mixture. Applied forces and displacements are also recorded to calculate the energy needed for breaking the bond between sealant and mold. The interfacial failure energy is the area extending from under the load-displacement curve to the peak point. The maximum loading force is considered as adhesive strength and is selected as the test performance parameter. The selected threshold is greater than 50 N for adhesion load to ensure good field performance. Figure 3.4 illustrates typical test results conducted for one material, showing the calculation of adhesive strength and interfacial fracture energy.

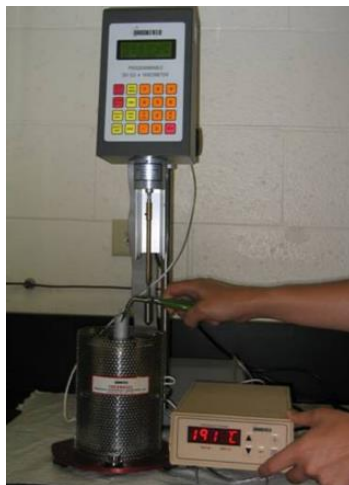
Figure 3.7. Crack sealant viscosity test.

A Brookfield rotational viscometer was used to measure apparent viscosity of the hot-poured crack sealants. This procedure was modified from the one adopted by Superpave for asphalt binders. The main difference is the change in spindle and hook configuration, in addition to changes in testing procedures, as shown in Figure 3.7. The viscosity test was designed to simulate installation conditions. Since viscosity can play an essential role in predicting the field performance of hot-poured crack sealants, upper and lower viscosity limits (1 to 3.5Pa.s) are recommended. Upper limit ensures the material is liquid so it can be poured. The lower limit helps avoid excessively liquid sealants which can create problems in the filling of cracks during installation. The test is conducted in accordance with AASHTO T366 at 60rpm at the installation temperatures recommended by the manufacturers.

(a) Apparatus (b) Modified spindle

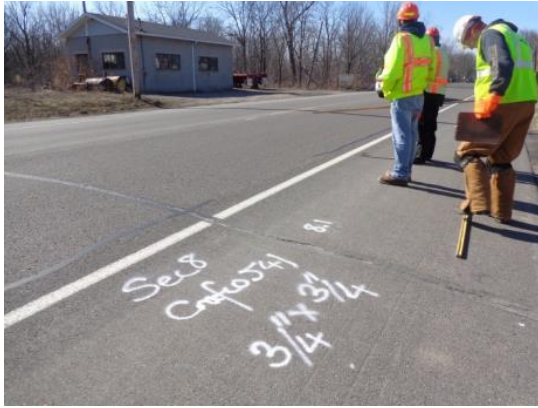
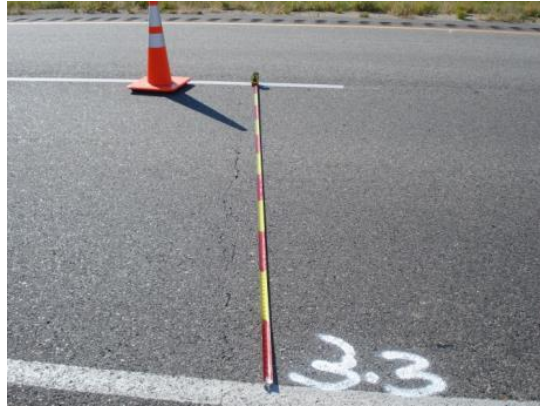
Figure 4.1. Initial survey and crack numbering of a test section.

A preliminary survey was conducted at the test sites prior to installation collect information about the initial condition of pavement and cracks. Each test site was surveyed rigorously to determine crack spacing, number of cracks, crack rating, station numbering, and photo documentation. A rating system was developed to document the cracks initial condition. The rating system is a qualitative measurement based on visual inspection. The cracks were rated based on initial condition (partial- or full-length crack, branching severity, and cracks width and depth) and suitability for sealing. Ratings from 1 to 5 were assigned to cracks with 5 indicating best condition per the selection criteria (full-length crack, no branching, <10 mm opening) and 1 indicating worst condition. Crack ratings below 3 were not considered in this study; however, such ratings were considered for field sampling. Figure 4.1 shows pictures from two different test sites.

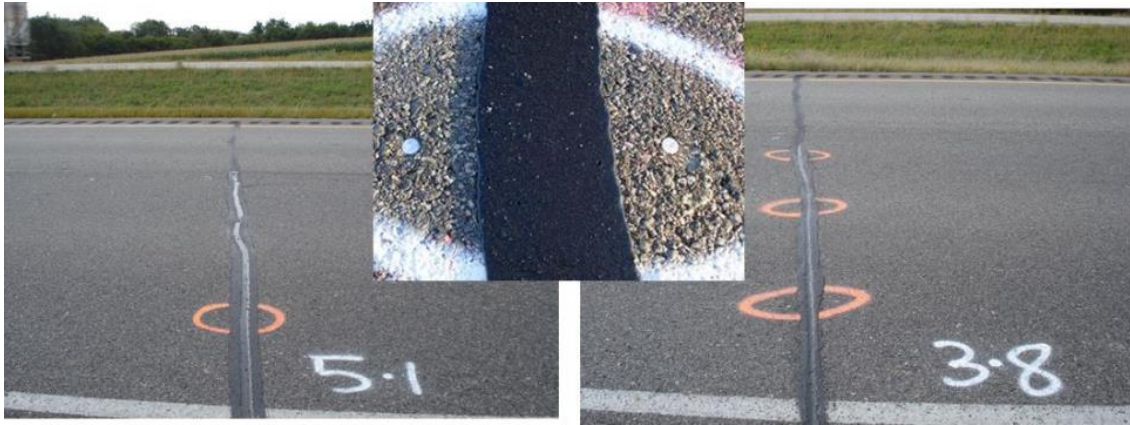
Figure 4.2. Crack displacement pins: Single-point measurement (left) and three-point measurement (right).

Steel pins were installed at the edge, mid-lane, and center lane locations. Figure 4.2 shows two cracks at a test site with single- and triple-point displacement pins. Initial measurements were taken after installation.

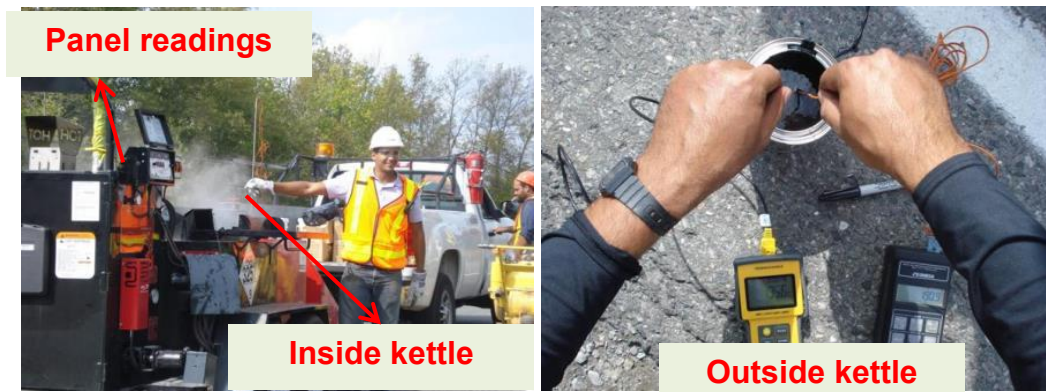
Figure 4.3. Temperature measurement methods during test site installation.

- Sealant temperature measurements – The temperature of sealants is critical for ensuring proper installation and expected performance. Temperature readings were recorded at regular intervals from (1) panel readings (dial gage and heated hose); (2) inside the kettle using a 180 cm long probe that can record temperatures at three locations: at the tip and 12.5 and 25 cm above the tip of the probe; and (3) outside the kettle using infrared and T-type thermocouples. Figure 4.3 shows the various methods used to record temperature during installation.

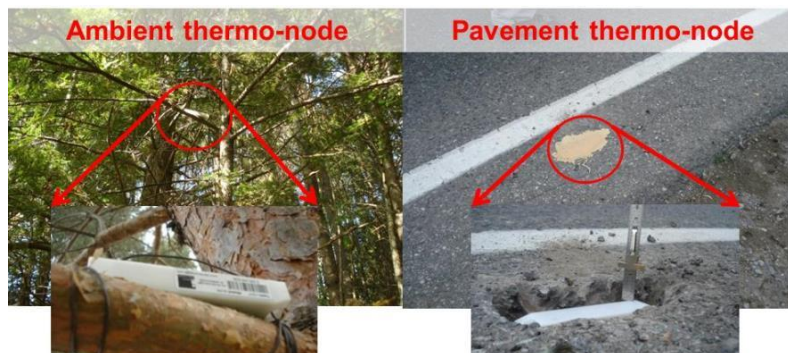
Figure 4.4. Wireless temperature nodes for ambient temperature (left) and pavement temperature (right).

- Pavement and ambient temperature measurements – Two wireless temperature nodes were installed at each test site to monitor pavement and air temperatures during the evaluation period. One of the nodes was installed in the proximity of test site, avoiding direct sun light, to monitor ambient temperature. Another node was buried in the pavement (25 mm below the surface) using epoxy, as shown in Figure 4.4, to measure pavement temperature.

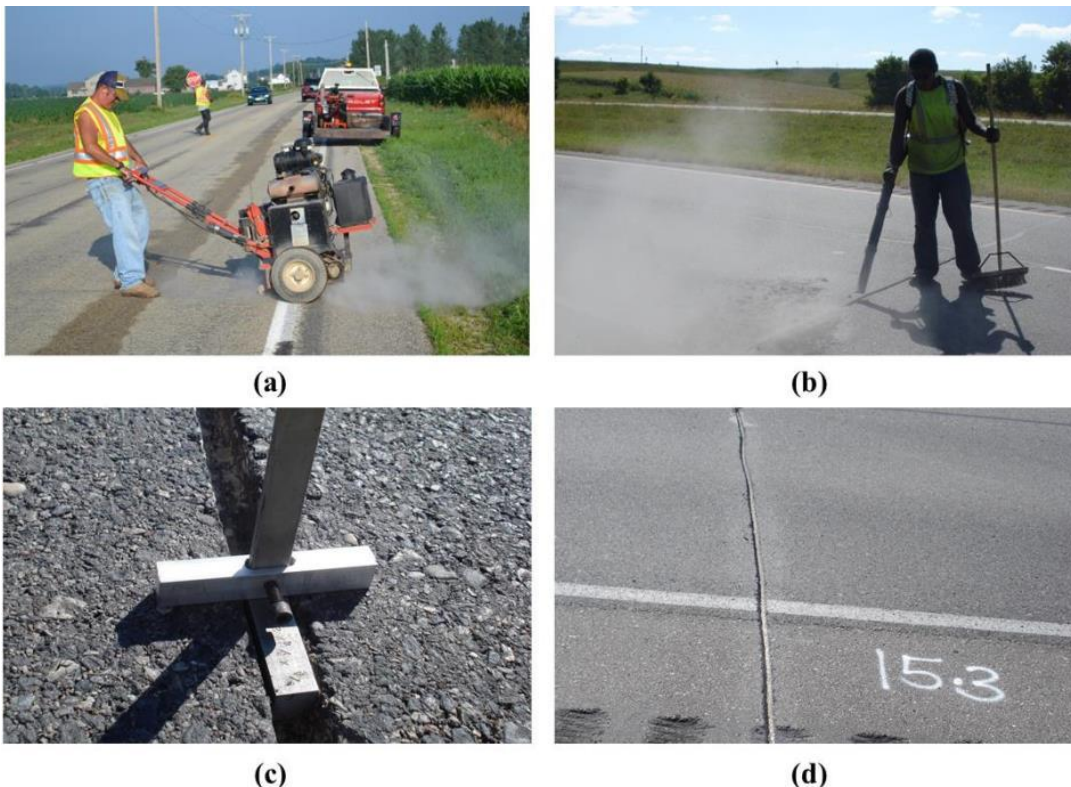
Figure 4.5. Typical operations prior to crack sealing: (a) routing; (b) pavement and crack cleaning; (c) route size checking; and (d) a properly finished rout and clean pavement surface.

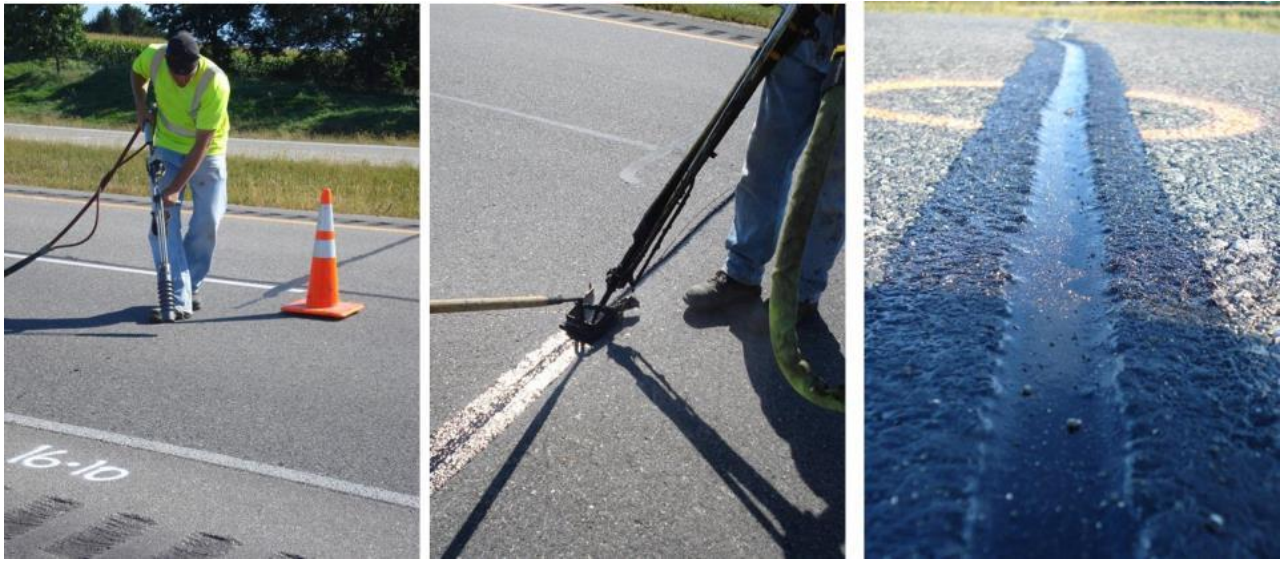
Figure 4.6. Typical crack sealing operations: Drying and cleaning the rout using hot air lance and compressed air (left); sealant and overband application using squeegee (middle); and the finished product (right).

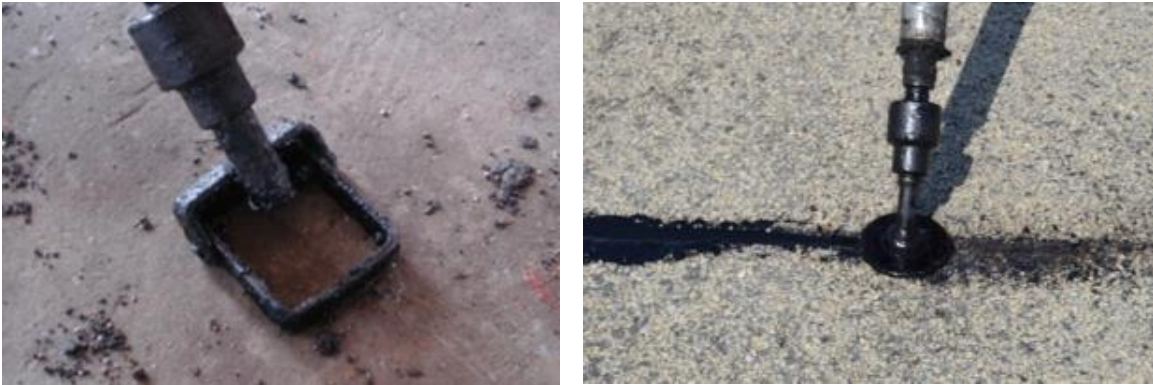
Figure 4.7. Various sealing adapters to apply sealant and overband: Horse shoe (left) Disk (right).

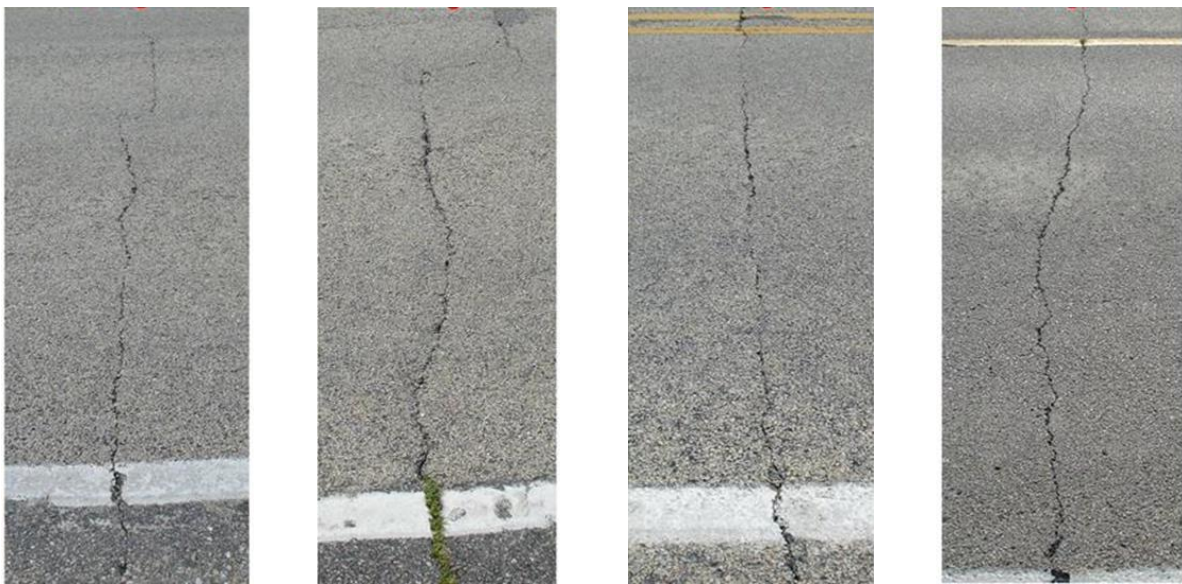
(a) Crack 1.1, Rating 4 (b) Crack 2.1, Rating 3 (c) Crack 3.25, Rating 4 (d) Crack 4.18, Rating 4.5

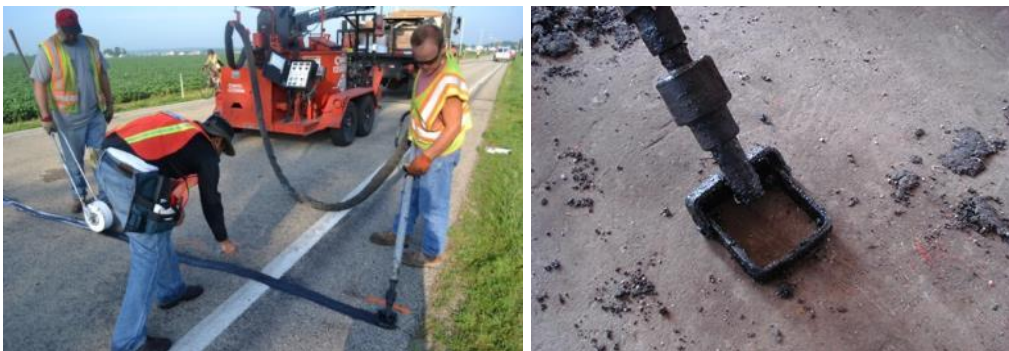
Figure 4.10. Kettle used in Wisconsin for heating sealant (left) and horse shoe adapter (right).

The sealants were installed on July 19–21, 2011. Green County Highway Department controlled traffic and installed the sealants. The driving lane was closed to traffic during the day of installation. Moving traffic control was maintained with the help of two flaggers. The crew consisted of eight personnel (One router, two flaggers, one cleaner, two drivers, one sealer, and one blotter). Two different Crafcro model kettles were used in this project: Crafcro EZ 500 (475 L capacity) and 1000 (985 L capacity). Figure 4.10 shows the smaller capacity kettle and one of the adapters used during installation. Hot air lance and compressed air were used for cleaning the routs.

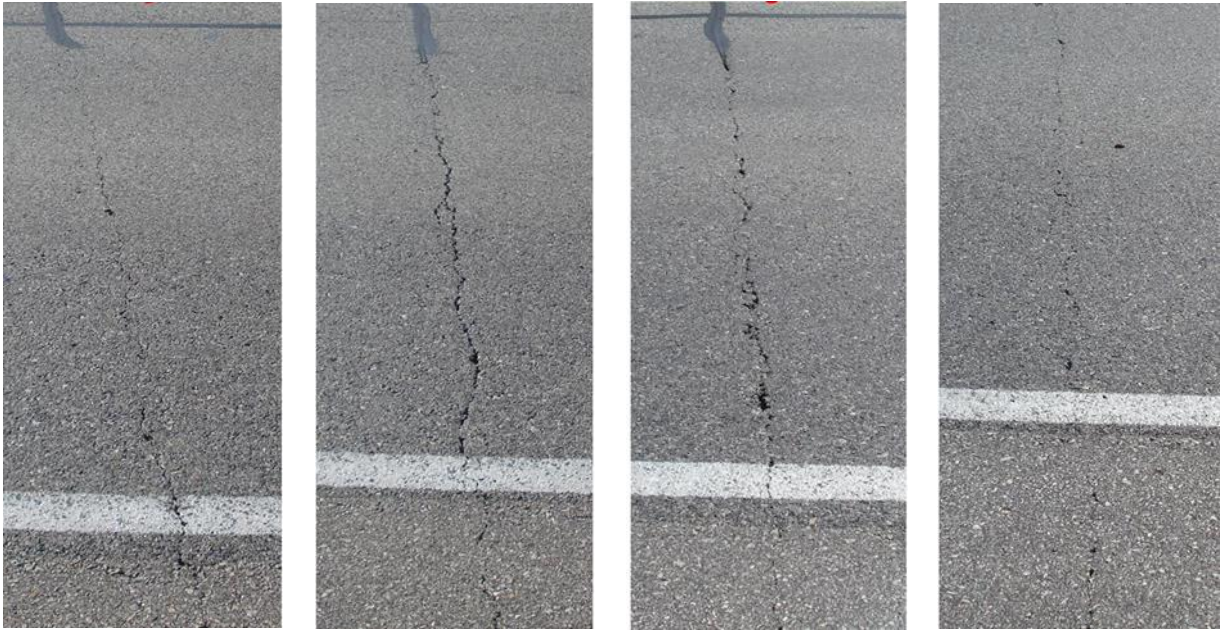
(a) Crack 4.1, Rating 4.5 (b) Crack 4.4, Rating 3 (c) Crack 5.9, Rating 3 (d) Crack 12.6, Rating 5

Reflective transverse cracking was found to be the main crack type in this test site. Figure 4.14 presents pictures taken during the initial survey of the project site, reflecting the general condition of pavement and cracks. A summary of crack ratings is presented in Table 4.10. The survey indicates that cracks were generally in a very favorable condition (ratings are in the range of 4 to 5) for sealing.

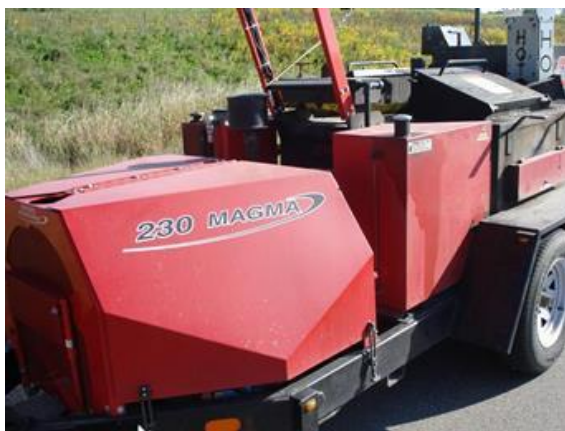
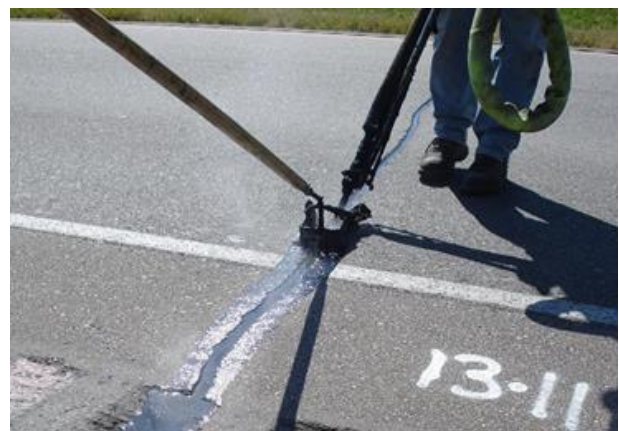
Figure 4.15. A kettle and sealant installation at the Minnesota test site (Section 13).

Installation took place during the week of September 11, 2011. Traffic control was provided by MNDOT. The driving lane was closed to traffic during installation. Two contractors worked on the test site. The test site was also part of sealant verification trials conducted by MNDOT; the products were installed by contractors representing the manufacturers. The first contractor's crew consisted of five personnel (one sealer, one finisher, one router, one rout cleaner, and two truck drivers). The second contractor's crew consisted of six personnel (one sealer, one finisher, one router, one blower, one rout cleaner, and one truck driver). Two kettle types were used: Crafcro SuperShot 125 with 475 L capacity and Cimline Model 2009 with 870 L capacity. A squeegee finisher was used to apply sealant and overbanding. Figure 4.15 shows the kettle and adapter used by the second contractor. The second contractor used a leaf blower to clean the pavement after routing and followed a double-finishing approach to apply overbanding where routs had been recently filled. Both contractors used hot air lance and compressed air for cleaning cracks prior to sealing. After sealing all cracks in a section, the crew created overband by injecting more sealant and sweeping with a squeegee.

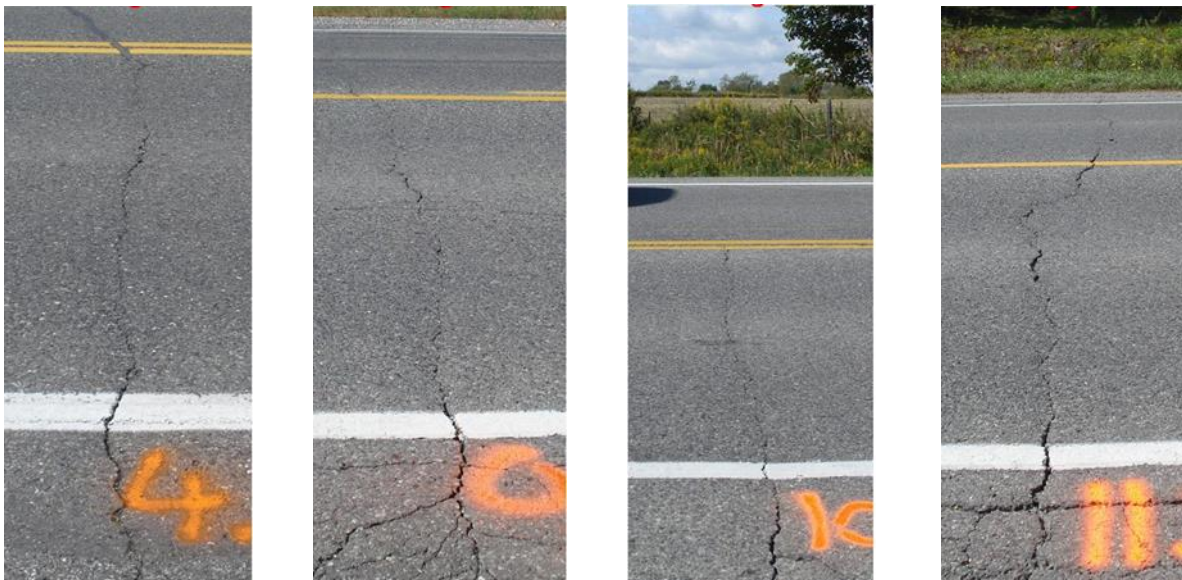
(a) Crack 4.10, Rating 3 (b) Crack 9.24, Rating 4.5 (c) Crack 10.28, Rating 4.5 (d) Crack 11.3, Rating 2.5
 Figure 4.20. Initial condition of cracks at various sections at Ontario test site.

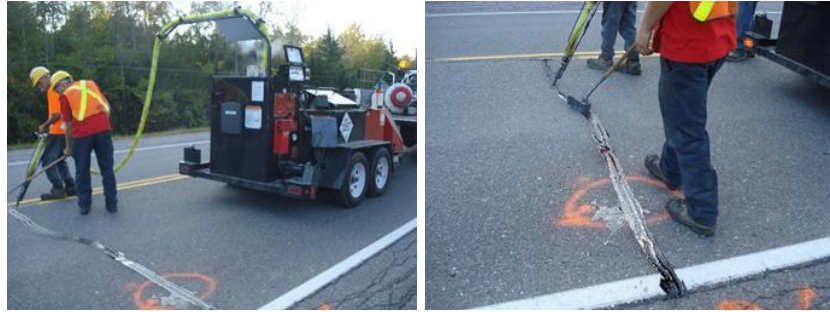
Figure 4.21. The kettle used at Ontario (left) test section and finishing with a squeegee (right).

Procedures similar to those implemented in other project sites were followed for heating and sealant installation. Table 4.13 presents the time log for each activity. Installation was completed in three days. Temperature measurements were taken during installation from inside and outside the kettle. Figure 4.22 illustrates the temperature readings taken during installation. The panel readings were consistent with the inside- and outside-kettle temperature information.

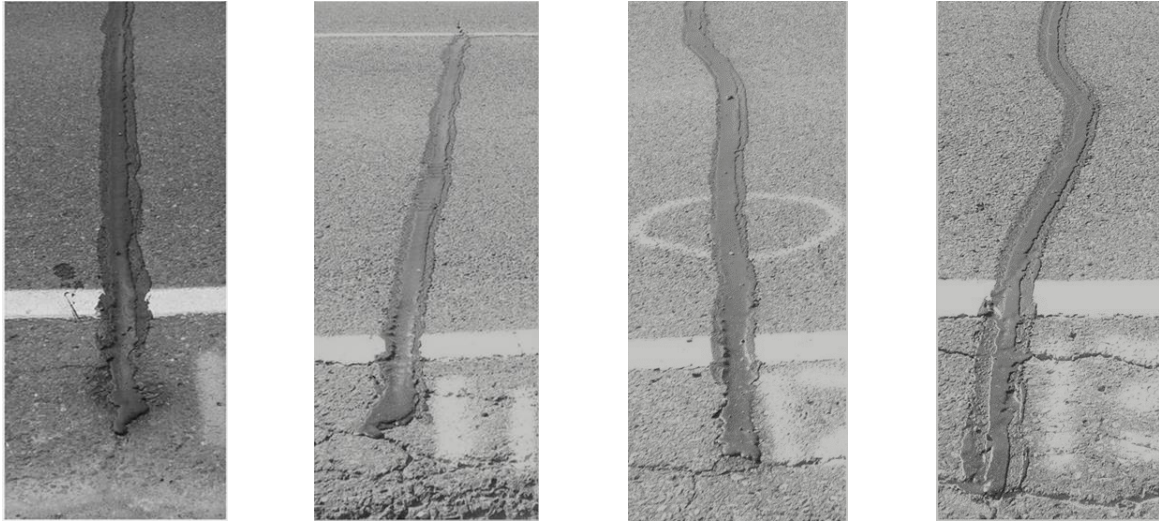
Figure 4.23. Pictures after crack sealant treatment in Ontario (Sections 10 through 13).

After sealant installation was completed, each crack was digitally documented as shown in Figure 4.23. It was observed that the thickness of overbanding was relatively greater than that at other sections.

(a) Crack 10.5,
20x20 mm

(a) Crack 11.7,
30x15 mm

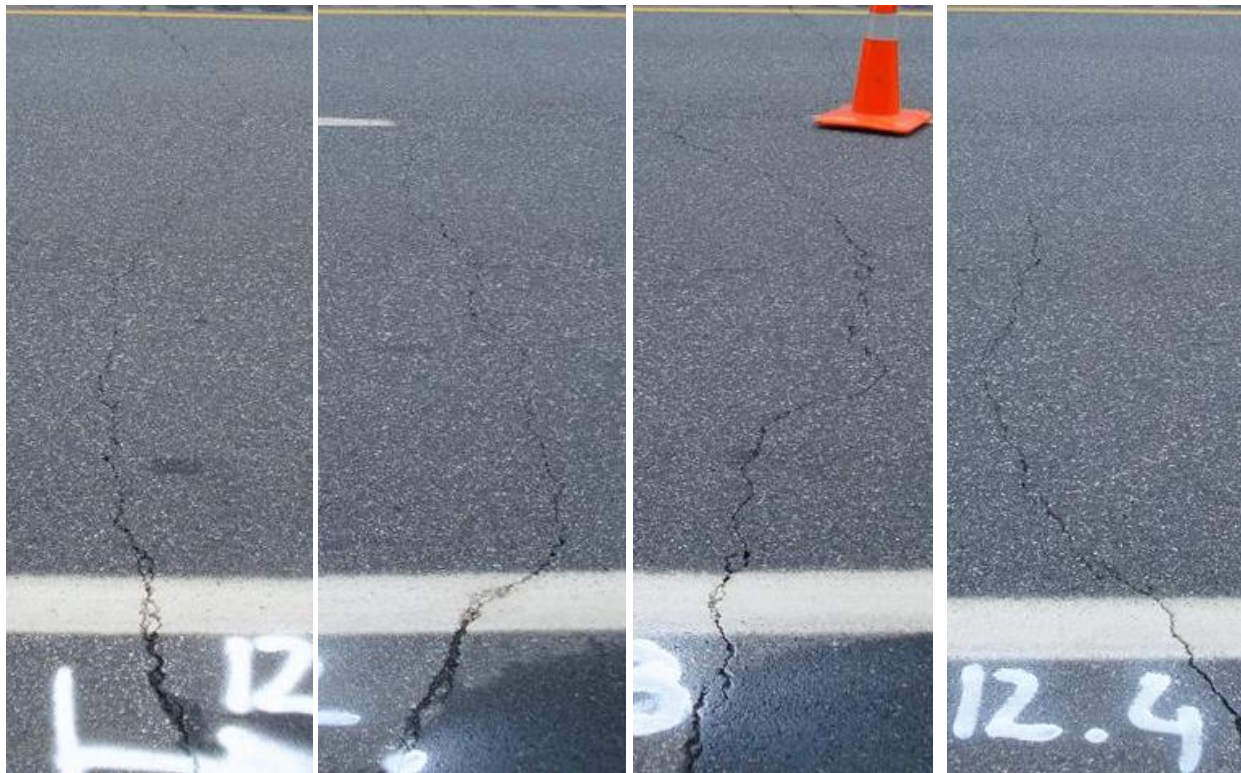
(a) Crack 12.1, Rating 4.5 (a) Crack 12.2, Rating 5 (a) Crack 12.3, Rating 4 (a) Crack 12.4, Rating 5
Figure 4.26. Initial crack condition in Section 12 of the New Hampshire test site.

Transverse reflective cracks were the main cracking type with a few longitudinal cracks developing in some sections. The rating system adopted in this study was used to evaluate cracks initial condition. Cracks generally met the criteria set in this study as shown in Figure 4.26. A summary of crack rating is presented in Table 4.15.

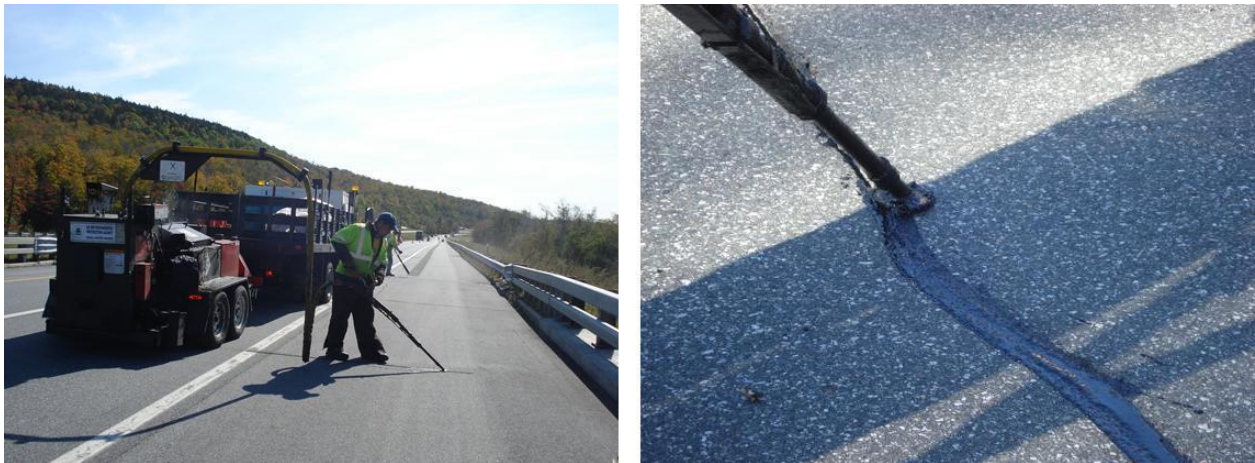
Figure 4.27. Kettle and sealant installation using disk shape adapter in New Hampshire. After draining the kettle to achieve kettle cleanliness, 300-400kg of sealant blocks were added to the kettle for each section. A time log detailing all activities is presented in Table 4.16. Sealant installation was completed in two days.

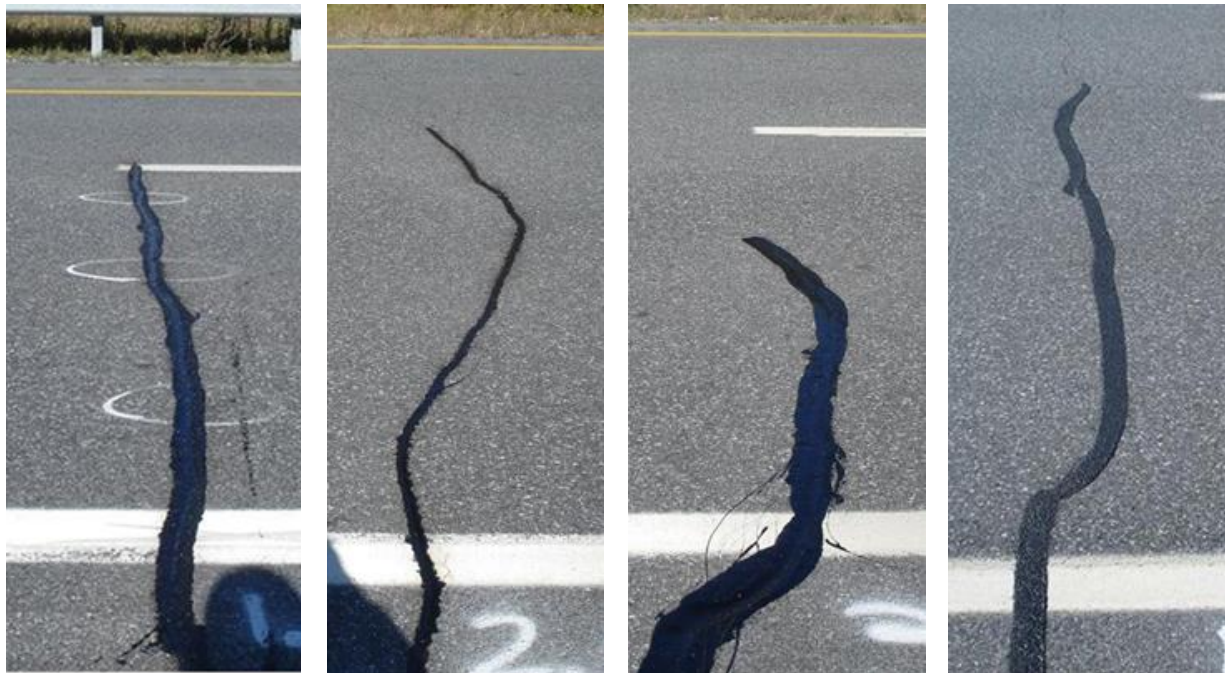
Figure 4.28. Crack sealant treatment in Sections 1, 2, 3, and 16 in New Hampshire.

After sealant installation, each crack was digitally documented as shown in Figure 4.28.

(a) Crack 1.8, 20x20 mm
 (b) Crack 2.6, 20x20 mm (no overband)
 (c) Crack 3.4, 20x20 mm
 (d) Crack 16.7, clean and seal

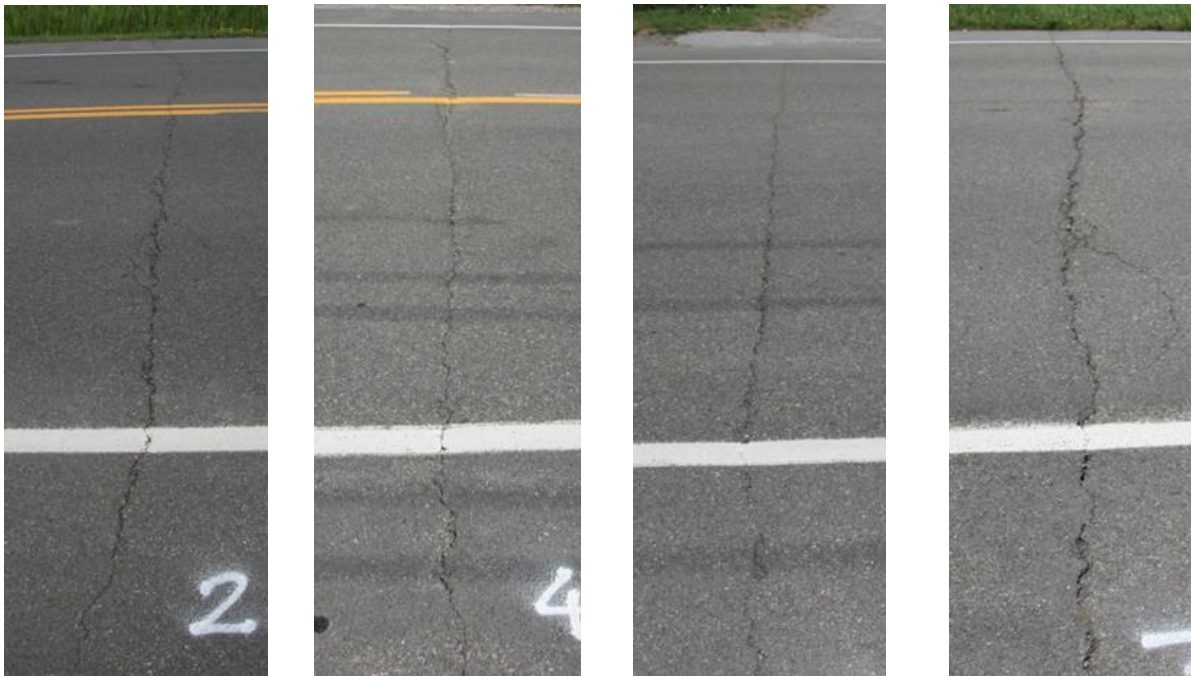
a) Crack 2.6, Rating 4 (b) Crack 4.6, Rating 4.5 (c) Crack 5.6, Rating 5 (d) Crack 7.7, Rating 3.5
 Figure 4.31. Initial crack conditions in New York test site.

Transverse cracks were the main cracking type at the site with a few longitudinal cracks. The initial condition of the cracks was evaluated in accordance with the study criteria and was found to meet the study parameters, as presented in Figure 4.31. A summary of crack rating is presented in Table 4.18.

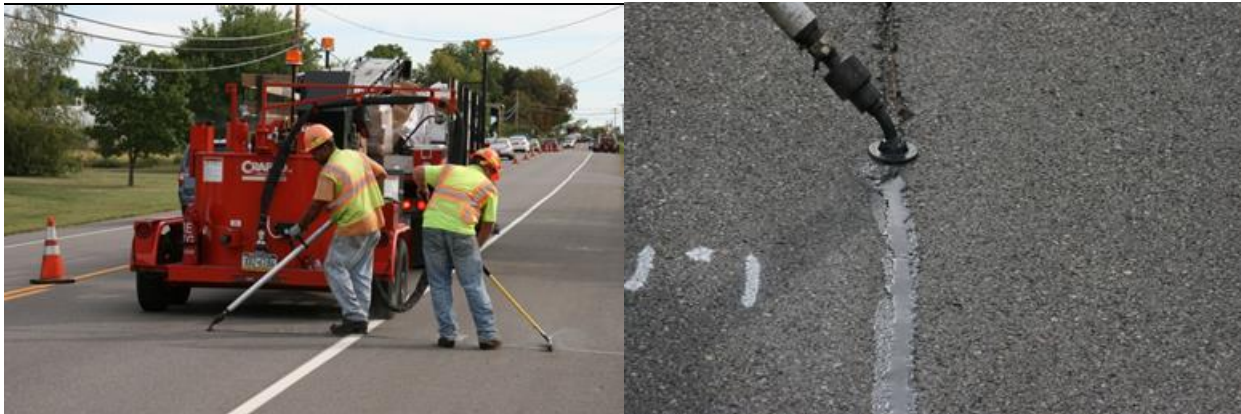
Figure 4.32. Kettle (left) and disk shape adapter (right) used at New York test section sealant installation.

Crafco EZ 500 (125 gallon capacity) and 1000 (260 gallon capacity). Figure 4.32 shows the kettle and adapter used in most sections. Hot air lance and compressed air were used for cleaning the routs. Disk shape adapters (without swivel shoe) were used to apply sealant and a squeegee was used to apply overband. Routing was performed utilizing a pavement cutter.

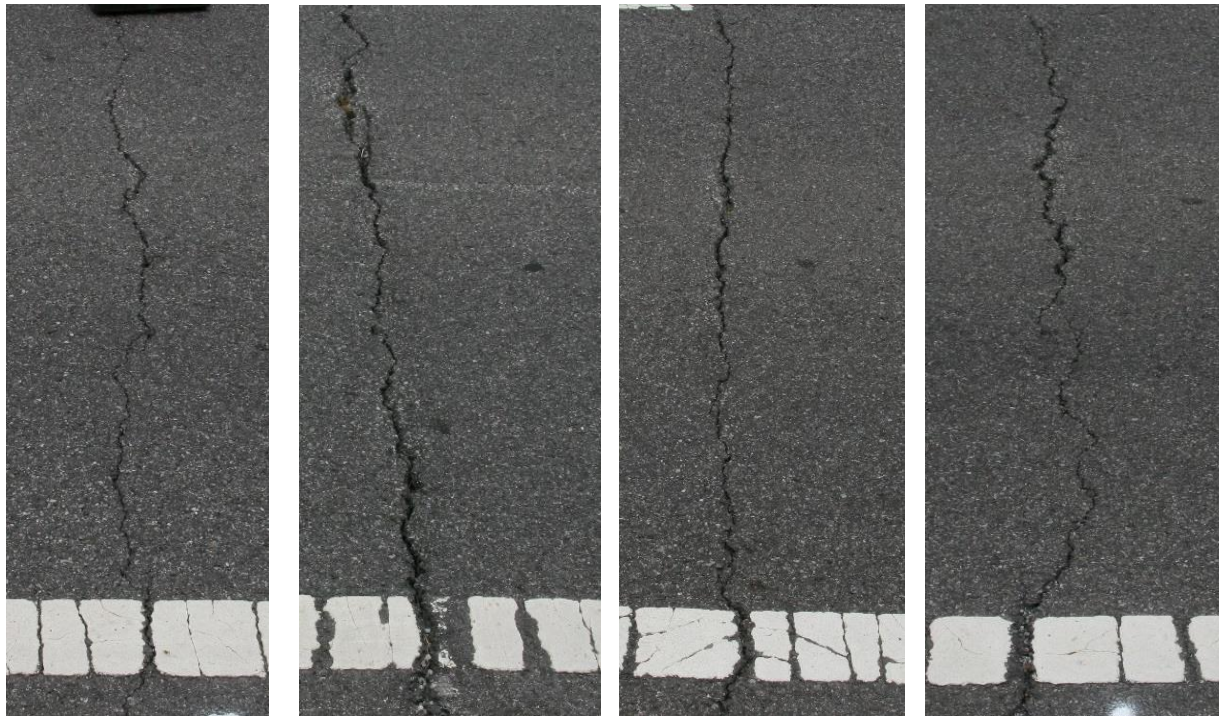
(a) Crack 2.13, Rating 4 (b) Crack 3.17, Rating 2 (c) Crack 3.29, Rating 4 (d) Crack 4.22, Rating 3
 Figure 4.36. Initial crack conditions in Virginia test site.

Transverse cracks were the main cracking type at the site with a few longitudinal cracks. The cracks were evaluated in accordance with the study criteria and were found to meet the study's parameters, as shown in Figure 4.36. A summary of crack rating is presented in Table 4.18.

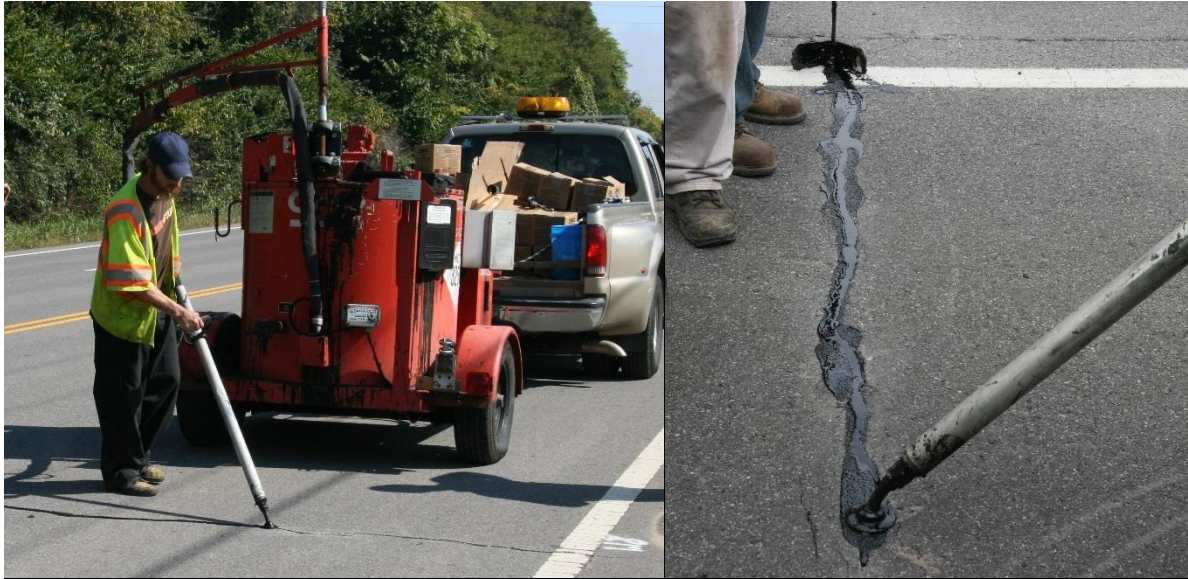
Figure 4.37. Kettle (left) and disk shape adapter (right) used at Virginia test section sealant installation.

Sealant installation took place during the week of September 29, 2014. Traffic control was provided by the contractor. Part of the right lane was closed to the traffic during installation. The contractor’s crew consisted of five personnel (one finisher, one router, one blower, one rout cleaner, and one truck driver). Crafcro EZ 500 (475 L capacity) were used in this project, as shown in Figure 4.37. Hot air lance and compressed air were used for cleaning the routs. Disk shape adapters (without swivel shoe) were used to apply the sealant; overband was applied utilizing a squeegee; and a diamond saw pavement cutter was used for routing.

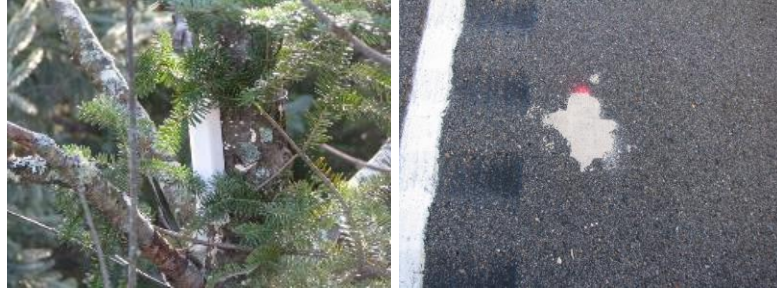
Figure 4.40. Wireless temperature nodes for ambient (left) and pavement (right) temperatures.

Two wireless temperature nodes were installed at the test site to monitor pavement and air temperature during the evaluation period. One of the nodes was installed in the proximity of the test site to avoid direct sunlight and to monitor the ambient temperature. Another node, shown in Figure 4.4, was buried in the pavement (2.5 cm below pavement surface) using an epoxy for measuring pavement temperature.

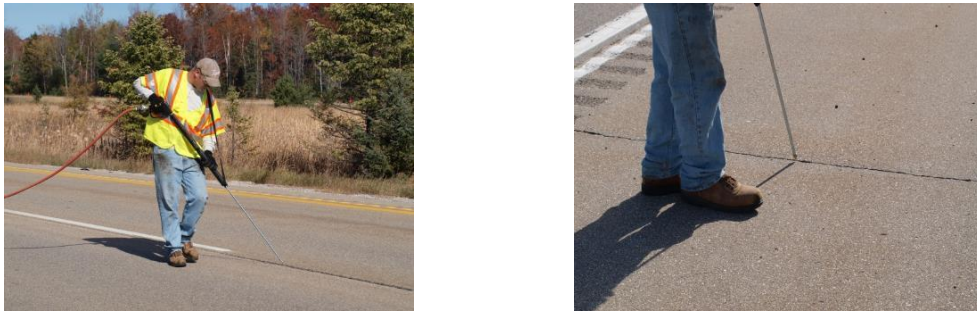
Figure 4.41. Typical cleaning operation prior to crack filling.

Cracks in this section were treated using clean and seal technique without routing. Figure 4.5 shows the crack and preparation operations.
