MODEL DEVELOPMENT AND VALIDATION OF BITUMINOUS-BASED CRACK
SEALANTS

DISSERTATION

Submitted in partial fulfillment of the requirements
for the degree of Doctor of Philosophy in Civil Engineering
in the Graduate College of the
University of Illinois at Urbana-Champaign, 2019

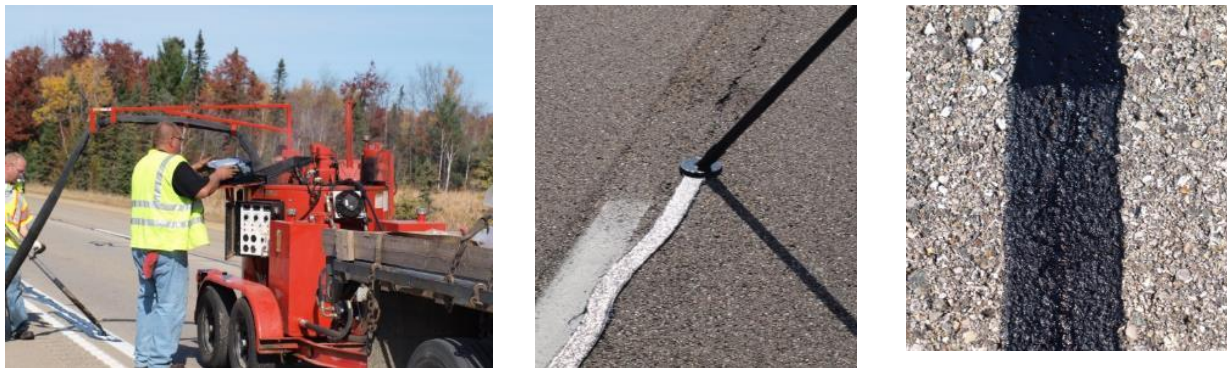
Figure 4.42. Typical crack filling operations: Heating the material in a kettle (left), sealant and overband application using disk adaptor (middle), and the finished product (right).

A typical crack filling operation consists of cleaning and drying the cracks with compressed air, then applying the sealant using a wand and overbanding with a disk-shaped adaptor as shown in Figure 4.6. The width of the overband varied from 7 to 10 cm. Crack filling was completed using a disk adaptor that does not require a squeegee to apply an overband. After sealant installation, a final survey was conducted. Pictures of each crack were also taken to document the condition of sealed cracks.

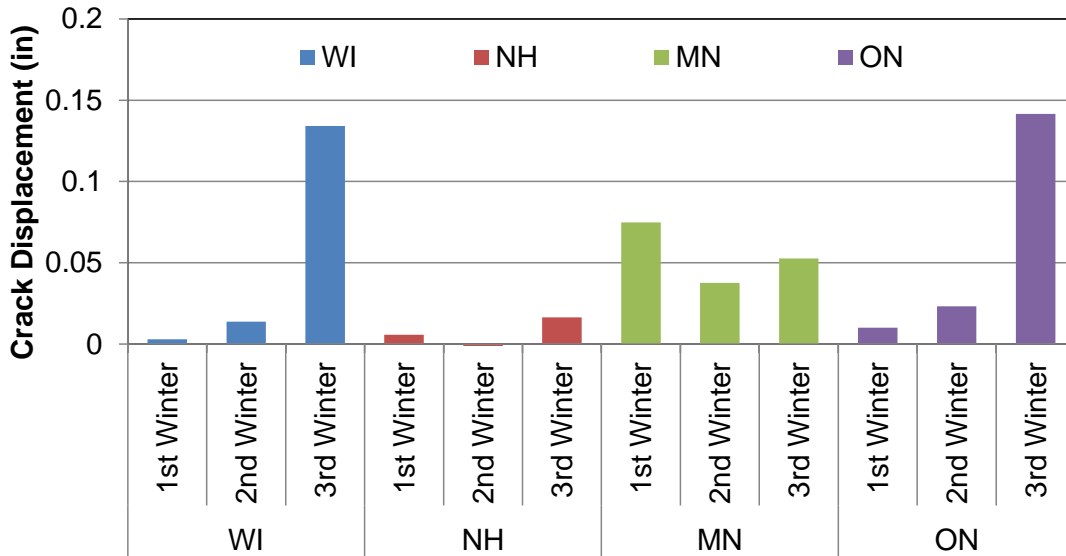
Figure 4.49. Average crack displacements measured at each test site.

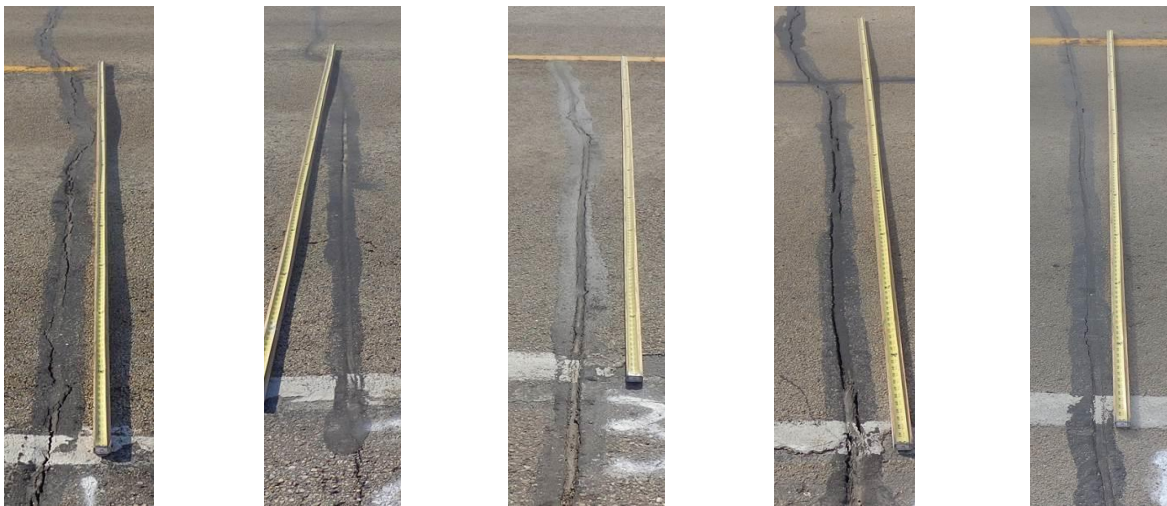
Figure 4.64. Sample photos from the Wisconsin test sections in winter 2014.

This test site was partitioned into five sections for installing five different sealants. All sections on this test site had standard rout geometry of 20 × 20 mm. A summary of evaluation results for the Wisconsin test site for winters 2012, 2013, and 2014 is presented in Figure 4.62. Similar to most other test sites, the site underwent three winters. Until winter 2013, most sealants were performing well except Pb, which was in fair condition and sealant Fb which was in poor condition. However, after the third winter, only two out of five sealants were performing well (PI higher than 70). It was expected to see some sealants fail completely after winter 2015. The drop in PI values can easily be seen in Figure 4.63. A sample crack picture taken from each section in winter 2014 is presented in Figure 4.64.

(a) Crack 1.17 (b) Crack 2.5 (c) Crack 3.27 (d) Crack 4.8 (e) Crack 5.13

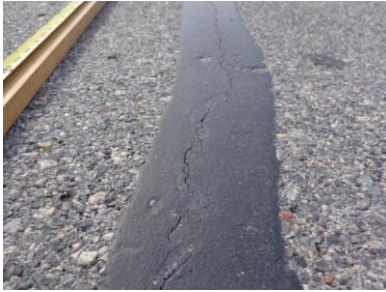
(a) Cohesive failure

Figure 4.68. Common failure modes of clean and seal treatment.

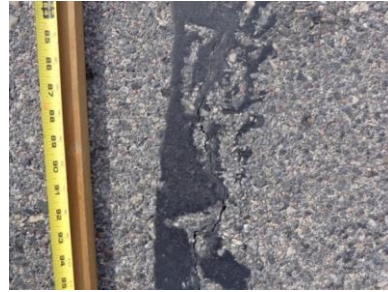
(b) Overband failure

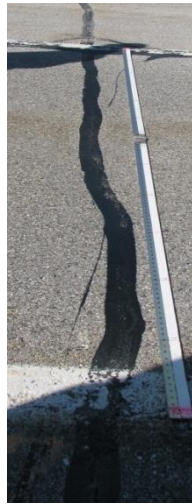
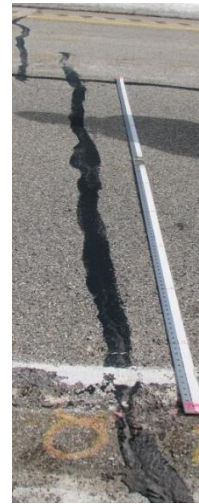
Figure 4.69. Sample pictures for sealants field performance: Good performance (first row) and poor performance (second row).

(b) Crack 5.7

(c) Crack 9.8

(d) Crack 8.7

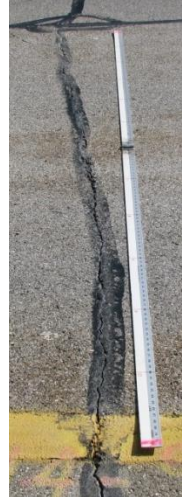
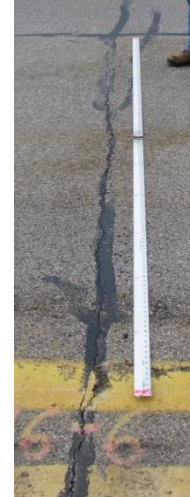
The sealant in crack 1.1 failed due to poor cohesive performance while the overband was still in contact; the sealant in cracks 14.9 and 16.6 failed due to poor cohesive and overband performance.

(h) Crack 14.9

(g) Crack 16.6

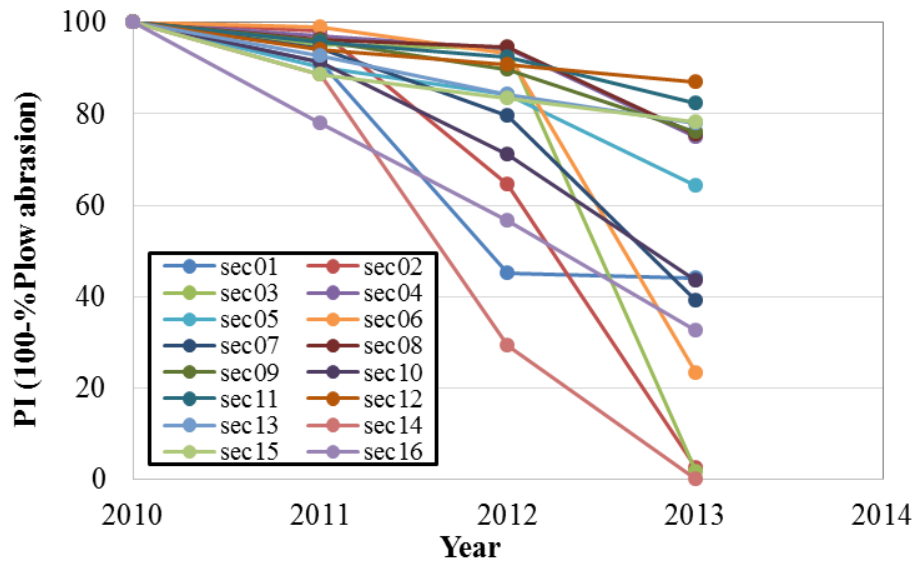
Figure 4.71. Performance index of all sealants based on overband failure.

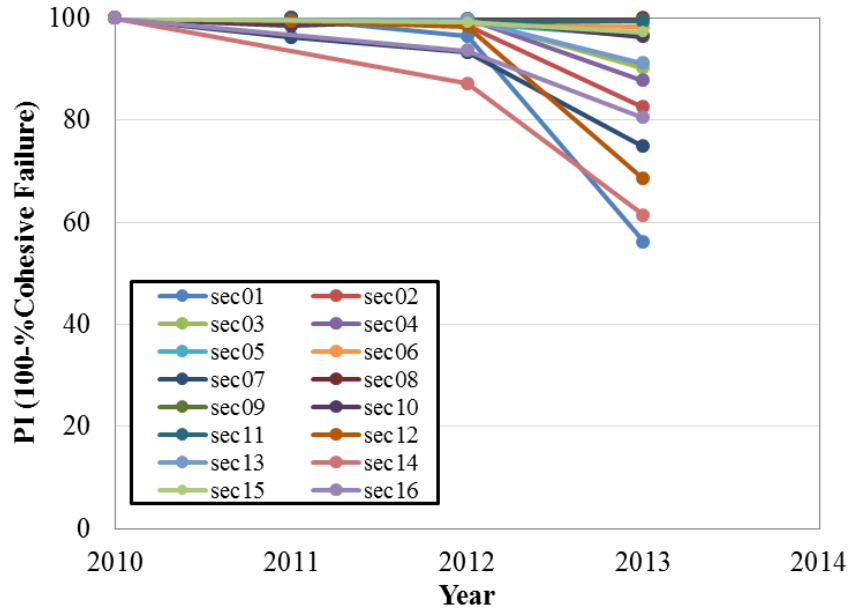
Figure 4.72. Performance index based on cohesive failure for different sealants.

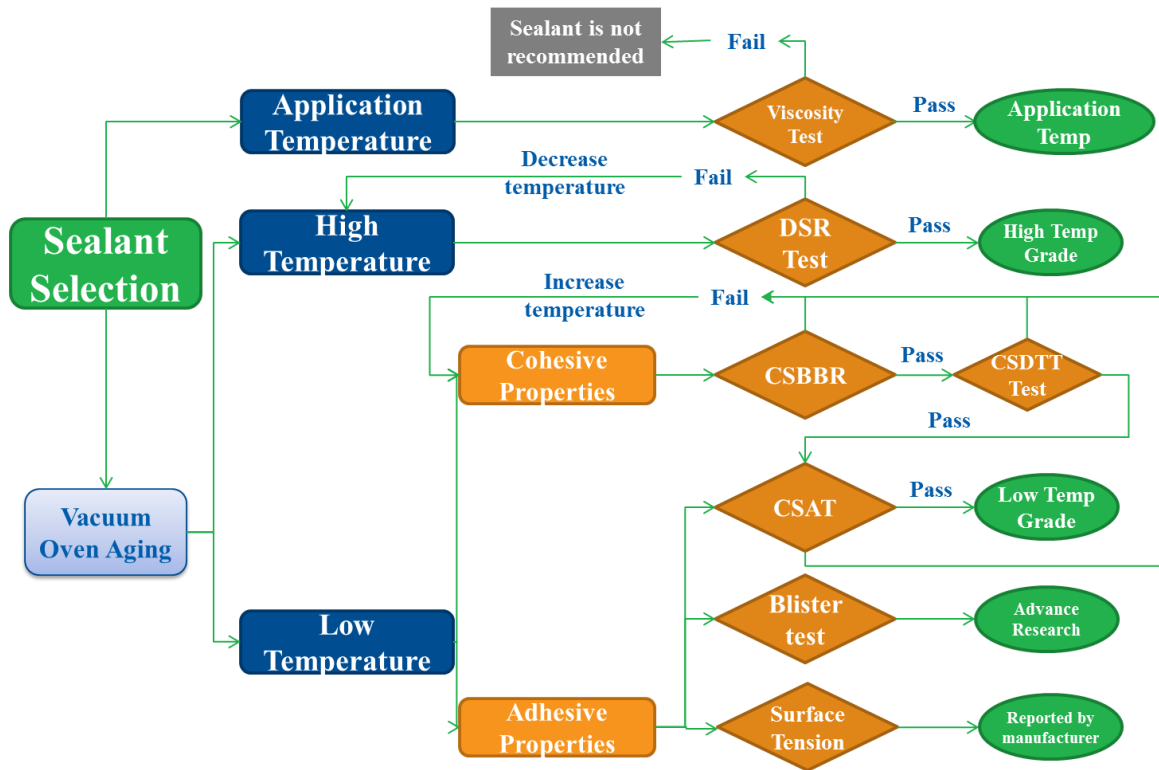
Figure 5.1. Illustration of steps necessary for determination of sealant performance grade.

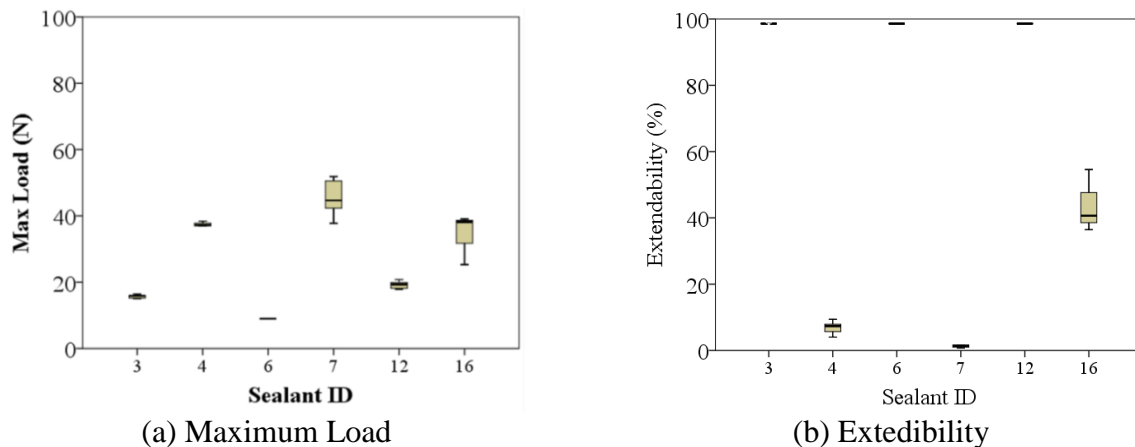
Figure 5.18. Boxplots of CSDTT results illustrating variation in the maximum load and extensibility.

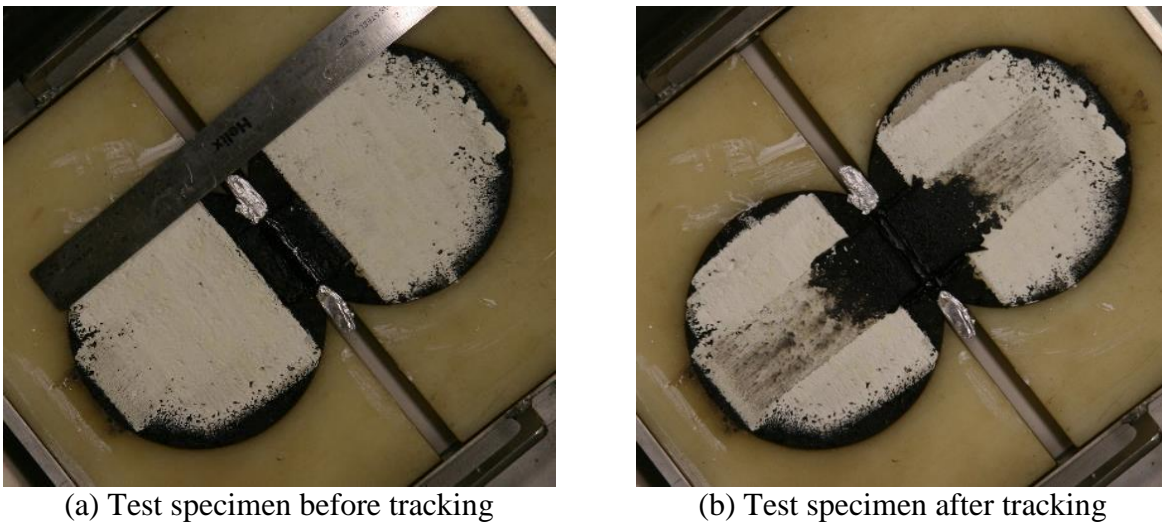
Figure 5.23. Hamburg wheel test.

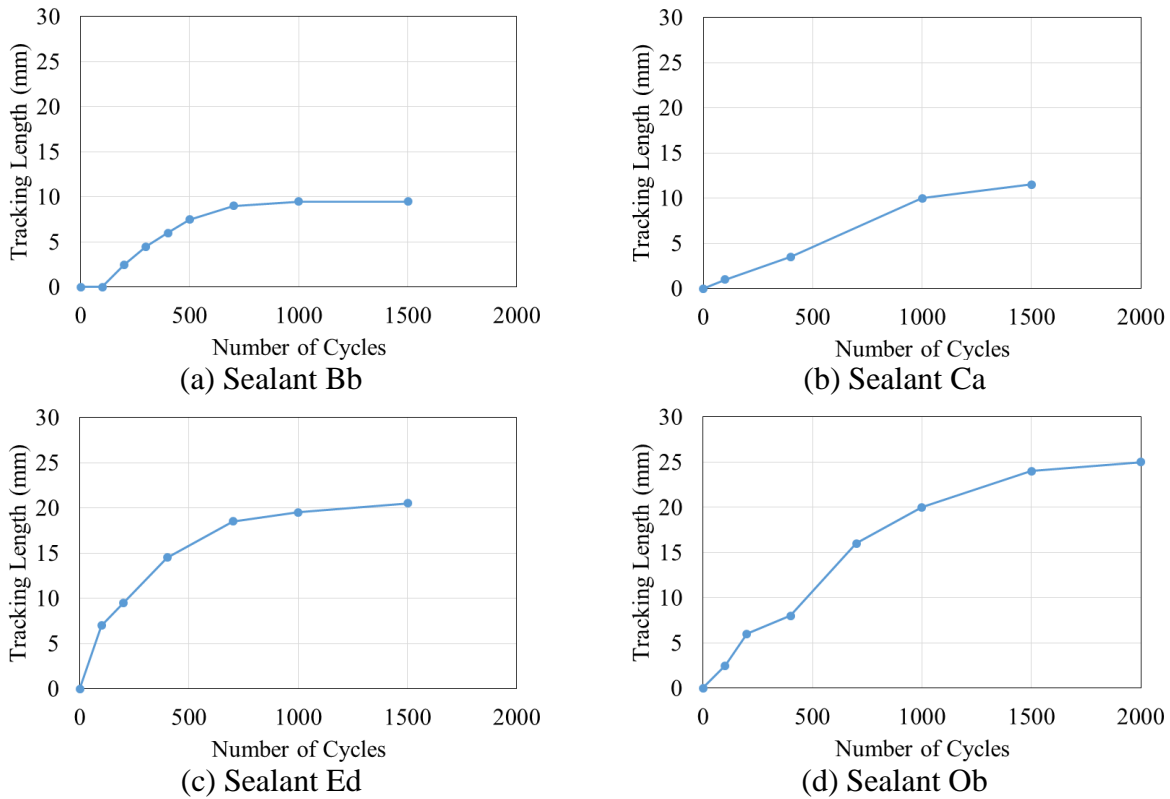
Figure 5.24. Tracking length by number of cycles for four selected sealants.

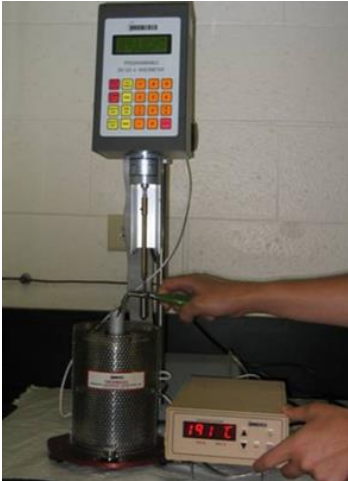
Figure 5.25. Viscosity test and results

A Brookfield rotational viscometer was used to measure the apparent viscosity of hot-poured crack sealants (Figure 5.25a). This procedure was modified from the one adopted by SuperPave™ for asphalt binders (AASHTO T366). The main difference is the change in spindle and hook configuration along with some changes in testing procedures. The viscosity test was designed to simulate installation conditions. Since viscosity plays an essential role in predicting the field performance of hot-poured crack sealants, upper and lower viscosity limits were recommended. The upper limit ensures that the material is sufficiently liquid so it can be poured; the lower limit helps avoid excessively liquid sealants which create problems in filling cracks during installation. The tests were run in accordance with AASHTO T366 at 60 rpm at the installation temperatures recommended by the manufacturers. Test results for all sealants are presented in Figure 5.25b. Based on the field observations during installation, the thresholds showed reliability for ensuring sufficient workability during installation at the recommended pouring temperature. However, it is very important not to overheat or underheat sealants as will be discussed hereafter.

(a) Rotational Viscometer

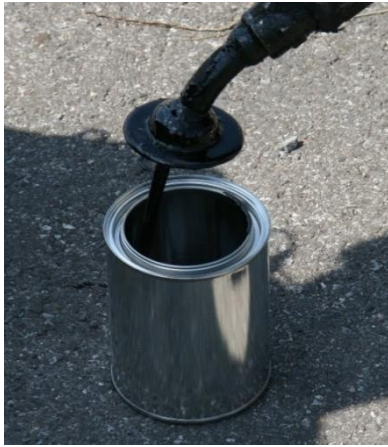
During field installation, two to three samples were obtained from each material at different times. The first sample was collected right before installation when the material was at the recommended temperature. The second and third samples were collected during installation. These samples were used to study the effect of kettle aging (short-term aging) on the rheological properties of crack sealants (Figure 6.2a). Also during the annual field surveys, field-aged

(a) Field kettle (FK) sampling

Figure 6.2. Collection of field-aged samples.

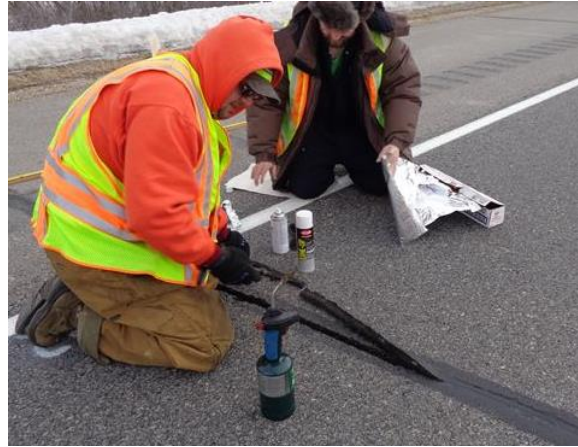
(referred to as FA2 and FA3) samples were collected from Minnesota, Wisconsin, Ontario, New Hampshire, and New York test sites during the second and third evaluation periods (Figure 6.2b).

(b) Field-aged (FA) sampling

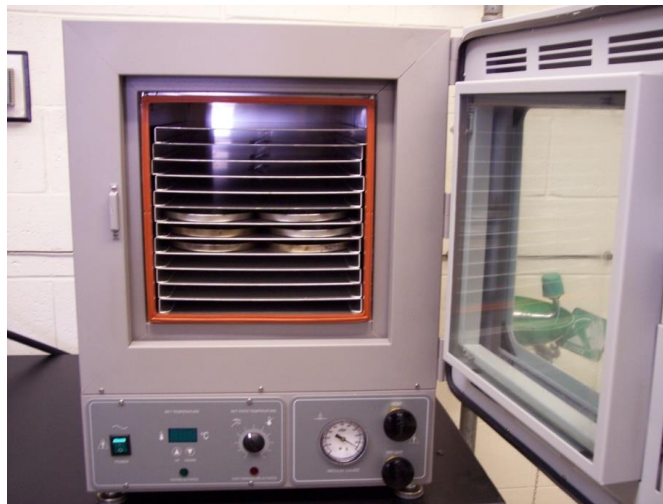
The sealants were homogenized and melted for one hr in lab melter, in accordance with ASTM D5167 standard. These samples are considered laboratory-unaged samples. This is a standard procedure used to prepare sealants for laboratory tests. The unaged sealants are then aged per the VOA procedure: 35g sealant was kept at 115°C in vacuumed air for 16hrs (Figure 6.3). The last set of laboratory-aged samples was prepared using the melter by heating and stirring the sealants for extended 4 and 8hrs to represent aging during installation.

Figure 6.3. Vacuum oven aging to simulate long-term aging for crack sealants.

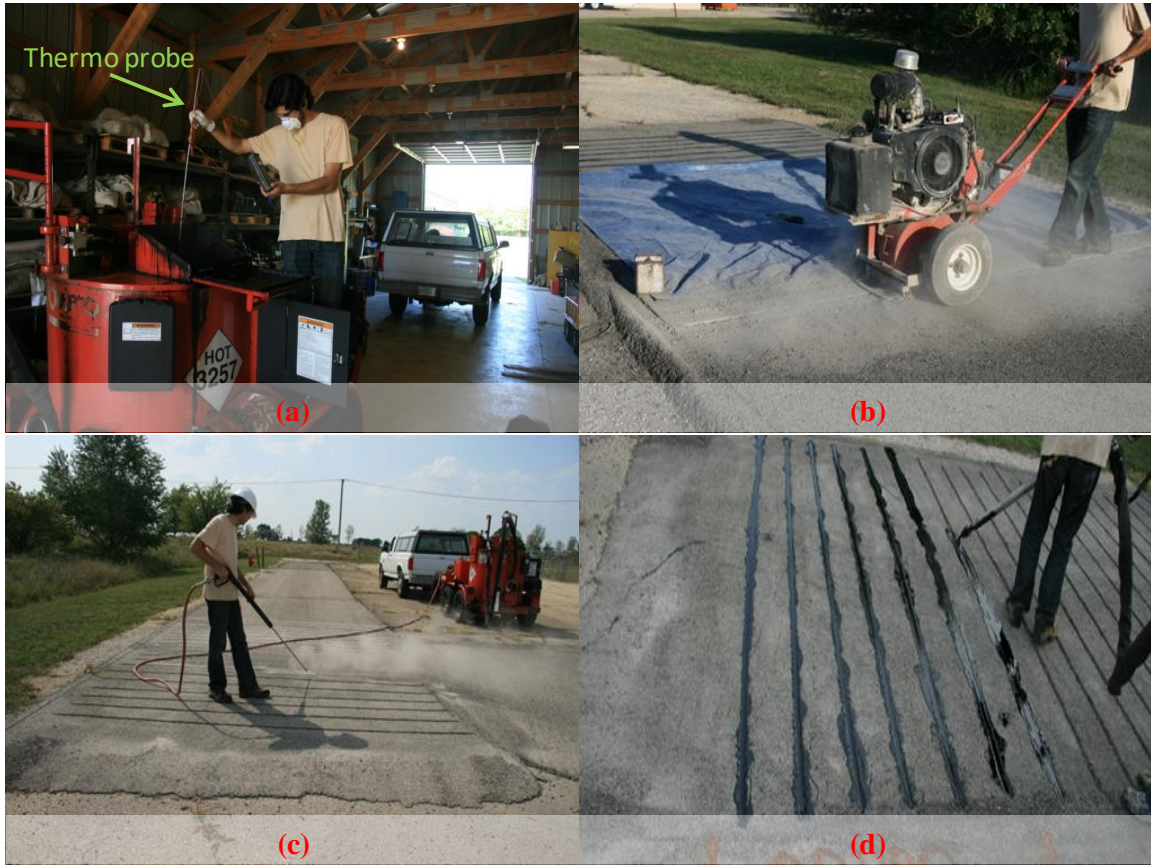
Figure 6.8. Sealant installation process: (a) Sealant heating and temperature monitoring; (b) routing; (c) rout cleaning with high-pressure air; and (d) finishing the installation in the routs.

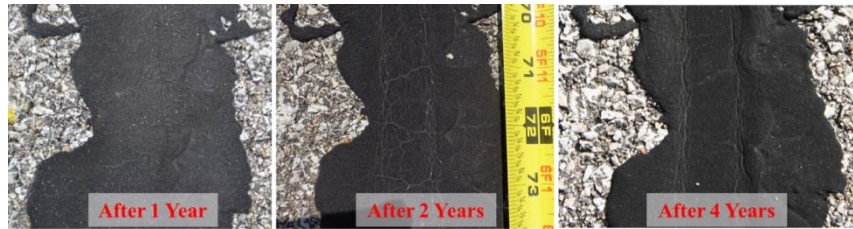
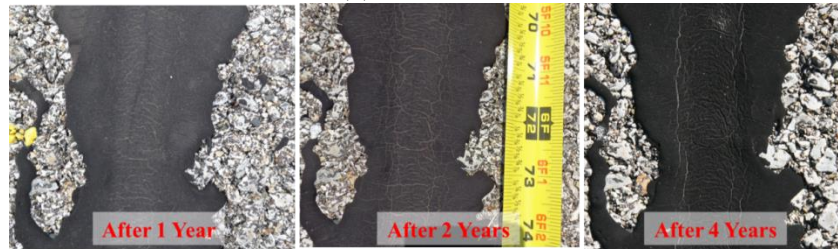
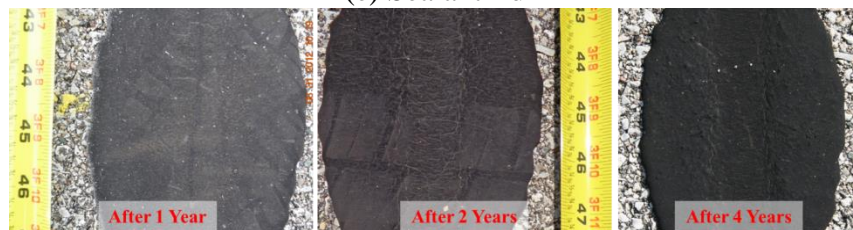
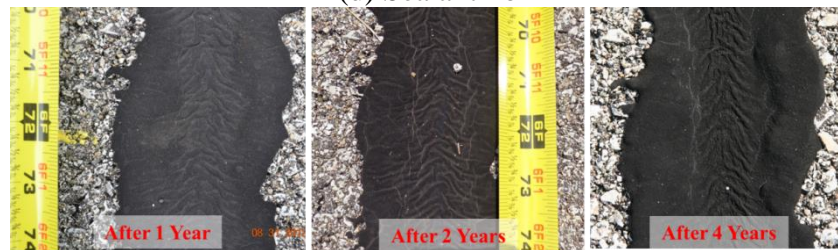
Figure 6.10. Pictures taken from routed and sealed cracks to illustrate surface aging of various sealants under the same weathering conditions.

Sealants were subjected to weathering effects after installation in a traffic-free section. Figure 6.10 shows photos taken approximately 1-4 years after installation; the effect of aging can be clearly seen. Several sealants exhibited significantly different aging patterns. Most sealants developed block cracking style surface deformations; while the surface pattern of the two

materials (Jd and Kc) was quite distinctive. These two materials were obtained from the same manufacturer and both are intended for cold climates. For the majority of sealants, the amount of surficial cracks increased after one year of aging.

(a) Sealant Ca

(b) Sealant Da

(d) Sealant Fb

(e) Sealant Jd

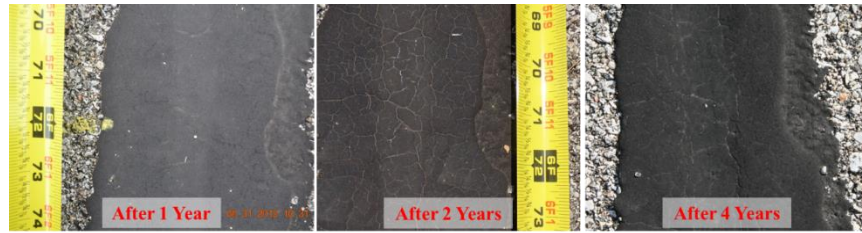
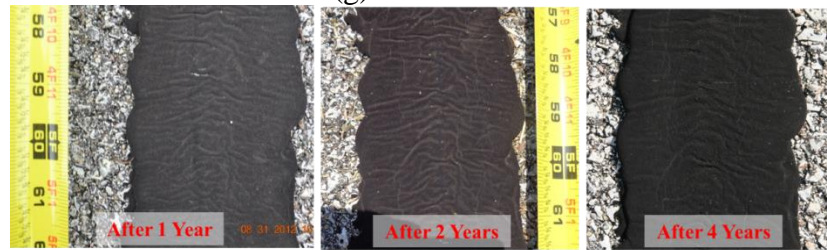
Figure 6.10 (continued)

(f) Sealant Mb

(h) Sealant Kc

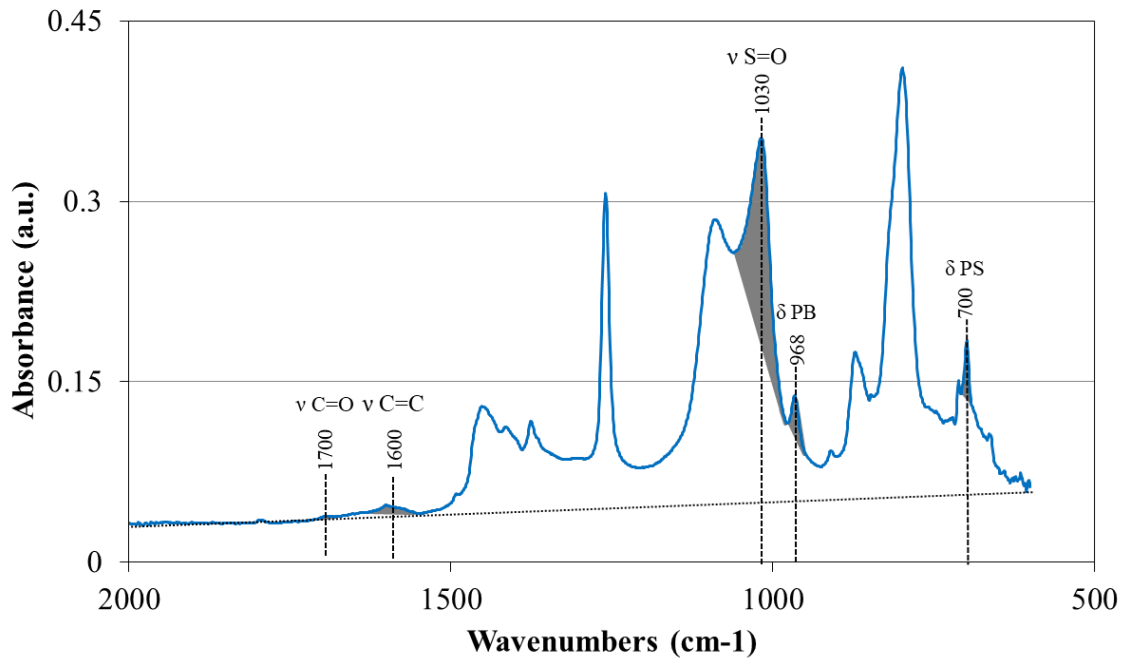
Figure 6.22. Identification of crack sealant components on FTIR spectrum for fingerprinting region between 200 and 600cm-1.
