# INVESTIGATION OF EARLY-AGE CRACKING IN CONCRETE BRIDGE CURBS

THESIS

Civil Engineering

This research was conducted as part of New Hampshire Department of Transportation's (NHDOT) project 26962P, *Reducing Cracking in New Bridge Curbs*. The Bureau of Bridge Maintenance (BoBM) at NHDOT has been experiencing early-age cracking on several bridge curbs as shown in Figure 1. Some cracking has been documented in as little as a few days after placement. For the purpose of this research, early-age cracks are those that form within one year following placement. NHDOT's BoBM performs maintenance and rehabilitation work on many

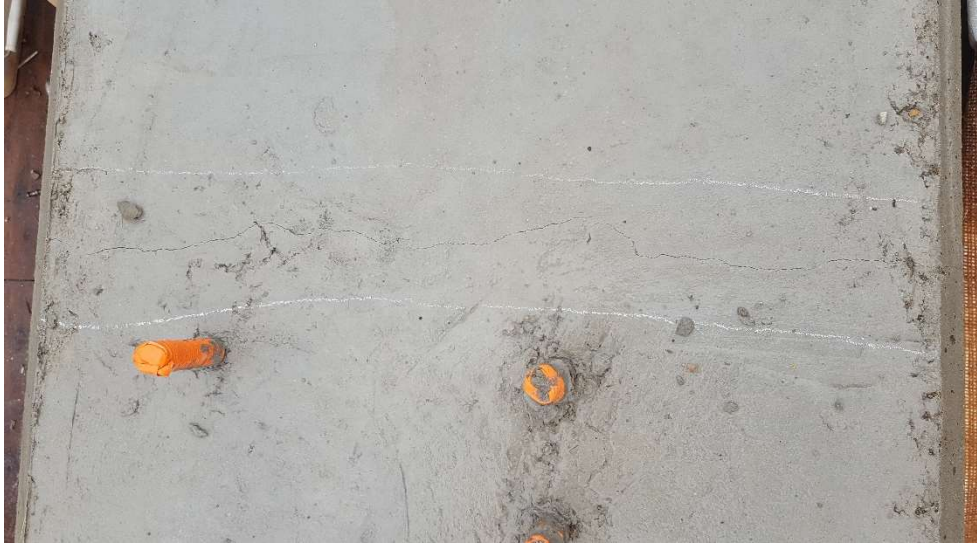
**Figure 1: Crack in a bridge curb 5 days after placement.**

Bridge curbs that experience large amounts of cracking, particularly at an early age, may facilitate accelerated deterioration of the curb. This results in a curb replacement that needs to be conducted before the deck replacement. The early-age cracking that has been seen by the BoBM has been noticed, in some cases, as soon as three days after placement.

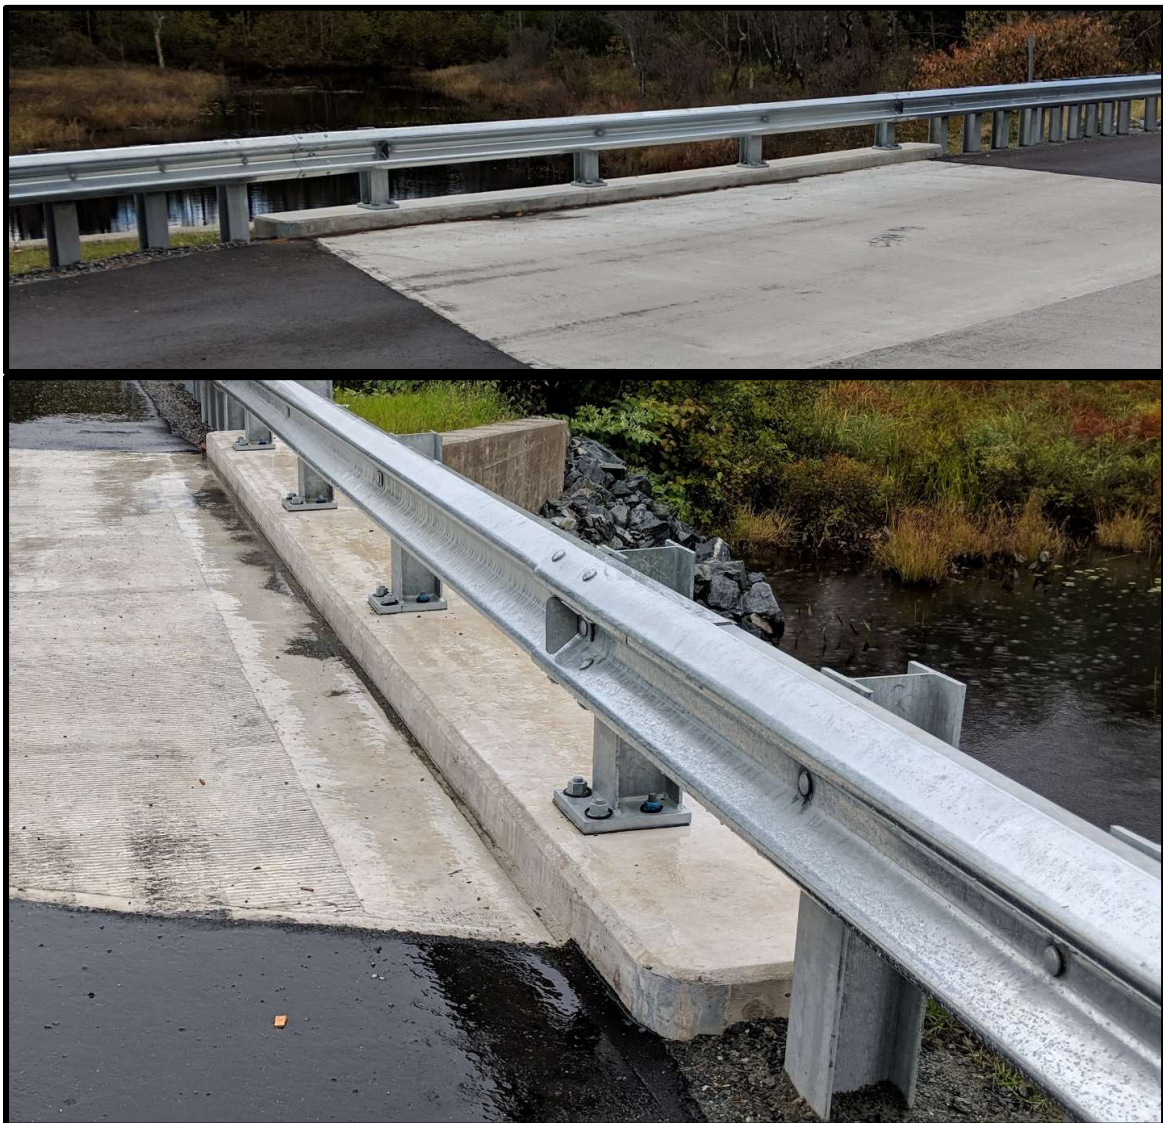
**Figure 3: Example of a concrete bridge curb. This curb is approximately 29 feet long and is located on NH 113 in Grantham, NH.**

Bridge curbs, similar to the one in Figure 3, provide a place for guardrail to be mounted as well as provide drainage characteristics to the bridge. As vehicles drive over the bridge dust and debris may be deposited on the roadway. When it rains, water flows down from the center of the roadway to the edges parallel to the direction of travel. The curbs prevent runoff, which can be

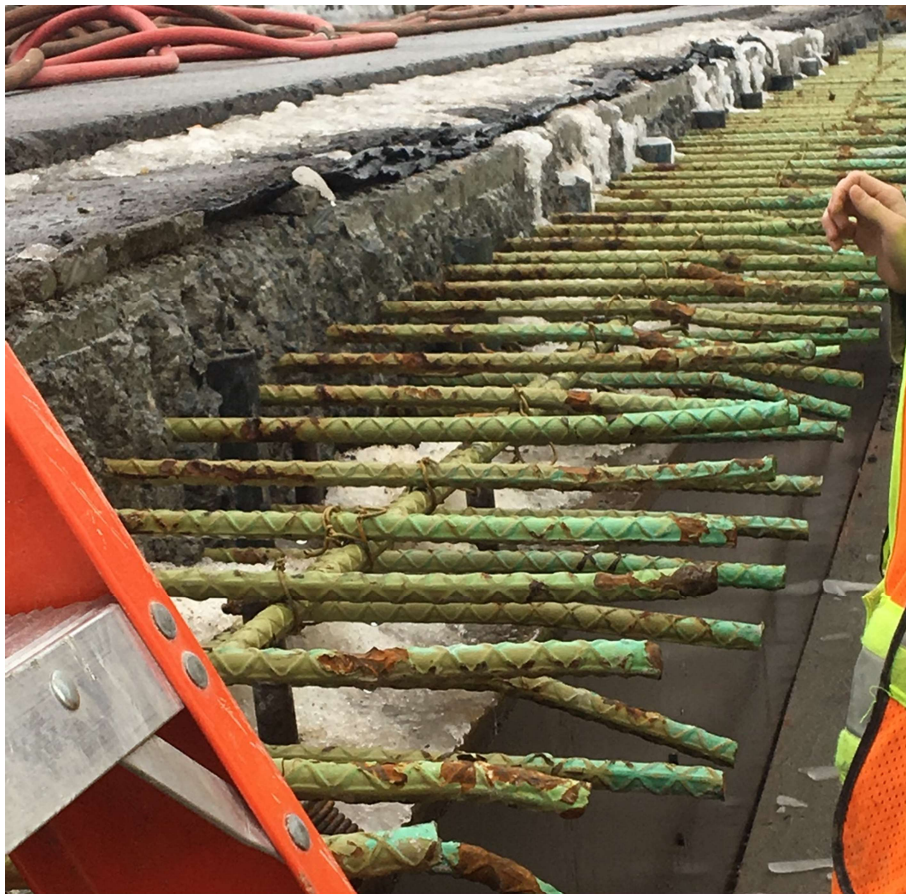
**Figure 4: Exposed rebar extending out from a bridge deck after the former curb had been demolished.**

curb rising above the deck. The figure also shows the steel beam and shear studs that were once buried underneath the old curb concrete. Once the curb has been demolished new reinforcement can be installed and tied to the existing deck reinforcement as shown in Figure 5. The guardrail anchor systems are also placed with the reinforcement. Additional hoop reinforcement is placed near the guardrail post locations to provide additional strength in case of a vehicle collision with guardrail. The additional reinforcement and anchor system can be seen in Figure 6.

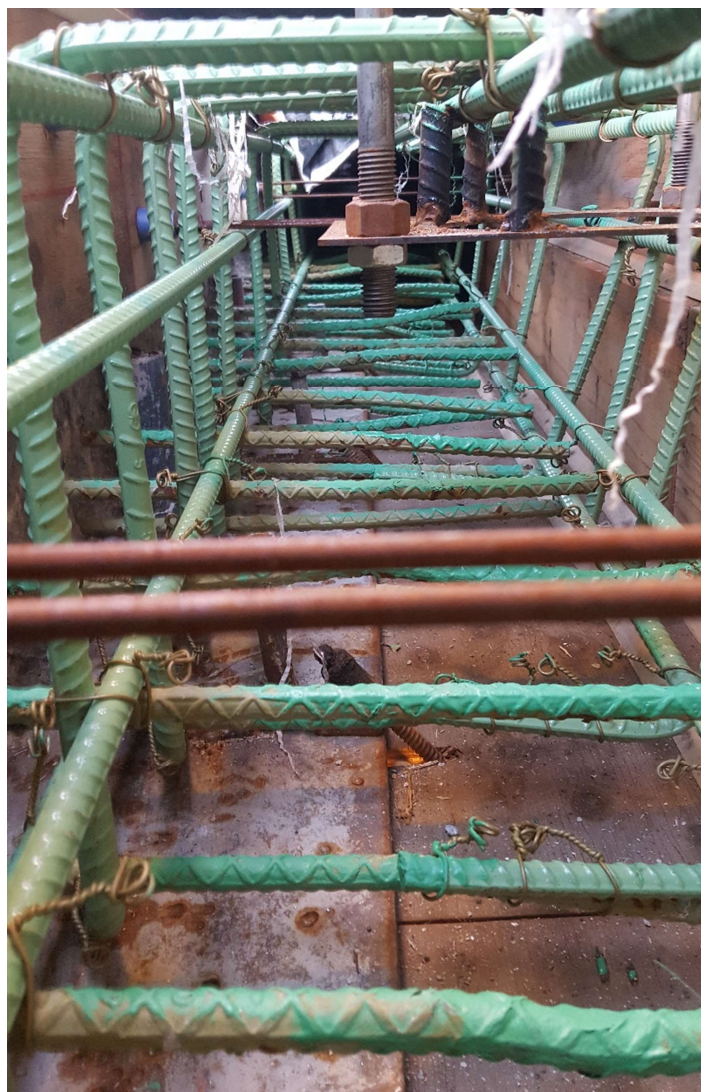
**Figure 5: Curb formwork and reinforcement on a curb replacement project.**

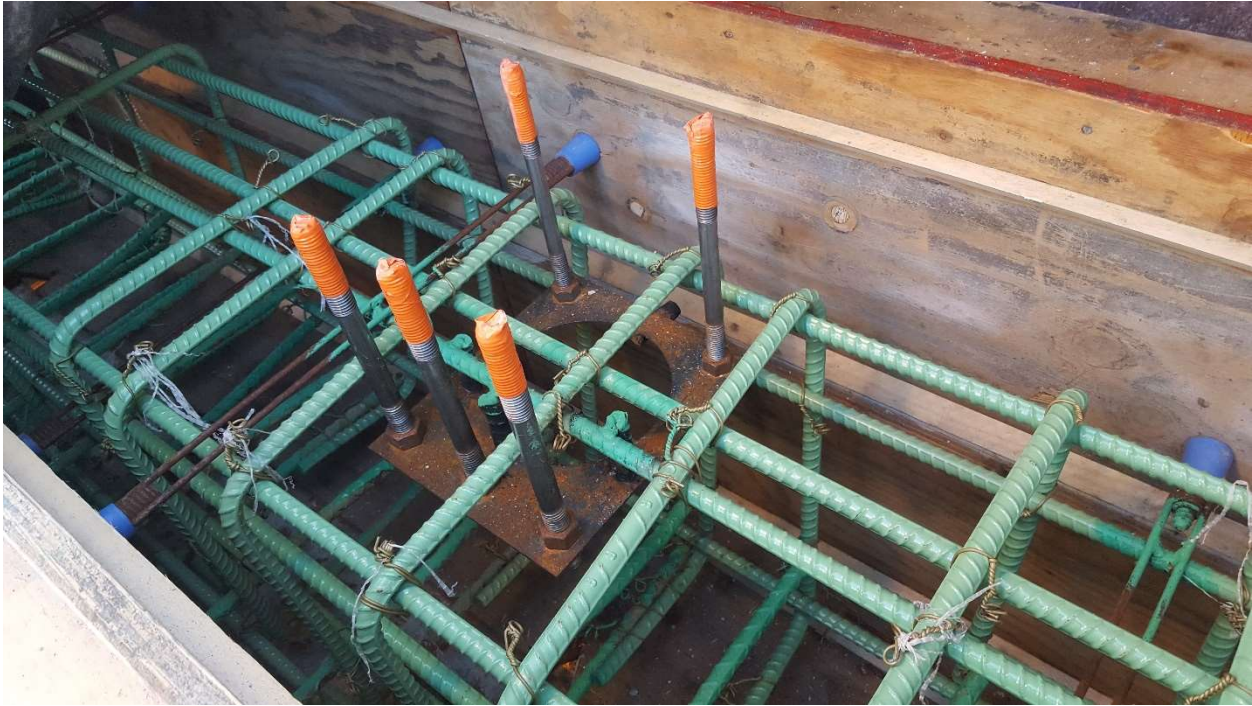
**Figure 6: Guardrail anchorage and reinforcement in curb formwork. Tape on the top of the anchoring system keeps threads clean during concrete placement.**

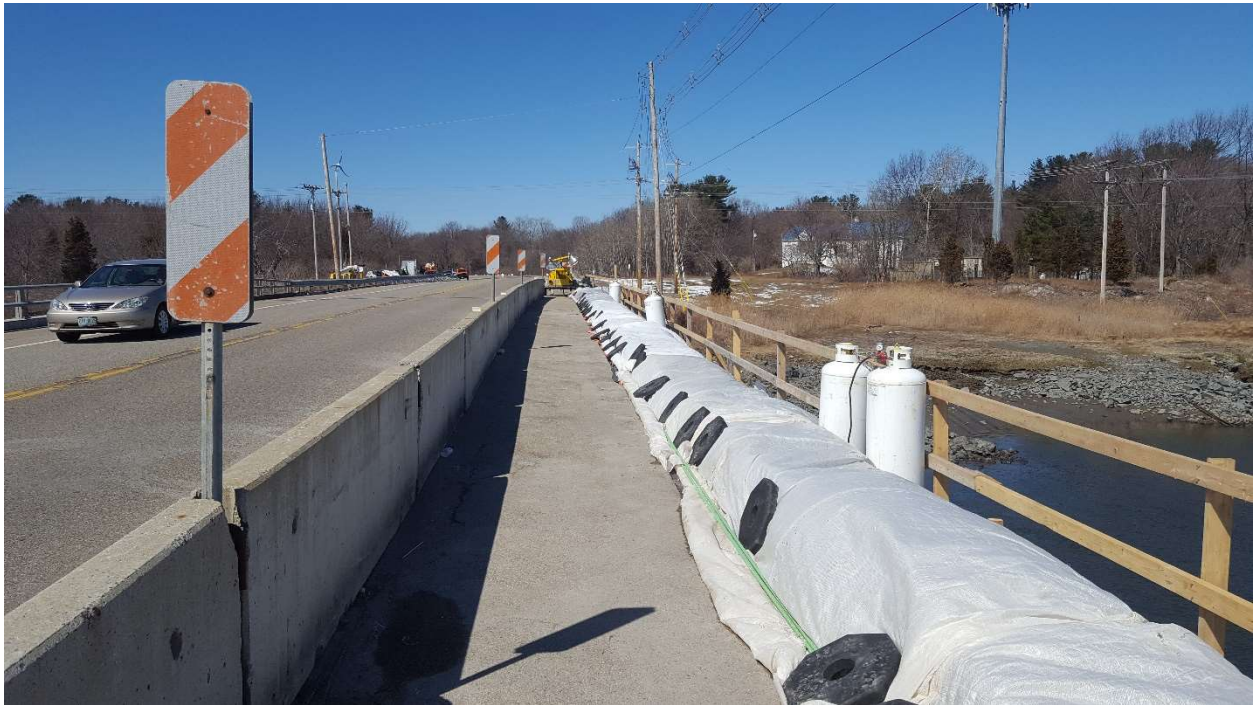
**Figure 7: Insulated wrap and heaters on a bridge curb after cold weather placement.**

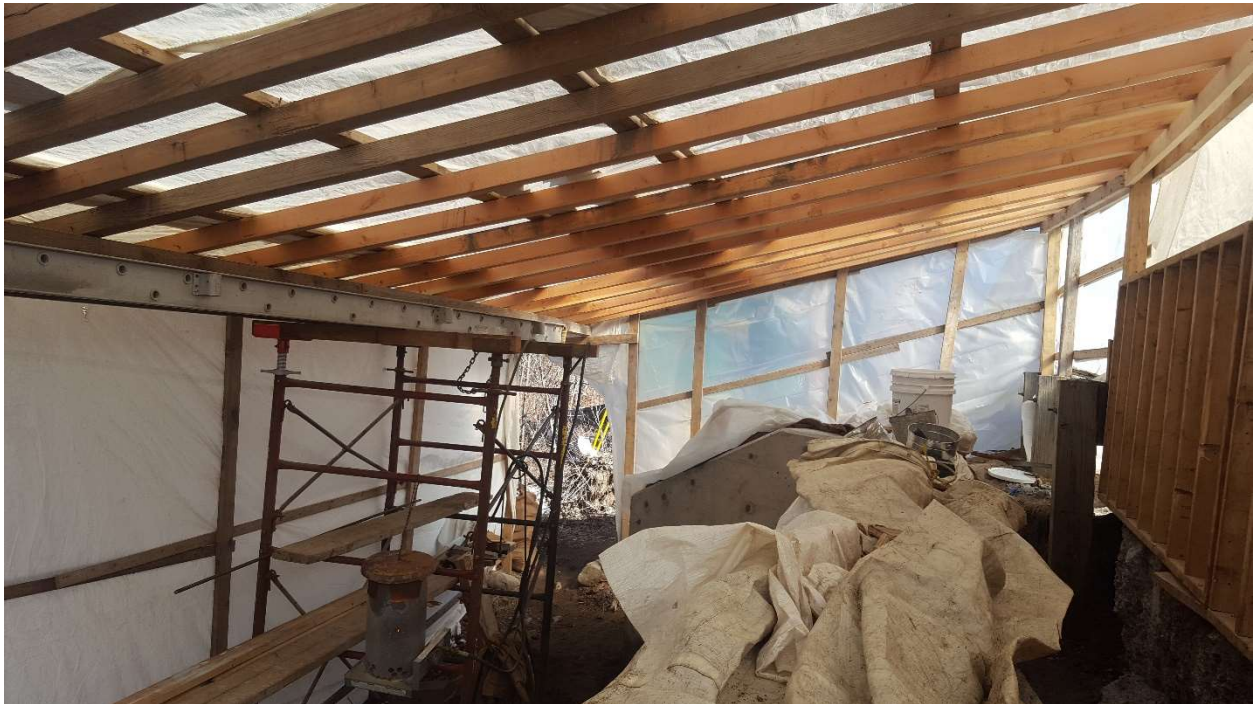
**Figure 8: A heated enclosure constructed over a bridge to prevent concrete from freezing during curing.**

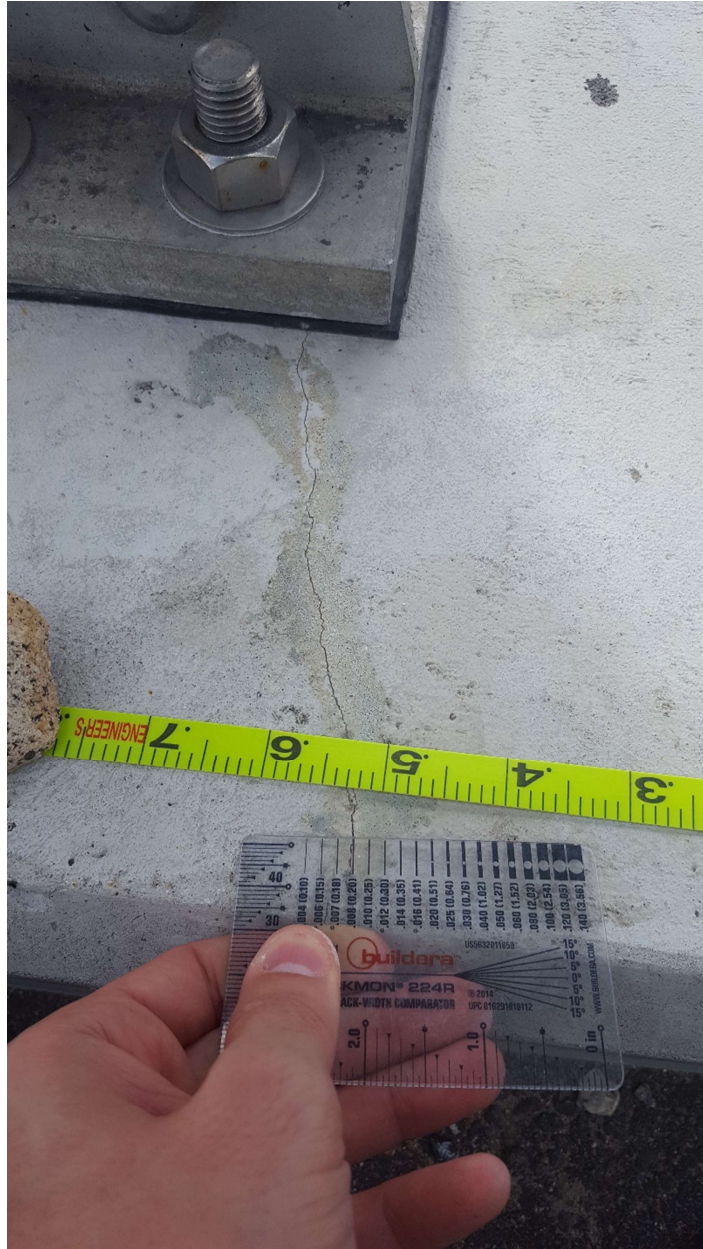
**Figure 9: Crack comparator used to aid in crack width determination.**

Additionally, each crack is given two index values based on its length and width. These values are discussed later. A crack comparator is used to determine crack width. The widest portion of the crack is used to determine the index value. An image of the crack comparator being used can be seen in Figure 9. It should be stated that cracks were only evaluated if visible. On several occasions cracks that were visible during a previous survey were no longer visible or appeared shorter or thinner than before. This could be due to dust and debris covering the crack, changes in humidity, changes in temperature, or a combination of the three. Recording of the crack location can be done in any way that is convenient to the surveyor. Initially during this study, photos of every crack were taken. While this method is beneficial when creating a visual record of the cracks it is much more time consuming, requires a significant amount of data storage, and on cold days may become difficult as batteries tend to lose their charge quickly without being kept warm. A common method used in this study was to use a voice recorder to verbally note crack location, width, and length.

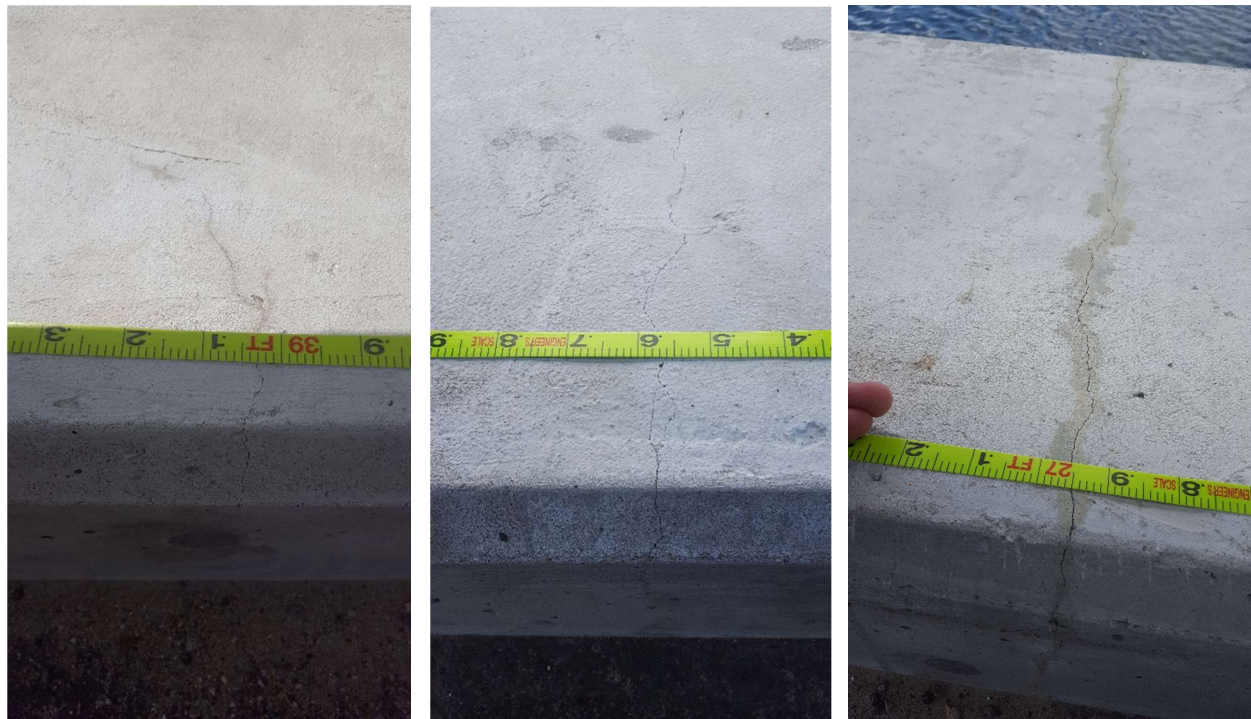
Length Index 1

A length index of 2 indicates a crack that has nearly full cracking on one face and partial cracking on another face. The example of a length index 2 crack in Figure 11 shows a fine crack that extends more than halfway along the upper face of the curb and only extends down the front face to the chamfer.

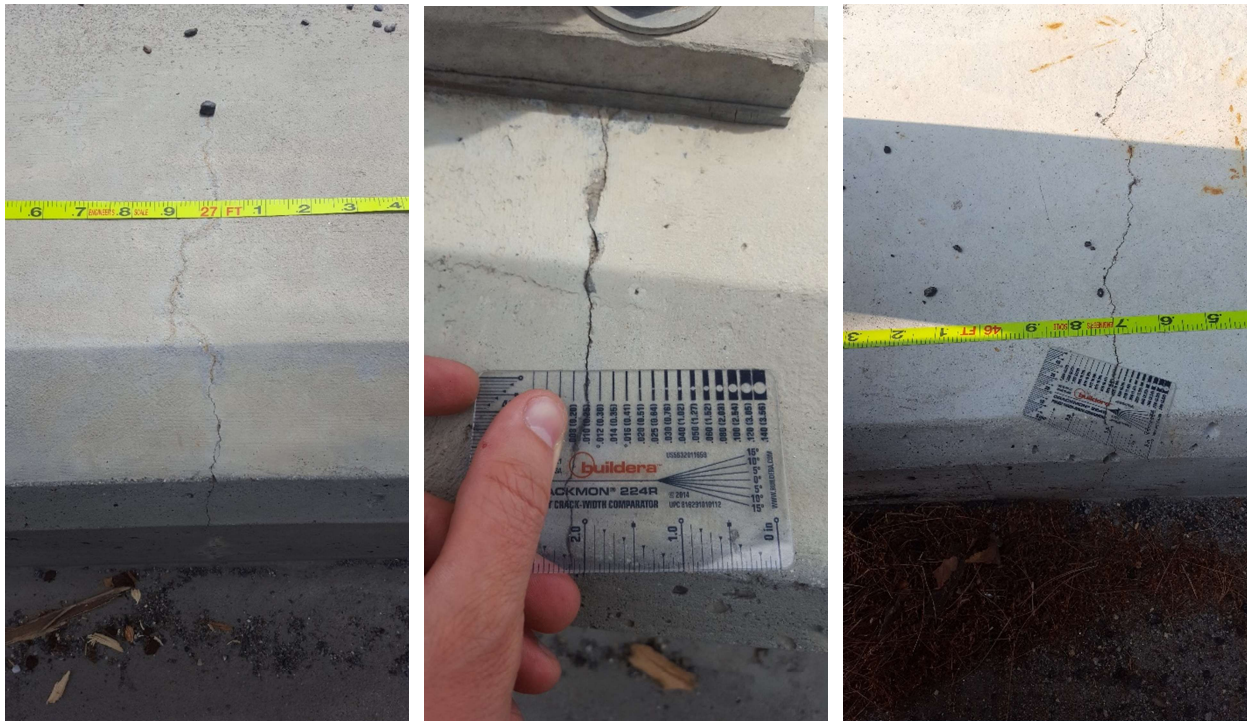
Intensity Index 1

Another important consideration is that an intensity index value of 1 does not mean the crack does not adversely affect the curb. Furthermore, a crack that has an initial intensity of index of 1 may very well become an intensity 2 or 3 at a later date. An example of the crack intensities can be shown in Figure 12.

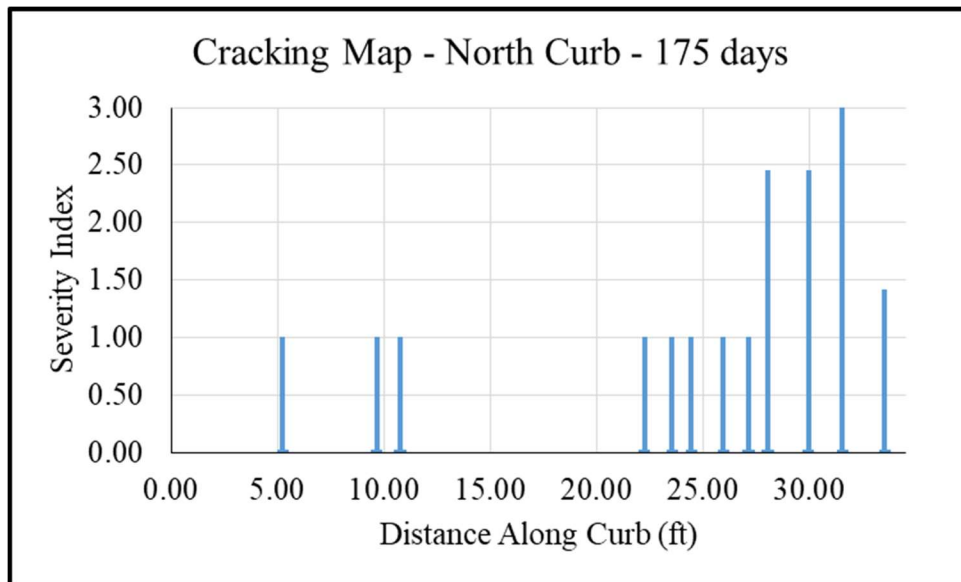
**Figure 13: Graph showing crack location and severity index.**

After a site visit all the recorded data was entered into a spreadsheet. The spreadsheet would automatically calculate severity index, average severity index, average uncracked length, and curb cracking index. The location and severity index of each crack was plotted on a graph to serve as a visual representation of cracking along the curb. This can be seen in Figure 13. At this point, data can be collected from this curb along with other curbs in order to do statistical analysis.

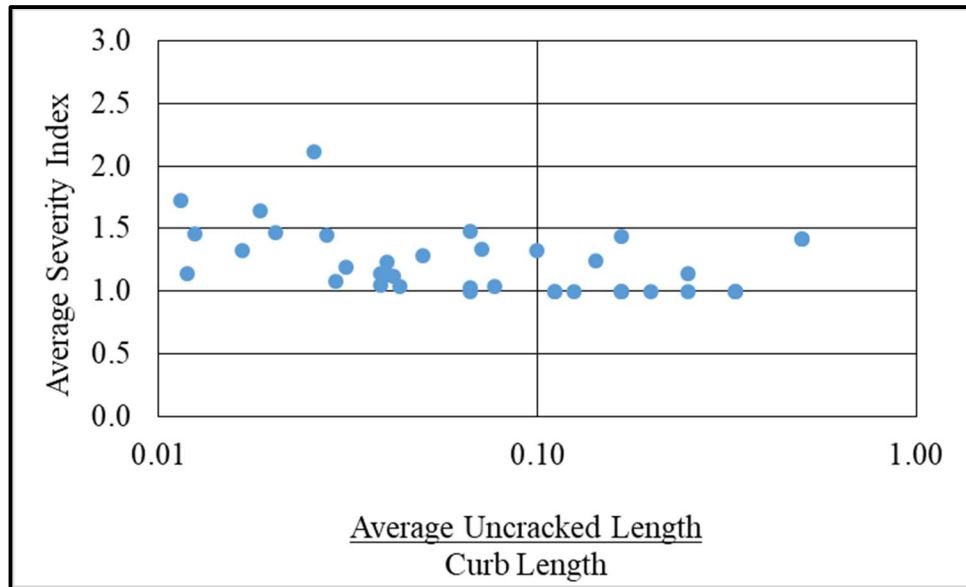
**Figure 16: Comparison of the average uncracked length of a curb to the average severity index.**

normalized to the length of the curb. This can be seen graphically in Figure 16. A t-test was also conducted using this data with the boundary being point with a normalized average uncracked length less than or equal to 0.1 in one group and those greater than 0.1 in another group. The results of the t-test are shown in Table 3 and reaffirm the idea that average severity index is significantly different on curbs with smaller average uncracked lengths.

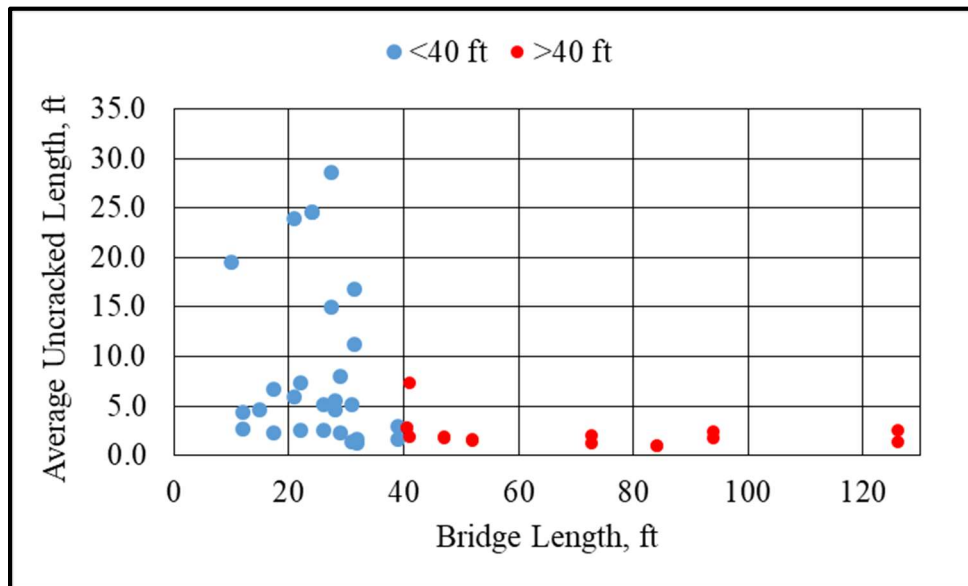
Figure 17: Effect of bridge length on average uncracked length.

The effect of bridge length on the average uncracked length of the curb can be seen in Figure 17. It can be seen that curbs less than approximately 35 ft exhibit a larger range of values for average uncracked length. The high average uncracked length is attributed to minimal

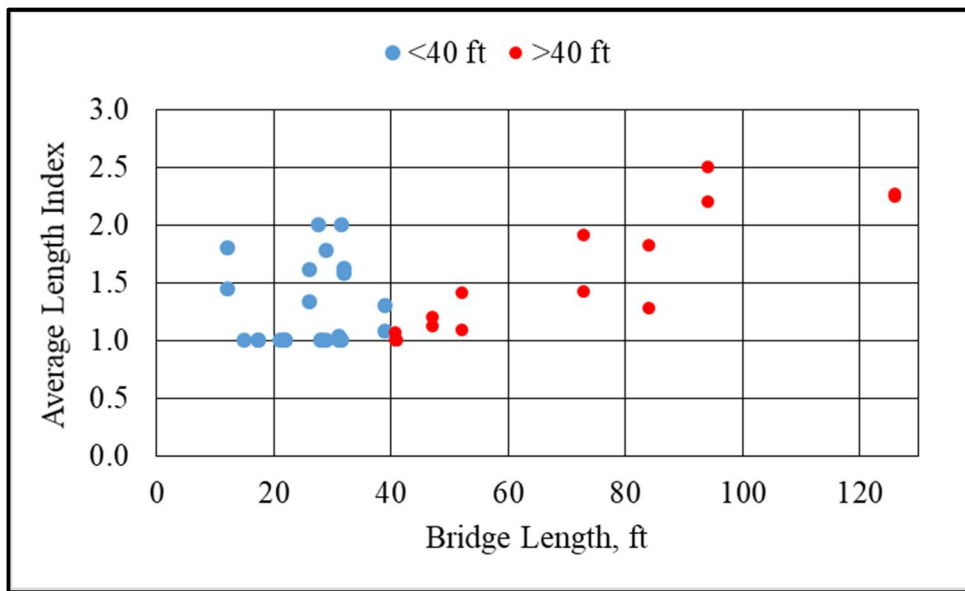
**Figure 18: Effect of bridge length on average length index.**

When looking at the distribution of average length index compared to bridge length, Figure 18, there seems to be clusters of higher length index values on both sides the 40 ft mark. The trend on curbs over 40 ft appears to indicate an increase in the average length index at increasing bridge lengths. A t-test conducted suggests the average length index is not significantly different between curbs over 40 ft and less than 40 ft. This may hold true for the division line of 40 ft but perhaps the effects of bridge length on the average length index do not become significant until 60 ft or greater. Further investigation of this is required.

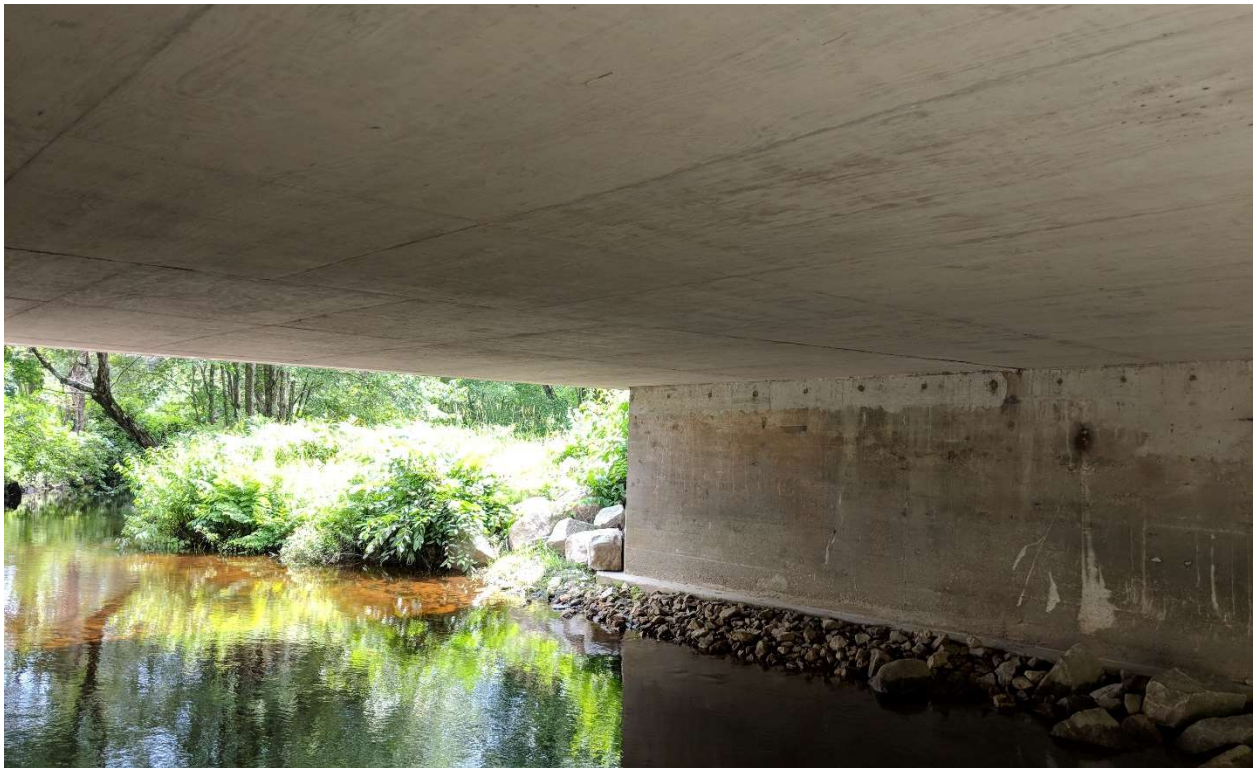
**Figure 20: Concrete slab bridge structure example in Alexandria, NH.**

One thing to consider in addition to the length of the bridge effecting cracking is the type of bridge structure the curb is on. The majority of the bridge curbs surveyed in this study were either concrete slab, CS, bridges or steel I-beam with concrete deck, IB-C, bridges. Typically, for shorter spans the concrete slab bridge structure, Figure 20, is used. As bridge spans become larger there is a tendency to use steel I-beams, Figure 21, for the structure.

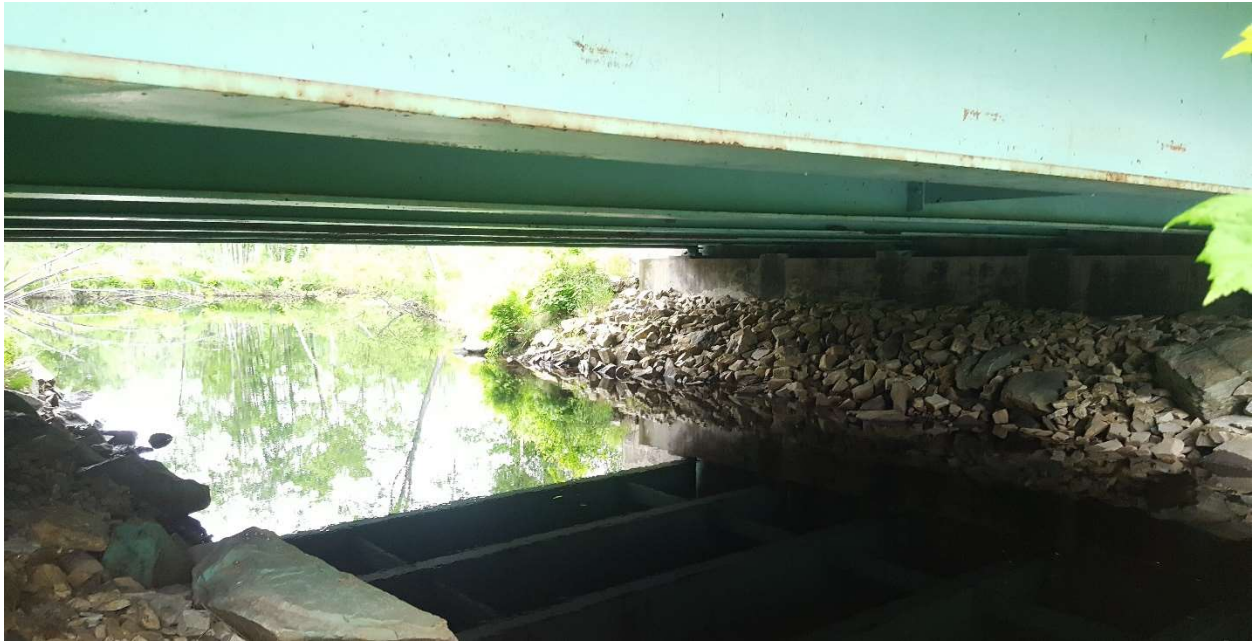
**Figure 21: Steel I-beam with concrete deck bridge structure example in Wakefield, NH.**

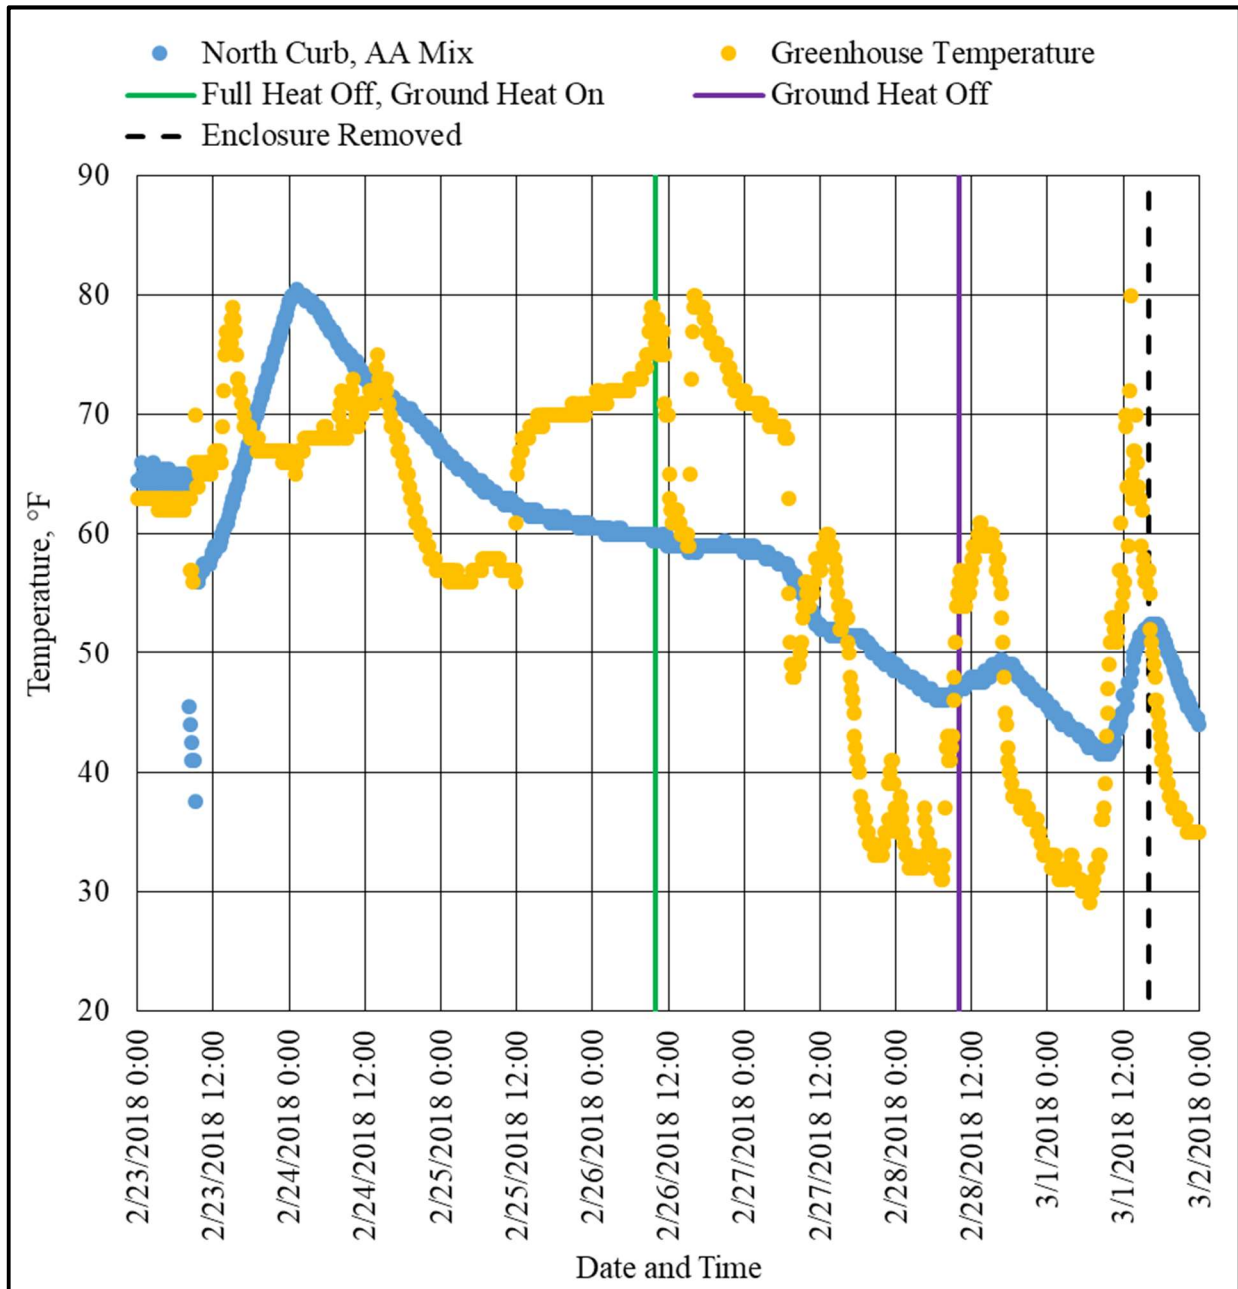
Figure 32: Thermocouple temperature measurements from inside a curb placed in the winter inside of an enclosure.

Additional concerns with curing, particularly cold weather curing in New Hampshire, is the internal temperature of the curing concrete. This study placed thermocouples in four curbs to see how the internal temperature of the curbs varied during curing. Two curbs were placed during the winter and two were placed during warmer weather in spring and summer. The thermocouple results for a curb placed in the winter can be seen in Figure 32.

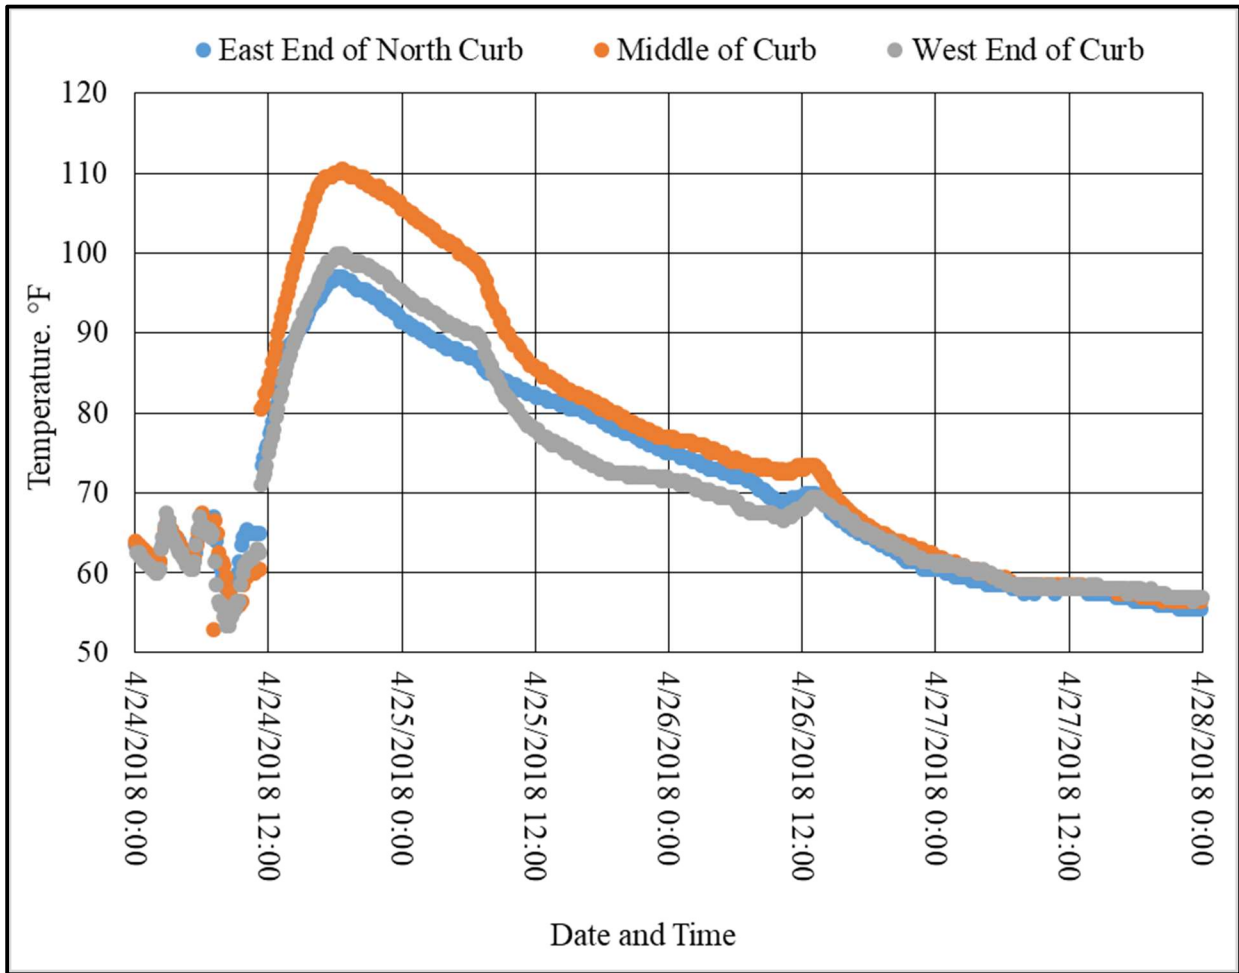
**Figure 33: Thermocouple temperature measurements from inside a curb placed on a day with a high of 73°F.**

The instrumented curbs suggest that nothing unordinary is happening with respect to the curb temperature that would be of a concern. Again, there has only been a limited amount of internal temperature data collected and further investigation may reveal excessively high or low temperatures early in curing.

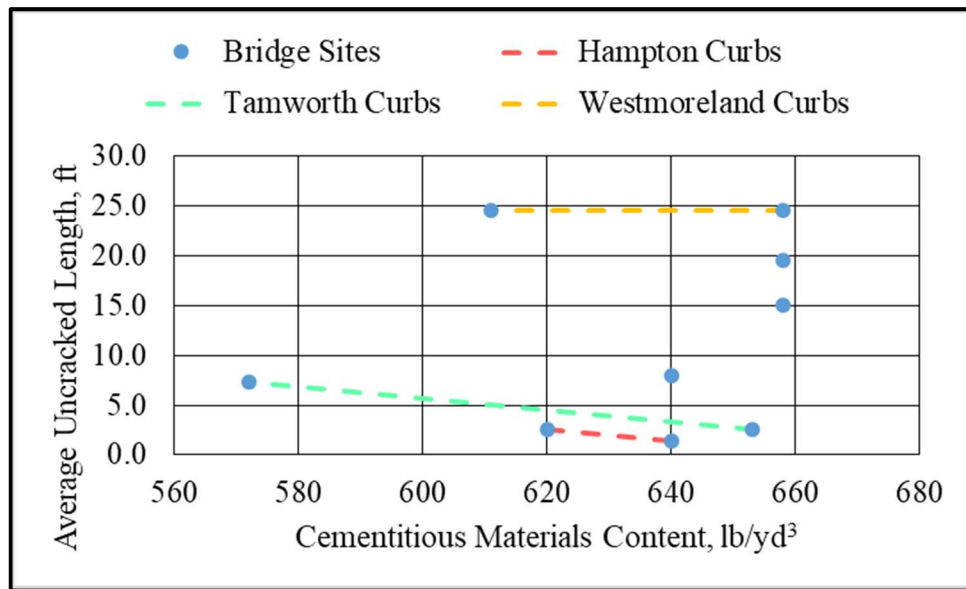
Figure 35: Cementitious content compared to average uncracked length.

The total cementitious material content per cubic yard of several curbs placed during the study were compared to cracking. When the total cementitious content is compared against average uncracked length, as shown in Figure 35, no trend is apparent. Further data is required in order to determine if the lower average uncracked lengths between 620 lbs/yd<sup>3</sup> and 640 lbs/yd<sup>3</sup> are significant or are the result from other factors. When comparing curbs placed on the same bridge, curbs with a higher cementitious content tend to exhibit a smaller average uncracked length.

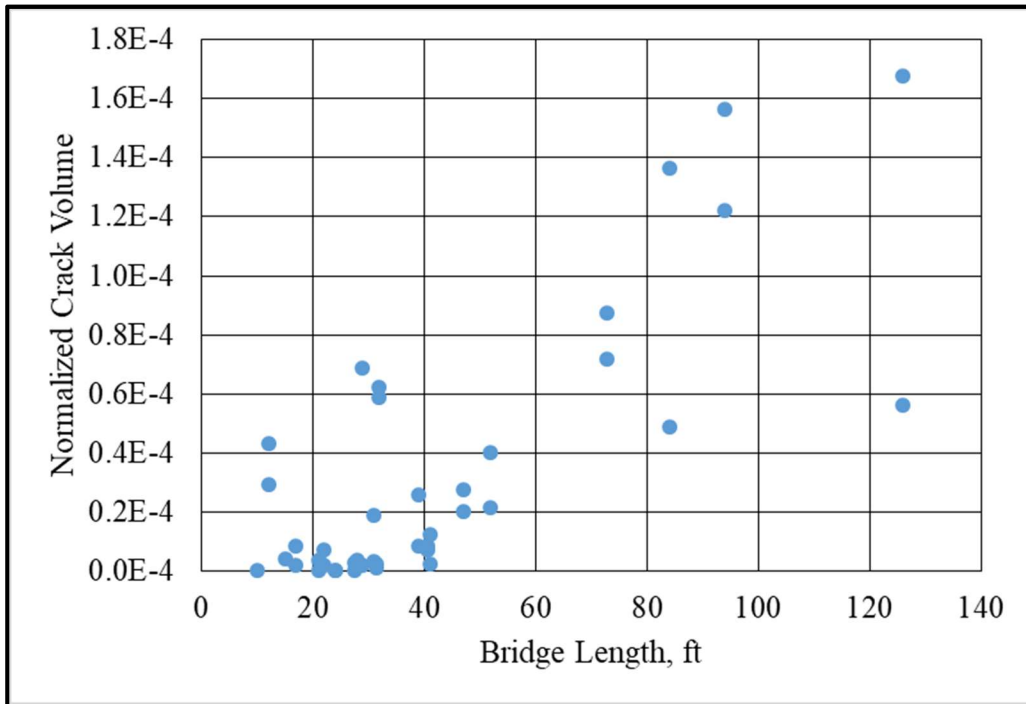
**Figure 54: Bridge length compared to normalized crack volume.**
