Method for Characterising and Quantifying Volumetric Edge-Wear in Ceramic-On-Ceramic Hip Arthroplasty Devices

**METHOD FOR CHARACTERISING AND  
QUANTIFYING VOLUMETRIC EDGE-WEAR IN  
CERAMIC-ON-CERAMIC HIP ARTHROPLASTY  
DEVICES**

A thesis submitted to the University of Huddersfield  
in partial fulfilment of the requirements for  
the degree of Doctor of Philosophy

Department of Computing and Engineering,  
The University of Huddersfield

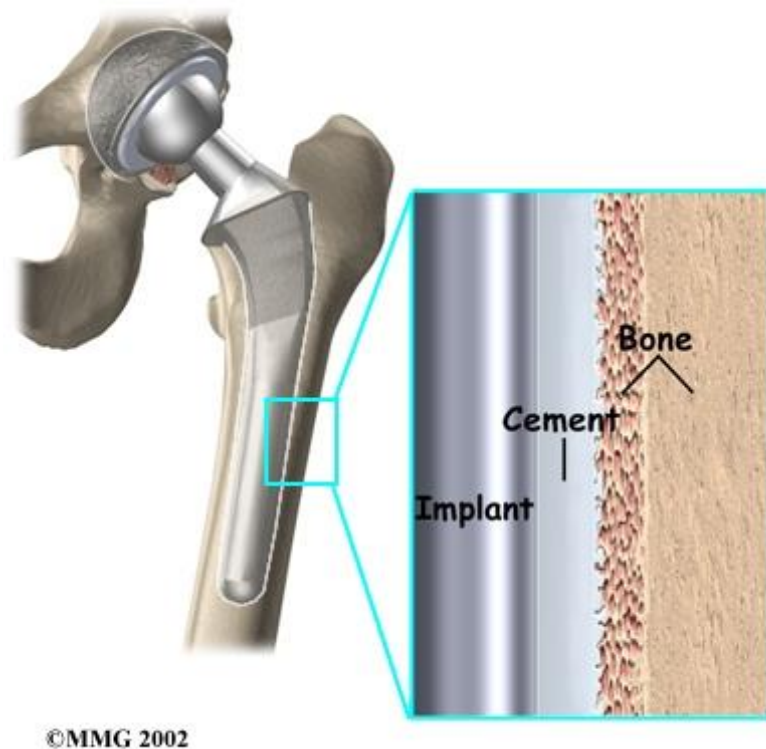
For cemented prosthesis, PMMA is utilised for fixation of both femoral stem and acetabular cup by pressurisation as seen in Figure 10. PMMA cement is not a glue but a grout and works on the principle of mechanical interlock rather than adhesion [20]. Hence pressurisation is required to drive the cement into the narrow spaces between the bone and prosthesis. It is comparatively easy to obtain pressurisation inside the femoral canal. Pressurisation techniques for acetabular have also been researched [93], however acetabular pressurisation is more challenging. PMMA is a low strength and brittle material hence to prevent fracture in bone cement it is essential to use sufficient thickness of bone cement [94].

**Figure 10: Image displaying cemented hip prosthesis fixation using PMMA [95].**

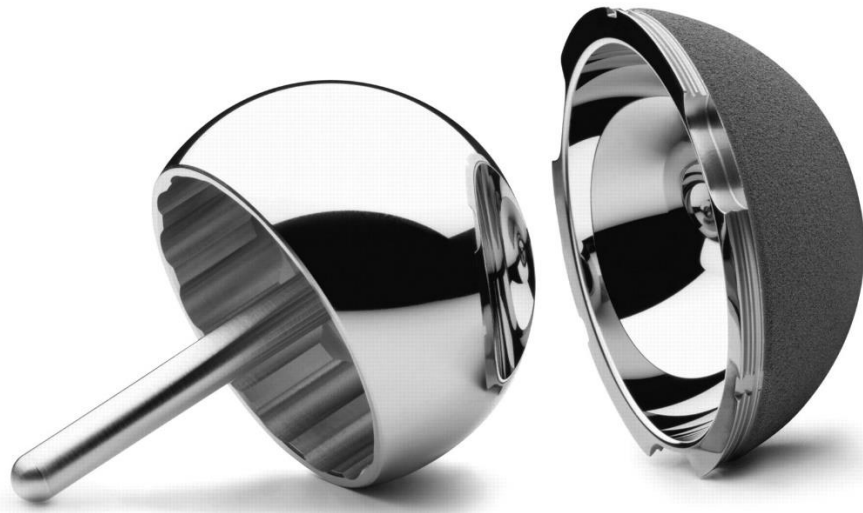
**Figure 14: An image of metal-on-metal hip resurfacing prosthesis [128].**

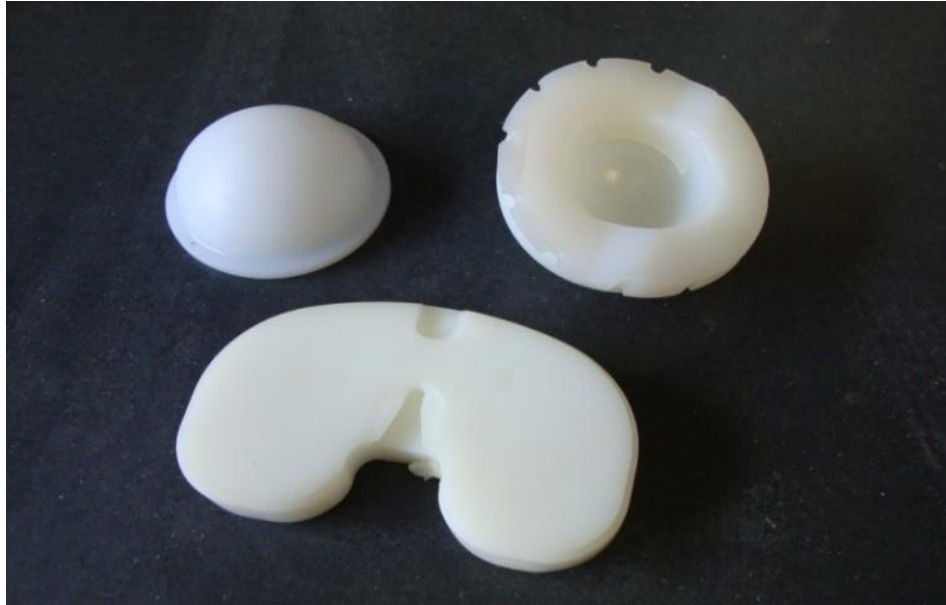
**Figure 15: Acetabular and tibial components fabricated from UHMWPE [141].**

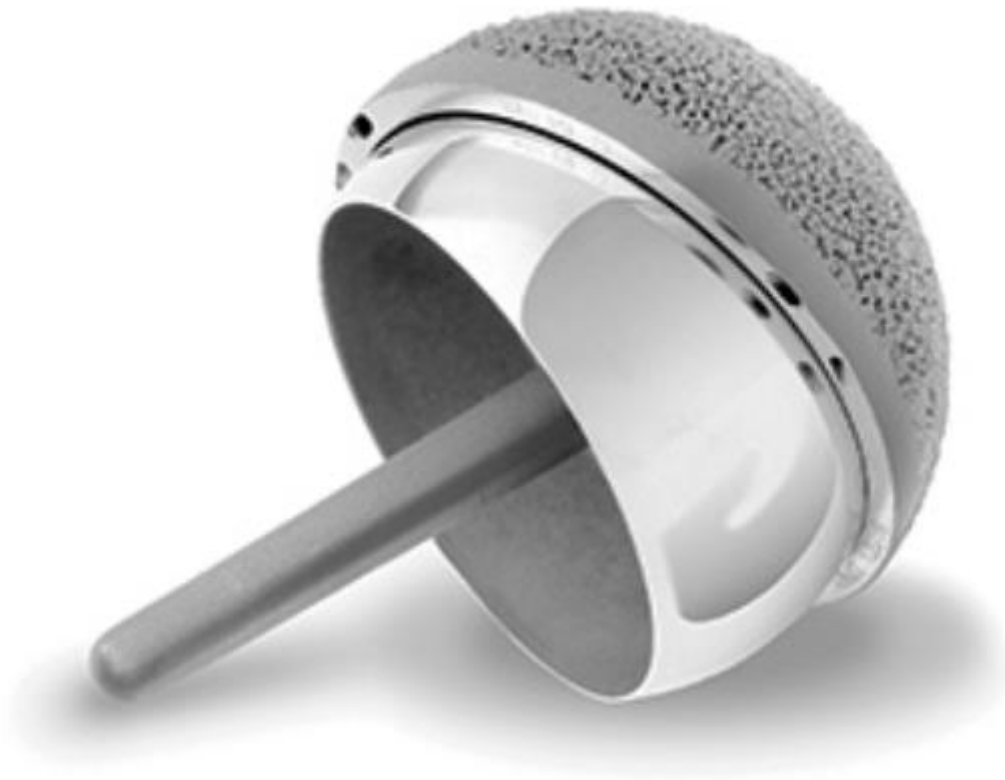
**Figure 17: An image displaying the McMinn prosthesis/Birmingham hip resurfacing system [214].**

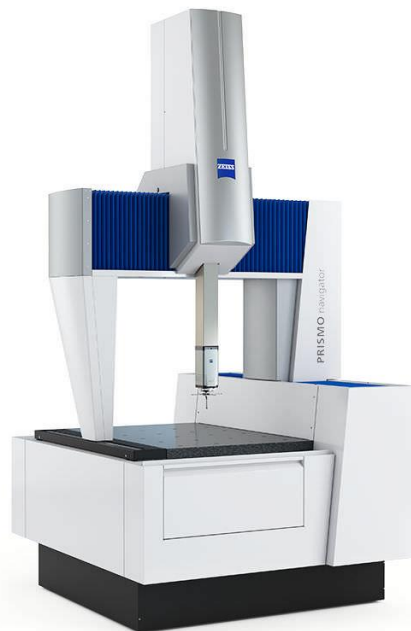
**Figure 24: Carl Zeiss Prismo Navigator CMM ([www.zeiss.com](http://www.zeiss.com)). A modern generation CMM.**

A CMM physically measures a given work-piece by probing various points on the surface as defined by the user. These probed points are recorded as co-ordinates and are used to align the co-ordinate system as desired. Using this constructed alignment more points are recorded in a strategic manner to construct the feature and calculate the required size and form data on the provided software. Advanced features allow patterns and to set up more than one alignment in the work-space to perform batch work and can measure more than one component per routine.

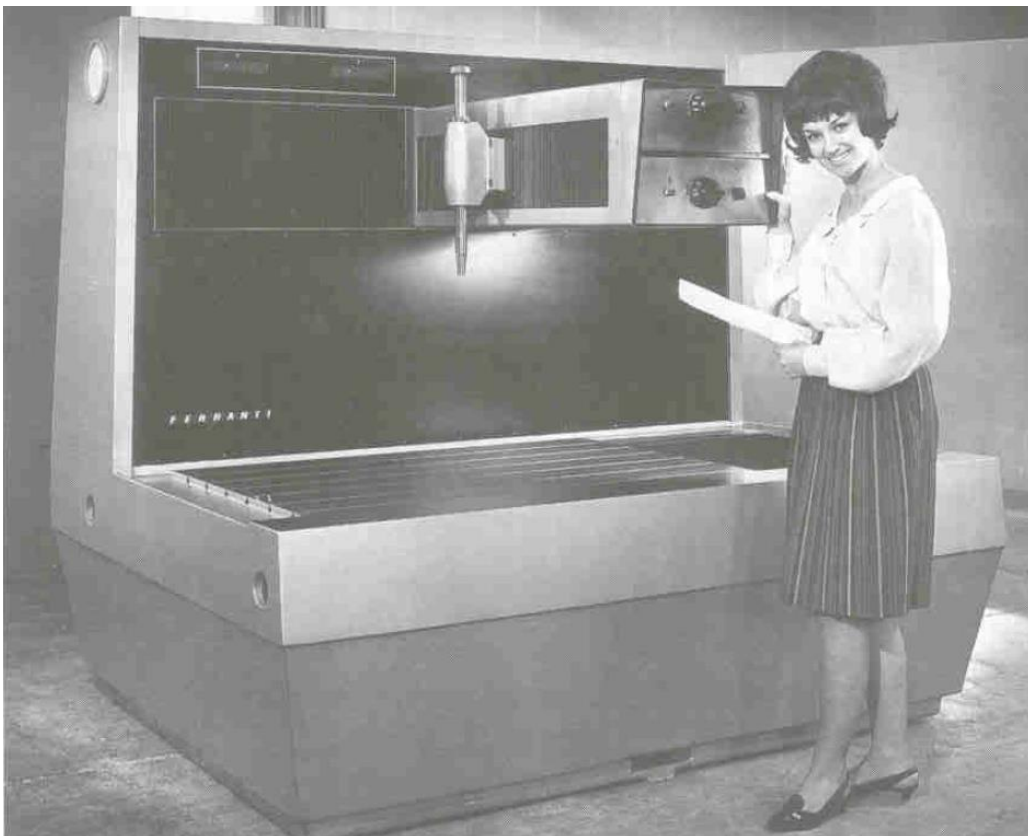
**Figure 25: The first CMM introduced by Ferranti [282].**

The first CMM (Figure 25) was developed and introduced by Ferranti Ltd of Dalkeith, Scotland [281] in the early 1950s and arrived in the British market in 1959. Initially it was designed as a companion product to numerical controlled machine tools in response to the requirement for more rapid and more flexible measurements. This was only possible with the development of a precise, long range and electronically compatible digital measuring system.

The use of an optical grating in combination with a moiré fringe sensing system made it possible. Rather than a conventional machine tool design the Ferranti CMM was a classic kinematic design which was supported by involving minimum constraints with provision of alignment of the moving elements. The Ferranti CMM opened a huge market in the industrial world and led to the advancement of similar machines with higher capacities and better accuracies and resolutions [282].

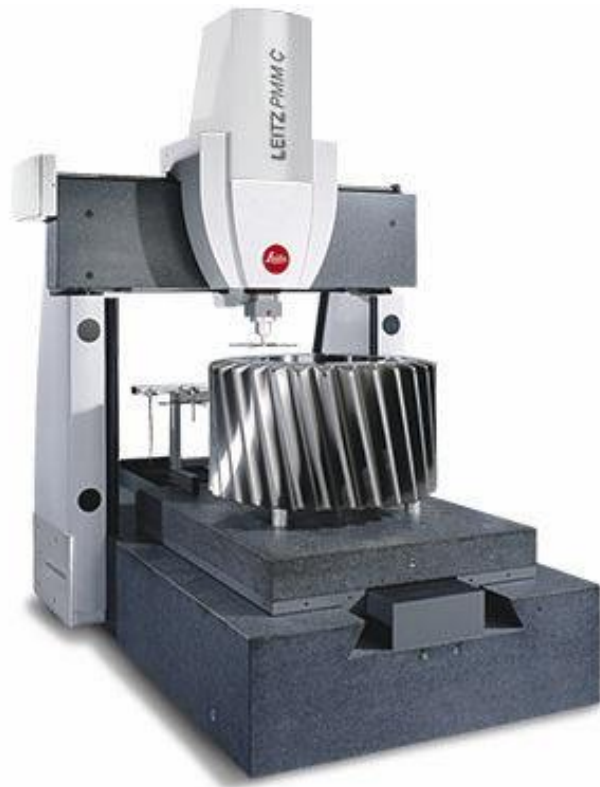
**Figure 27: A CMM with fixed bridge configuration [282].**

In the fixed bridge configuration, unlike moving bridge configuration, the bridge is rigidly attached to the machine bed. However, the table upon which the work piece is mounted provides one of the three axes of the motion (see Figure 27). Such fixed bridge design eliminates the yawing problem faced by moving bridge design and provides high rigidity and better accuracy. Out of all the CMMs offered in the market, the most accurate CMM has fixed bridge configuration. This accuracy comes at the cost of low operating speed as it requires to move the heavy table with the part fixated on it which results in lower throughput of the machine. The maximum allowable weight is also a limitation for CMMs with such configuration. The requirement of extended guide ways to allow long table movements is a disadvantage as it requires larger space [282].

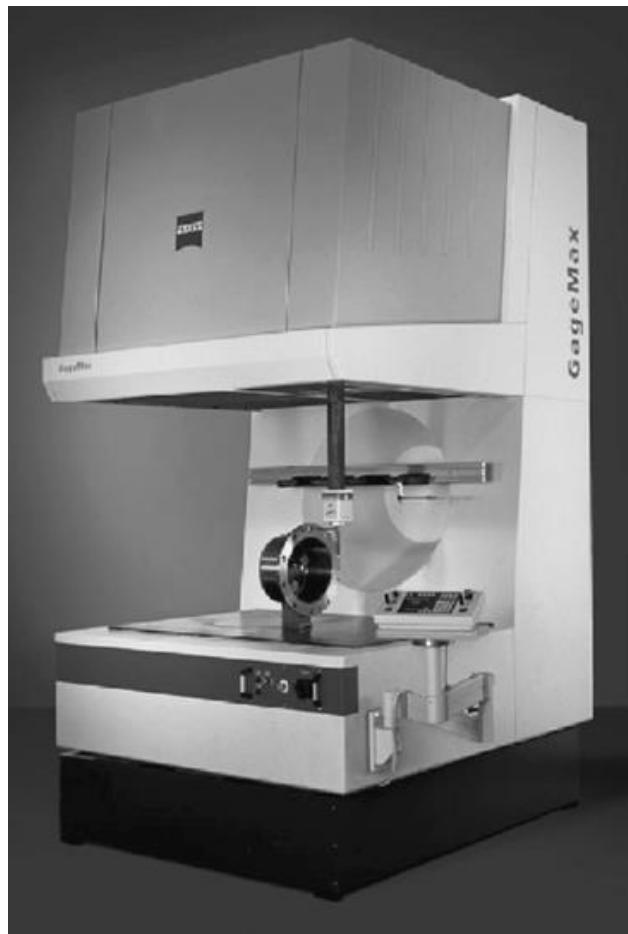
**Figure 28: A CMM with cantilever configuration [282].**

The CMMs with cantilever design are equipped with a cantilever arm that supports a carrier to move back and forth. The carrier supports the probe arm for vertical movements to move in Z axis (see Figure 28). The artefact to be measured is placed on a fixed table in cantilever design similar to that of the moving bridge. The table does not include the bearing guideways and hence can uphold heavy components without affecting the measurement accuracy. A cantilever configuration CMM with fixed table favours good accessibility to the work-piece and flexibility to mount it with three sides open, however overhead loading is generally not possible. The cantilever type CMMs usually have low mass of moving structures which makes it agile and grants the machine with higher output. All such advantages make this configuration makes it favourite general metrological applications. The bending is however a major disadvantage for cantilever type CMMs. There are chances for bending occurs when the carriage travels toward the extreme outer position. The cantilever CMMs have long table with comparatively smaller range for other

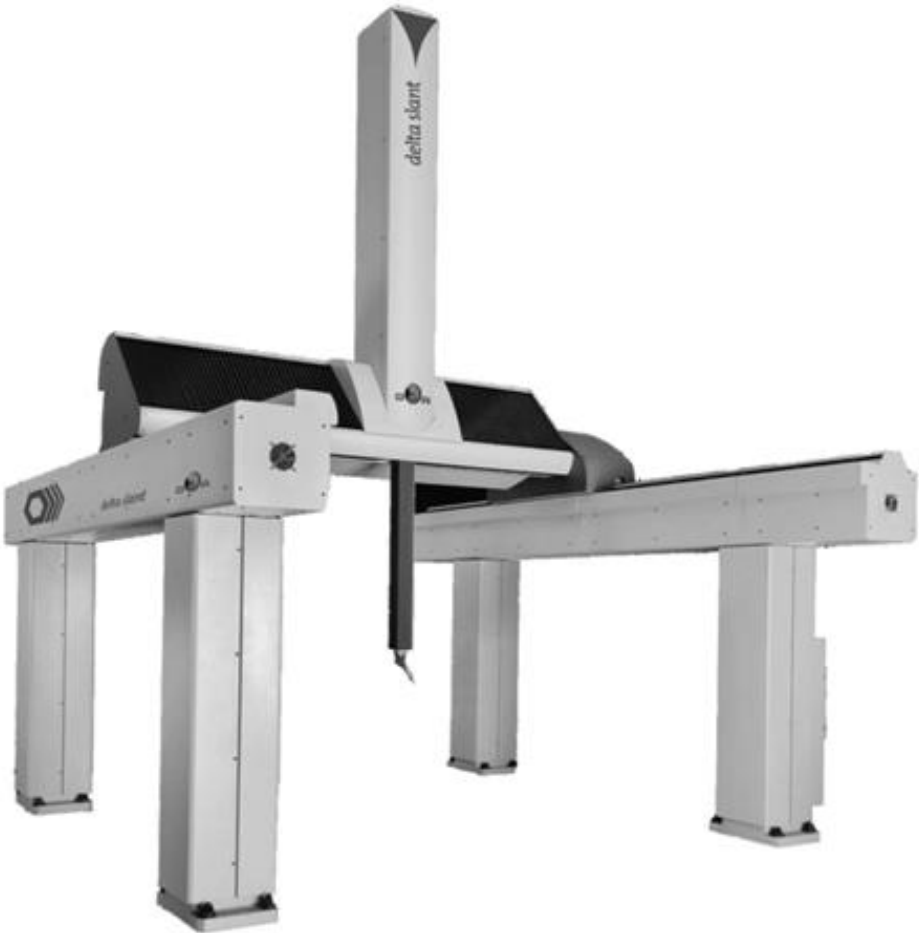
**Figure 30: A CMM with gantry-type configuration [282].**

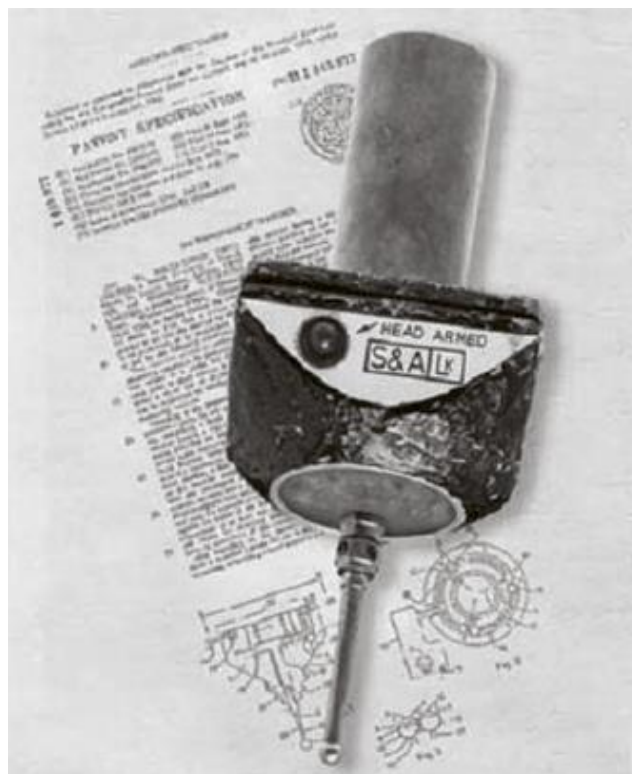
**Figure 31: The original three dimensional touch trigger probe invented by Sir David McMurtry in 1972 [282].**

Probe is an important hardware component that is used in all CMM as an interface between the machine and the work piece to be measured. All geometric measurements in coordinate metrology are established by positions and distances of a set of points detected on the physical surface of a work piece. Probing systems are employed to detect the position of these points with respect to the coordinate system of a CMM. In early days, CMMs used hard probes to contact the work piece surface manually until Sir David McMurtry of Rolls Royce Group invented touch trigger probe system (see Figure 31) in 1972. This invention carved the way for developing more

Touch trigger probe system is the most commonly used and most widely available type of modern probing system. In the touch trigger probing system an electrical signal triggers the reading of Cartesian position of the probed point on the measuring component when the probing force on the component exceeds an electronically or mechanically controlled value. The measurement uncertainties of electromechanical method used in the touch trigger probing systems are dependent on measurement direction and preload due to forces induced by acceleration and deceleration. Uncertainties caused by such forces form a triangular pattern and are termed as lobing errors [282]. With the use of piezo sensors in the probes that are sensitive to tension and compression these uncertainties can be reduced [55].

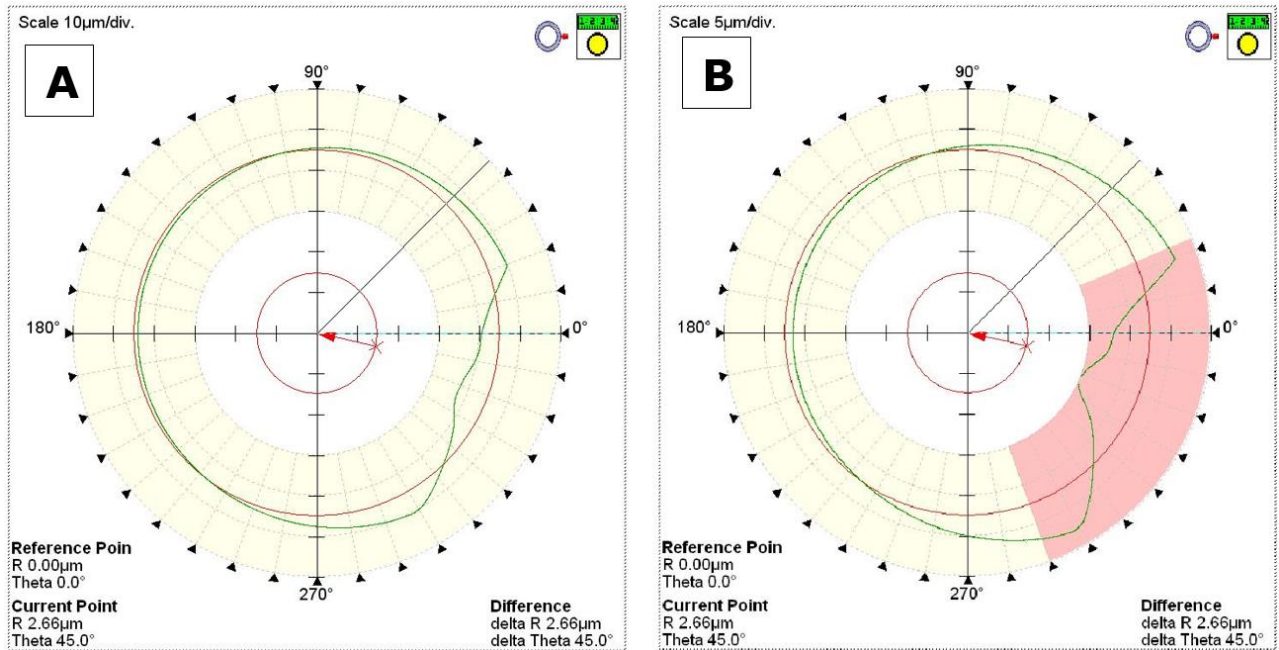
**Figure 37: Image displaying the roundness traces as measured on RMM at the edge of the acetabular liner 2. Image (A) on the left is the actual roundness trace without elimination of any data and the image (B) on the right is the roundness trace that displays the form at the edge area when the wear patch is ignored.**

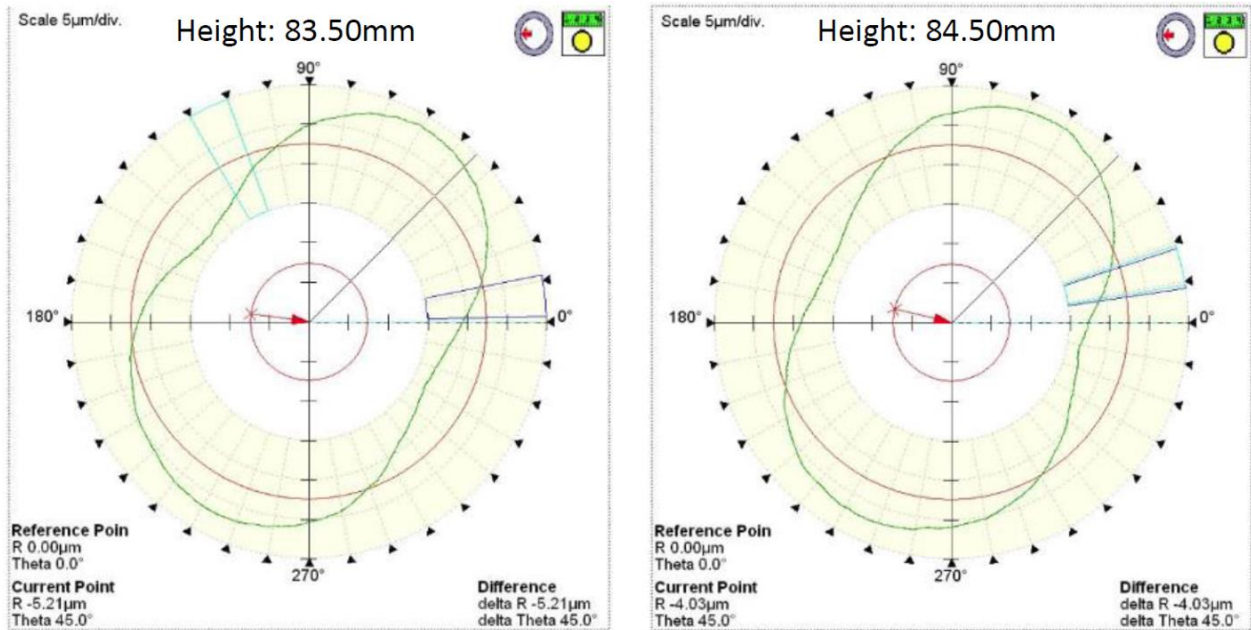
**Figure 39: Image displaying two roundness traces of the surface above the edge of liner 2 from the unworn cohort-B measured at different height to study the form of the surface above edge.**

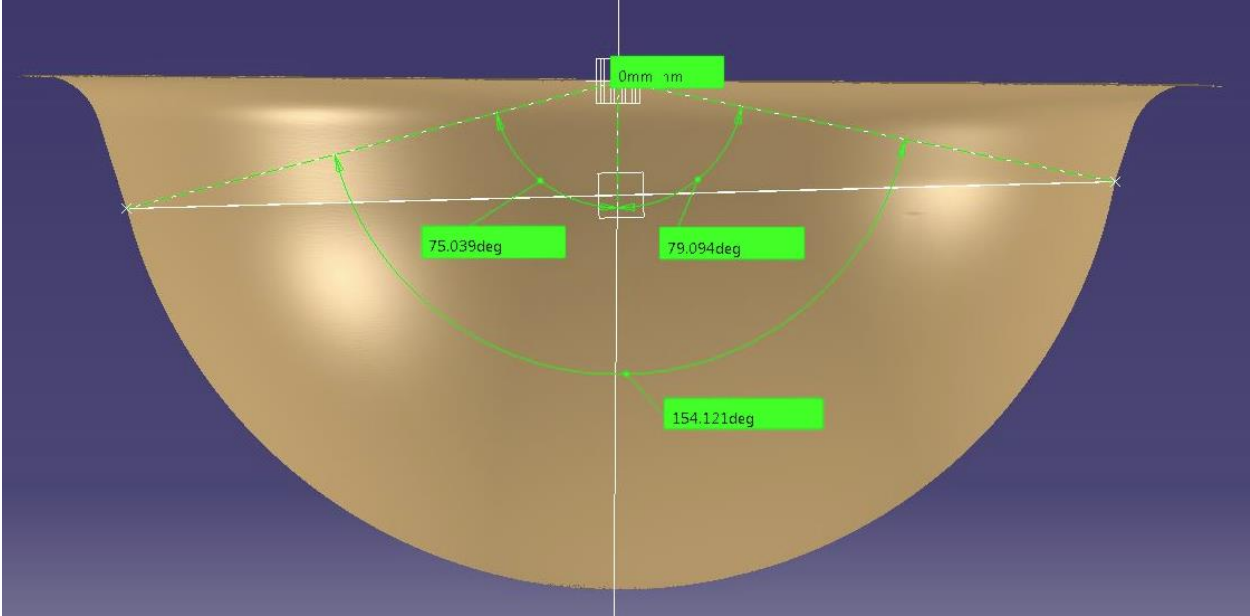
**Figure 43: Image displaying the coverage angle assessment of liner 2 from the unworn cohort-B as an example.**

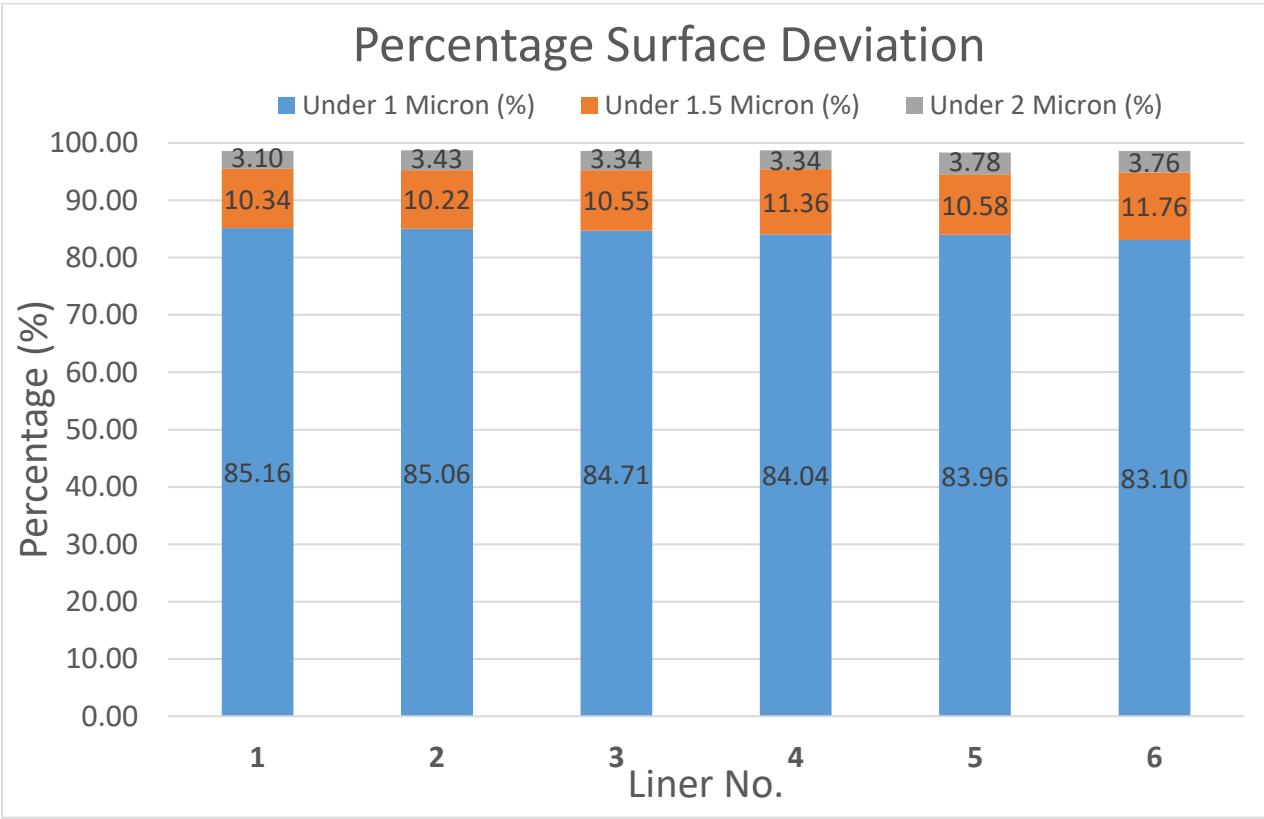
**Figure 46: A bar graph displaying the results from the deviation analysis performed to test the deviation between the reconstructed surface and measured surface for all six liners of the unworn cohort-B.**

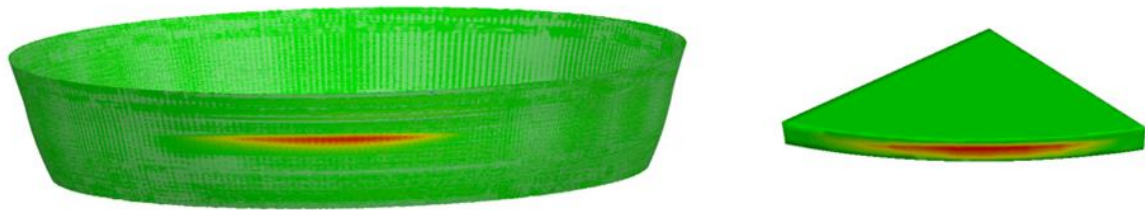
**Figure 51: Wear measurement narrowed down from full liner to wear sector in order to limit the errors induced.**

On rare occasions scanning error or debris deposit were observed on the measured surface through the deviation analysis. In order to limit such errors from hindering the volumetric wear computation, the surface affected by the error is discounted from volume computation process. For discounting the surface affected by such error, both the enclosed surfaces are segmented down to just the area around to the wear patch using the same planes as seen below in Figure 51. This segmentation allows to focus the volume computation of just the wear distribution and small amount proximal area and discounts the volume of the error affected surface.

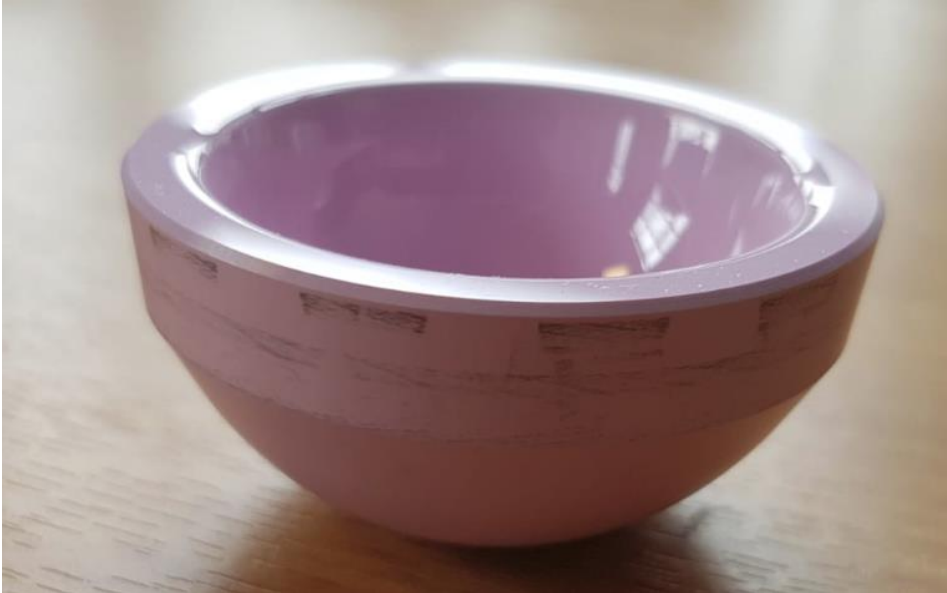
**Figure 53: Image displaying wear at the clamping area on the exterior part of the liner.**

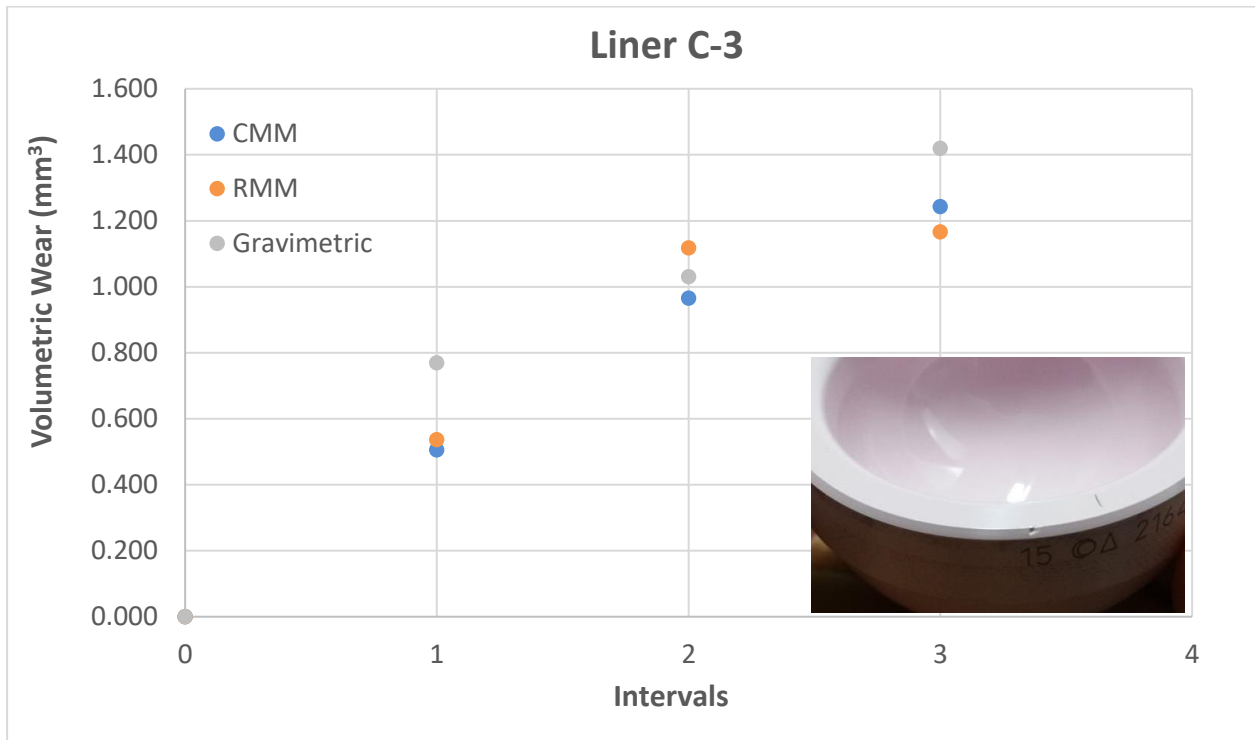
**Figure 90: Graph displaying volumetric wear result obtained by CMM, RMM and Gravimetric at each interval for liner 3. The picture of the liner displays the chipped rim.**
