Modal properties variation and collapse assessment of masonry arch bridges under scour action

F. Scozzese ¹, L. Ragni ¹, E. Tubaldi ², F. Gara¹

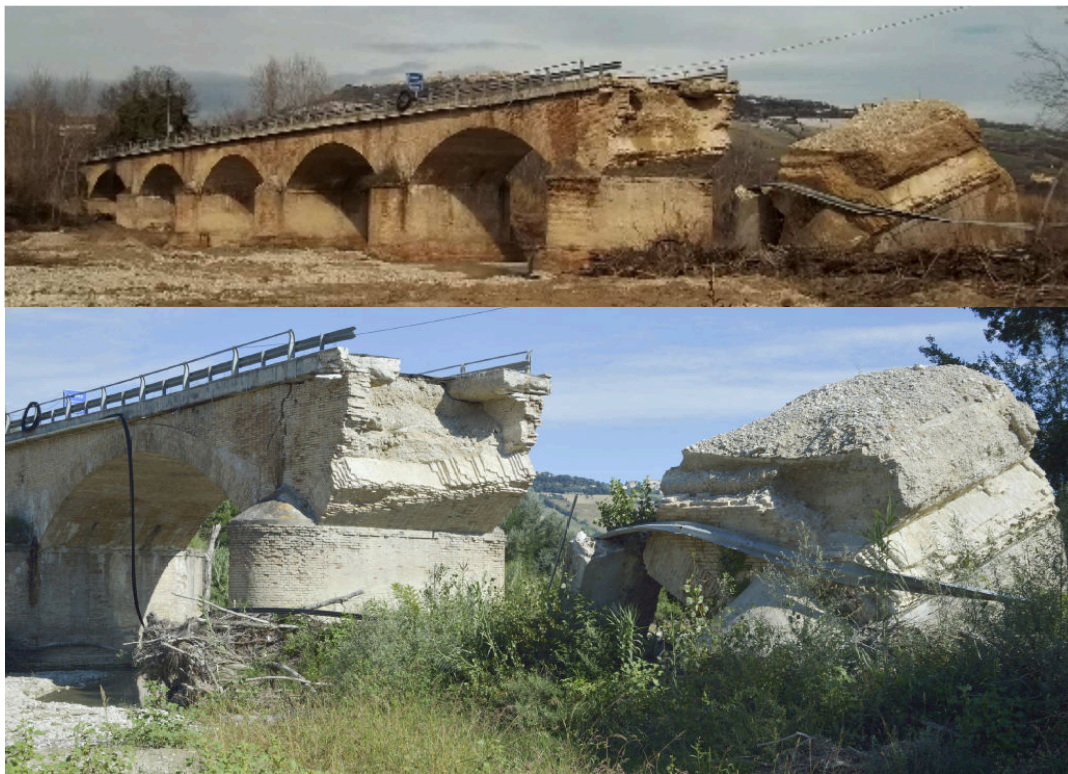
of the sixth pier foundation, i.e., the one located adjacent to the right abutment looking at the bridge from the up-stream side. The collapse mechanism of the bridge was characterized by a rotational movement of the pier towards the upstream side, a very recurrent mechanism in bridges subjected to scour [3]. This is due to the fact that the scour hole often presents a non-symmetric shape, with the up-stream side steeper than the down-stream one [1].

Figure 1. Global view of the bridge after the pier collapse during the 2013 flood and detail of the scour-induced down-stream rotation of the pier.

Based on the results shown in this section, it is possible to conclude that the partial collapse of Rubbianello bridge was caused by the attainment of a scour level of around 5.50 m after the intense flood on 2013. Moreover, the failure pattern and the location of the cracks identified within this simulation, as well as the rotational mechanism induced by the scour at the base of the pier, are in line with the post-collapse state of the bridge observed after the 2013 flood (see Figure 1).

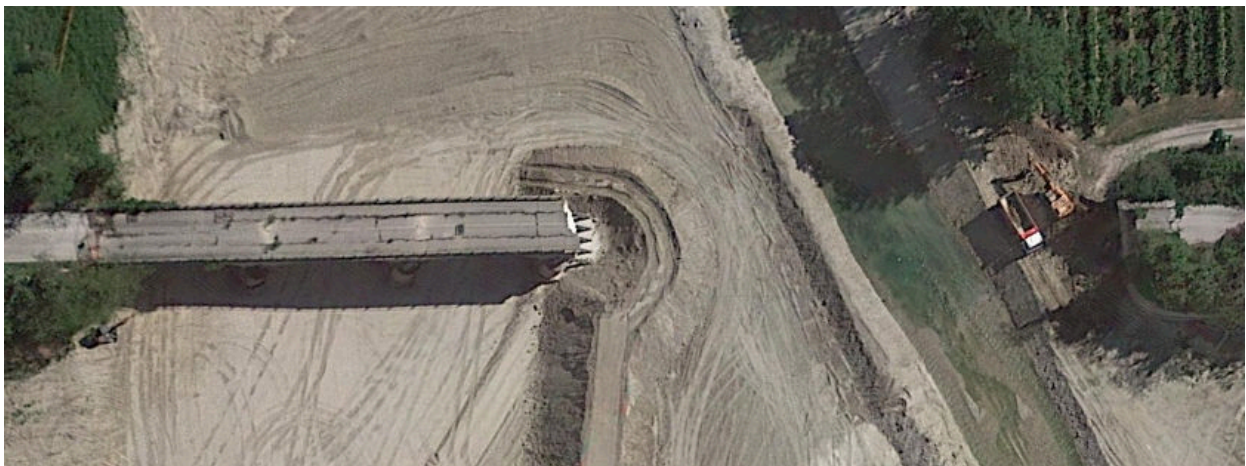
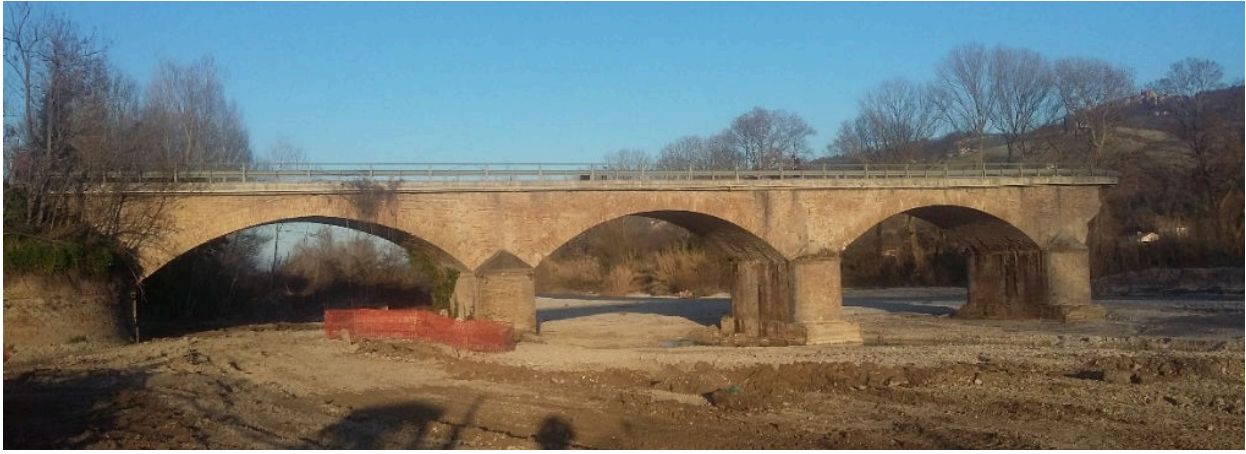
The bridge experienced further collapse of two more spans following the flood of March 2016. Afterwards, the seismic events of August and October 2016 and the heavy rains and floods recorded until February 2017 led to the actual state of the bridge, which consists of 3 piers and 3 bays, for a total length halved with respect to the beginning (Figure 2).

Figure 2. Current state of the bridge (year 2019), with 3 piers and 3 spans remaining: (a) top-view and (b) lateral view.

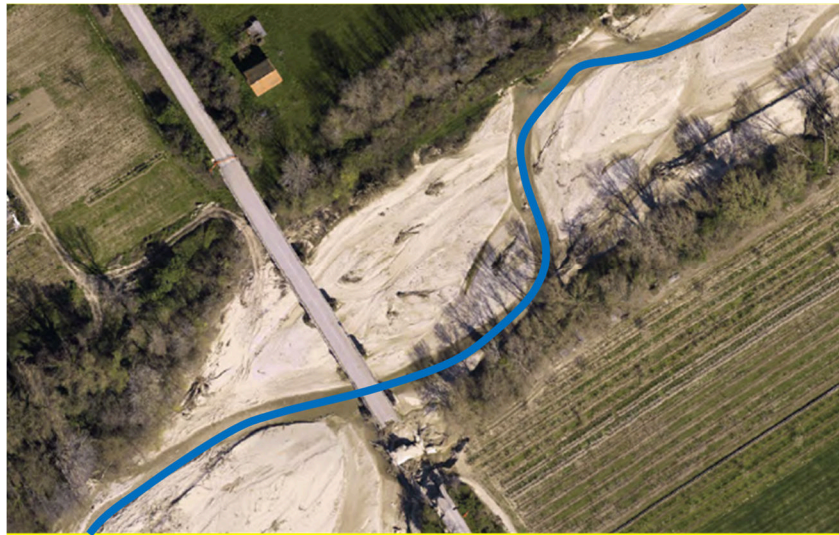
According to the hydraulic studies performed in 2013, the year the first collapse occurred, the meanders developed by the Aso river were such that the main channel was located exactly underneath the sixth pier. Such meandering configuration of the river is also testified by the photograph in Figure 3, showing the path of the riverbed (highlighted by a blue line) at the end of 2015, which is a few months before the second collapse occurred, involving the two piers located in proximity of the main channel.

Figure 3. Path of the meandering Aso river in 2015 (a few months before the collapse of piers n. 4 and n. 5).

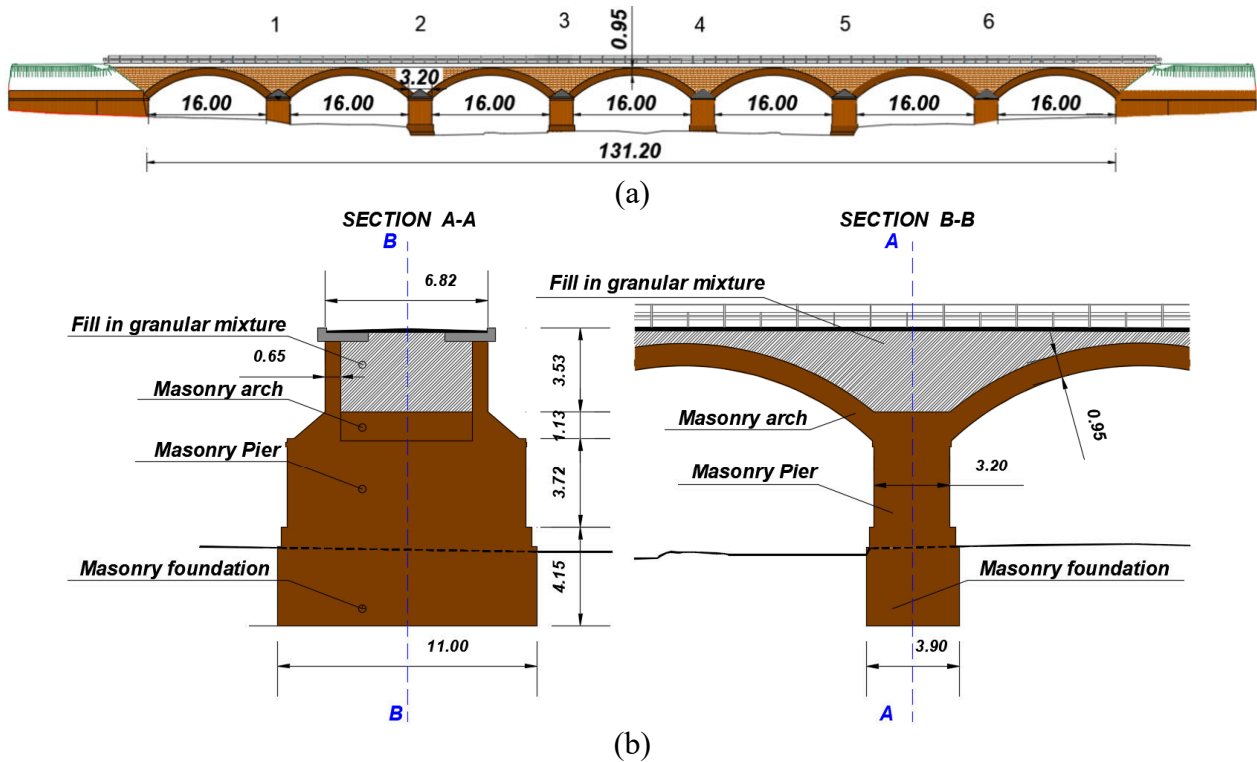
The bridge original length was 131.20 m, with spans of 16.00 m length. The piers are identical, with a plan size of 9.5 m x 3.2 m, excluding the extreme circular parts with a radius of 2.0 m along the transverse direction (Y direction). The arches have thickness of 0.95 m and a radius of 11.58 m. Spandrel walls have thickness of 0.65 m. The pier foundations have a rectangular plan shape of 11.00 m x 3.90 m and their height is 4.15 m. More details about the bridge geometry are given in Figure 4, showing a lateral longitudinal scheme of the bridge (Figure 4a) and two sections (Figure 4b), one transversal and one longitudinal.

Figure 4. Geometrical details of the Rubbianello bridge.

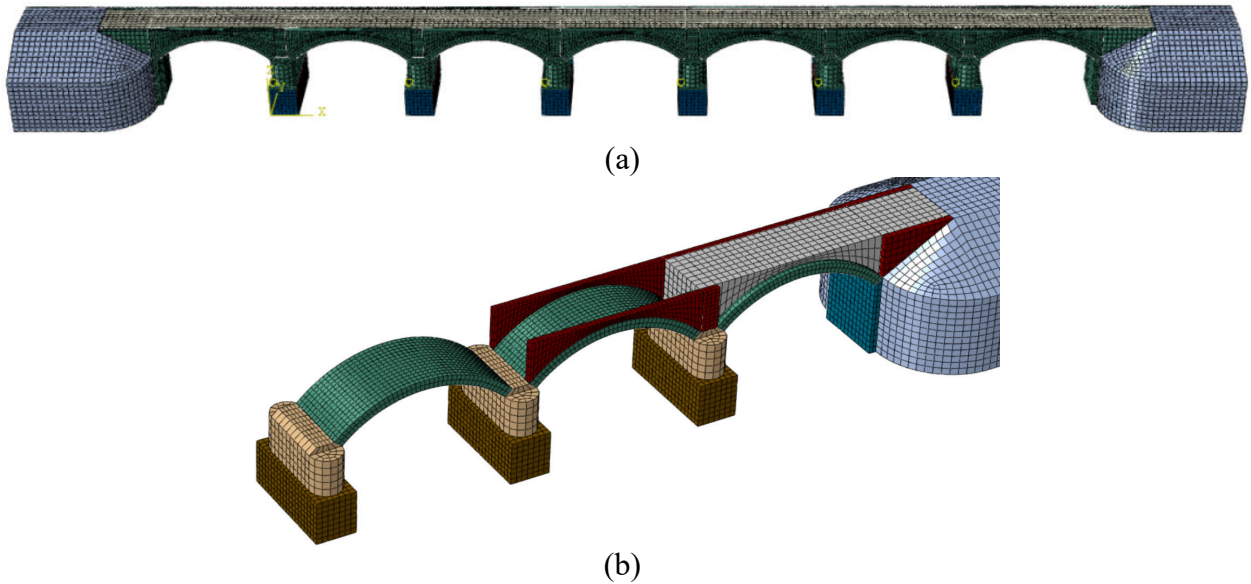
A 3D model is developed in ABAQUS 2017 (Figure 5), by accounting for both geometrical and mechanical nonlinearities. Details about the modelling issues are given in Subsection 3.1, while the model elastic parameters calibration is described in Subsection 3.2, where the numerical modal results are compared to those provided by the experimental tests based on OMA.

Figure 5. Finite element model: (a) whole bridge and (b) half bridge with material parts highlighted.

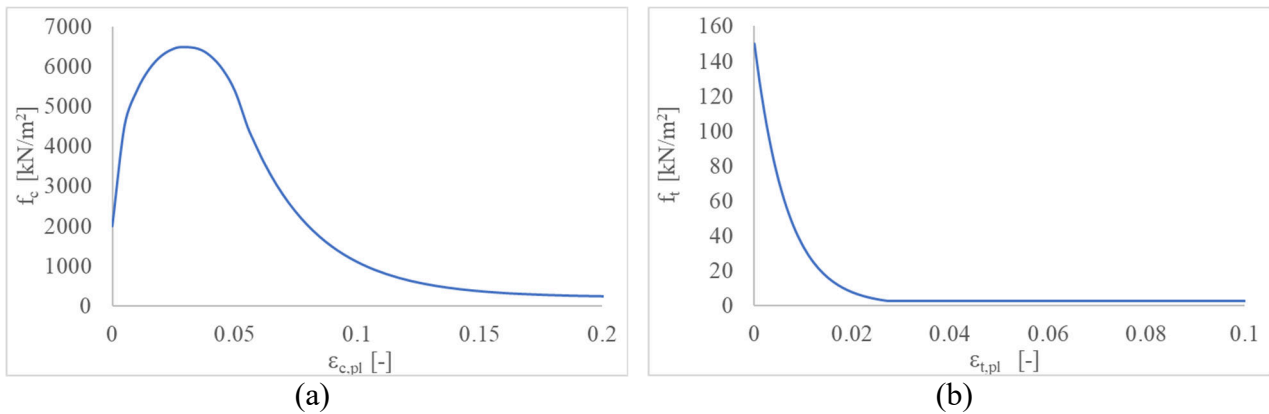
Different constitutive properties are used for the various constituent materials of the model. The behaviour of the masonry components in the linear elastic field is described by assigning the properties summarised in Table 1. The non-linear behaviour is described through the Concrete Damage Plasticity (CDP) model. This model, available in Abaqus Standard [17], is characterized by a non-associated flow rule, and is suitable for simulating the nonlinear, softening behaviour of quasi-brittle materials. The stress-strain under uniaxial tension is linear elastic until the peak cracking stress is attained, followed by a softening branch [10] due to propagation of micro-cracking within the material. The stress-strain under uniaxial compression is linear elastic until the yield stress is attained, followed by a nonlinear strain hardening branch until the ultimate compressive stress which is lastly followed by softening. The adopted masonry constitutive relationship in terms of stress-plastic strain in compression and tension are illustrated in Figure 6.

Figure 6. Stress-plastic strain relationship for masonry (a) in compression and (b) in tension.

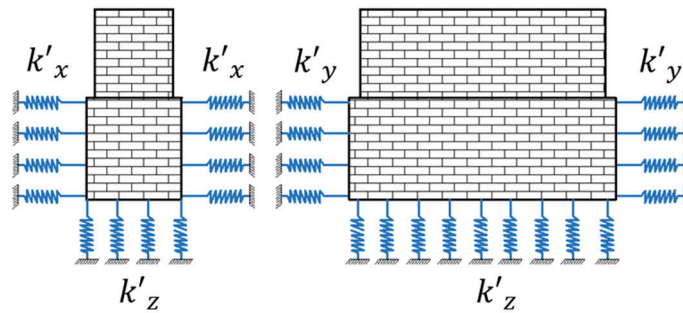
Similarly to Tubaldi et al. [3], a Winkler modelling approach is employed to describe the soil-foundation interaction, using zero-thickness cohesive elements surrounding the foundation. These cohesive elements have a zero tensile resistance and a linear elastic behaviour in compression. The relationship between the soil pressure and the corresponding settlement is described by the coefficient of reaction k , whose value depends on the footing size and can be estimated on the basis of plate load tests or through analytical expressions. Different impedances formulations are available in the scientific literature [18,19]; in this study, the expression developed by Gazetas [19] are used, furnishing the impedances k_x, k_y, k_z (unit kN/m) along the three directions x, y, z of a rigid embedded foundation as a function of its geometry and of the soil shear modulus G .

Figure 8. Impedances along the x, y, z directions

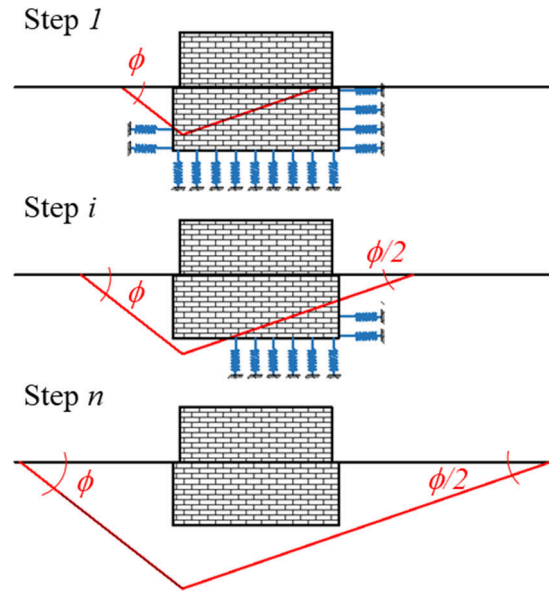
The scour progression is simulated numerically by performing a time-history analysis. At each time step, the level of the maximum scour depth is increased and the depth of the centroid of each cohesive element representing the foundation-soil interaction is compared with the depth of scour at the same location. If the element centroid is within the scour hole, then the element is deactivated. In this study, the simulation of the deepening of the scour hole is described by considering 8 discrete steps. Figure 9 illustrates the development of the scour hole at three different stages: at the early stages of the scour

developments, where the excavation involves only the vertical up-stream side of the foundation; a medium-advanced stage, where the soil under the pier has been partially removed; the last stage of the scour progression, where the pier is completely detached from the surrounding soil.

Figure 9. Scheme of scour progression modelling.

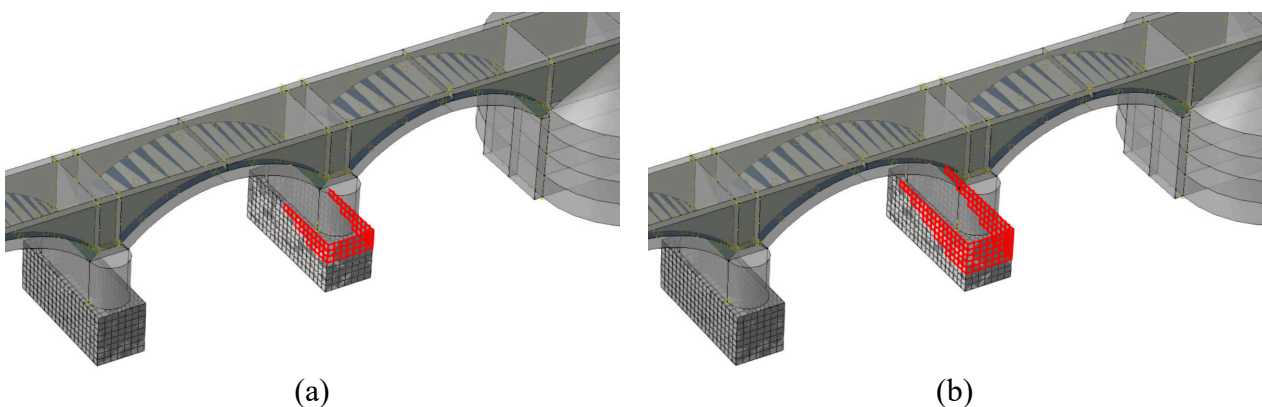
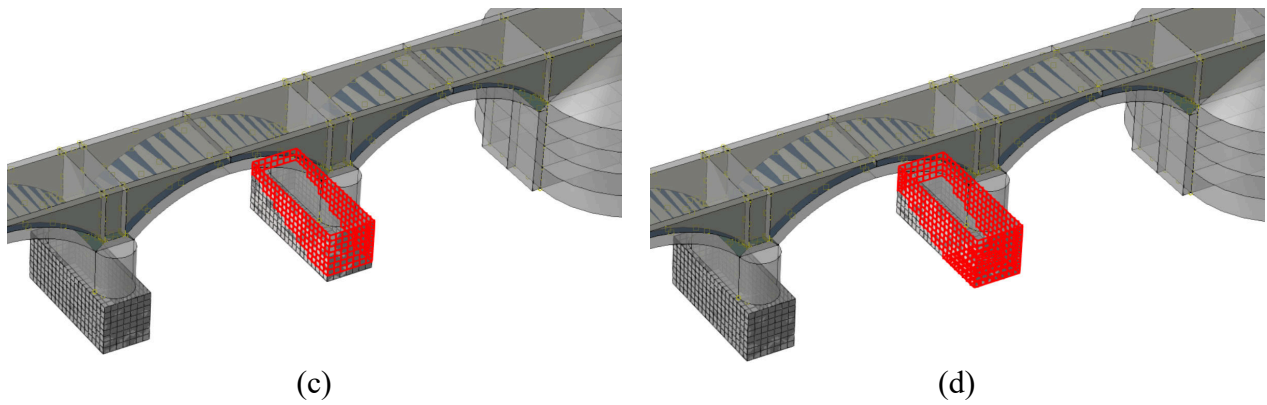
Step 0 corresponds to the starting condition, with gravity loads acting on the bridge (self-weight loads plus a uniform pressure of 6.6 kN/m^2 simulating the road pavement loads) and no scour. From Step 1 to Step 7, the scour development is simulated by considering increments of y_s equal to 1.0 m per step, for a total maximum scour depth of 7.0 m attained at Step 7, corresponding to an excavation of 3.0 m under the base of the pier's foundation (whose height is 4.15 m). For sake of clarity, highlighted in Figure 10 are the cohesive elements (modelling the impedances) that are deactivated at four consecutive steps of analysis: Step 2, with $y_s = 2.0 \text{ m}$ (Figure 10a); Step 4, with $y_s = 4.0 \text{ m}$ (Figure 10b); Step 5, with $y_s = 5.0 \text{ m}$ (Figure 10c); Step 6, with $y_s = 6.0 \text{ m}$ (Figure 10d).

Figure 10. Scour simulation by progressively deactivating pier's impedance elements.

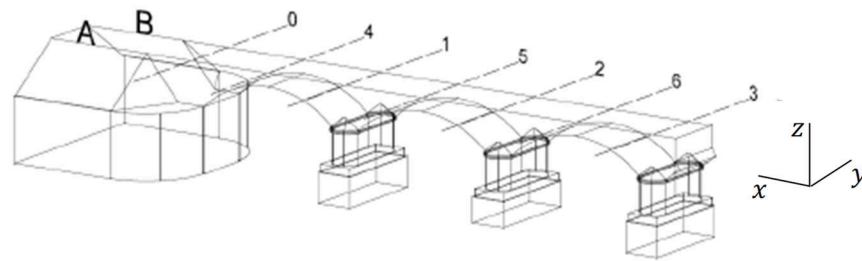
where each sensor is identified based on position and orientation (see Figure 11). For what concerns the longitudinal placement, the sensors positioned in correspondence of the piers are identified by numbers from 1 to 3 (ascending from the abutment), whilst sensors at middle span locations with numbers from 4 to 6. The sensors located in correspondence of the abutment are identified by the number 0. The labels A or B denote the transversal placement along the bridge deck. Finally, suffix X, Y or Z identify the sensor orientation, according to the reference system of Figure 11. Sensors 2AY, 2AZ and 2BZ were kept fixed in their position throughout the whole experimental campaign to

Figure 11. Scheme of sensor location.

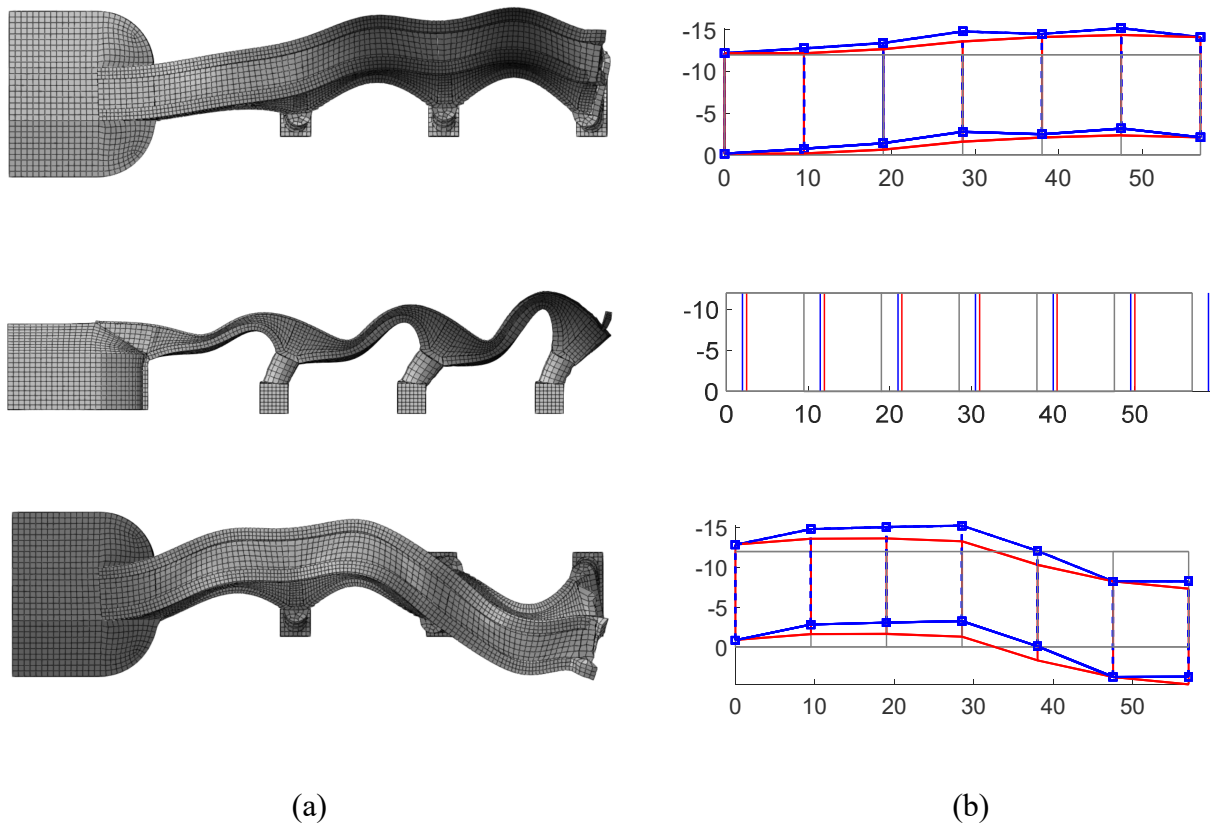
Table 4 reports and compares the frequencies of the first three modes of vibration obtained via OMA and by using the numerical model of the three-span bridge developed in Abaqus [17], with the elastic properties summarised in Table 1. It can be observed that the numerical results are in good agreement with the OMA results. The maximum normalized deviation between measured and numerical frequencies is less than 5%. The match in terms of mode shapes is also satisfactory, as it can be seen in Figure 12. Specifically, a 3D view of the numerical mode shapes is provided in Figure 12a, while a comparison between numerical (blue lines) and experimental (red lines) mode shapes is given in Figure 12b by using a plan view from the top.

Figure 12. (a) 3D view of numerical mode shapes and (b) comparison between numerical (blue) and experimental (red) mode shapes.

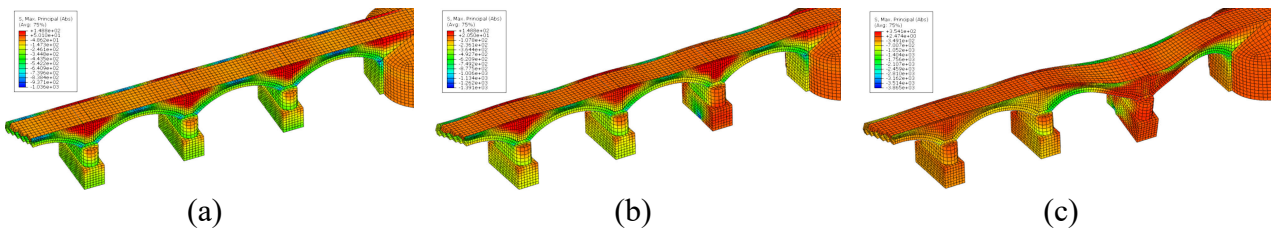
Figure 13 shows the evolution of the Von Mises stresses (colours from blue to red identifies the transition from compression to tension states) at different stages of scour development. An almost symmetric stress distribution is observed (Figure 13a) on all spans and piers up to scour depths lower

than the foundation depth (4.15 m). High tensile stress values, with peaks around 150 kN/m^2 , are observed in the spandrel walls above the piers. At the end of Step 5, i.e., when y_s attains the value of 5.0 m, stresses start concentrating on the pier 6, which also begins rotating (as shown in Figure 13b, with displacements amplified by scale factor 100). Finally, for $y_s > 5.0 \text{ m}$, the stress concentration on the arches and spandrels adjacent to pier n. 6 becomes very significant, together with the rocking effect (as shown in Figure 13c, with displacements amplified by a scale factor of 60).

Figure 13. Von Mises stresses evolution at different stages of scour development: (a) $y_s < 4.0 \text{ m}$; (b) $y_s = 5.0 \text{ m}$; (c) $y_s > 5.0 \text{ m}$. Colours from blue to red correspond to stress values from -1000 kN/m^2 (compression) to $+150 \text{ kN/m}^2$ (tension).

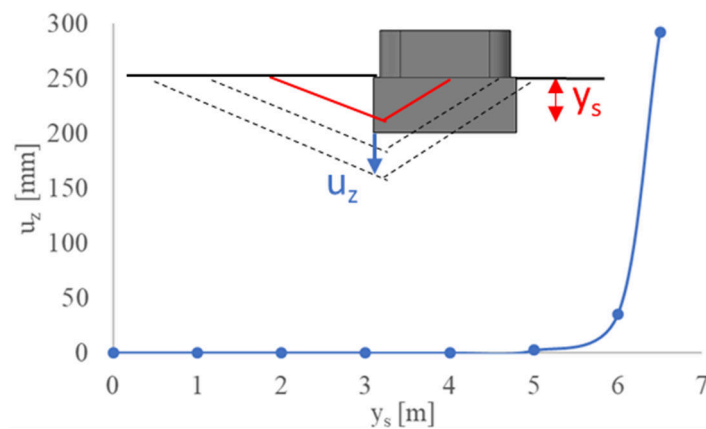
Figure 14 illustrates the relation between the pier's vertical settlement u_z (measured under the upstream side of the foundation) and the scour depth y_s . It is observed how the effects of scour are negligible for depths of scour less than the foundation depth of 4.15 m (Steps 0-4). The vertical settlement notably increases for higher depths of scour such that the soil below the foundation is undermined. According to Figure 14, the value $y_s = 5.5 \text{ m}$ identifies the limit beyond which small increments of the scour depth induce very high damage on the structure, and therefore this value can be assumed as the maximum scour depth at incipient collapse.

Figure 14. Plot of $u_z - y_s$ response for pier n. 6.

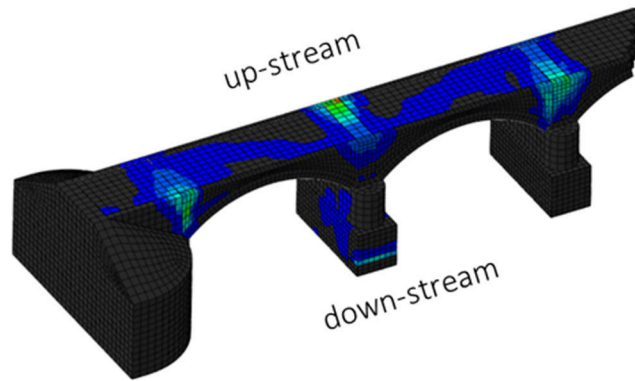
Figure 15 shows the Von-Mises plastic strain (ε_{pl}) distribution on the bridge before the end of Step 6, i.e., for y_s between 5 and 6 m. In the figure, the blue and green colour correspond to ε_{pl} values of the order of 10^{-4} to 10^{-3} . This result suggests that the failure occurs at the two sides of the spans, in correspondence of the connection with the abutment on the one side and with the pier on the other side.

Figure 15. Plastic strain distribution for y_s between 5.0 and 6.0 m. Colours from blue to green correspond to ε_{pl} values from 10^{-4} to 10^{-3} .

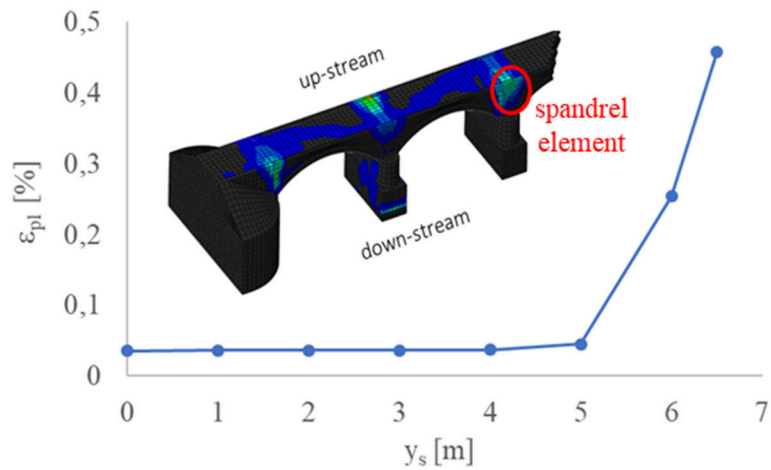
For sake of completeness, the plastic strain ε_{pl} developed on the spandrel wall at the location with maximum tensional demand (i.e., above the pier on the down-stream side, as highlighted in Figure 16 by a red circle) is plotted in Figure 16 as a function of the scour depth y_s . The concentration of stresses with values comparable to the masonry tensile strength (150 kN/m^2) leads to some very small values of ε_{pl} (lower than 10^{-5}) identified before the scour initiation (i.e., for $y_s = 0.0 \text{ m}$). These ε_{pl} values remain constant until the scour depth is lower than 4.15 m, then a sudden rise in plastic strains is observed for small increments of the scour, according to a trend very similar with the one noted before (Figure 15) for the pier's vertical settlement u_z .

Figure 16. Spandrel plastic strain (down-stream side, above Pier) as a function of the scour depth. For what concerns the arches, it can be observed (Figure 17) that the scour depth $y_s = 5.50$ m induces the formation of diagonal cracks located in proximity of the pier n. 6. It is worth noting how both the shape and location of such cracks under the arch barrels are similar to those observed in the work [3], concerning a different masonry arch bridge.

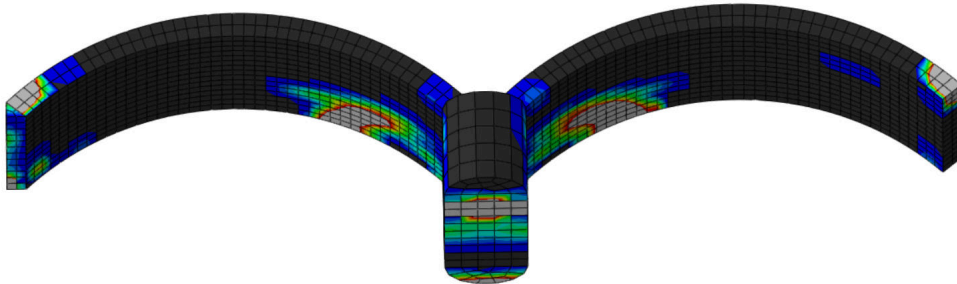
Figure 17. Onset of diagonal crack (plastic strain plot) under the arch barrels for $y_s = 5.50$ m (downstream view). Colours from blue to red correspond to ε_{pl} from 10^{-4} to 10^{-2} ; grey colour identifies $\varepsilon_{pl} > 10^{-2}$.

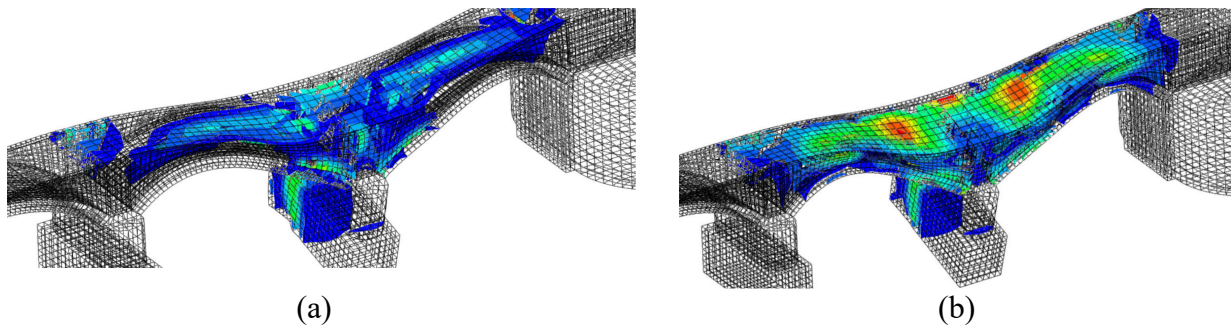
For values of y_s higher than 5.50 m, the damage propagation is very fast and the extent of plastic deformations is significant. For instance, Figure 18a shows the diffusion of plastic strains inside the bridge (involving backfill, spandrel walls and arches) for $y_s = 6.00$ m (Figure 18a) and $y_s = 6.50$ m (Figure 18b).

Figure 18. Plastic strain distribution inside the bridge for: (a) $y_s = 6.00$ m and (b) $y_s = 6.50$ m. Colours from blue to red correspond to ε_{pl} values from 10^{-4} to 10^{-1} .
