# Precast concrete terraces under static, incremental loading - a laboratory investigation

Hughes, B.P. and Karadelis, J.N.

# PRECAST CONCRETE TERRACES UNDER STATIC, INCREMENTAL LOADING. \_A Laboratory Investigation.

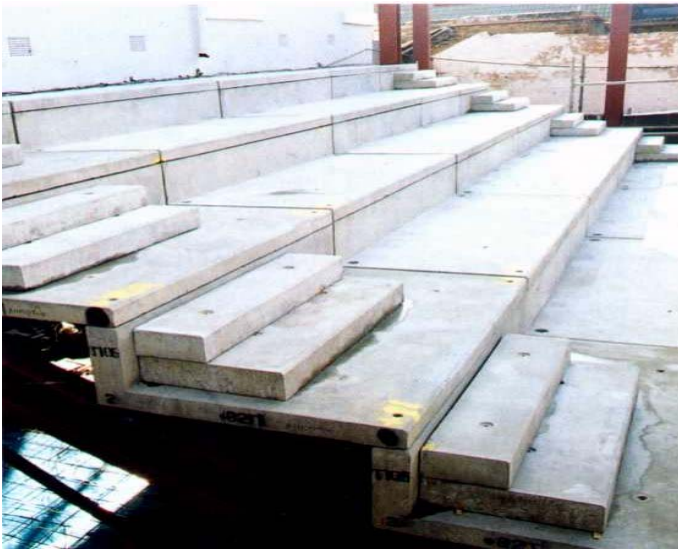
Figure 1 Precast concrete terraces.

The most common construction of sports stadia today is that of a hybrid type where precast concrete terrace units span between inclined (raker) steel beams and rest on each other, thus forming a grandstand (Figure: 1). Accurate analysis and design of these units (elements) as well as the grandstand as a whole requires a good understanding of their behaviour and performance under loading. Optimisation of their structural sections and improving economy, safety and comfort in use, is an

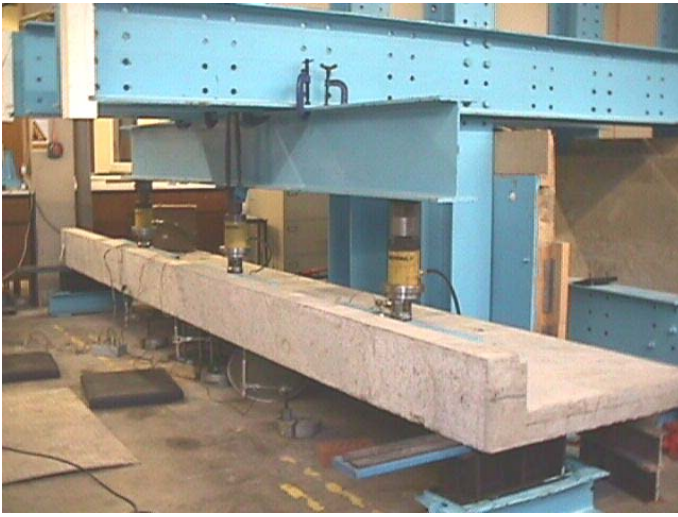
Figure 2. A precast concrete terrace unit in the laboratory.

The L-section terrace units were designed, manufactured and transported to University by BISON Ltd. Due to limited space in the laboratory the smallest actual size units were ordered. They were approximately 5 metres long, encompassing a 700 x 100 mm thick horizontal member (slab) and 150 x 275 mm upstand (Figure 2). Their properties were as follows:

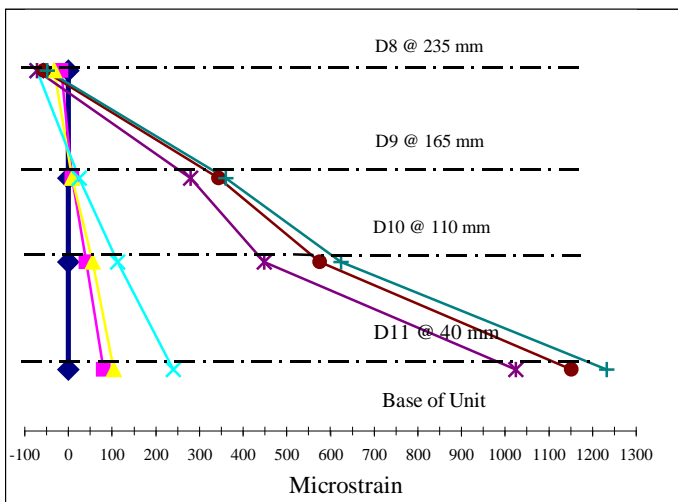
Figures 4 & 5 show the distribution of strain per load increment for an initially uncracked (Test 1) and a cracked (Test 2), section respectively. This strain was measured across the vertical symmetry line and at four different levels (D11= 40 mm, D10= 110 mm, D9= 165 mm and D8= 235 mm) above the soffit of the beam.

Figure 4. Terrace unit 1. Test 1. Strain distribution per load increment, across the depth of the beam.

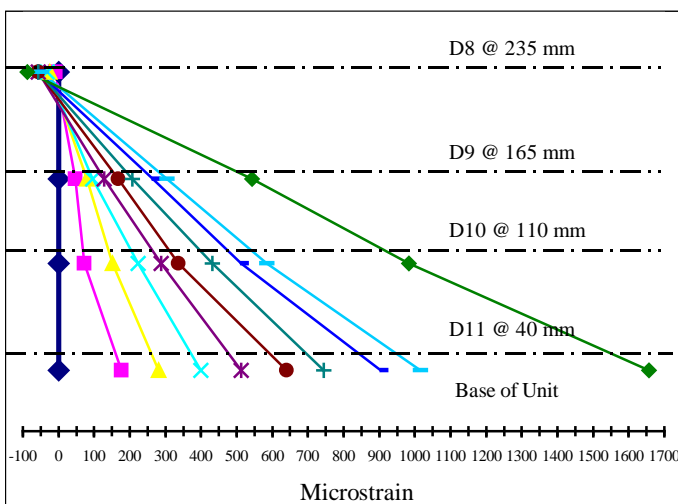
Figure 5. Terrace unit 1. Test 2. Strain distribution per load increment, across the depth of the beam.

The strain diagram in Figure 5 shows perfectly linear behaviour up to and including the load increment of 30 kN. That is, the applied loads are resisted by both concrete and reinforcement. Tension is gradually transferred to the reinforcement as the first cracks at the bottom of the unit appear, characterised by a non-linear distribution of strain for load increments of 48, 60 and 72 kN. Equilibrium of the section is maintained by a gradual movement upwards of the Neutral Axis; that is, by reducing the area of section in compression. Figure 5 presents a similar account; this time the strain was distributed more smoothly. Once the cracks are developed, no sudden changes of strain are present during reloading. As cracks open wider following the load increments, strain readings reach higher values causing the steel reinforcement to undergo local yielding.

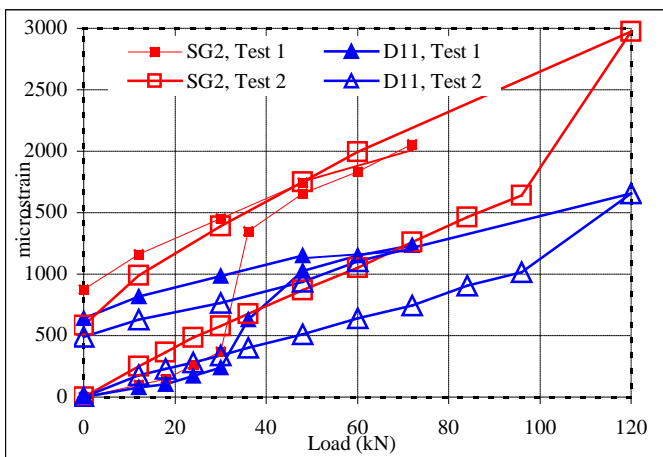
Figure 9 shows a comparison between strains measured by strain gauge SG2, attached to the tension reinforcement of the beam and demec points D11, attached 40 mm above the bottom of the same beam. That is, both SG2 and D11 were at approximately the same level from the soffit of the beam. Initially, and up to the load of 18 kN, both strains showed good correlation, becoming reasonably good up to 30 kN. However, beyond the 30 kN load, SG2 produced considerably higher strain values than D11, although both strain paths were remarkably similar. This indicated that strain resisted by the reinforcement was higher. Maximum values of strain were recorded for the final load of 72 kN and were 2100  $\mu\text{s}$  and 1200  $\mu\text{s}$  for SG2 and D11 respectively.

Figure 9. Terrace unit 1. Tests 1 & 2. Comparison between strains @ SG2 & D11

These can be turned into stress values assuming Moduli of Elasticity,  $E_{\text{steel}} = 200 \text{ N/mm}^2$  and (uncracked)  $E_{\text{concrete}} = 35 \text{ N/mm}^2$ . Therefore, for SG2, strain = 2100  $\mu\text{s}$  and stress = 420  $\text{Nmm}^{-2}$  and for D11, strain = 1200  $\mu\text{s}$ , stress = 42  $\text{Nmm}^{-2}$  respectively.

The unloading procedure was carried out without surprises giving residual strain values of 880  $\mu\text{s}$  and 640  $\mu\text{s}$  for SG2 and D11 respectively.

The behaviour of both curves for the fully cracked unit (Test 2) up to the load of 96 kN were smoother and more linear compared with that of the uncracked unit. Although both strain paths are similar, SG2 produced higher strain values for reasons already explained above. Maximum strain was reached at 120 kN with magnitudes equal to 3000  $\mu\text{s}$  (600  $\text{Nmm}^{-2}$ ) and 1650  $\mu\text{s}$  (57.75  $\text{Nmm}^{-2}$ ) for SG2 and D11. Both stress values were well beyond the yield stress values of the materials. Finally, unloading produced residual strains of 600  $\mu\text{s}$  and 500  $\mu\text{s}$  for SG2 and D11 respectively.
