# Corrosion durability of high performance steel fibre reinforced concrete

Sadeghi-Pouya, H. , Ganjian, E. , Claisse, P.A. and Muthuramalingam, K. (2013) 'Corrosion durability of high performance steel fibre reinforced concrete' in Proceedings of the third international conference on sustainable construction materials and technologies (paper no. 420). Coventry University and The University of Wisconsin Milwaukee Centre for By-products Utilization.

## **Corrosion durability of high performance steel fibre reinforced concrete**

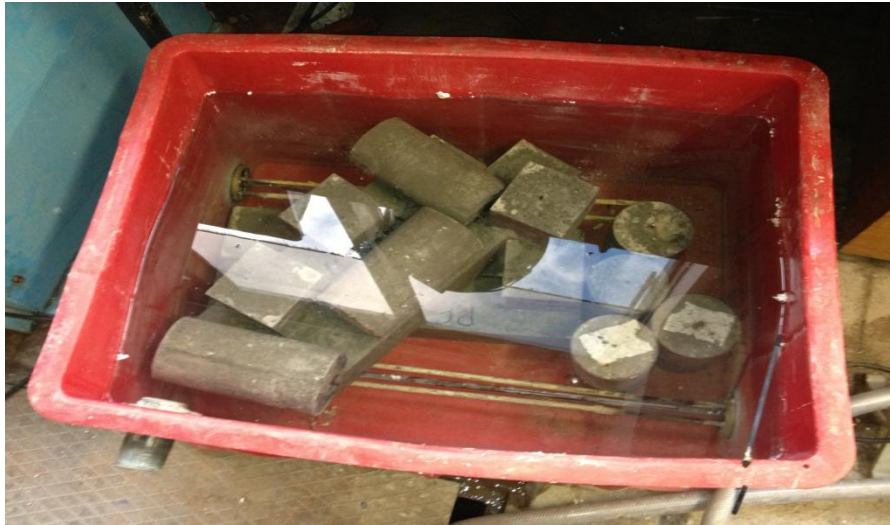
**Figure 1. Hot curing of concrete specimens**

Mixing and casting of concrete was carried out in accordance with the current British Standard BS 1881-125 (1986). Fibres were the final material to be added to the fresh concrete and mixing continued for 4 minutes to ensure dispersion of the fibres throughout the concrete. A mixed metal oxide coated titanium rod was placed in each specimen as part of preparation for accelerated corrosion test. On demoulding at 24 hours, all concrete specimens were cured in hot water curing conditions for 7 days ( $50^{\circ}\text{C} \pm 2^{\circ}\text{C}$ ) and then transferred to corrosion tank containing 3% chloride salt solution.

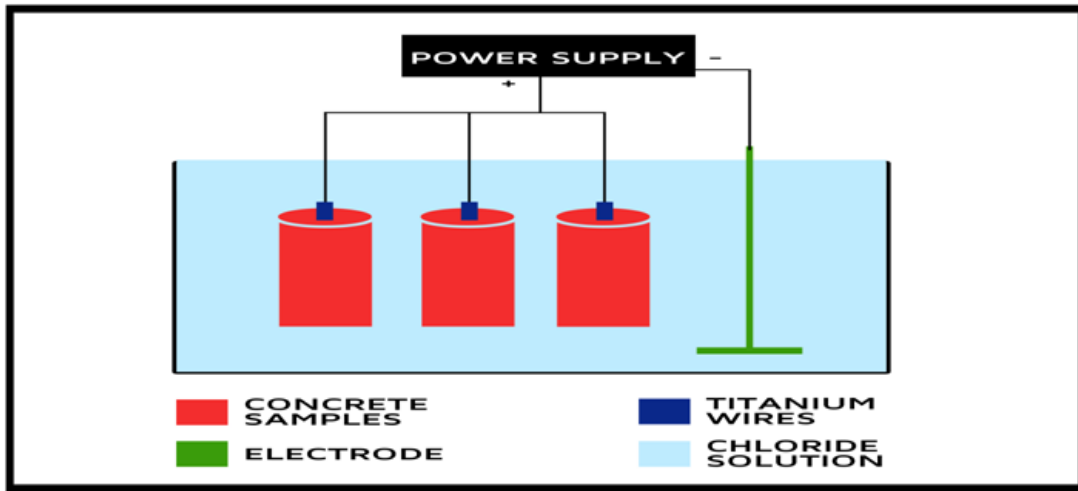
**Figure 2. Schematic diagram of the accelerated corrosion test used**

All specimens were placed in the tank containing salt solution and connected to the positive end of the power supply at titanium rods using copper core cables. The negative connection of the circuit was provided using a piece of bare steel electrode partly submerged in the solution. Figures 2 and 3 show the accelerated corrosion test setup. A constant 3A current was passed through the solution and specimens for 1 month. This is equivalent to approximately 50-60 years life of a typical bridge exposed de-icing salts. In this arrangement steel fibres acted as a consuming anode to maintain the current flow through the concrete

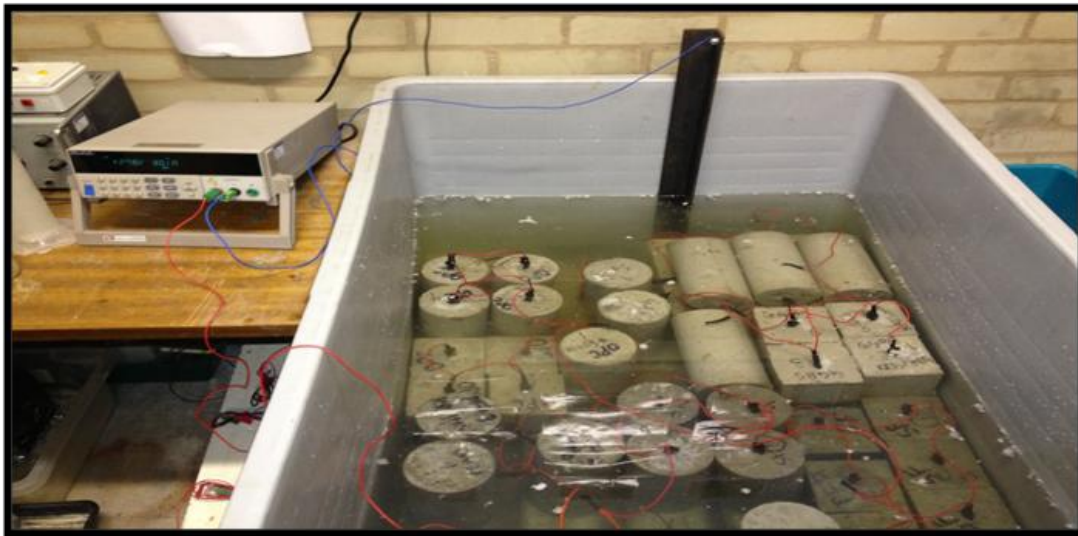
**Figure 3. Corrosion tank used for accelerated corrosion test**

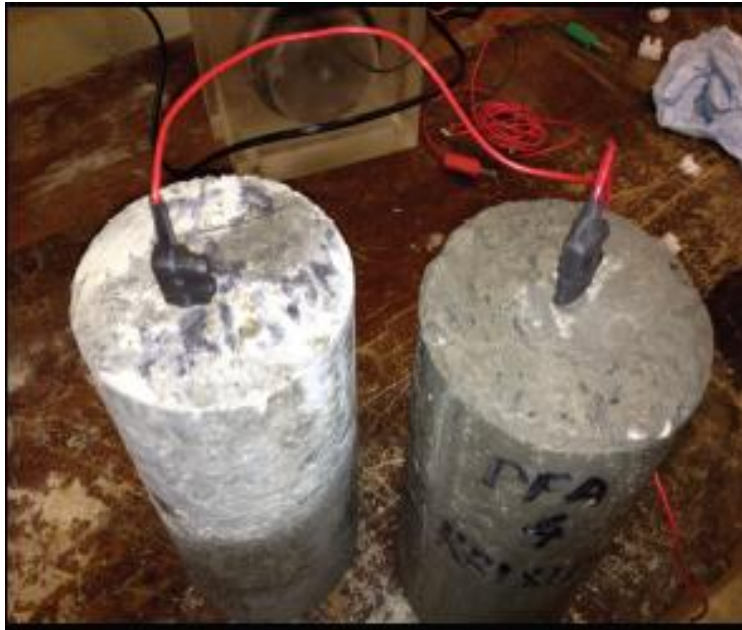
**Figure 4. Concrete specimens before accelerated corrosion test**

Concrete specimen were examined after 1 month exposure to the accelerate corrosion condition. Expect surface corrosion and a few microcracks in the control OPC sample no sign of significant corrosion or spalling was observed. Figures 4 and 5 shows the state of specimens before and after accelerated corrosion test. It was found that steel fibres were less susceptible to corrosion. This is likely to be due to discontinuity of steel fibres in the mix or small surface of fibres.

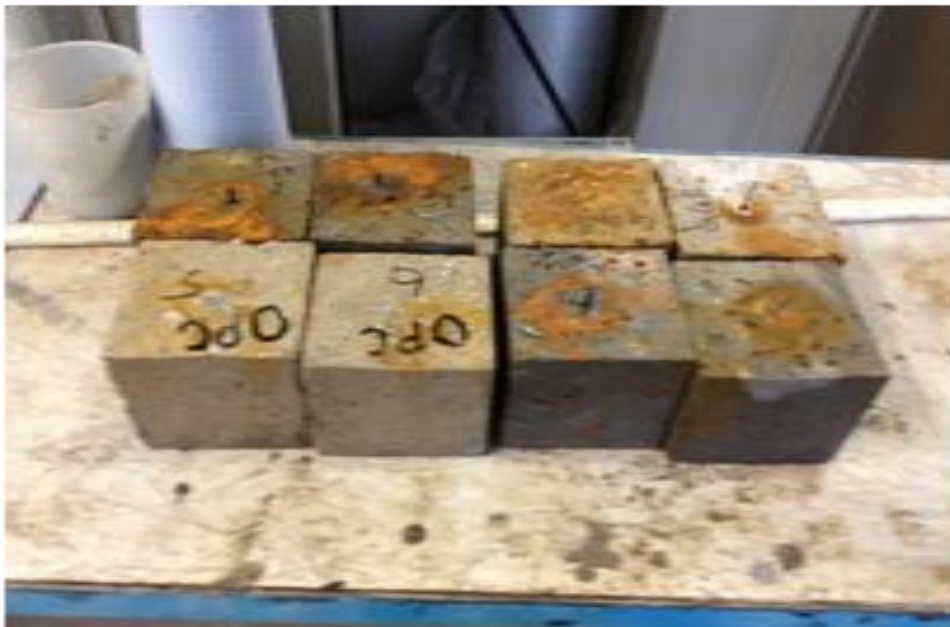
**Figure 5. Concrete specimens after accelerated corrosion test**

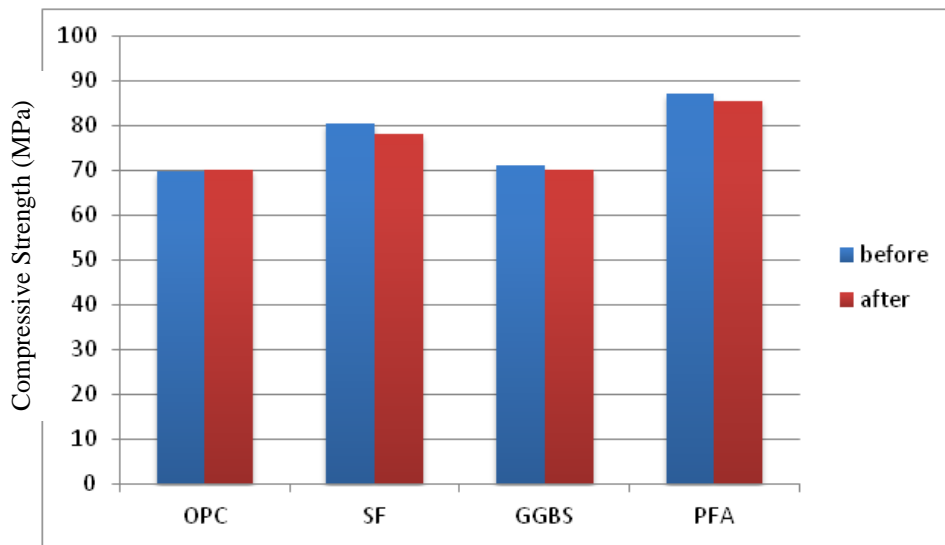
**Figure 6. Comparison of compressive strength before and after accelerated corrosion**

Figures 6-9 show mechanical properties of specimens before and after corrosion. It can be seen that specimens did not suffer from any significant strength or stiffness loss.

The data show that indirect tensile strength of specimens containing cement replacement materials increased marginally during accelerated corrosion test. This is in line with expected high performance of these mixes. The flexural strength and stiffness of the concretes tested thus far was consistent and correlated with the compressive strength data. In general results indicated that steel fibre concrete specimens were not significantly affected by corrosion except minor surface rust stain.

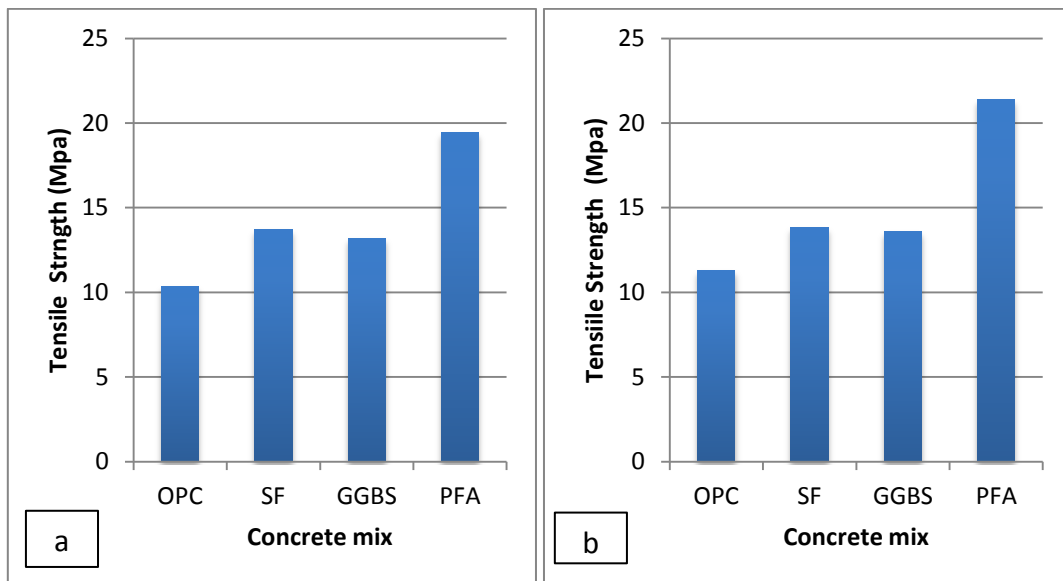
**Figure 7. Comparison of indirect tensile strength a) before and b) after accelerated corrosion**

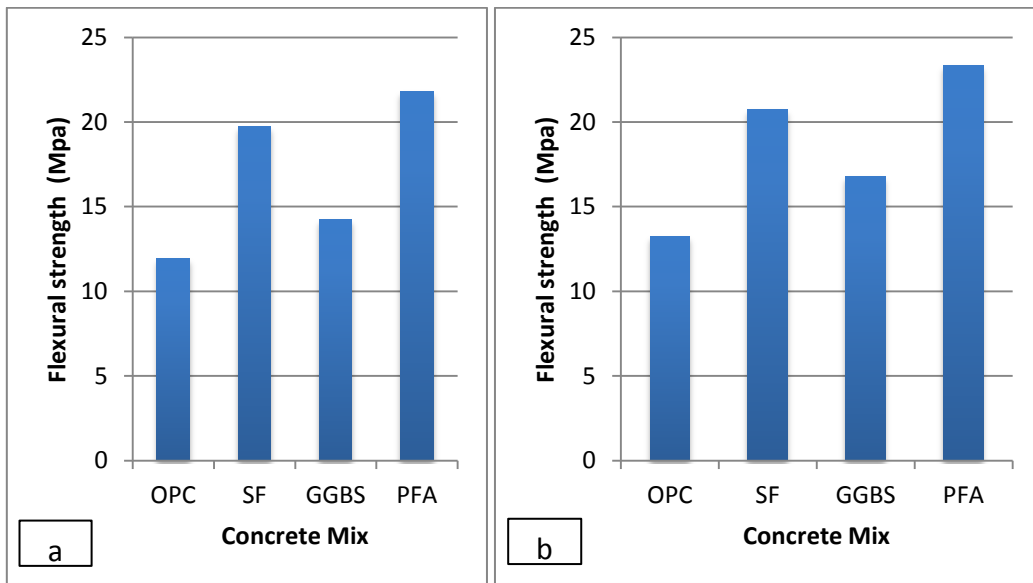
**Figure 8. Comparison of flexural strength a) before and b) after accelerated corrosion**

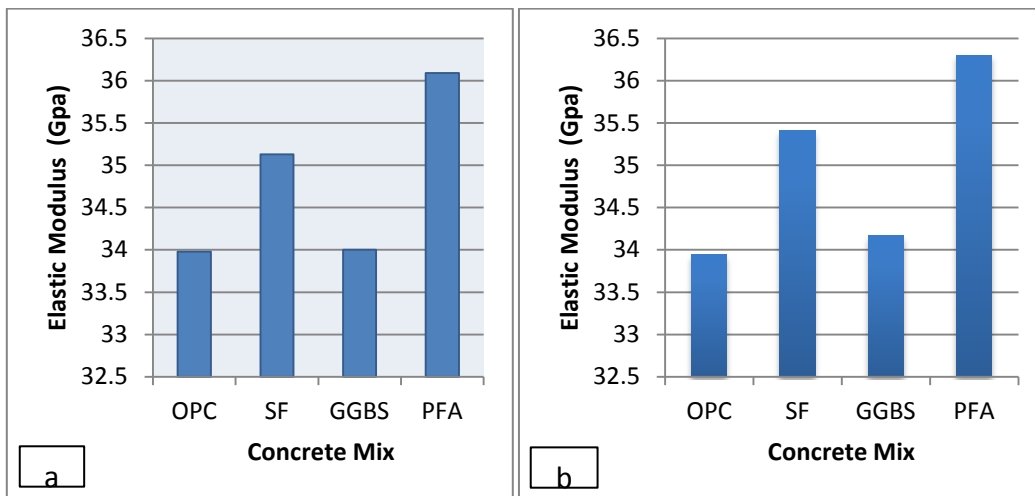
**Figure 9. Comparison of elastic modulus a) before and b) after accelerated corrosion**
