# Effect of impact damage on fatigue performance of structures reinforced with GLARE bonded crack retarders

Abdul Khadar Syed, Michael E Fitzpatrick, James E Moffatt, Jeremy Doucet, Isidro Durazo-Cardenas

To appear in: *International Journal of Fatigue*

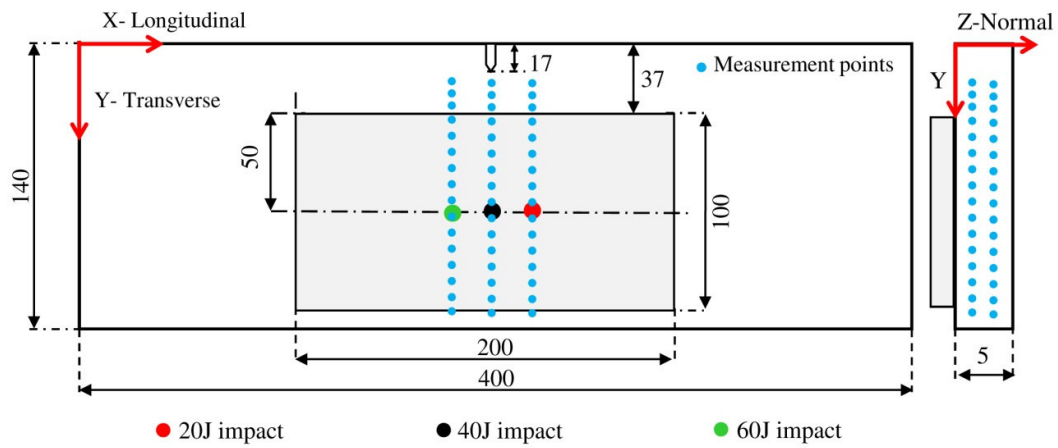
Figure 1. Geometrical details of the SEN(T) specimens

Single-edge-notched tension (SEN(T)) substrate specimens were prepared with dimensions  $400 \times 140 \times 5 \text{ mm}^3$ . A notch of 17 mm was introduced in the SEN(T) specimens before bonding the strap. The substrate thickness is indicative of that in wing cover applications. GLARE 2A-6/5 was chosen as the crack retarder strap, which consists of six layers of aluminium alloy sheets (0.4 mm thick) and five double layers (0.26 mm thick) of unidirectional glass fibre-reinforced epoxy oriented along the longitudinal direction of the strap. The mechanical properties for GLARE 2 (6/5) are tensile modulus ( $E_1$ ) = 64.1 GPa, ultimate tensile strength ( $\sigma_{ts1}$ ) = 1091 MPa and tensile yield stress ( $\sigma_{y1}$ ) = 331 MPa and, compressive yield strength ( $\sigma_{cs1}$ ) = 366.4 MPa. The dimensions of the strap were  $200 \times 100 \times 3.7 \text{ mm}^3$ . The GLARE strap configuration was chosen to give the desired stiffness ratio in the test coupons [18]. The front edge of the strap was placed at 37 mm from the edge of the specimen and thus the distance between the front edge of the strap and the crack tip was 20 mm. The design of the specimens was chosen to optimize the current study for unambiguous identification of the effects of the impact damage on residual stresses in the substrate and fatigue performance of the bonded crack retarders. The assembly was bonded using FM94<sup>®</sup> adhesive supplied by Cytec Ltd. Prior to bonding, the surface of the substrate and the external aluminium sheets of GLARE were etched with Phosphoric Acid Anodizing (PAA) which involves alkaline degreasing followed by PAA and priming with BR 127, a modified epoxy phenolic primer with corrosion inhibiting properties [19, 20]. Table 1 shows the mechanical properties of Al substrate, FM94 and GLARE constituents used in this investigation. Figure 1 shows the geometrical details of the SEN(T) coupon specimens and impact damage residual stress measurement locations.

After cure the specimens were inspected using an ultrasonic phased array to confirm the bond quality. The direction along the longest dimension is hereafter referred to as the longitudinal direction (X), the direction along the width dimension is referred to as the transverse direction (Y), and the distance through the thickness is referred to as the normal direction (Z) as shown in figure 1.

Measurements were carried out along the crack growth direction (Y-direction) from the notch tip, as shown in figure 1. Strains were measured in the three assumed principal directions: longitudinal, transverse, and normal. Measurements were performed in two

specimens, one without impact damage to quantify the residual stresses developed during the bonding process. The second specimen was impacted in three different locations (figure 1), on the GLARE with three different energies of 20 J, 40 J, and 60 J to investigate the change in the stresses owing to impact damage. The three impacts were made on a single specimen, with wide separation between them, in order to facilitate the subsequent residual stress measurements. The centre of the impact location was 90 mm from the edge of the specimen for both 20 J and 40 J impacts, and 86 mm for the 60 J impact. The slight variation in the impact location is a result of positioning difference of the specimen during impact. All residual stress measurements, except for the 20 J impact, were performed at two different thickness locations, at  $z = 1.5$  and  $3.5$  mm from the reinforced side in the aluminium plate. Owing to time constraints the region impacted with 20 J was measured only at  $z = 1.5$  mm.

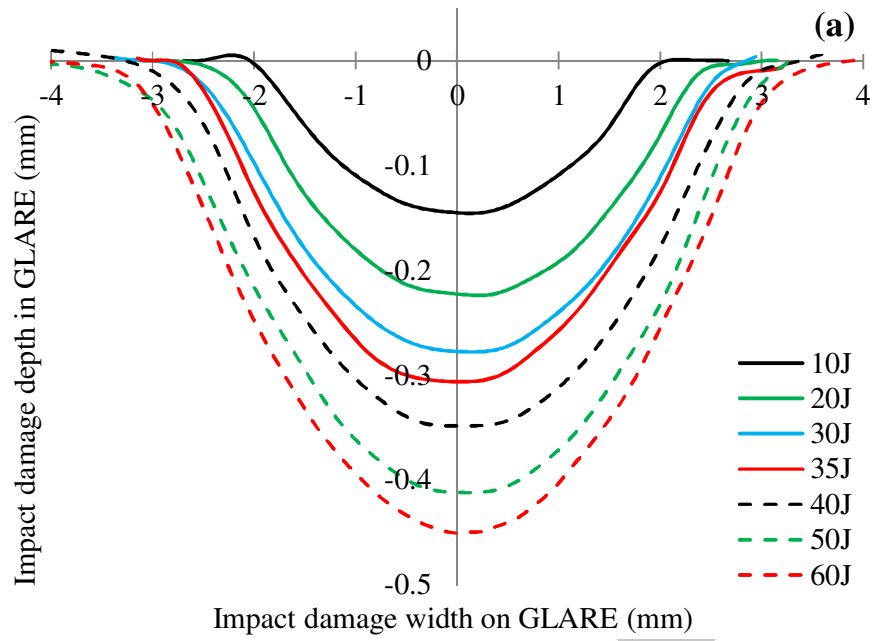
Figure 3. (a) Impact damage profiles determined by laser co-ordinate measurement (b)

Impact damage morphology of the specimen impacted with 50 J

The impact resulted in visible damage on the GLARE strap in the form of plastic deformation. Figure 2 shows optical images of the impact damage on the GLARE and figure 3 shows results of laser co-ordinate measurement on the GLARE strap impacted with different impact energies ranging from 10 J to 60 J, and the impact damage morphology of a specimen impacted with 50 J. Table 2 summarizes the depth and width of damage resulting from the impacts on the GLARE.

After impact damage analysis, fatigue tests on specimens with approximately 0.3 mm damage depth were conducted, representing the barely visible impact damage (BVID) scenario, which may be caused by tool drop. Figure 3b shows an example of the three dimensional impact damage morphology measurements performed by laser co-ordinate measurement on the specimen impacted with 50 J. For easy visualisation, a two dimensional impact damage line profile at the maximum impact damage depth was extracted from each impact and is shown in figure 3a. From table 2 and figure 3 an impact energy of 35 J, which produces 0.3 mm depth of damage on the GLARE, was selected as giving the required level of damage for fatigue testing. Three SEN(T) specimens (as shown in figure 1) were prepared and impacted at 35 J on the GLARE. In addition, two further

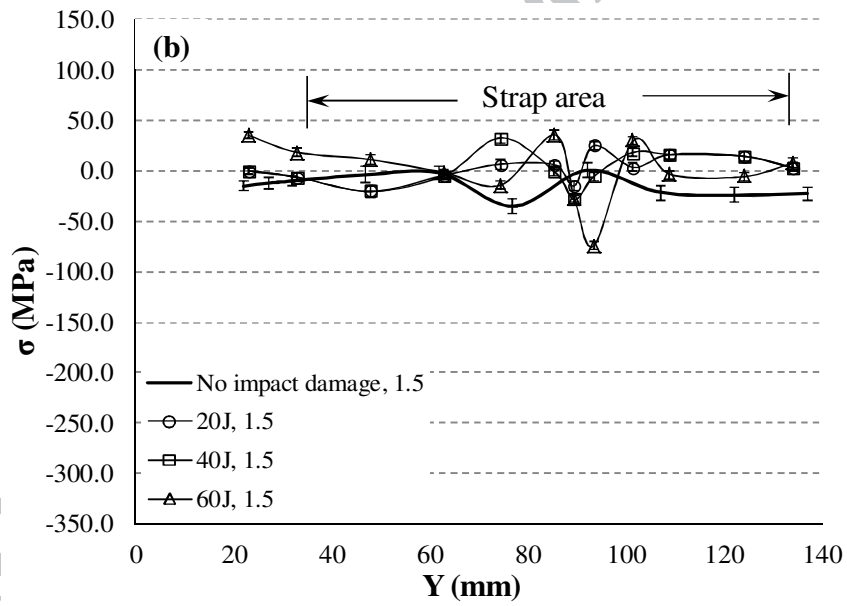
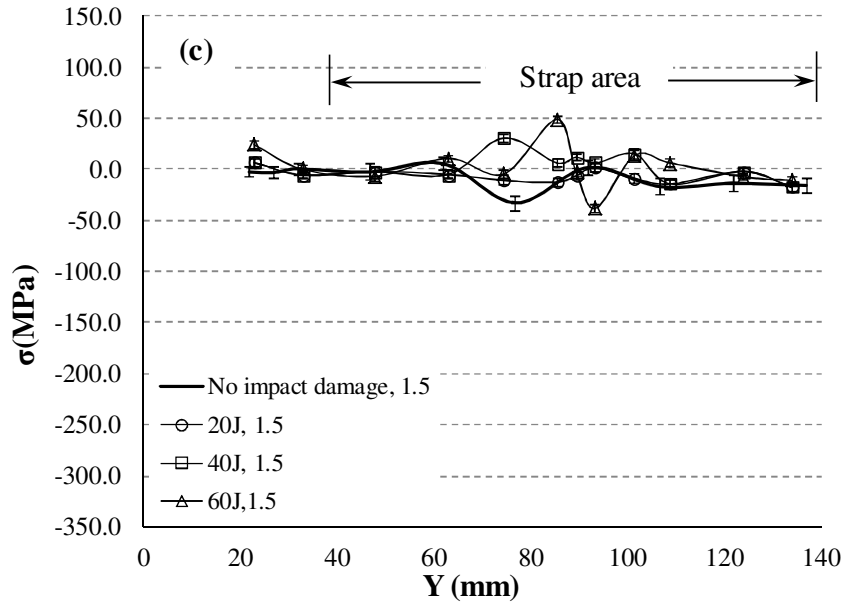
Figure 4. Residual stress in the aluminium plate at  $z = 1.5$  mm from the reinforced side before and after impact damage (a) Longitudinal (b) Transverse and (c) Normal component of stress

High temperature adhesive curing results in the development of thermal residual stresses, and specimen distortion arises owing to the asymmetric configuration with a strap on one side of the specimen only. The effects of impact on the residual stresses are of particular interest. Measurements were carried along the crack growth direction (Y-direction) from the notch tip. Data from a point well outside of the bonded area close to an edge were obtained in all three principal directions and were used to provide the stress-free values required in the computation of residual stresses. Figure 4 shows residual stresses in the aluminium plate at  $z = 1.5$  mm distance from the strap side.

From figure 4 it can be seen that in the specimen without impact damage the thermal residual stresses developed during the strap bonding process are relatively low. Also the measurements remote from the impact location in the impacted specimens show low stresses: the apparent variation in the stresses remote from the impact locations may not be real since the magnitude of the measured stresses are very low and approach the sensitivity of the technique. Also, the hydrogen-containing adhesive present in the assembly causes incoherent scattering of the neutrons which impairs the signal-to-noise ratio. There is also likely to be more inherent scatter in the data from the SALSA instrument, where only a single diffraction peak is used which will be sensitive to changes in texture through the plate thickness. This is not the case for the measurements performed at POLDI, where Pawley refinement of many diffraction peaks was used which effectively removes any texture effects.

Measurements performed at  $z = 1.5$  mm show low stresses compared to measurements at  $z = 3.5$  mm in both longitudinal and transverse directions. Stresses in the normal direction are always lower than the stresses in the longitudinal and transverse directions.

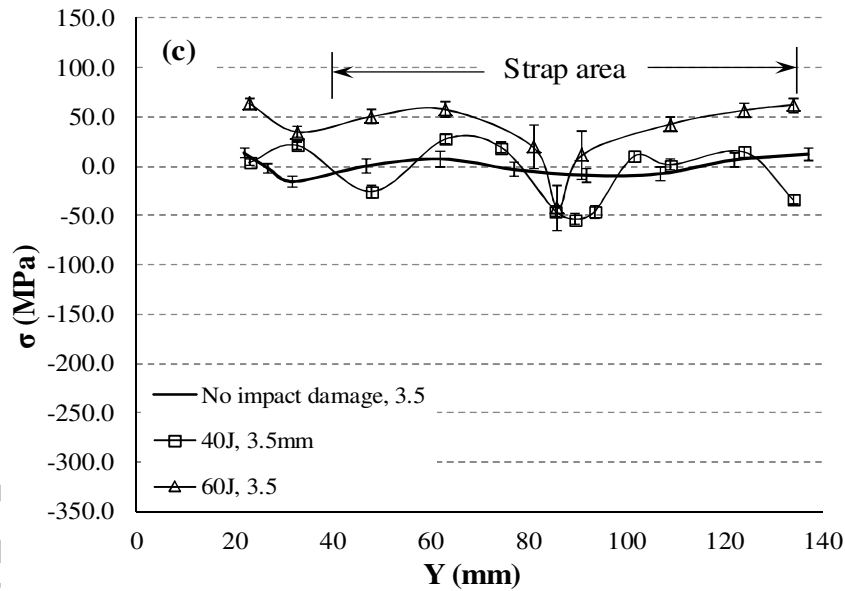
Figure 5. Residual stress in the aluminium plate at  $z=3.5\text{mm}$  from the reinforced side before and after impact damage (a) Longitudinal (b) Transverse and (c) Normal component of stress

Measurements performed at  $z = 3.5$  mm in the substrate are shown in figure 5 (owing to time constraints it was not possible to measure the specimen impacted with 20 J at this location). The results show a large variation in the stresses at and around the impact area compared to the specimen without impact damage. The impact damage at this depth shows the development of high compressive stresses in the longitudinal and transverse directions and low compressive stresses in the normal direction. The low compressive stresses in the normal direction are a result of the specimen not being constrained in this direction and owing to Poisson's contraction in this direction.

The specimen without impact damage shows very low stresses through the thickness which are almost constant along the width of the specimen. There is significant variation in the stresses developed owing to impact at different energies. Compressive residual stresses developed during impact increase with an increase in impact energy.

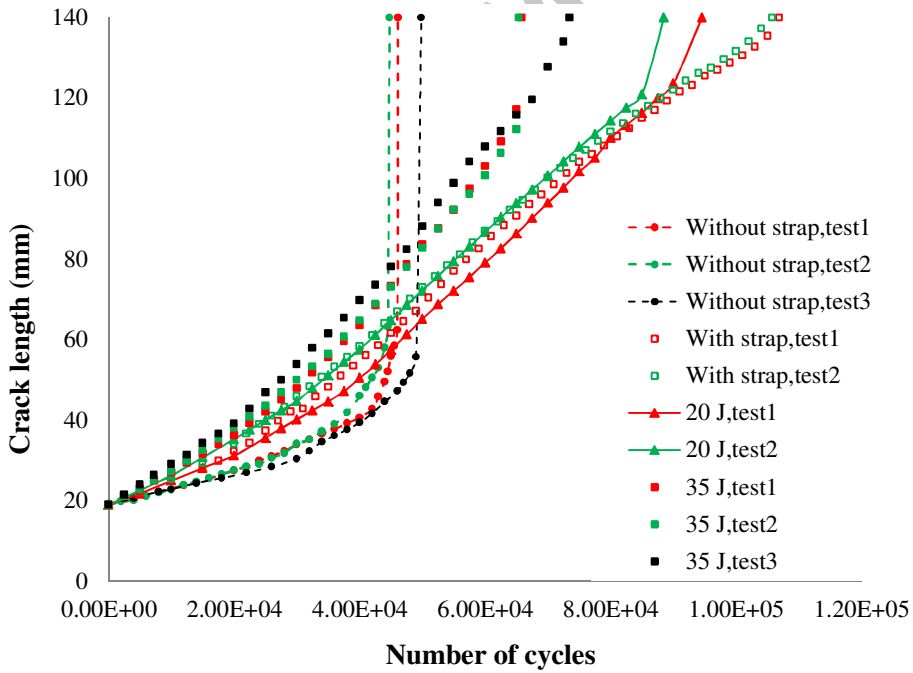
Figure 7. Fatigue tests on the SEN(T) coupon specimens

fatigue tests with specimens impacted at 20 J were conducted. Figure 7 shows the crack length versus number of cycles for each specimen.

Constant- amplitude fatigue crack growth tests on the SEN(T) coupons show that the specimens with a strap have a longer life compared to specimens without a strap, confirming the efficacy of the bonded crack retarder concept. The specimens with a strap produced a fatigue life more than double that of the fatigue life of an unstrapped specimen, and the life improvement factor for the strapped specimens was 2.26. Specimens impacted with 20 J and 35 J have shorter fatigue lives than the strapped specimen without impact damage, but had longer life when compared to an unstrapped specimen. Specimens impacted with 20 J showed a 16% reduction in fatigue life whereas the specimens impacted with 35 J showed a 55% reduction in fatigue life when compared to the undamaged strapped specimen.

The shorter fatigue life of the impact damaged specimens is attributed to the additional residual stresses and interfacial damage introduced at the bonding interface. There was no evidence of any damage within the strap as a result of the crack growth in the substrate. However, specimens impacted with 20 J and 35 J suffered interface damage in the form of delamination between the GLARE and the substrate and hence a lower fatigue life. The specimen impacted with 35 J exhibits a greater degree of interface damage, greater residual stresses after impact, and lower fatigue life when compared to the specimen impacted with 20 J.
