Sustainable, “green” solutions for concrete pavement rehabilitation - a feasibility (pilot) study

SUSTAINABLE, “GREEN” SOLUTIONS FOR CONCRETE PAVEMENT REHABILITATION. _A feasibility (pilot) study.

J.N. Karadelis, K. Koutselas, A. Khan, Zhou Jiebin, K. Moscicka, A. Plachta.

Coventry University, Coventry, UK.

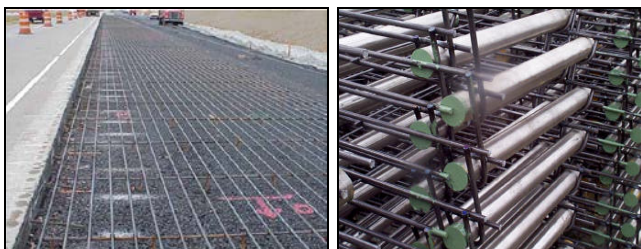
Figure 1 Rigid pavement steel reinforcement and dowel bars detail.

As it was mentioned earlier, a major drawback of the concrete roads compared against their asphalt counterparts is the very slow speed of construction of the former. This is owned to the time taken for the reinforcement to be placed and for the concrete to develop its full strength (Figure 1).

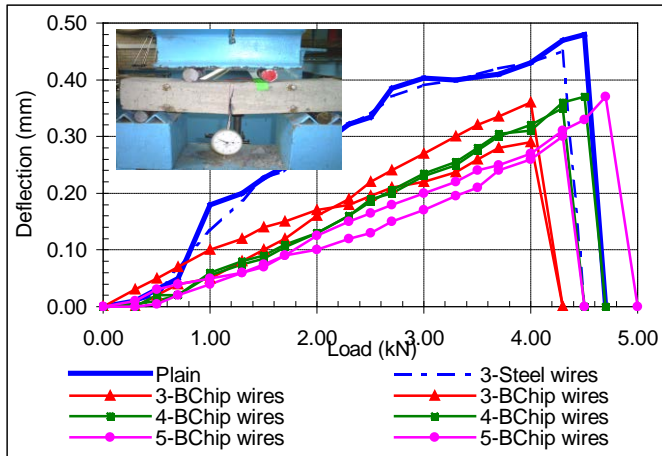
Figure 3. Flexural tests. Load v Deflection. Comparison between beams with different amount of BarChip reinforcement.

A series of laboratory tests were carried out on small, prismatic, polymer modified, concrete beams (360x60x60 mm) reinforced with BarChips to assess their performance. Similar plain concrete prisms as well as prisms with 1.00mm diameter steel wire reinforcement are also plotted alongside, for comparison. The “BarChip ratio” obtained was much lower than the corresponding minimum steel ratio allowed by BS8110 and Eurocode 2. However, the point was made. A sample of the results is shown in Figures 3 & 4.

It is recognised that the results are preliminary and that more tests are needed for confidence to increase. However, indications are that replacing conventional with continuous synthetic reinforcement may be possible, with substantial reductions in deflection and strain achieved by increasing the number of BarChip ‘wires’. That is, BarChip reinforcement can

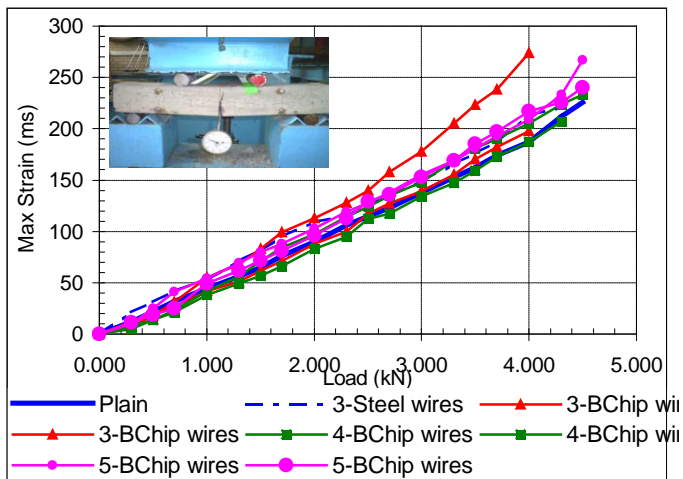
Figure 4. Flexural tests. Load v Strain. Comparison between beams with different amount of BarChip reinforcement.

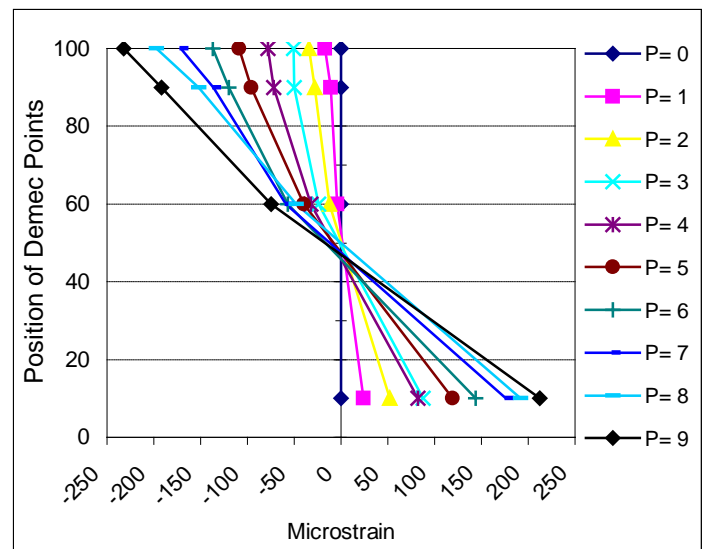
Figure 8. Strain distribution per load increment at midspan, across the depth of Beam 2F.

The strain distribution per load increment across the depth of the beams, at midspan, was also plotted. Some indicative results are shown in Figure 8, below. Whole load increments are shown only, for clarity. The position of Neutral Axis was estimated from the graph to be at approximately 47.5mm above the bottom of the beam; slightly lower than halfway up or down, attributed to the influence of the polymeric concrete layer.

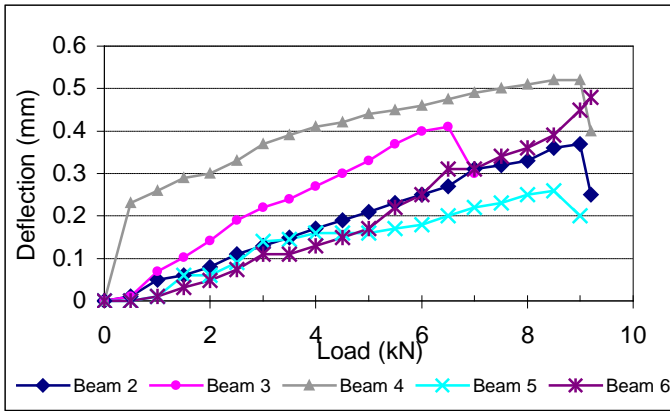
Figure 10. Variation of Deflection with Load. Beams 2F – 6F.

Figure 10 shows the variation of maximum deflection (at midspan) with load for Beams 2F (50 brush-passes) to 6F (250 brush-passes). The familiar trend continuous as beams with rougher interface between ‘old’ and polymeric concrete tend to behave as ‘composites’, withstand more load and undergo larger deflections.

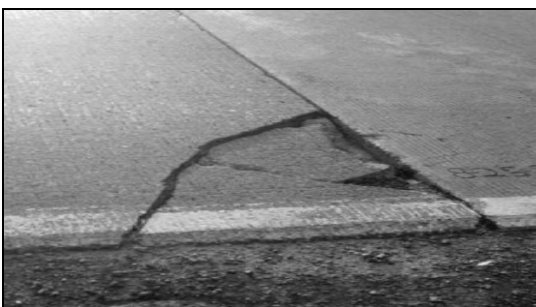
Figure 11. Warping failure

These tests incorporated a series of small concrete slabs (300x300x30 mm), approximating their behaviour under thermal and traffic loads and establishing their mode and mechanism of failure. These slabs were reinforced with both BarChip fibres and wires as shown in Figure 12(b).
