1
2
3
4 Compression After Multiple Low Velocity Impacts of NCF, 2D and 3D Woven
5
6 Composites

8 Mohamed Nasr Saleh^{a,1*}, Hassan M. El-Dessouky^{b,c,1*}, Milad Saeedifar^a, Sofia Teixeira De
9 Freitas^a, Richard J. Scaife^b, Dimitrios Zarouchas^a

27 **Abstract**

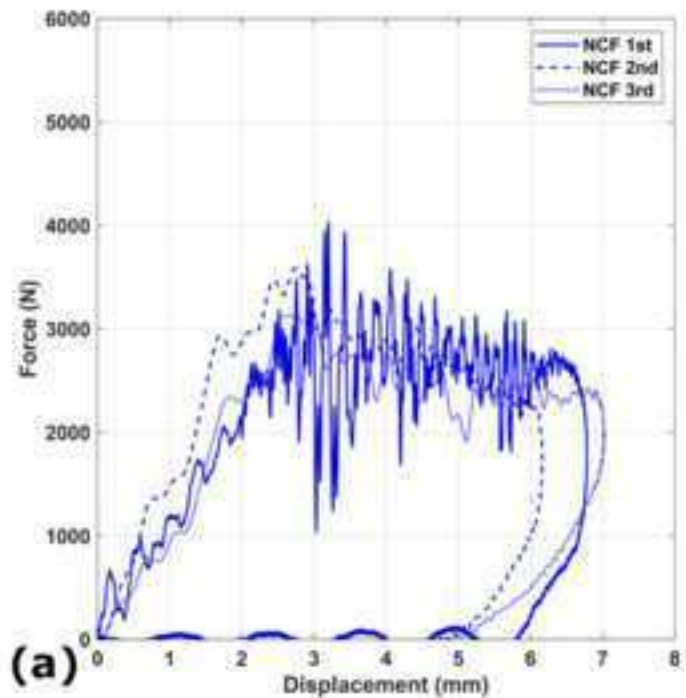
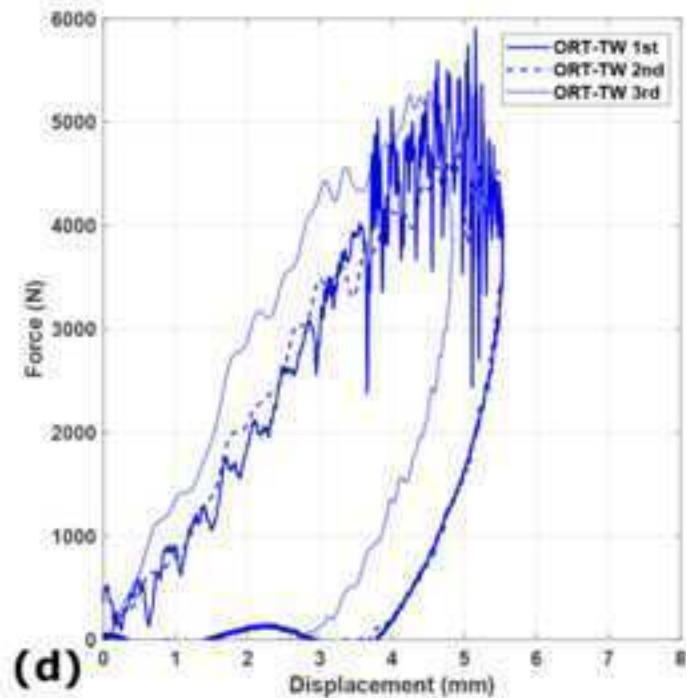
Figure 6
[Click here to download high resolution image](#)

55
56 Representative impact load-displacement curves obtained from the weight-drop impact
57
58 tower for the three impacts are summarized in Fig. 6 for all the architectures. As a general
59
60 remark, the effect of the clamping boundary conditions due to the clamping fixture “specimens’
61
62 holder” is clear when comparing the stiffness of the load-displacement curve of the first impact
63
64
65

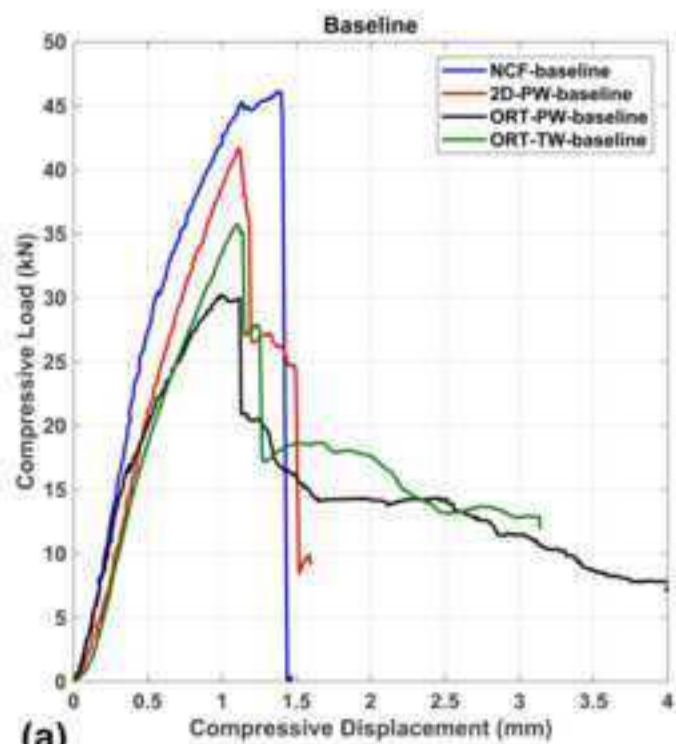
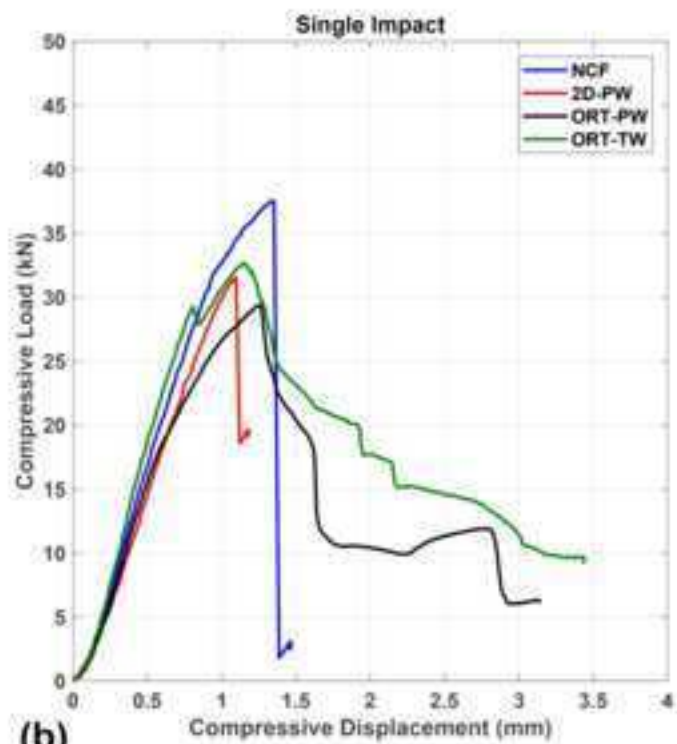
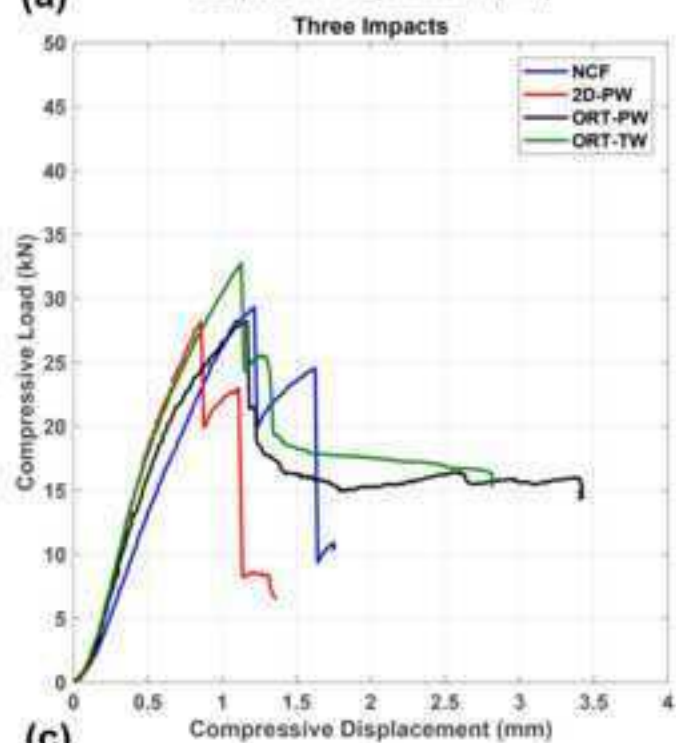
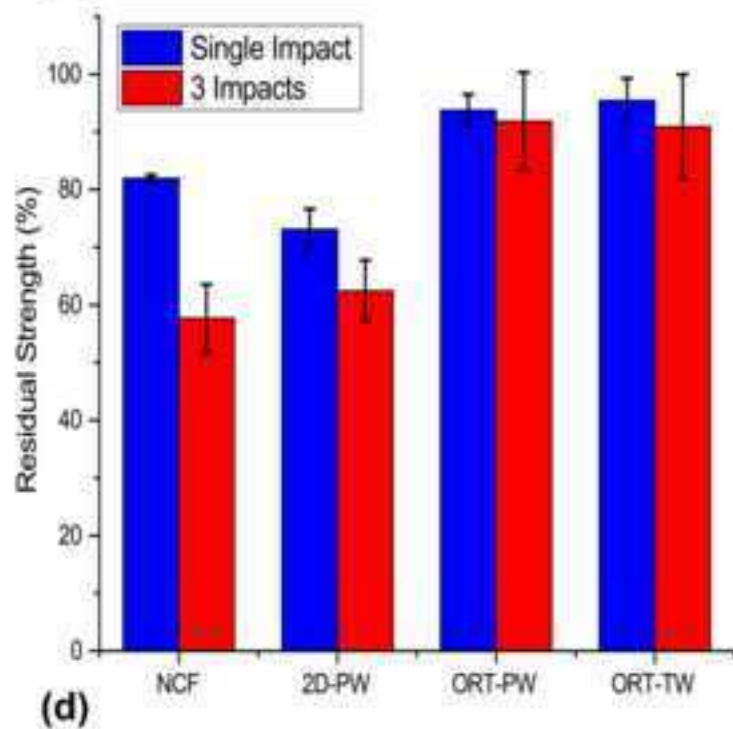
Figure 10
[Click here to download high resolution image](#)

36 The load-displacement curves for: baseline, single impact and multiple impact specimens
37 are shown in Fig. 10a-c. A clear distinction, between the NCF and 2D-PW from one side and the
38 3D woven composites (ORT-PW and ORT-TW) from the other side, is observed when it comes
39 to the nature of the final failure. For NCF and 2D-PW, baseline and single impact (see Fig. 10 a,
40 b), the failure is more like a catastrophic failure with a sudden drop in the compressive load and
41 a relatively less failure displacement (~1.5 mm). In the case of multiple impact for NCF and 2D-
42 PW (see Fig.10 c), the failure is still catastrophic but the compressive load drops in steps, each of
43 which corresponds to failure occurring in the vicinity of one of the three impacts. On the
44 contrary, the ORT-PW and ORT-TW 3D woven architectures (see Fig. 10 a-c) exhibit a
45 progressive failure response with a gradual drop in the compressive load and a larger

46 deformation indicated by the compressive displacement (~ 3.5 to 4 mm). This directly indicates
47 the importance of the z-binding yarns in 3D woven composites in resisting the internal damage
48 and transforming the failure behavior from a catastrophic to a progressive one.
