Purdue University

Steel Bridge Research, Inspection, Training, and Engineering (S-BRITE) Center

August 2018

Member-Level Redundancy of Built-Up Steel Axially Loaded Members

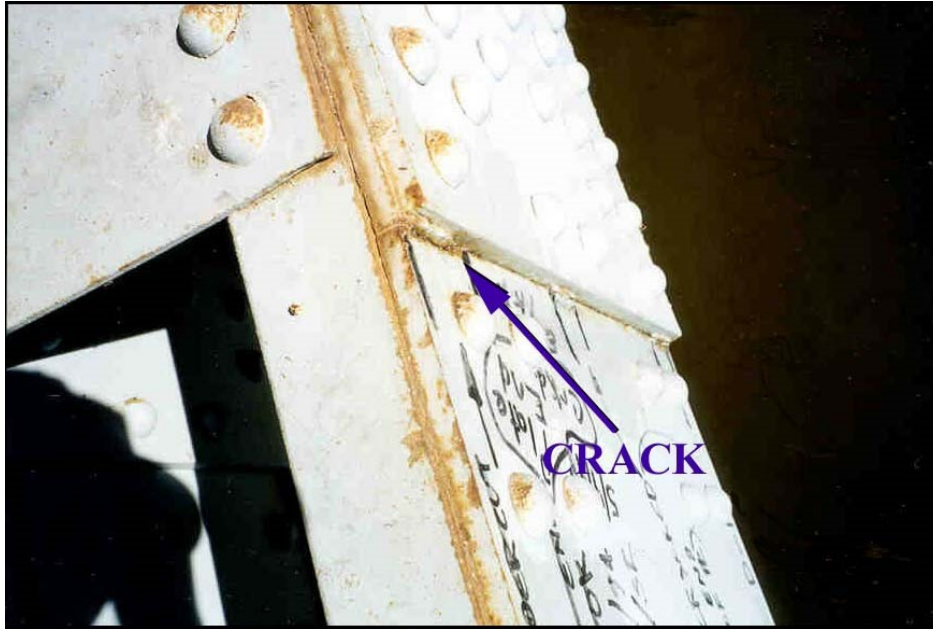
Figure 2.2 Fractured tie girder plate, Hastings Bridge (Niemann, 1999)

Two separate arms-length inspections revealed two partial member fractures on the Hastings Bridge in Minnesota in 1997 and 1998. The bridge was a tied-arch through truss bridge built in 1949 with riveted built-up members (see Figure 2.1). Both fractures occurred in the same plate of the same tie girder. While the first fracture arrested in adjacent rivet holes, the second fracture propagated through the entire tie girder web plate (see Figure 2.2). Initiating, at a tack weld the second fracture ran the entire length of the web plate. Investigations later determined that a single plate used in the fabrication of the tie girder erroneously had very low toughness causing each of these fractures to occur (Niemann, 1999). The internal member redundancy of the built-up tie girder prevented the fracture from propagating into adjacent components.

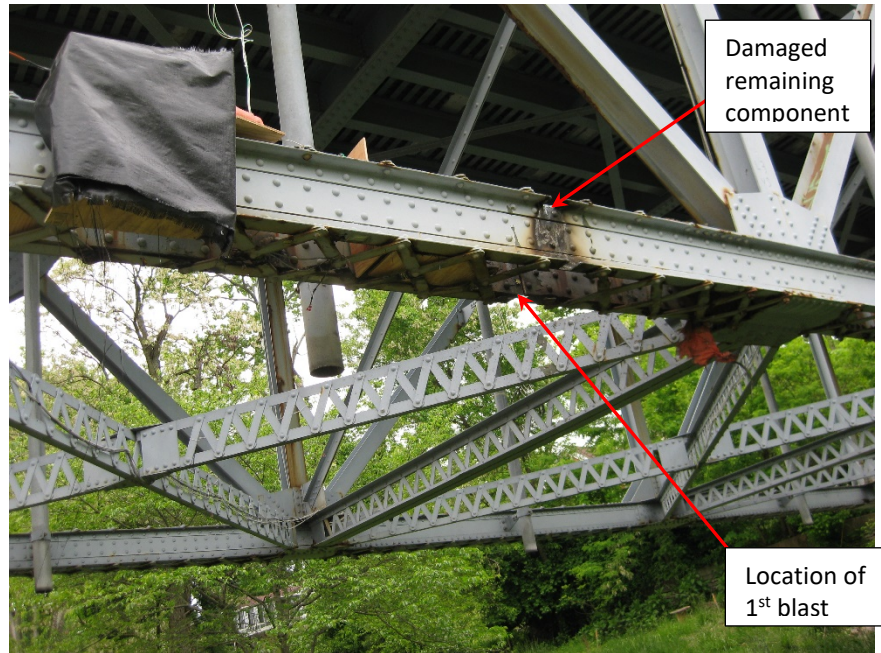
Figure 2.4 Partially severed FCM, Milton Madison Bridge approach span

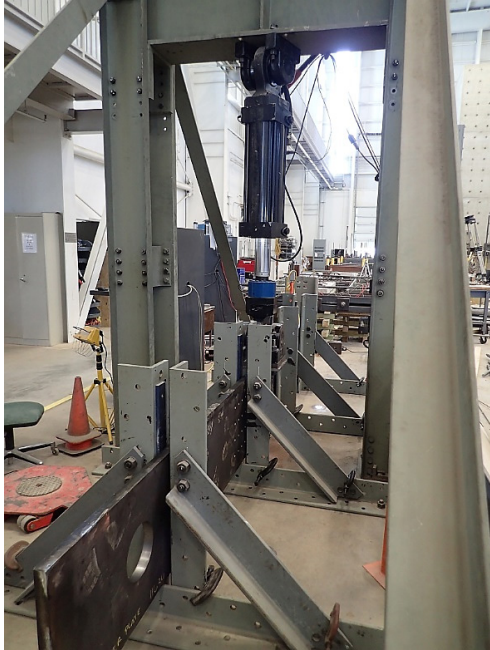
Figure 3.4 Fatigue station setup

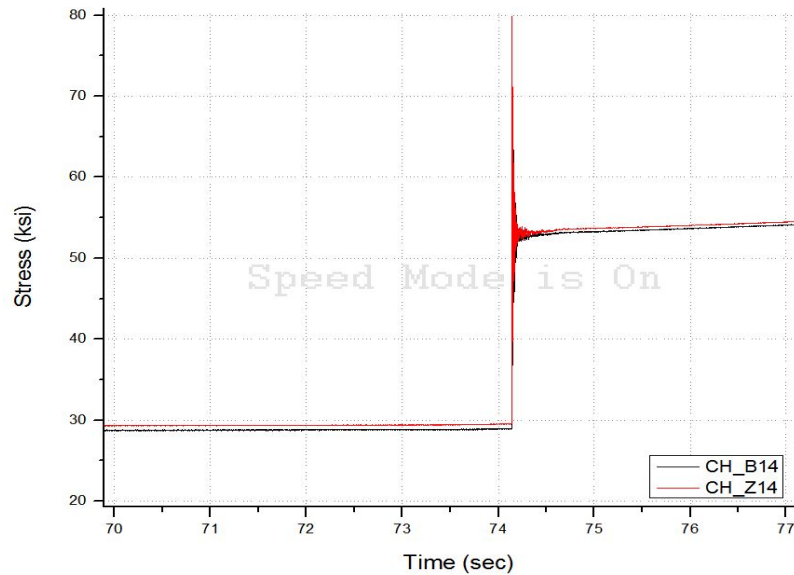
Figure 3.10 Sample of stress data from Test 3 using finger-tight bolts

bolts to ensure all load was transferred through bearing in the bolt and bolt hole and effectively no load could be transferred through friction. In this context, “finger-tight conditions” means no wrenches were used to tighten the bolts; rather, the three plates were brought into contact by simply turning the nut using the strength of a worker’s own hands. This left no perceivable gaps between plates while ensuring the lowest possible clamping force in each bolt. Figure 3.10 plots stress data from two strain gages located at the same locations as the strain gages in Figure 3.9. The data were collected at a rate of 10 kHz. The measured fracture load for test 3 was within 6% of the fracture load for test 4. However, the measured peak stress reached 79.4 ksi in both central gages before the load dropped off (the load was sustained for approximately 1/100th second). This means the redundancy plates sustained an impulse loading that was equal to their measured tensile strength of 80 ksi. Once the load dropped off, the sustained stress in the redundancy plates exceeded their nominal yield strength of 50 ksi, slightly below the measured yield strength, 59 ksi. Upon removal from the test frame, the redundancy plates were examined for any damage, such as elongated holes or cracks. No damage could be detected.

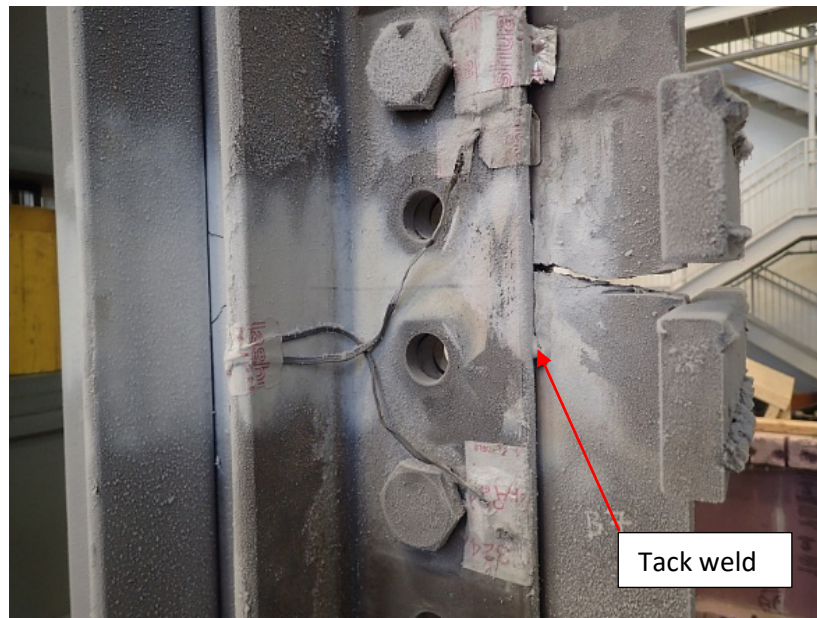
Figure 3.14 Fractured tack weld and center plate

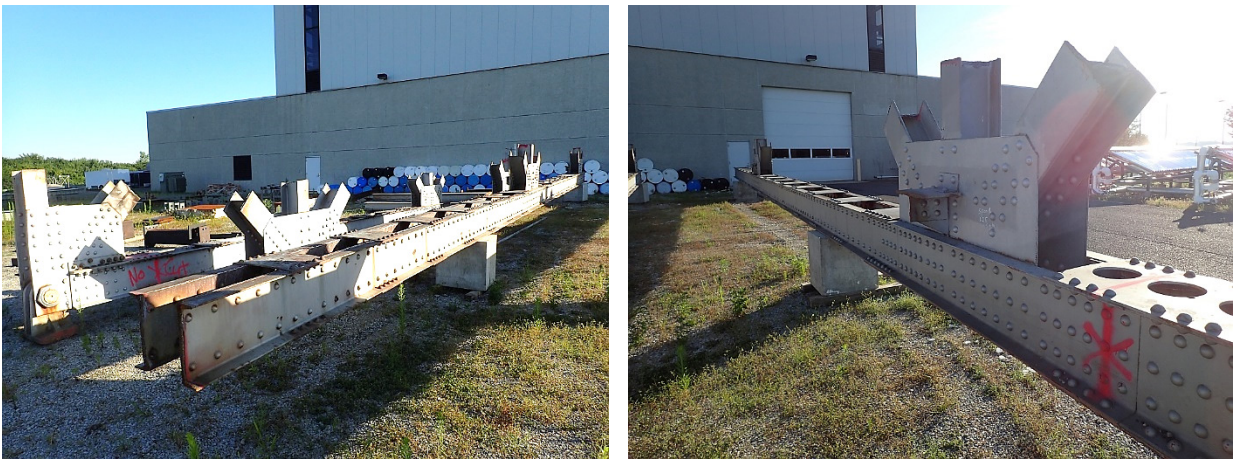
Figure 3.15 Winona Bridge specimens as they arrived

Specimens 6 and 7 were members that had previously been in service for an extended period of time, removed from approach span 16 of the Winona Bridge that was built in 1940 and carried traffic over the Mississippi River near Winona, MN. The Minnesota Department of Transportation (MNDOT) donated the specimens as part of a related study. Following completion of the other testing the specimens were adapted for the IRM research. Figure 3.15 and Figure 3.16 show the general condition of the specimens as they were delivered. The condition of the rolled channels was generally clean with some minor section loss resulting from corrosion. Significant pack rust was evident between the channels and the cover plates along the top of the chords, being the cover plated the components with the greatest section loss. The gusset connections for the mid-span tension chord sections were also in good condition with some slight corrosion damage. Figure 3.17 shows a sketch of the specimen cross section at one of the stay plates, which makes the appearance of a box section, however the stay plates were intermittent along the lengths spaced at a distance of 43 inches center-to-center (28 inch clear distance). The channels were C15x40 rolled channels sections, continuous through the gussets. The cover plates were 14-3/4 inches tall by 3/8 inches thick and were discontinuous at the gussets.

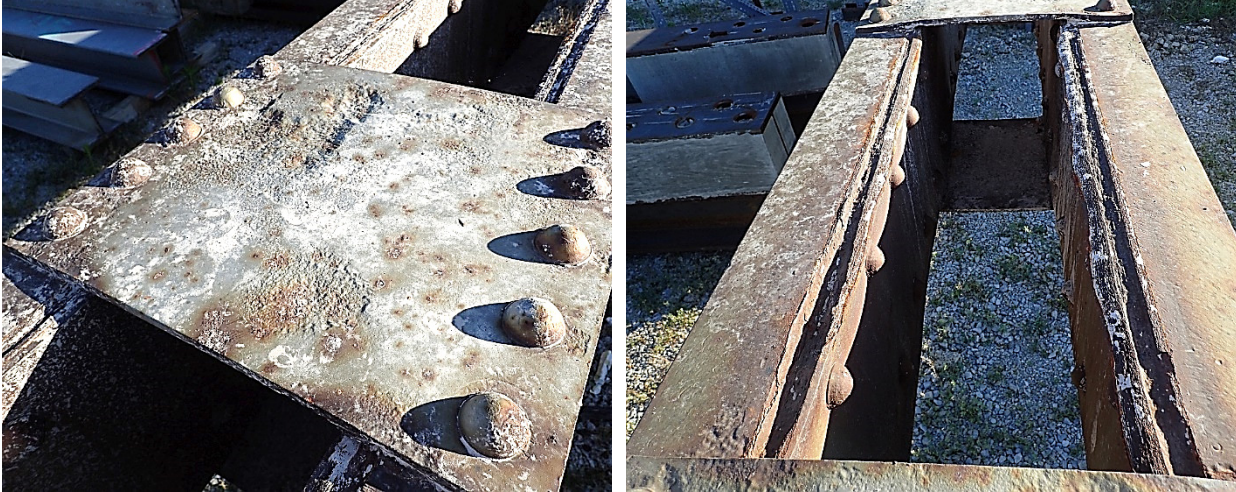
Figure 3.16 View of corrosion damage resulting in section loss and pack rust

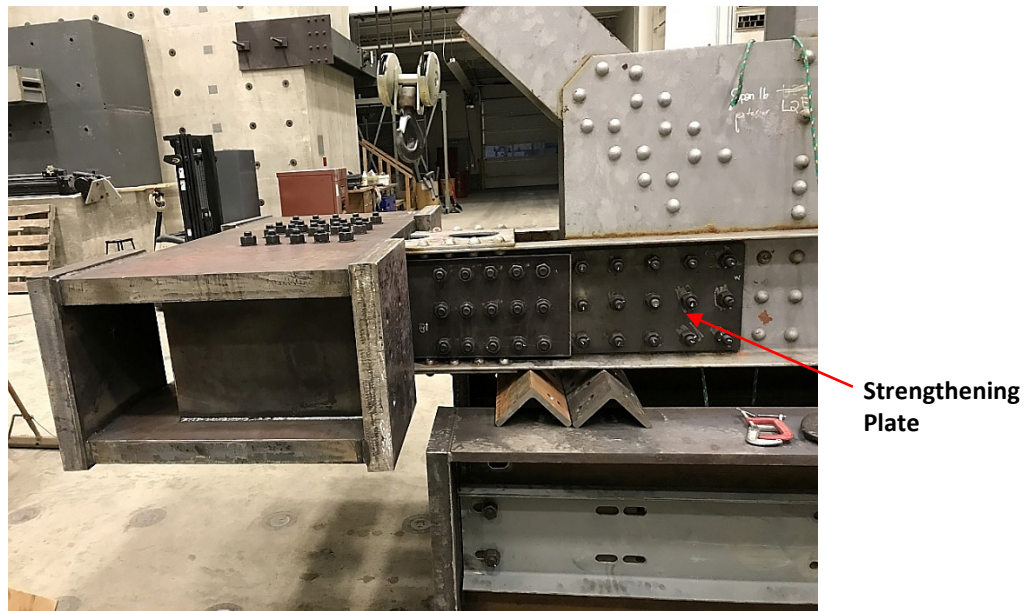
Figure 3.23. Connection at the reaction end of the specimen showing the additional plate

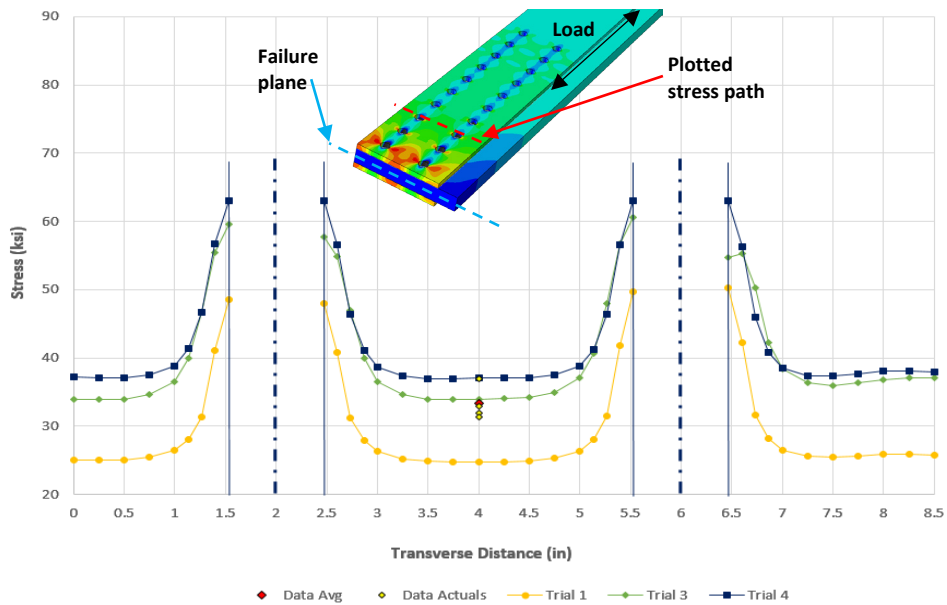
Figure 4.4 Experimental data compared to FEA results – plotted along transverse dimension

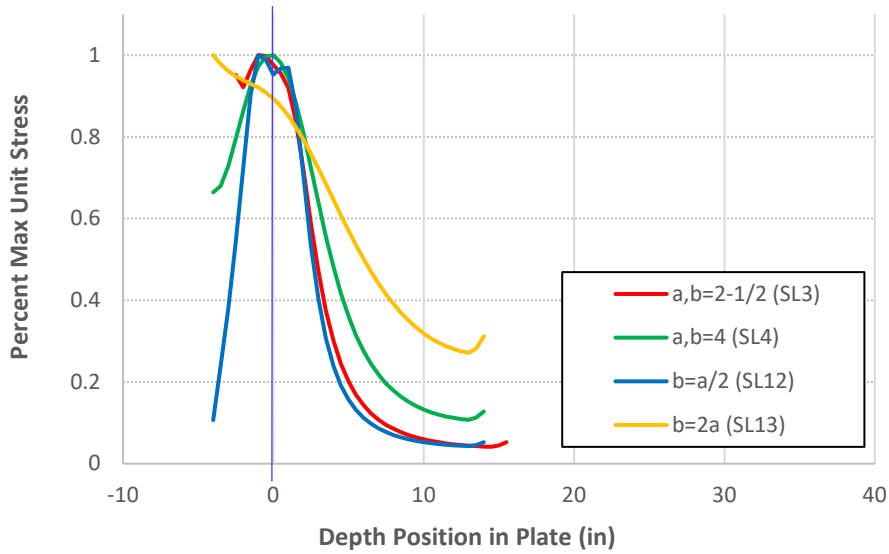
Figure 4.12 Depth into plate to maximize stress range calculation

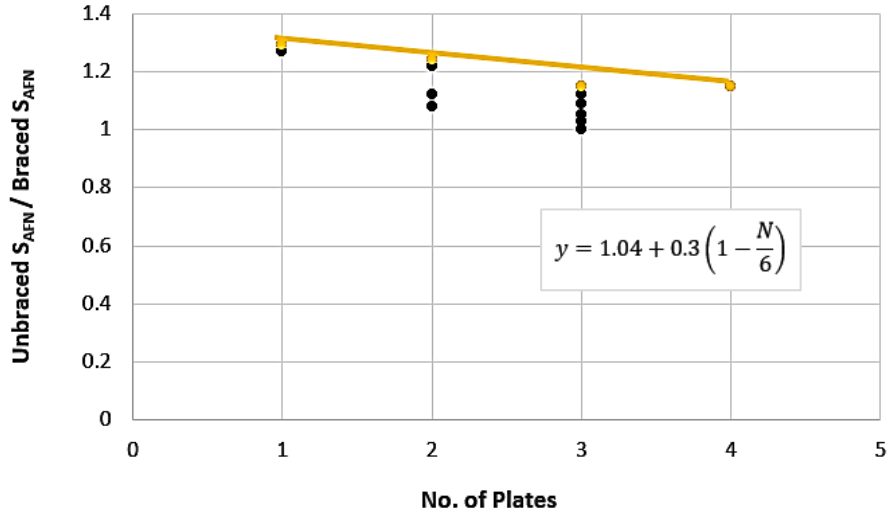
Figure 4.17 Ratios of Unbraced to Braced longitudinal after-fracture net section stress

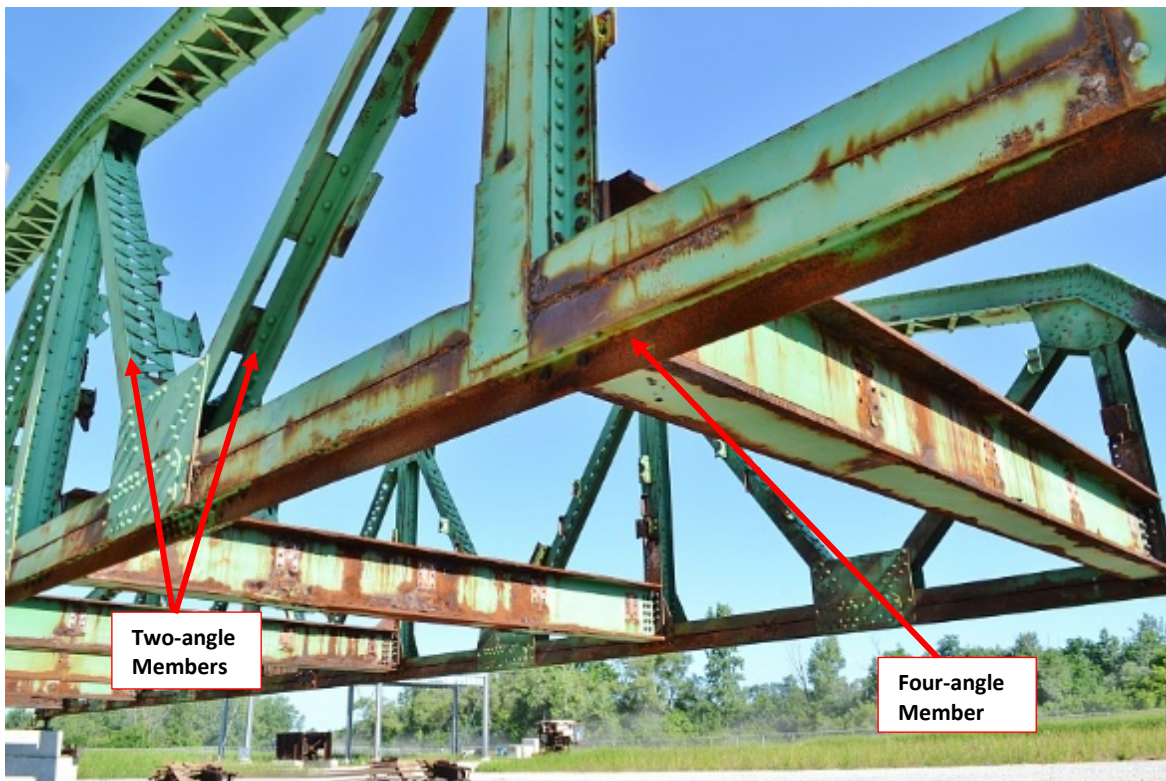
Figure 4.21 Simple-span pony truss showcasing several angle-only member types

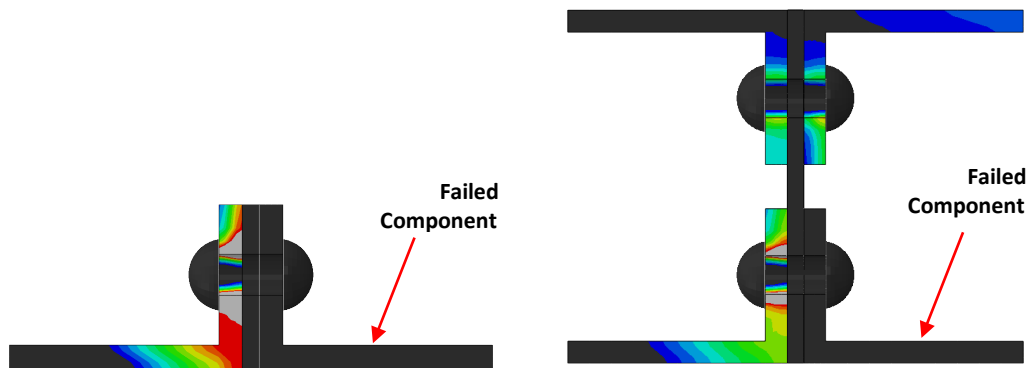
Figure 4.23 Examples of stress concentrations for two-angle and four-angle members

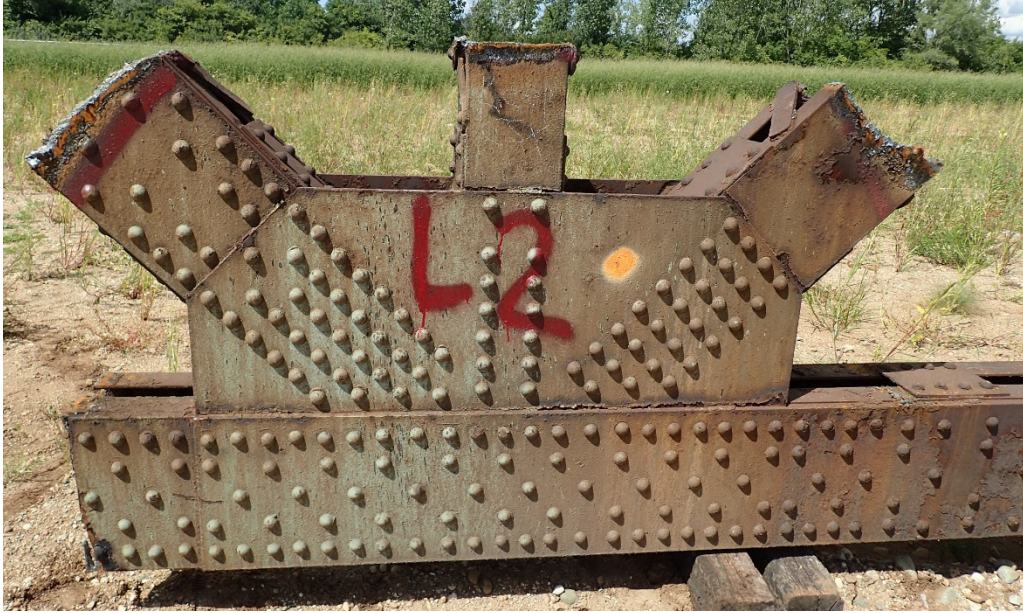
Figure 4.47 Example of deeply set two-channel diagonal members connected into a gusset plate
