Issue 24
Spring/Summer 2011

a journal of environmental and sustainability issues

Stream Restoration

2 Reestablishing Groundwater and Surface Water Connections in Stream Restoration

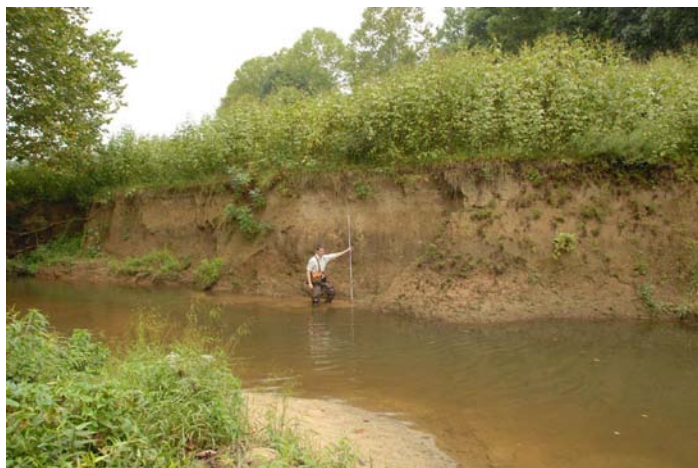
Figure 1. Fine-grained sediment deposits upstream of historic dams. Mike Croasdaile is standing on the pre-settlement floodplain identifiable from exposed saw-cut stumps in the bank. Measurement rod length is approximately 2 meters.

One of the most significant effects human activities have had on streams in the eastern US has been the burying of valley bottoms in sediment. In Kentucky, as elsewhere, 19th-century clearing, burning, farming, and grazing of hillsides led to soil erosion and the accumulation of those fine sediments on valley bottoms (Trimble 1974, 1981; Costa 1975; Magilligan 1985; Jacobson and Coleman 1986; Knox 1987). In some valleys, layers of this post-settlement alluvium (Happ et al. 1940) eventually filled the ponds upstream of thousands of dams built to power mills, transport logs, or create fish ponds or farm ponds (Parola et al. 2007; Walter and Merritts 2008). At stream restoration sites in Kentucky, some valley bottoms have been found to have filled with enough post-settlement alluvium to increase their elevations by as much as 3 meters above pre-settlement levels (Figures 1 and 2).

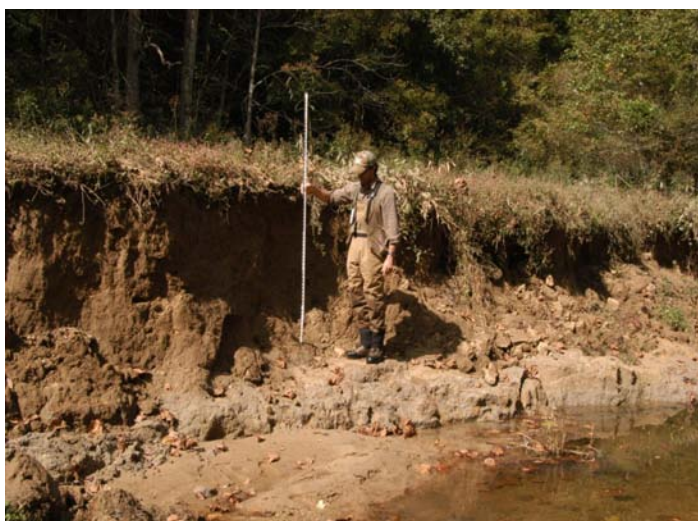
Figure 2. Brown historic fine-grained sediment overlays historic wetland sediment in the banks of Cane Creek, a tributary of the Red River. William Vesely is standing on the historic wetland floodplain. Measurement rod length is approximately 2 meters.

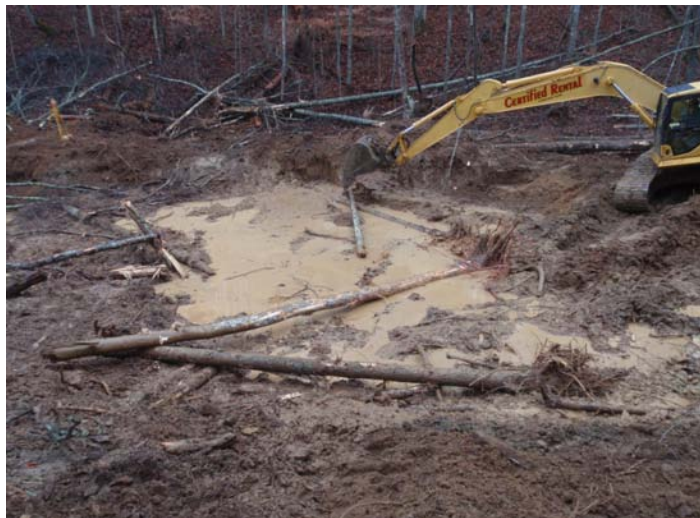
Figure 3. Approximately 1 meter of sandy fine sediment deposited over the valley bottom was excavated to expose pre-settlement gravel. Logs were placed over gravel and were at least partially buried to provide grade control across the valley bottom and to provide habitat wherever they were exposed by stream flow.

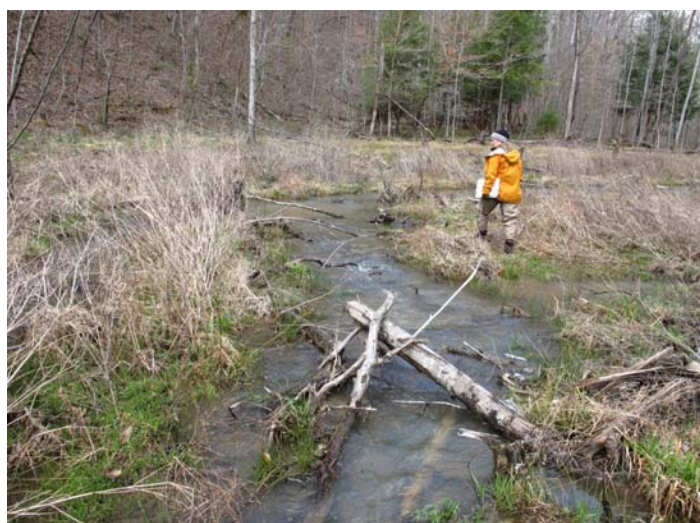
Figure 4. Slabcamp Creek restored valley bottom and channel reestablished on pre-settlement gravels. Photo taken approximately one year after construction.

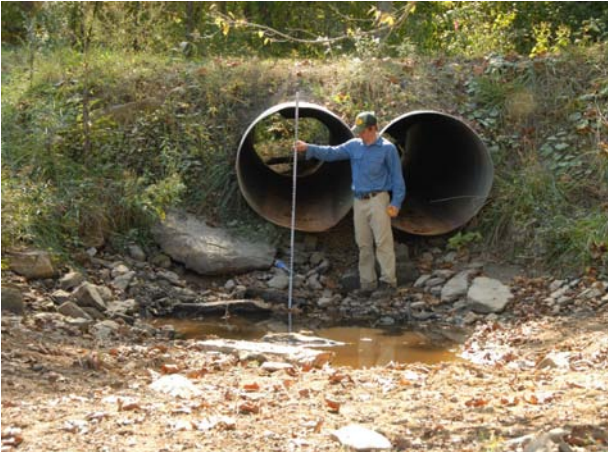
Figure 5. One of two pools in the pre-restoration Mill Branch channel that provided refuge for the threatened blackside dace during the summer and fall drought of 2008.

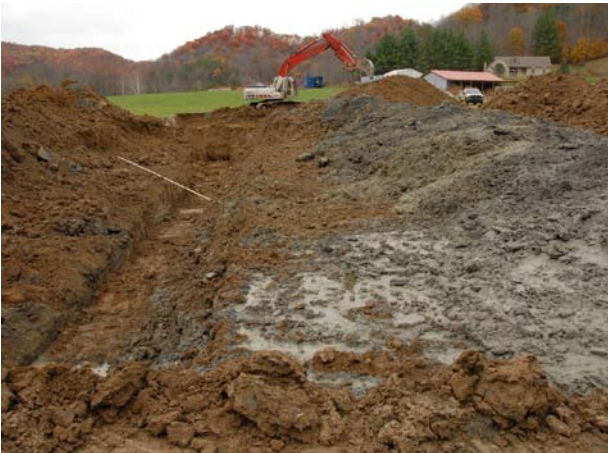
Figure 6. Construction of cross-valley groundwater dam at Mill Branch. Gray, organic-rich gravel and wetland soils were removed and placed on the surface. Brown, clayey silt was placed and compacted in a trench to form the groundwater dam.

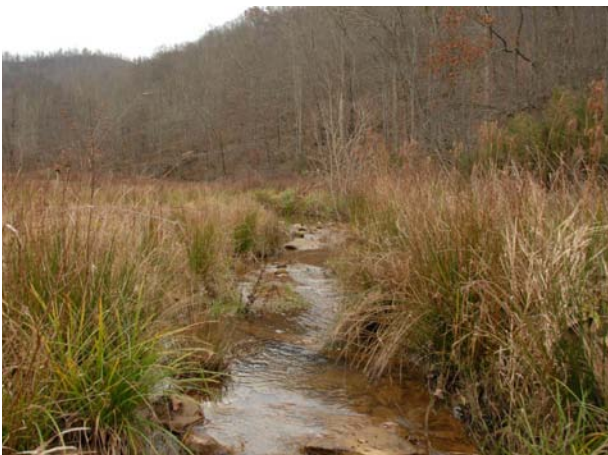
Figure 7. Mill Branch channel and valley bottom two years after completion of restoration construction.

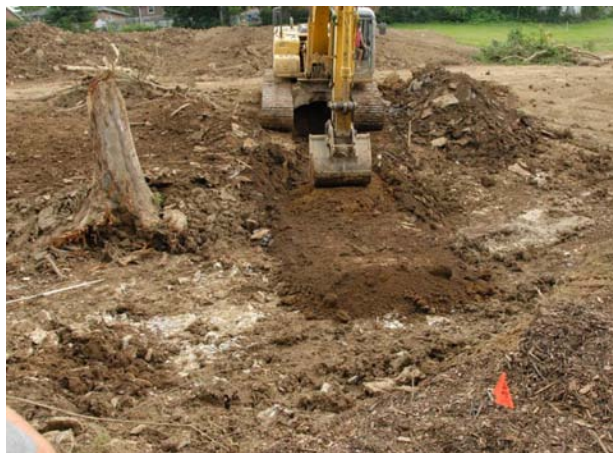
Figure 8. Small groundwater dam constructed at riffle.

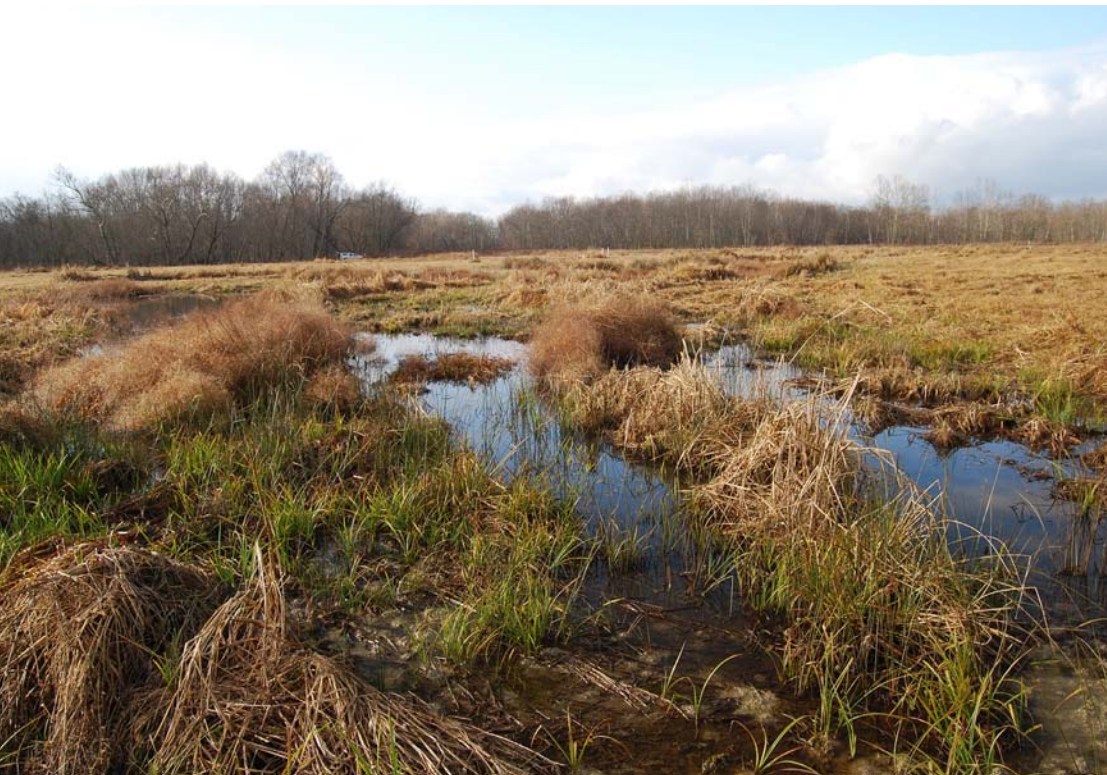
This ephemeral wetland is one of many restored at Dix River. The wetland provides breeding habitat for amphibians and helps to recharge groundwater.

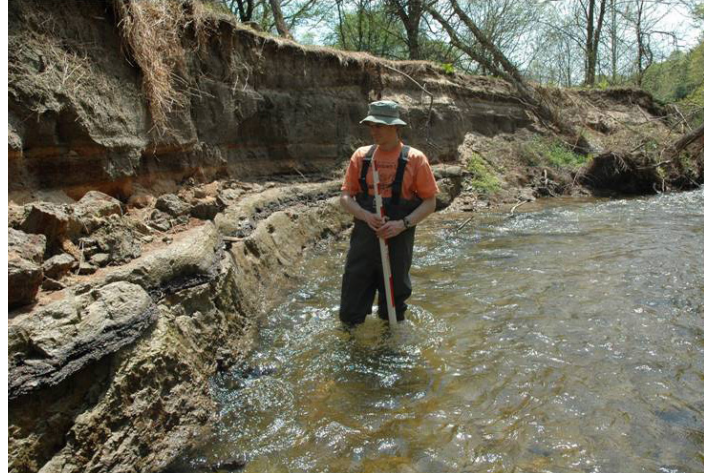
Figure 4. Channel Bank Erosion and Exposed Legacy Sediment. Channel bank erosion and exposed legacy sediments are evident after dam removal in Mount Holly Springs, PA.

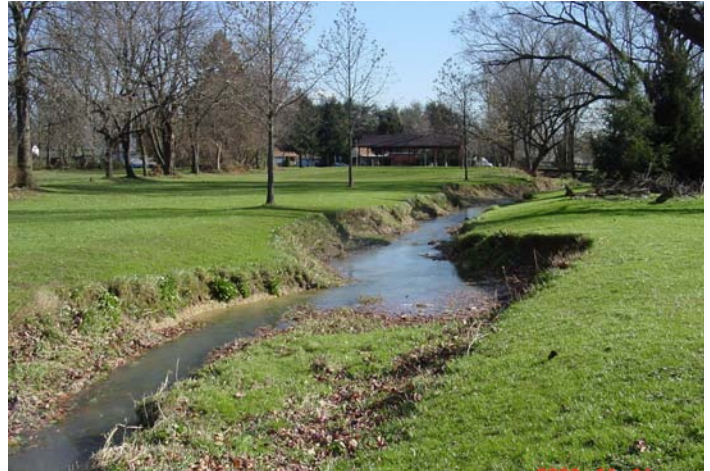
Figure 6. Santo Domingo Creek in New Street Park, Lititz, PA - Before Restoration. The existing stream was channelized, unstable and eroding both vertically and horizontally.

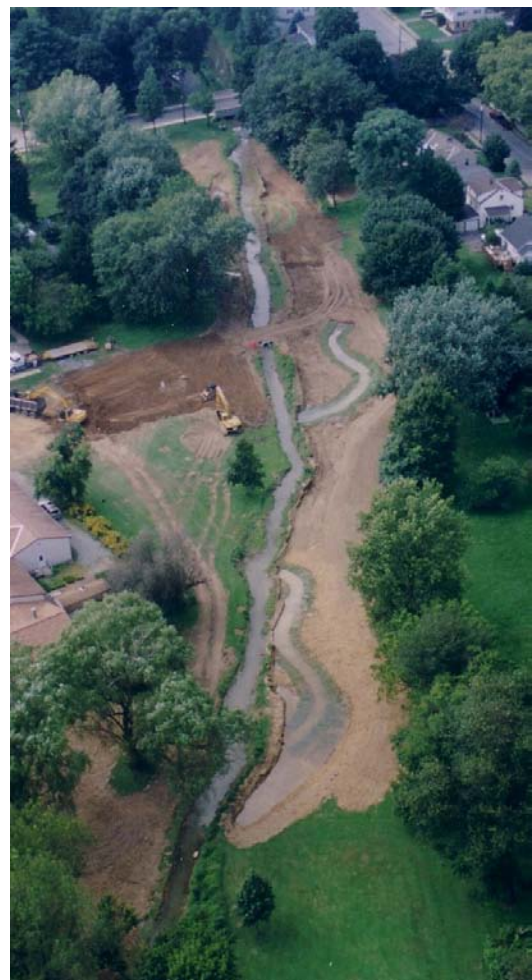
Figure 7. Santo Domingo Creek in New Street Park, Lititz, PA - During Construction. Aerial view shows the new, meandering channel under construction as water continues to flow through the existing straightened channel.

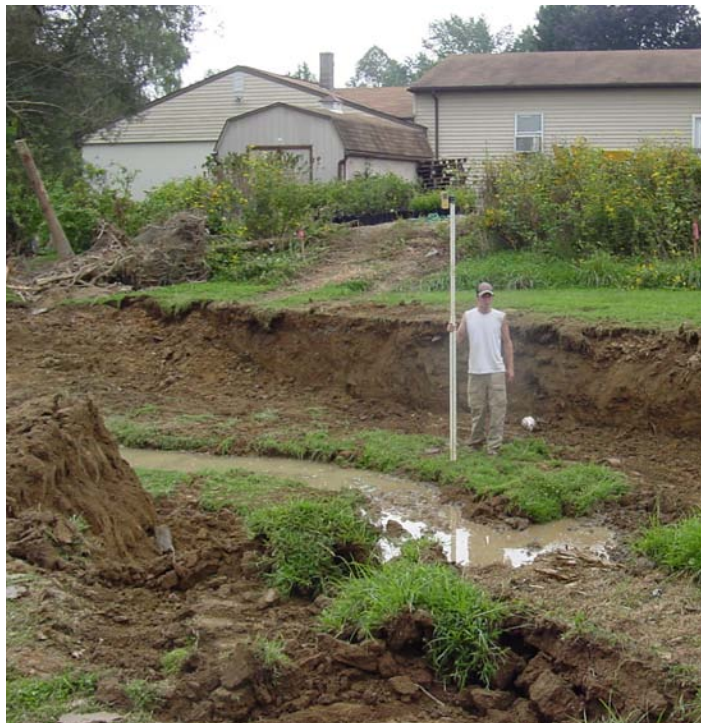
Figure 8. Santo Domingo Creek in New Street Park, Lititz, PA - During Construction. The man is standing on restored floodplain, now attached to the restored channel. The old floodplain elevation, created by the deposition of legacy sediments, can be seen behind him.

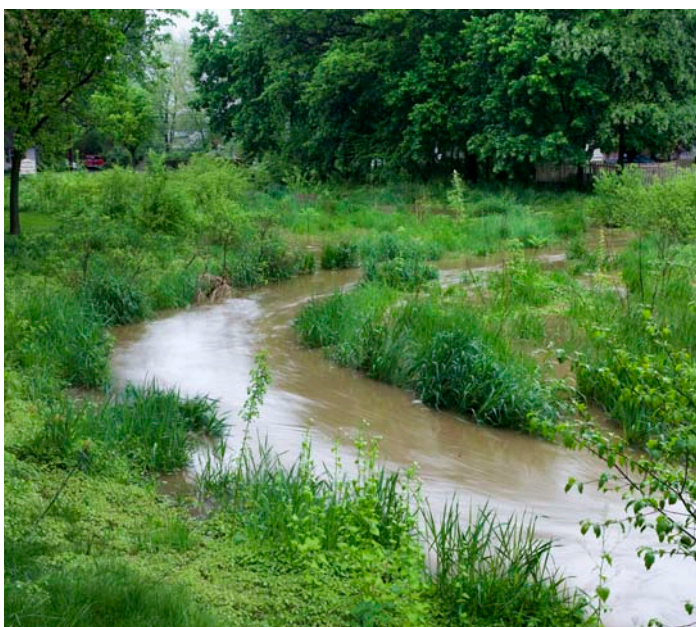
Figure 9. Santo Domingo Creek in New Street Park, Lititz, PA - Post Restoration Restored Condition. The restored site during a late spring storm event.

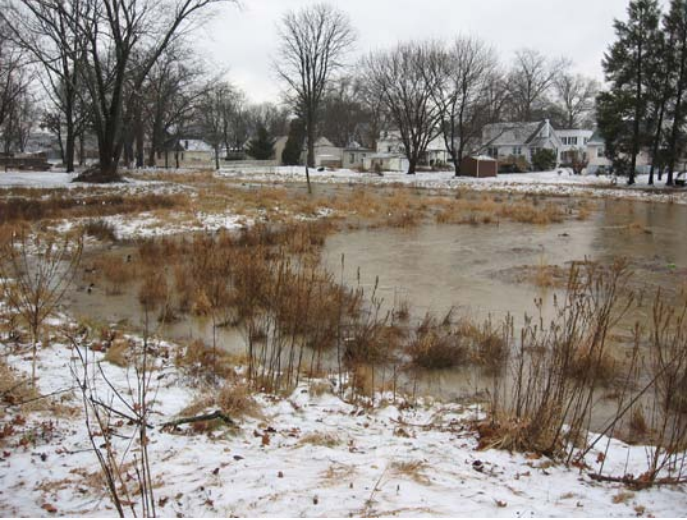
Figure 10. Santo Domingo Creek in New Street Park – Post Restoration Restored Condition. The restored site during a late winter storm event. Notice the restored floodplain receiving flood flows in the now-attached floodplain, where the energy of high flows is dissipated and storage and infiltration can occur.

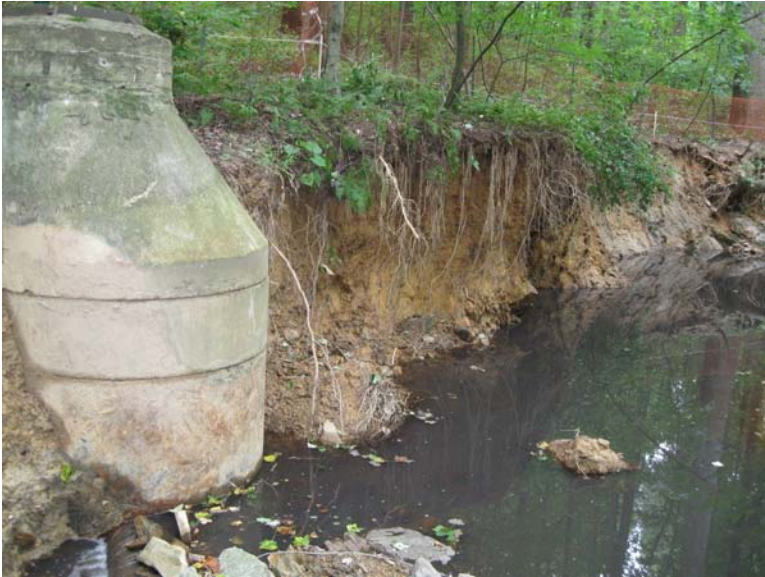
Exposed sanitary manhole.

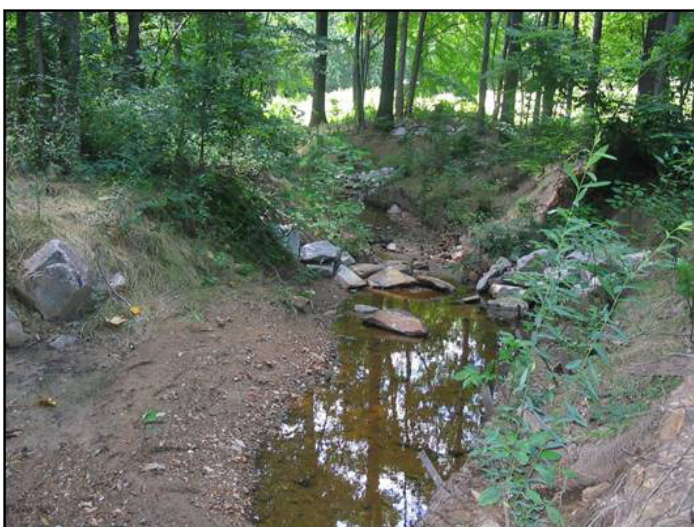
Before - Channel is incised.

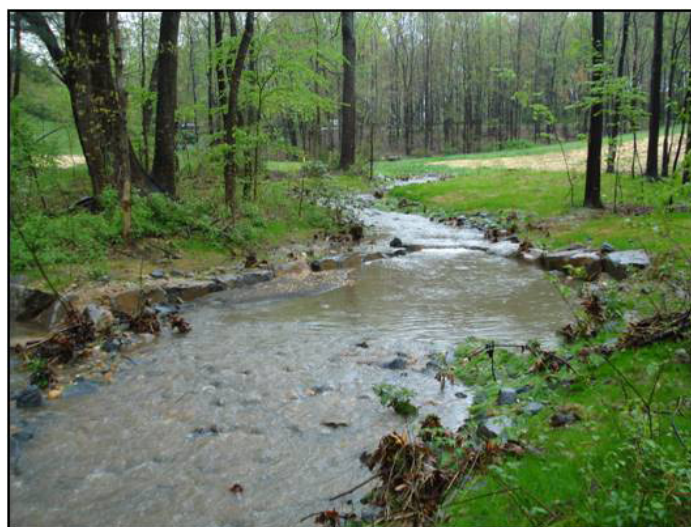
After - Channel is raised to provide floodplain access.

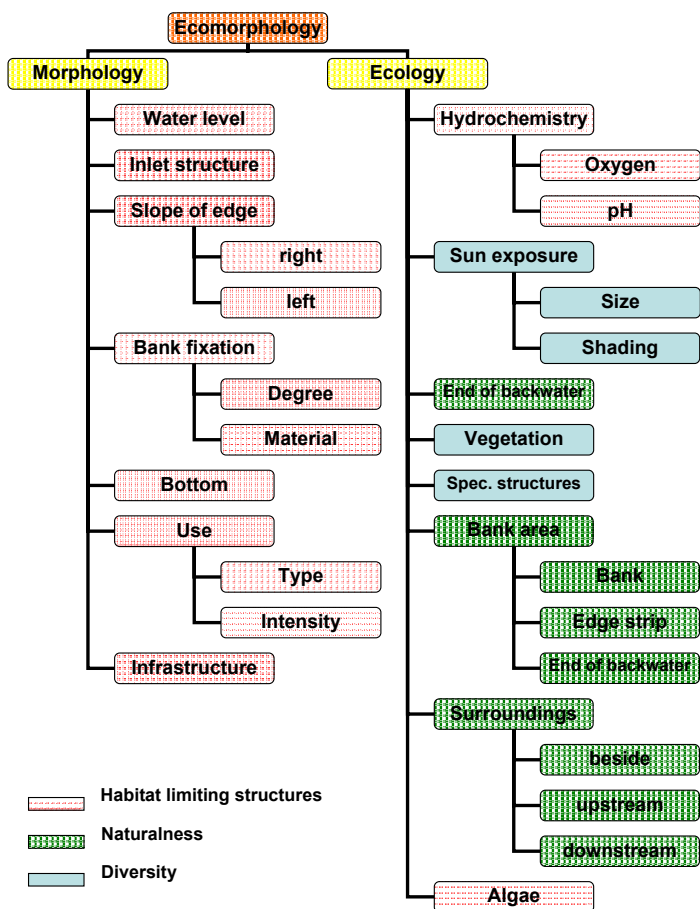
Figure 4. Eco-morphological assessment structure.

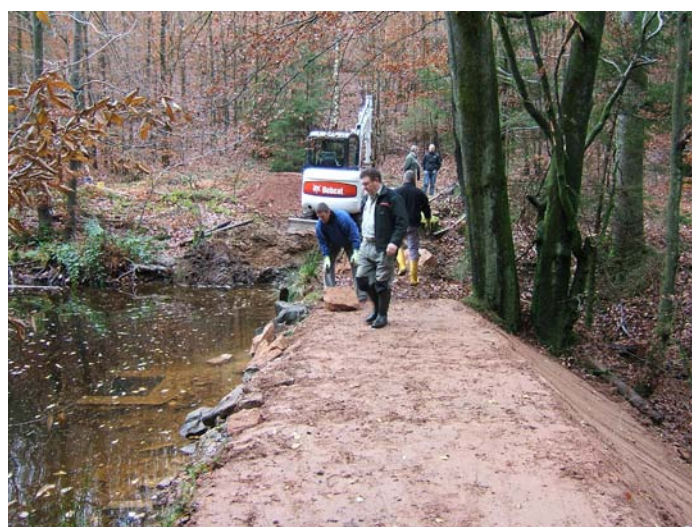
Figure 9. Renewal of a damaged dam wall because of a blocked outlet (left, beneath water level)

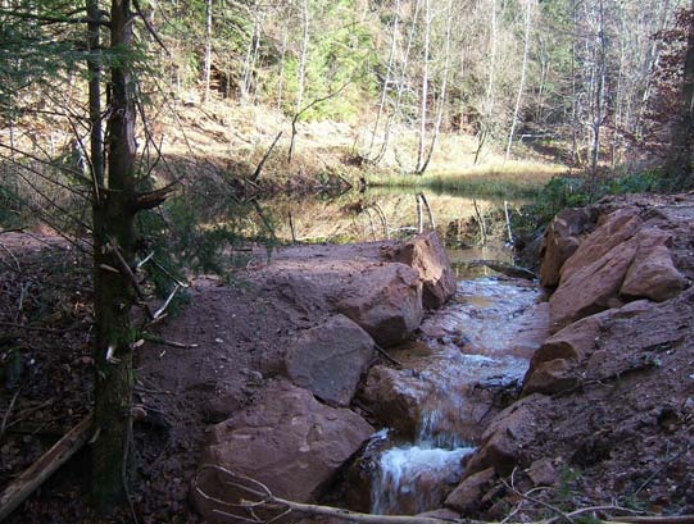
Figure 10. New outlet construction formed as an overfall with cascades into the tailwater

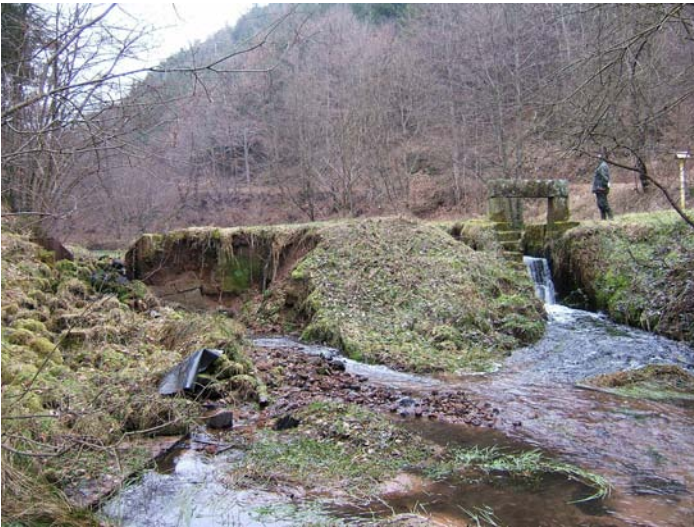
Figure 11. Drift pond dam from the 19th century with historical outlet structure (right side) and damage requiring restoration (left side)
