# Fluorescent thermal imaging of a non-insulated pancake coil wound from high temperature superconductor tape

To cite this article: R Gyuráki *et al* 2019 *Supercond. Sci. Technol.* **32** 105006

We have wound a 157-turn, non-insulated pancake coil with an outer diameter of 85 mm and we cooled it down to 77 K with a combination of conduction and gas cooling. Using high-speed fluorescent thermal imaging in combination with electrical measurements we have investigated the coil under load, including various ramping tests and over-current experiments. We have found that the coil does not heat up measurably when being ramped to below its critical current. Two over-current experiments are presented, where in one case the coil recovered by itself and in another case a thermal runaway occurred. We have recorded heating in the bulk of the windings due to local defects, however the coil remained cryostable even during some over-critical conditions and heated only to about 82–85 K at certain positions. A thermal runaway was observed at the center, where the highest magnetic field and a resistive joint create a natural defect. The maximum temperature,  $\sim 100$  K, was reached only in the

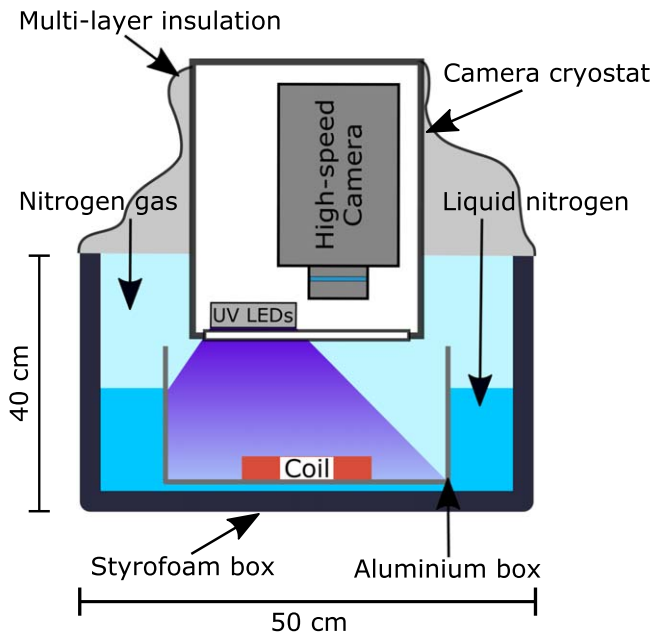
**Figure 1.** Cross-section view of the experimental setup.

To avoid complex and expensive vacuum and cryocooler setups with optical windows—and since the aim was to test the coil only at 77 K—a simple, two-component cryostat was constructed, as shown in figure 1. An aluminum container was placed inside a larger polystyrene container, and the space between the two was filled up with liquid nitrogen. The coil was placed into the aluminum box and a good thermal

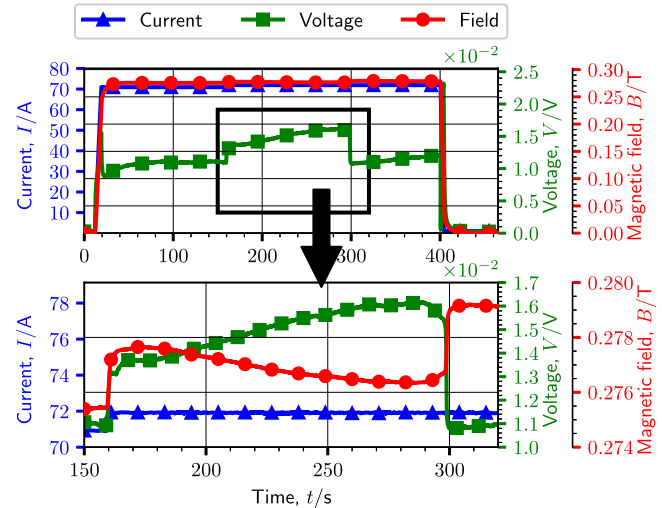
**Figure 3.** Electrical measurements of the coil during the 72 A over-current test. The bottom plot shows a zoomed area marked by the black rectangle. Note that the axes ranges are changed on the zoomed plot.

The coil current was first ramped up to 71 A at a rate of  $10 \text{ A s}^{-1}$  and the voltage was monitored, as shown in figure 3. It eventually stabilized and so the current was increased to 72 A, this time at a slower  $1 \text{ A s}^{-1}$  rate, as shown at time 160 s.

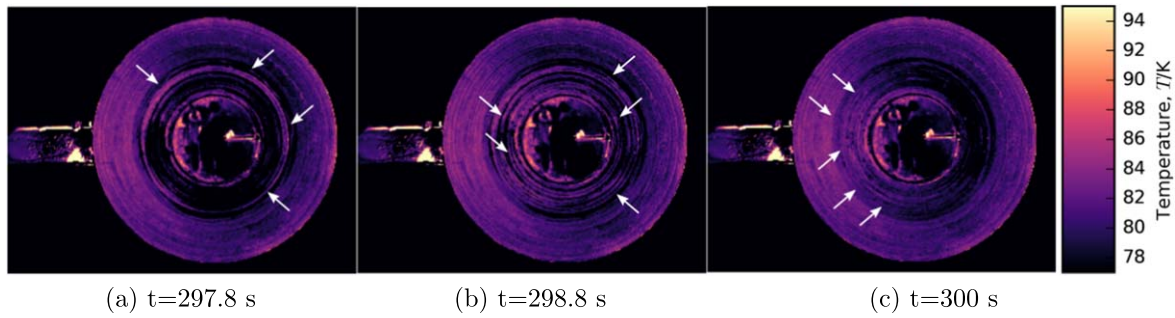
**Figure 4.** Thermal images of the coil during the 72 A over-current test showing different time points just before and right after the ‘self-recovery’. The white arrows indicate features, as described in the text.

Since the magnetic field also reduced with the increasing voltage, the current must have been changing from the spiral to the radial path. This is also supported by the quasi-linear voltage rise observed, as expected with increasingly more current flowing through a resistor. In figure 4(a) one can see that the outer turns of the coil are initially at a higher temperature, due to slightly worse cooling at the outer edge of the coil compared to the inner former as well as due to the over-current regime. At the same time, distinct heating is visible in the form of circles with varying width, as can be seen in figures 4(a) and (b) highlighted by the white arrows. This indicates that at particular locations in the coil, the current flows through the turn-to-turn contact resistance and generate losses. At about 298 s into the measurement, the voltage dropped and the magnetic field increased sharply, indicating that the current reverted back into the spiral path abruptly. Simultaneously, the center windings of the coil have heated up, as indicated by the white arrows in figure 4(c), where the ring-like hot areas have been replaced by an uniformly warmer zone, mostly on the left hand side of the coil. Hence the current flowing through the turn-to-turn contact resistances of the coil can be seen on the thermal image as heating over possibly several turns, which is most likely a function of the cooling performance and the distribution of local fluctuations of  $I_c$  along the length of the wound conductor.

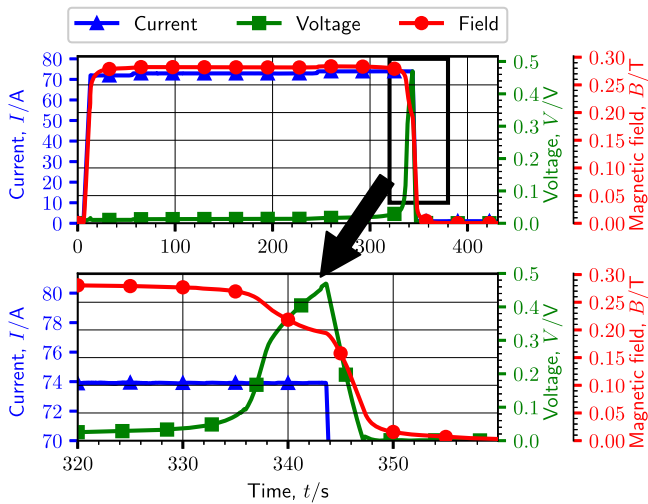
**Figure 5.** Electrical measurements of the coil during the 74 A over-current test. The bottom plot shows a zoomed area marked by the black rectangle.

To reproduce previous results and observe the same behavior again, the coil current was ramped up in a subsequent measurement directly to 72 A at a rate of  $10 \text{ A s}^{-1}$ , as shown in figure 5. However, in this case, no voltage drift was observed. The current was therefore ramped up to 73 A, and finally 74 A, at a slower  $1 \text{ A s}^{-1}$  rate, where the coil voltage became

unstable and started increasing once again. Over the course of two minutes at a steady current of 74 A, the coil voltage rose up continuously until its final value of 0.47 V, at which the coil current was ramped down quickly. The field started decaying with the developing voltage, indicating a slow current transfer into a radial path. Then, after 336 s, a much sharper voltage rise and accompanying field drop became visible, likely due to (some of) the HTS tapes becoming resistive. Figure 6 shows excerpts of the thermal imaging recording at three different time instants. In figure 6(a), one can see that the outside of the coil is again at a higher temperature, however still cryostable. Warmer zones are still visible around the center and middle layer of the coil (shown by the white arrows), indicating heating due to currents flowing through the turn-to-turn contact resistances. Figure 6(b) shows that the middle layers seem to have mostly cooled down, and at the same time—due to the superconducting transition—the innermost windings started heating up. At the bottom of the image, where the outer current lead arrives at the coil, a hot spot is also visible. Then in figure 6(c), just before the current was ramped down to protect the coil, the hottest temperature of around 100 K was reached at the few innermost windings of the coil. When looking at the dynamic development (see the online

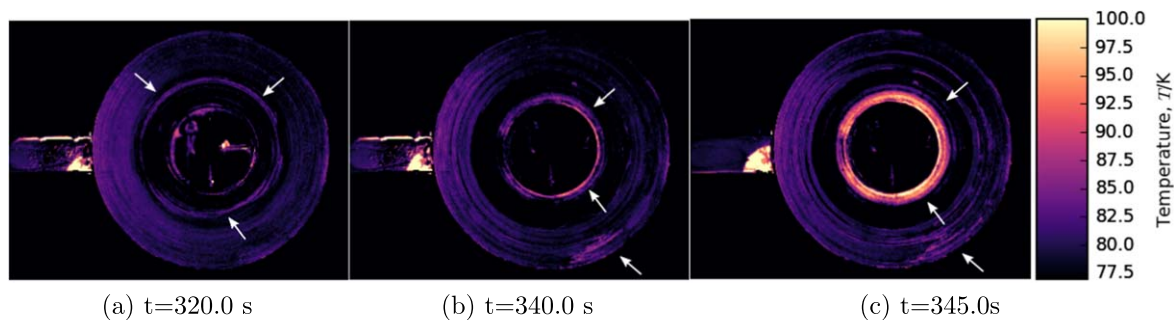
**Figure 6.** Thermal images of the coil during the 74 A over-current test showing different time points just before and at the moment of thermal runaway and ramping down. The white arrows indicate features, as described in the text.

supplementary video<sup>3</sup>) one can identify a stage between figures 6(a) and (b). Between these times the middle turns of the coil actually cooled down, and when the voltage continued to rise, the central windings started heating up instead. A possible explanation is that when the coil voltage is low, only the ‘major’ defects in the coil can be bypassed. However, at higher voltages, more current can be forced through the turn-to-turn contact resistances, thereby reducing the current in the superconductor as well as the local heating. Due to the fact that the energy is dissipated over a larger volume, this could then manifest in a form of a local cooling effect. Then in figure 6(c), the center windings see the combined effect of superconducting to resistive transition of the HTS due to the reduced temperature margin and high magnetic field, combined with the current bypass and joule heating due to the resistive joints. To check for damages, after each measurement, the coil resistance was measured and compared with its previous values. At the end, a second  $I_c$  measurement was also done and no degradation was observed.
